Inspection Photos
Location Name: SANTA FE 43-27 AND TR
API #: 05-071-07803
Insp. Doc. # 695100355

COLORADO
Oil & Gas Conservation
Commission
Department of Natural Resources

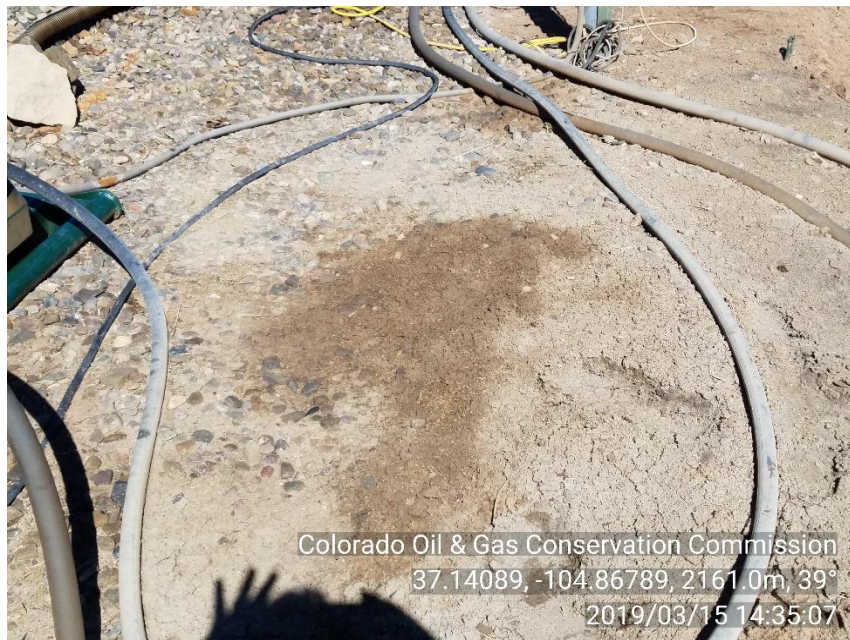
PHOTO 3: IMPACTED SOIL ON EAST SIDE OF COMPRESSOR

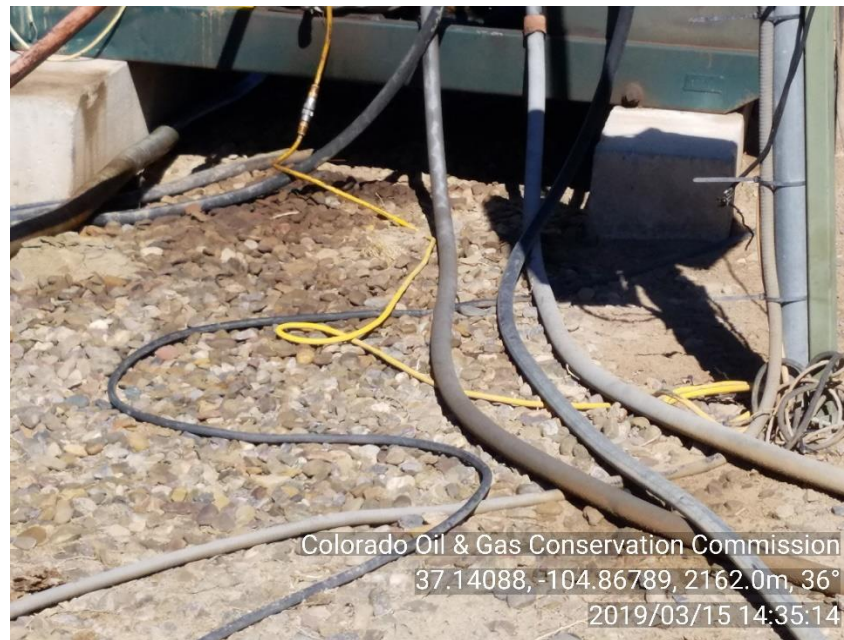
PHOTO 4: IMPACTED SOIL IN SEVERAL SPOTS ON SOUTH SIDE OF ENGINE SKID

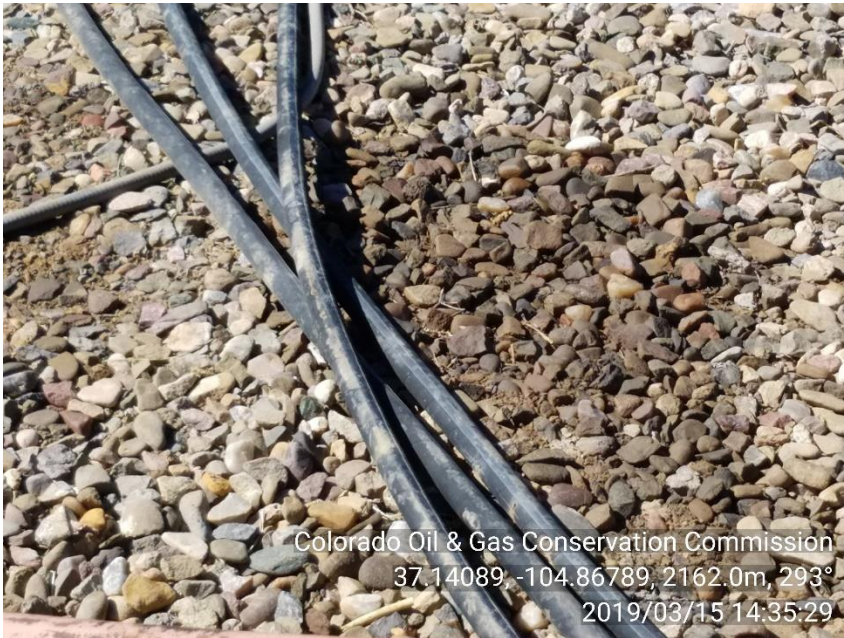
PHOTO 5: IMPACTED SOIL BETWEEN ENGINE SKID AND WELLHEAD ALONG HYDRAULIC HOSES

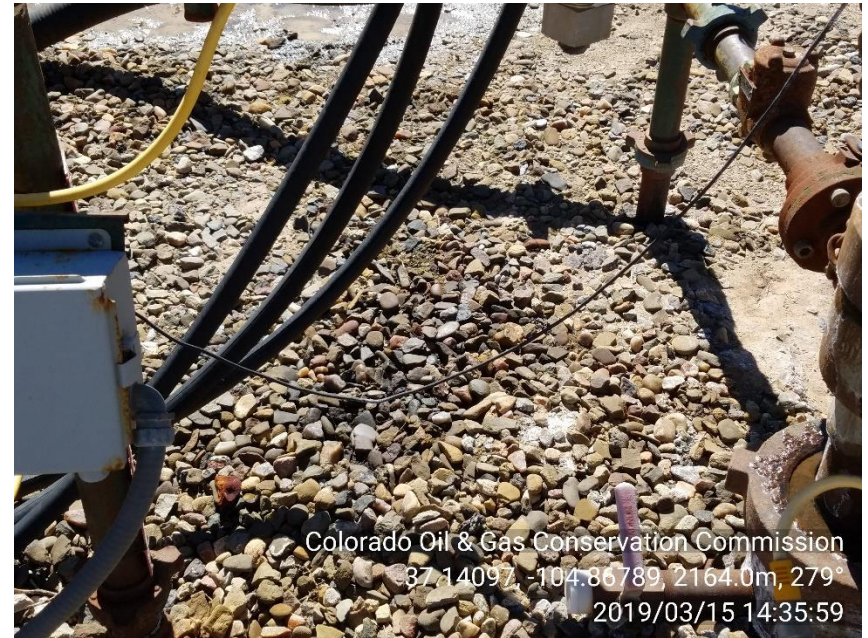
PHOTO 6: IMPACTED SOIL IN SEVERAL SPOTS AROUND WELLHEAD

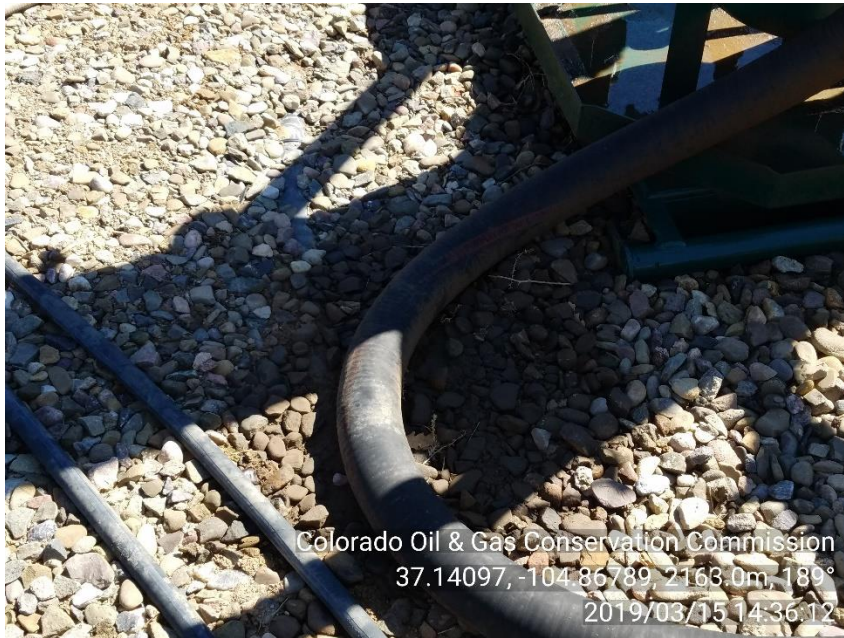
PHOTO 7: IMPACTED SOIL ON WEST SIDE OF COMPRESSOR
