Inspection Photos
Location Name: PACHECO 33-27 TR
API #: 05-071-08384
Insp. Doc. # 695100357

COLORADO
Oil & Gas Conservation
Commission
Department of Natural Resources

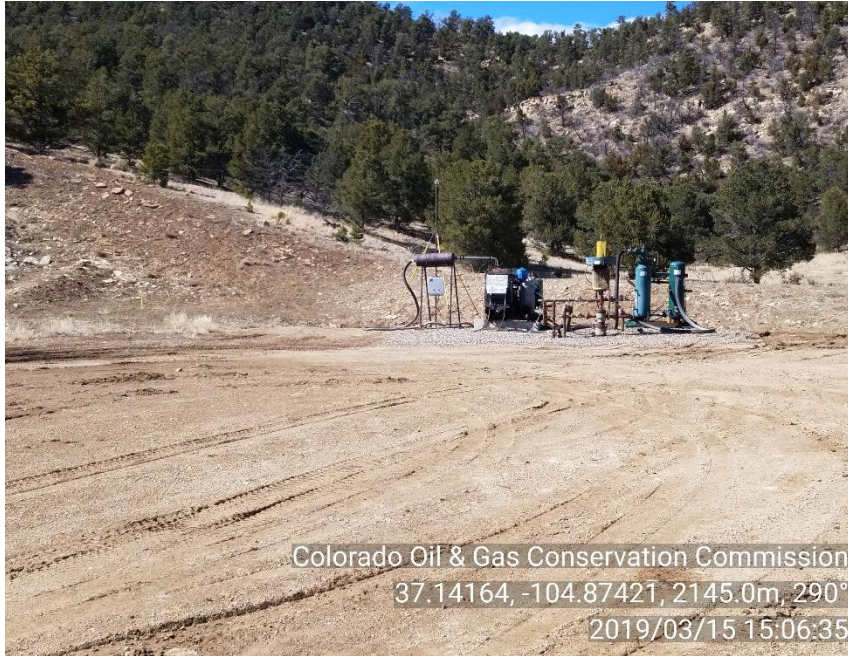
PHOTO 1: LOCATION

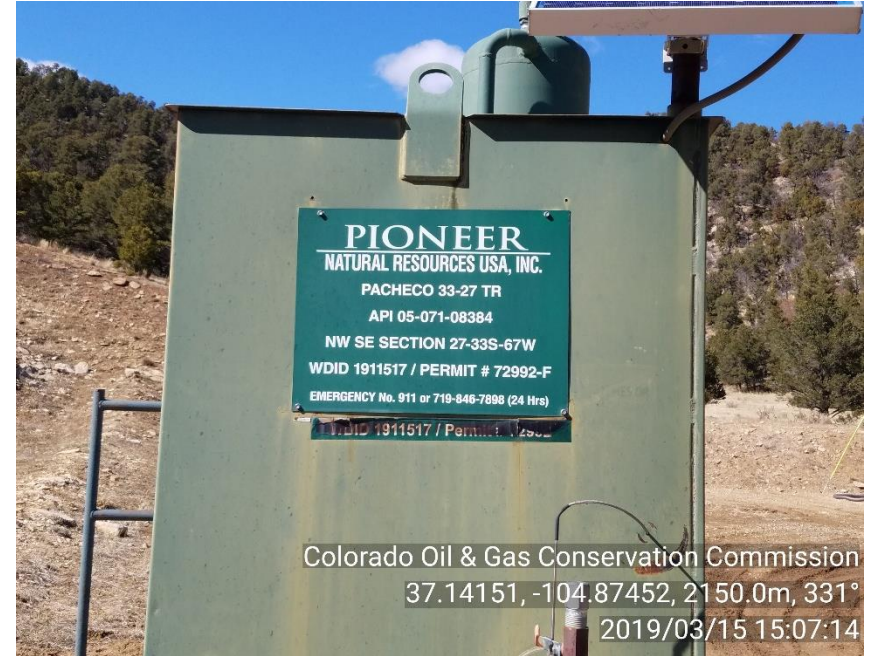
PHOTO 2: WELL SIGN/METER HOUSE

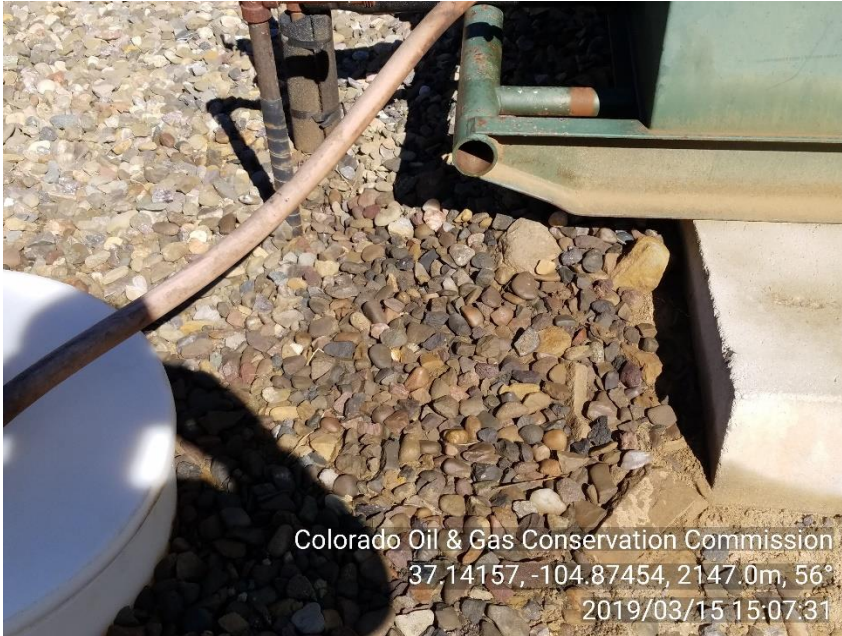
PHOTO 3: IMPACTED SOIL ON NORTH SIDE OF METER HOUSE

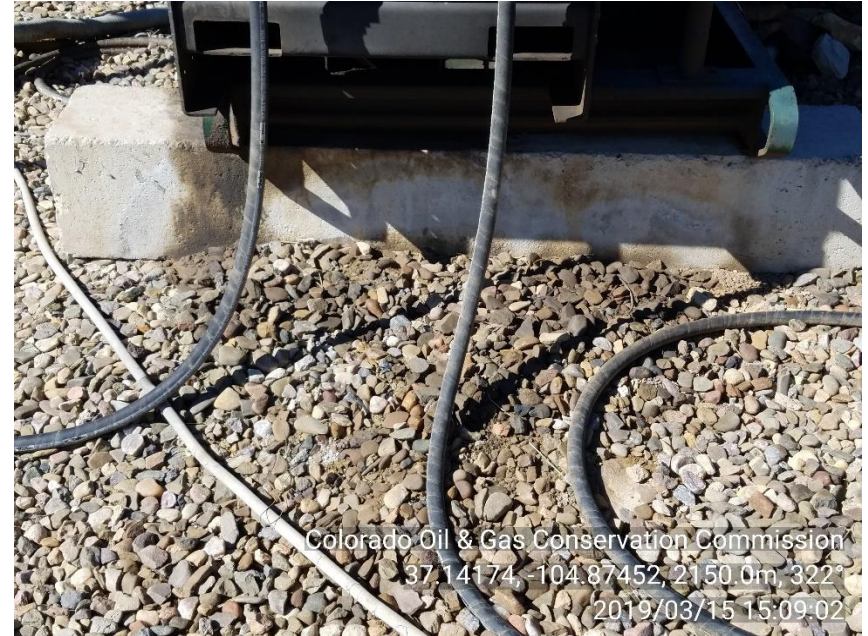
PHOTO 4: IMPACTED SOIL ON WEST SIDE OF ENGINE SKID

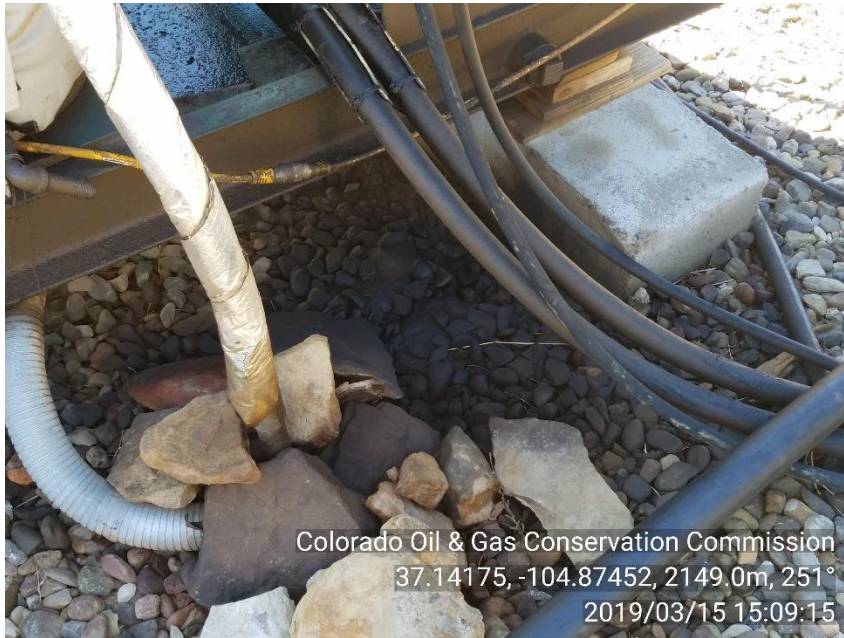
PHOTO 5: IMPACTED SOIL ON EAST SIDE OF ENGINE SKID

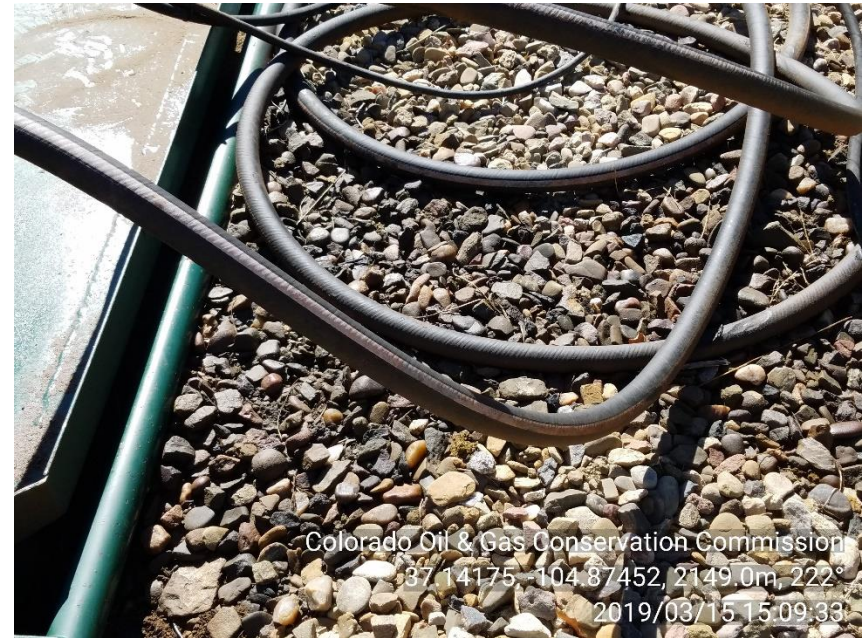
PHOTO 6: IMPACTED SOIL ON EAST SIDE OF COMPRESSOR
