# Inspection Photos

Operator: VERDAD RESOURCES LLC # 10651

Location ID: 462872

Inspection Doc. Number: 682504597

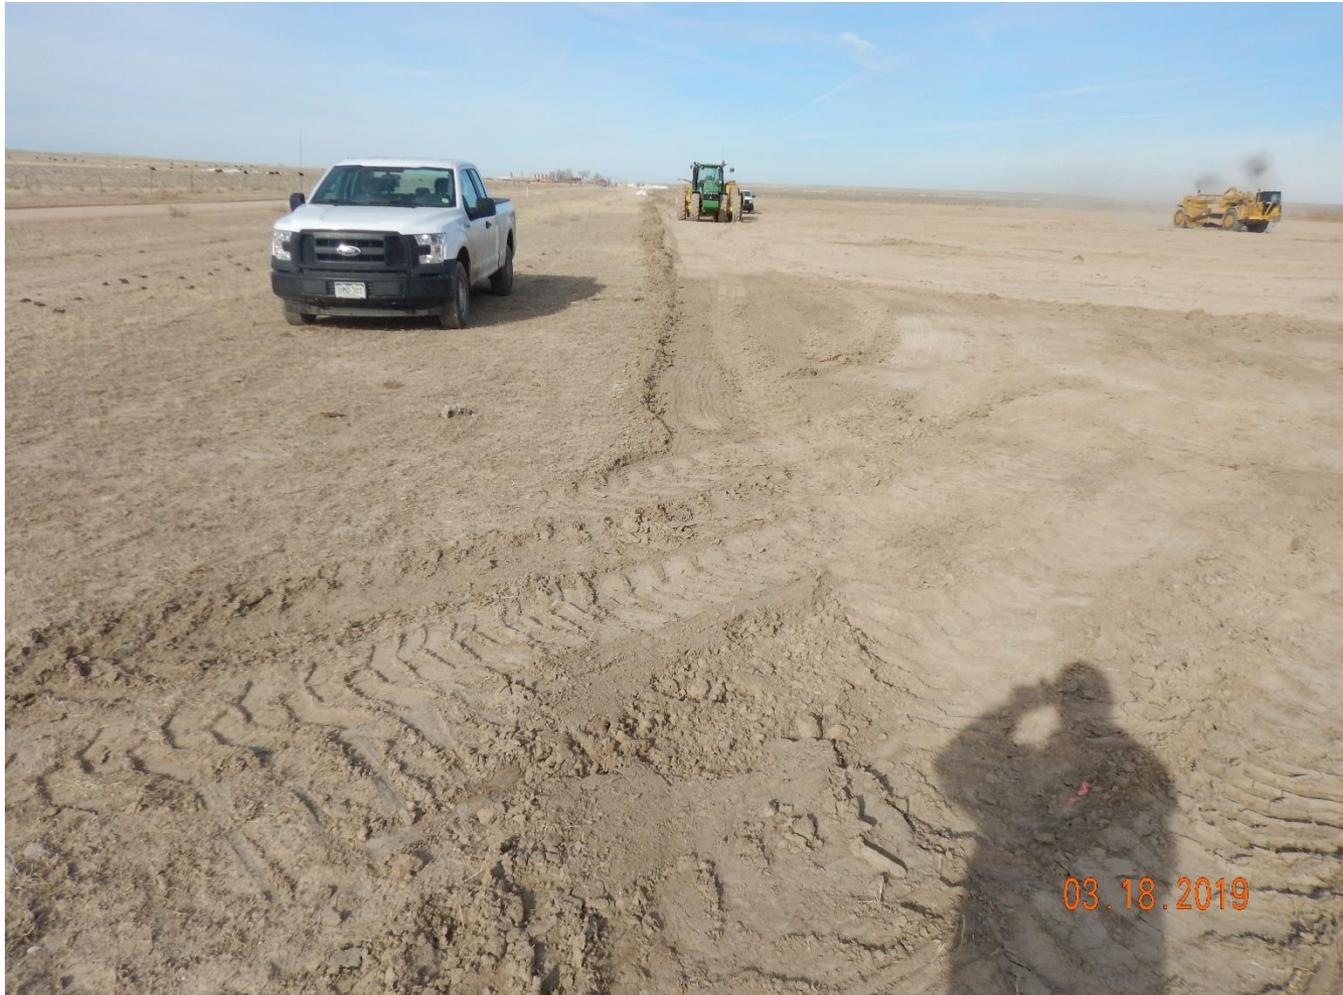
**Photo 1:** Photo taken from the southeast corner of the location, facing west. Photo provides overview of construction in-process. Photo also shows operator failed to install perimeter stormwater and erosion control BMPs prior to construction activities in accordance with Rule 1002.f and COAs from the permitted 2A

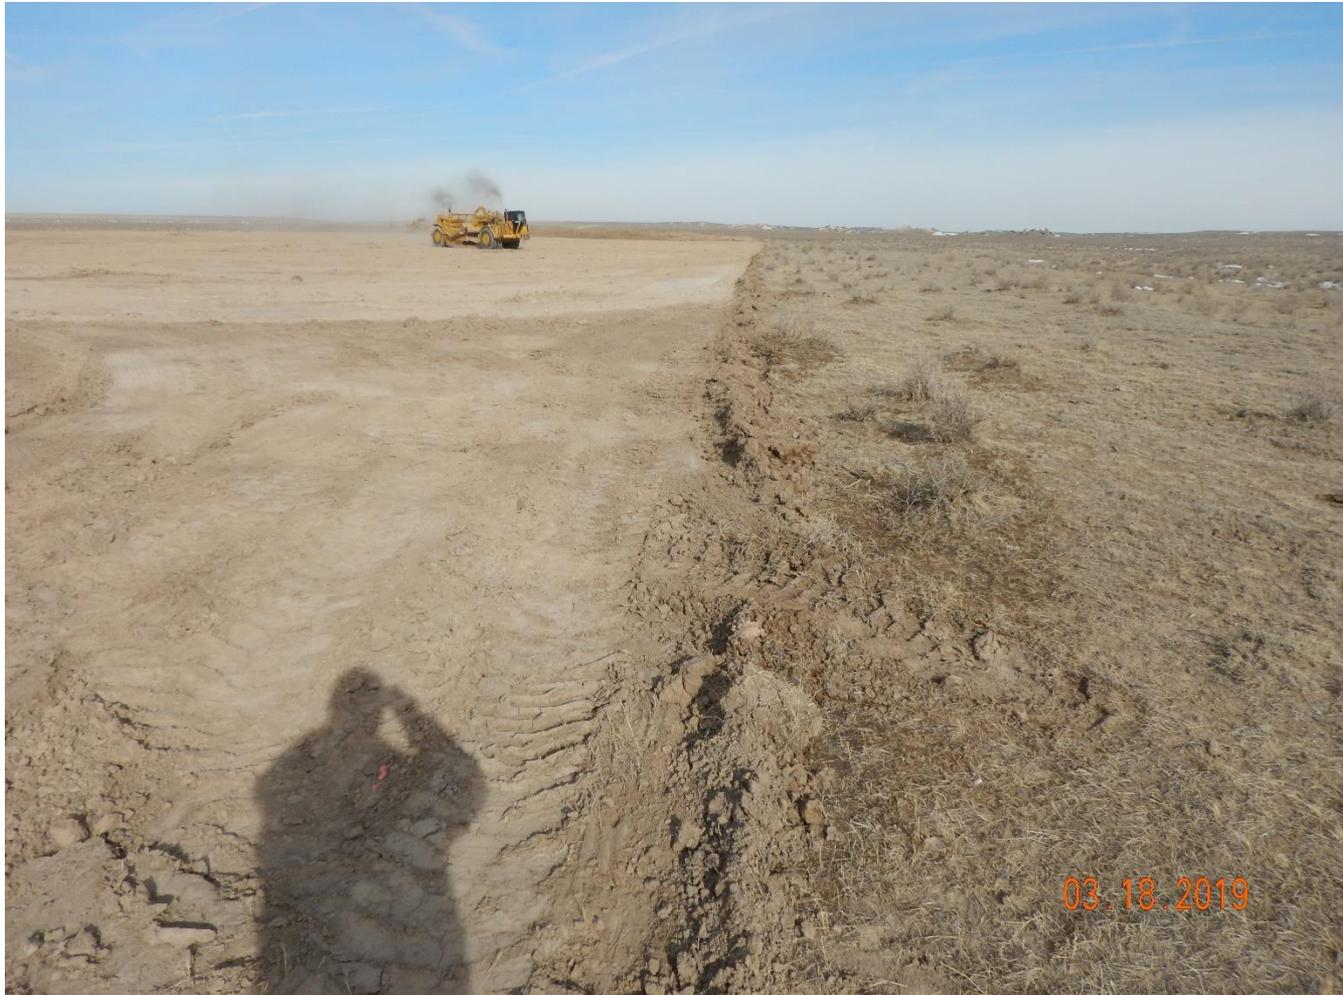
**Photo 2:** Photo taken from the southeast corner of the location, facing north. See comments under photo 1.

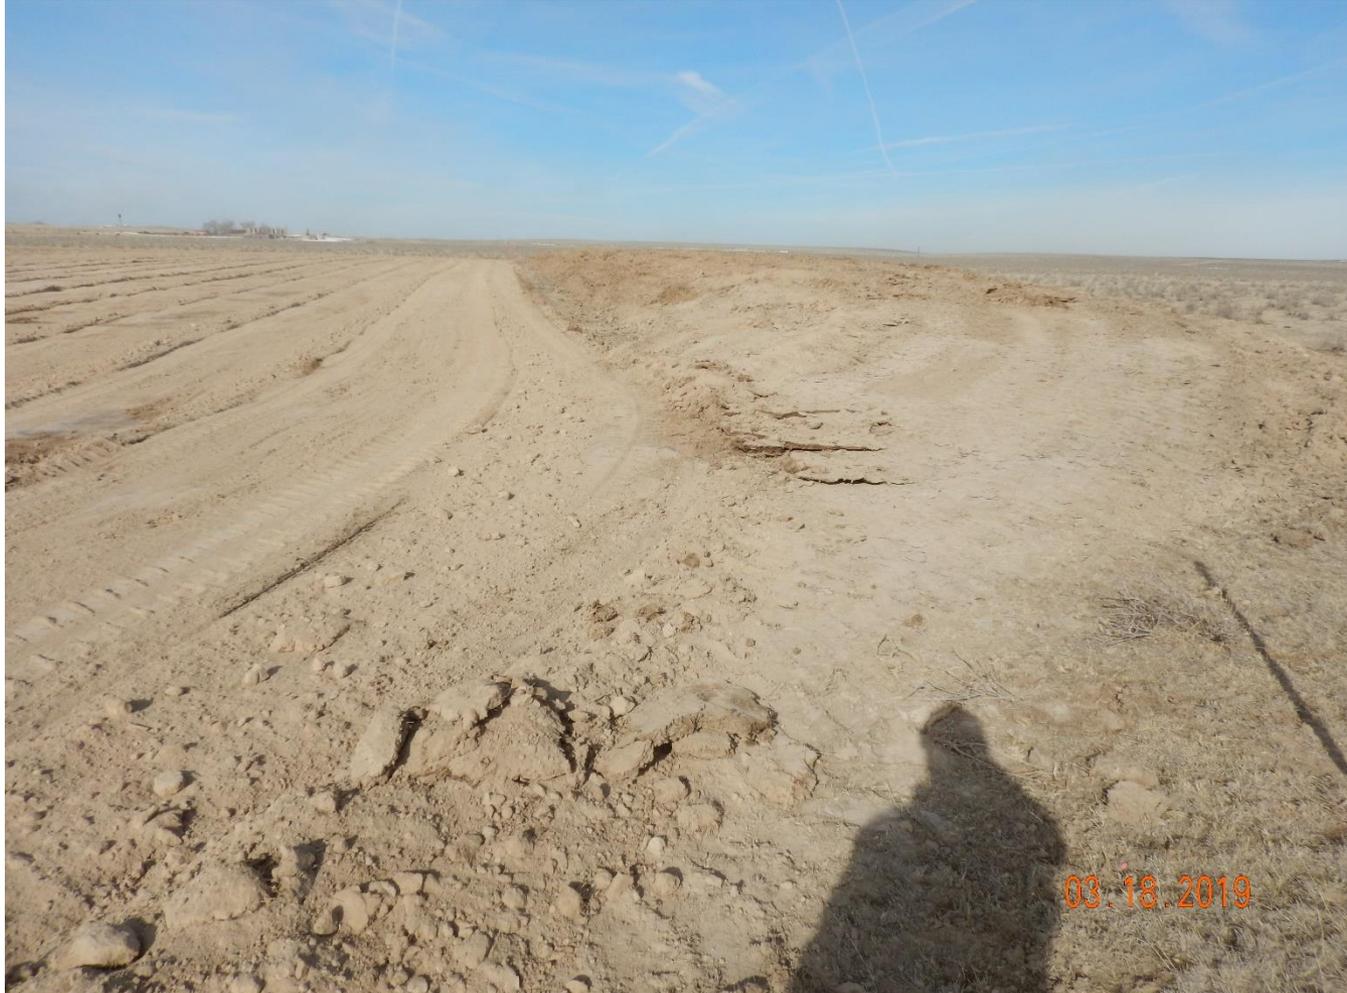
**Photo 3:** Photo taken from the northeast end of the location, facing west. Photo shows topsoil stockpile. Ensure BMPs are implemented to protect stockpiled soils in accordance with 1002.c

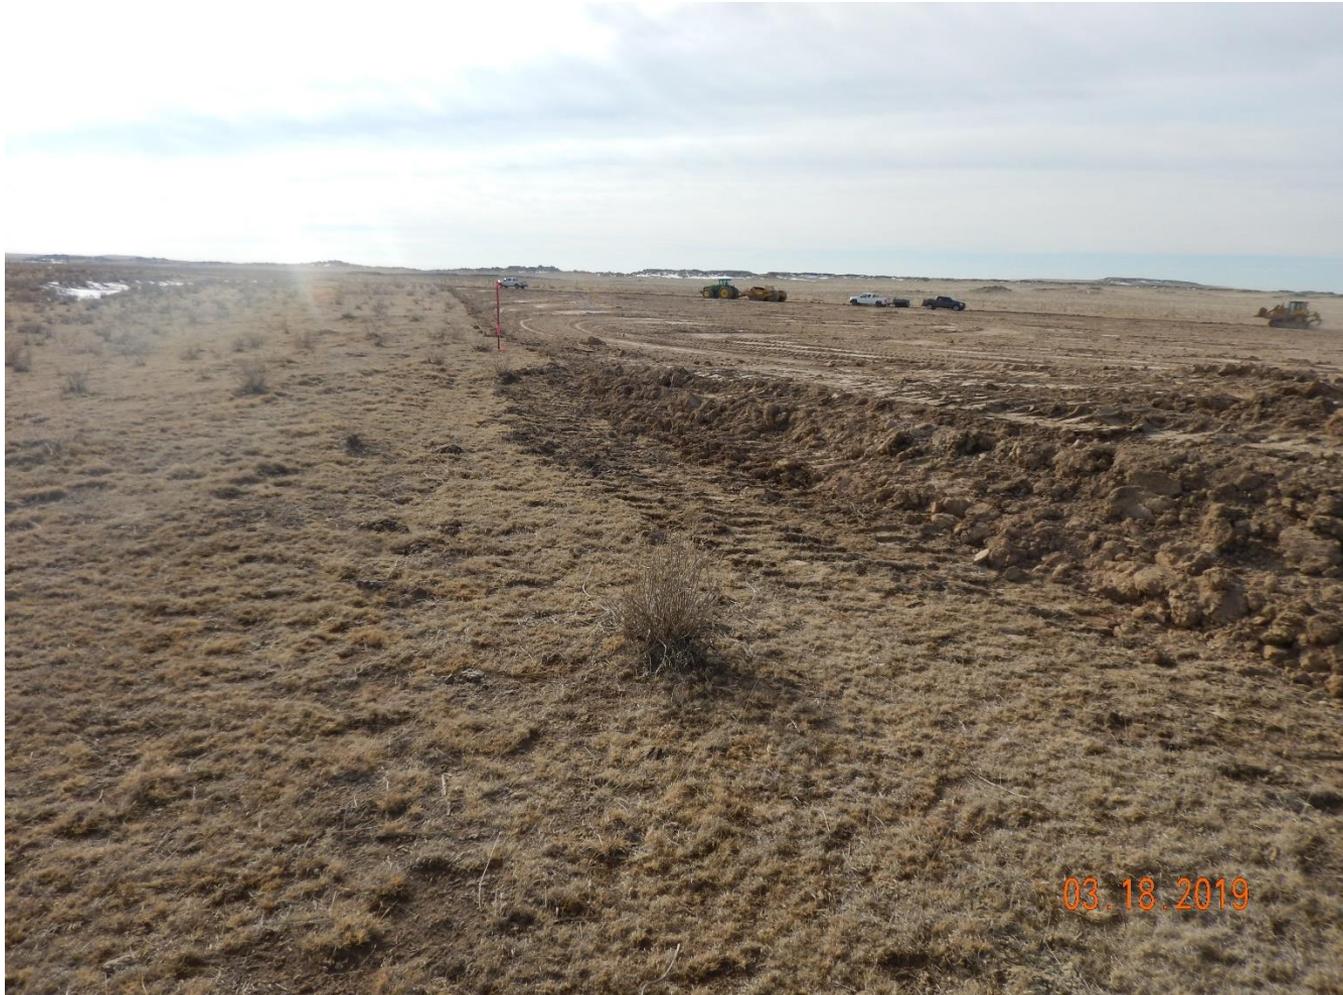
**Photo 4:** Photo taken from the northeast corner of the location, facing south. See comments under photo 1.

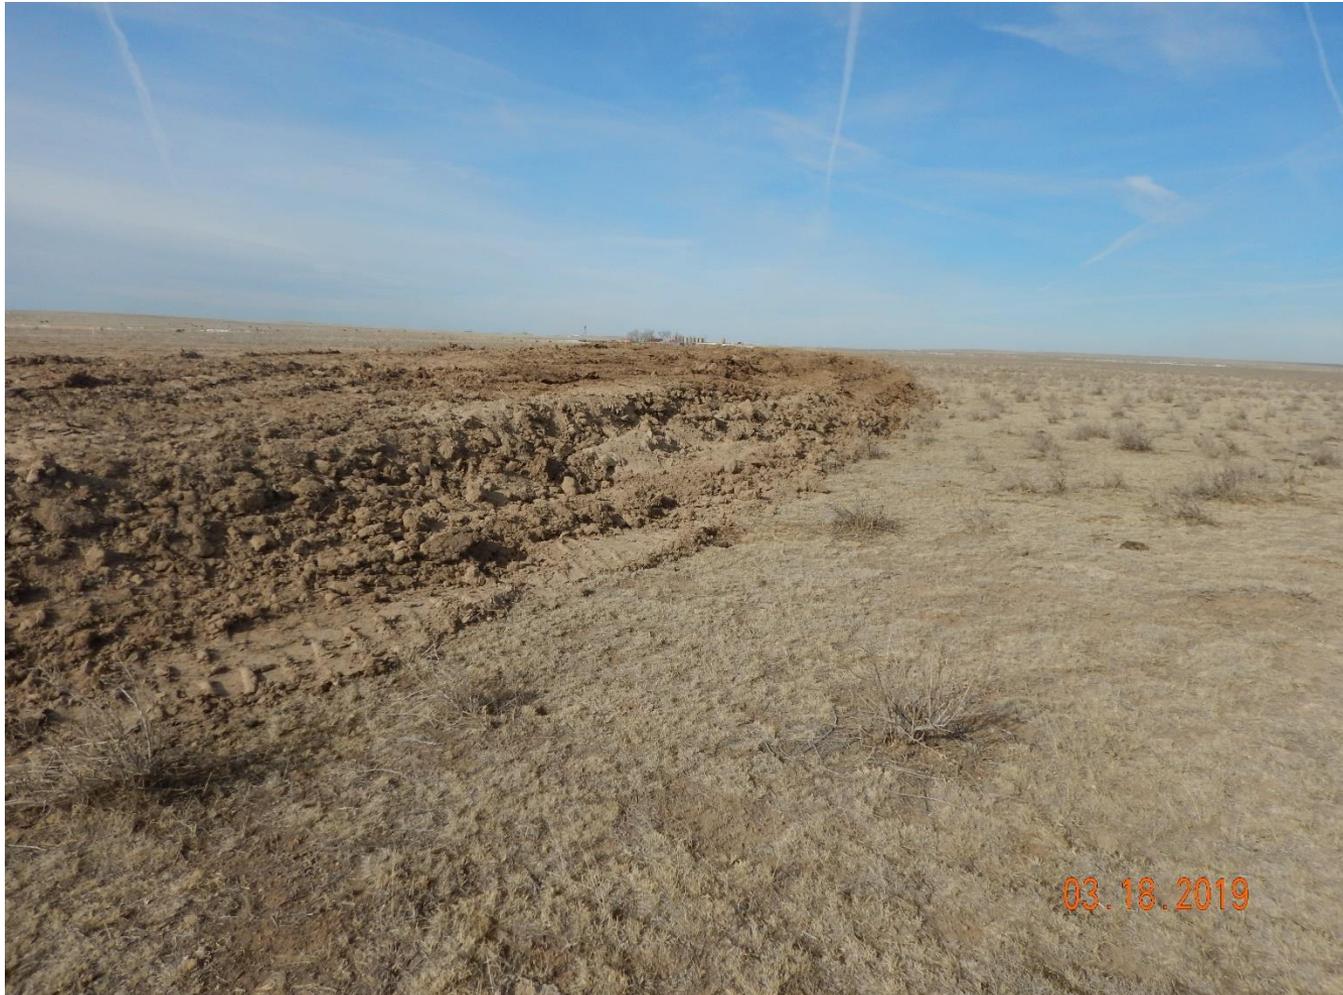
**Photo 5:** Photo taken from the northeast corner of the location, facing west. See comments under photo 1.

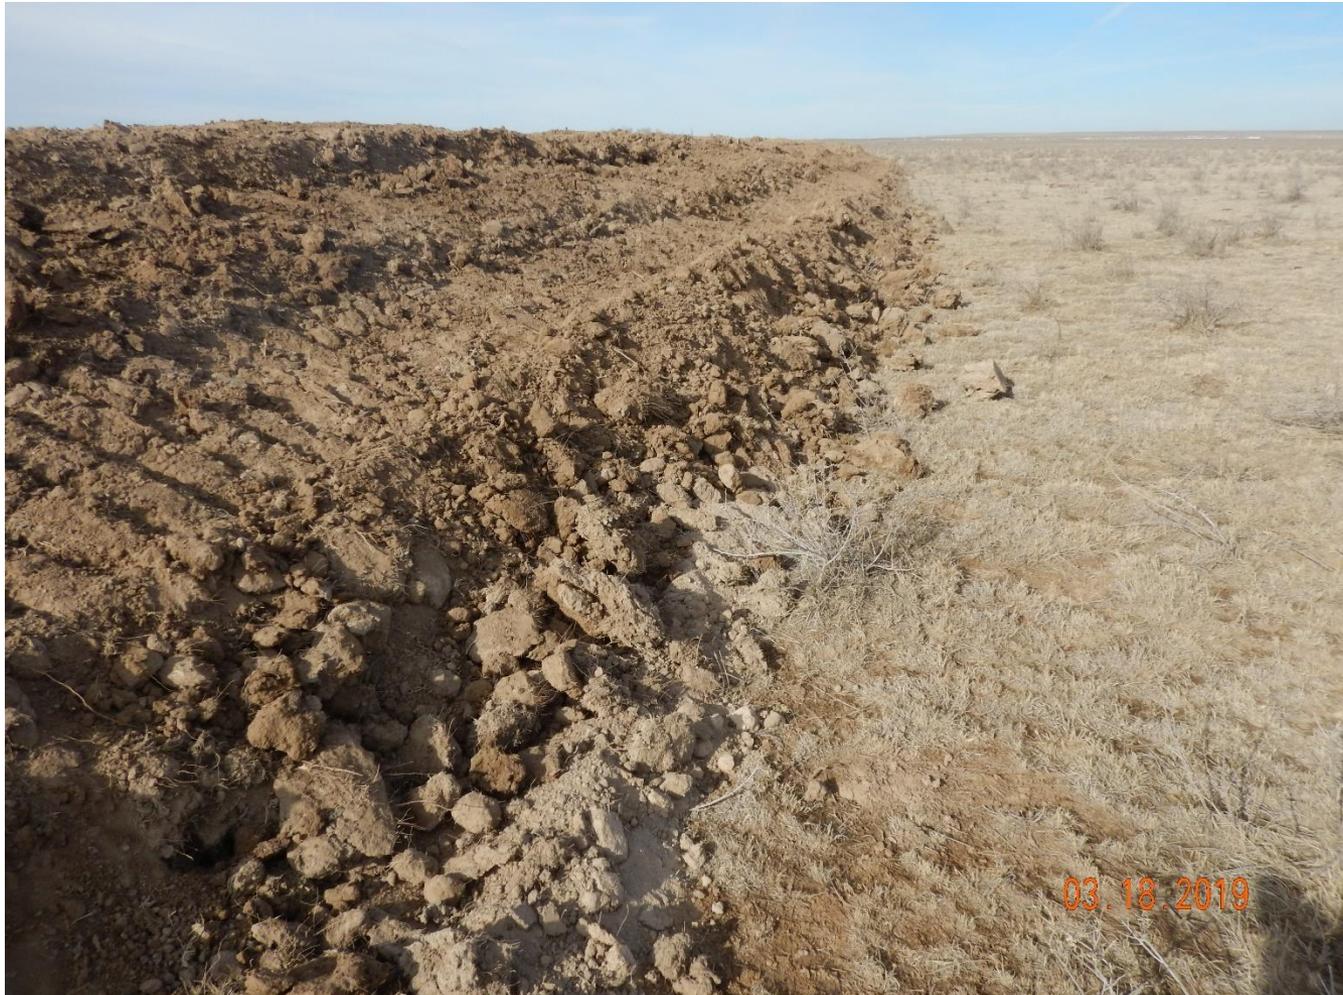
**Photo 6:** Photo taken from the topsoil stockpile on the north end of the location, facing west. See comments under photo 1.

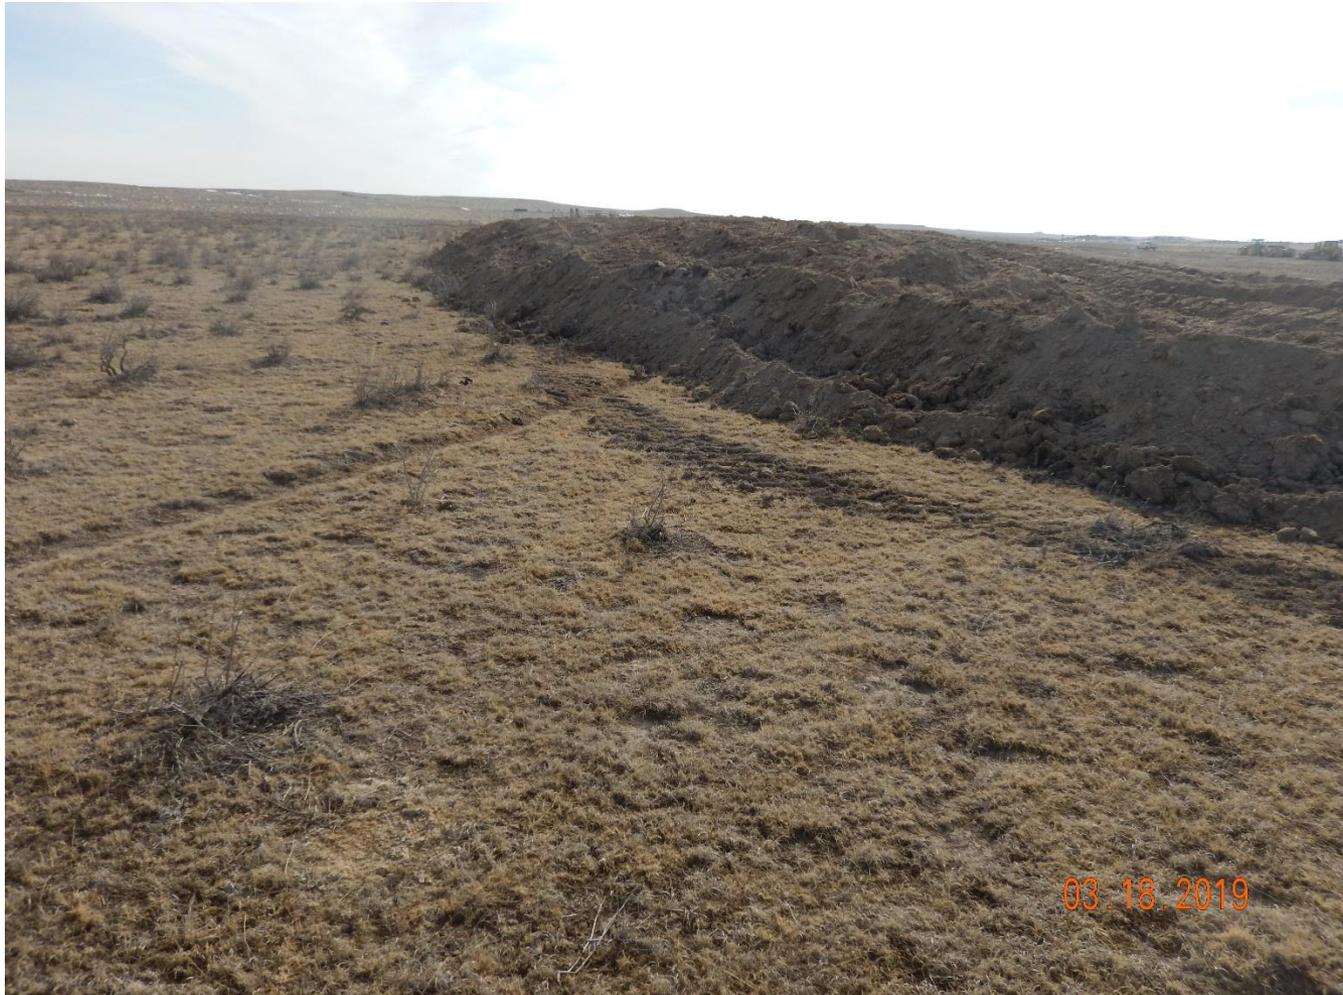
**Photo 7:** Photo taken from the northwest corner of the location, facing east. See comments under photo 1.

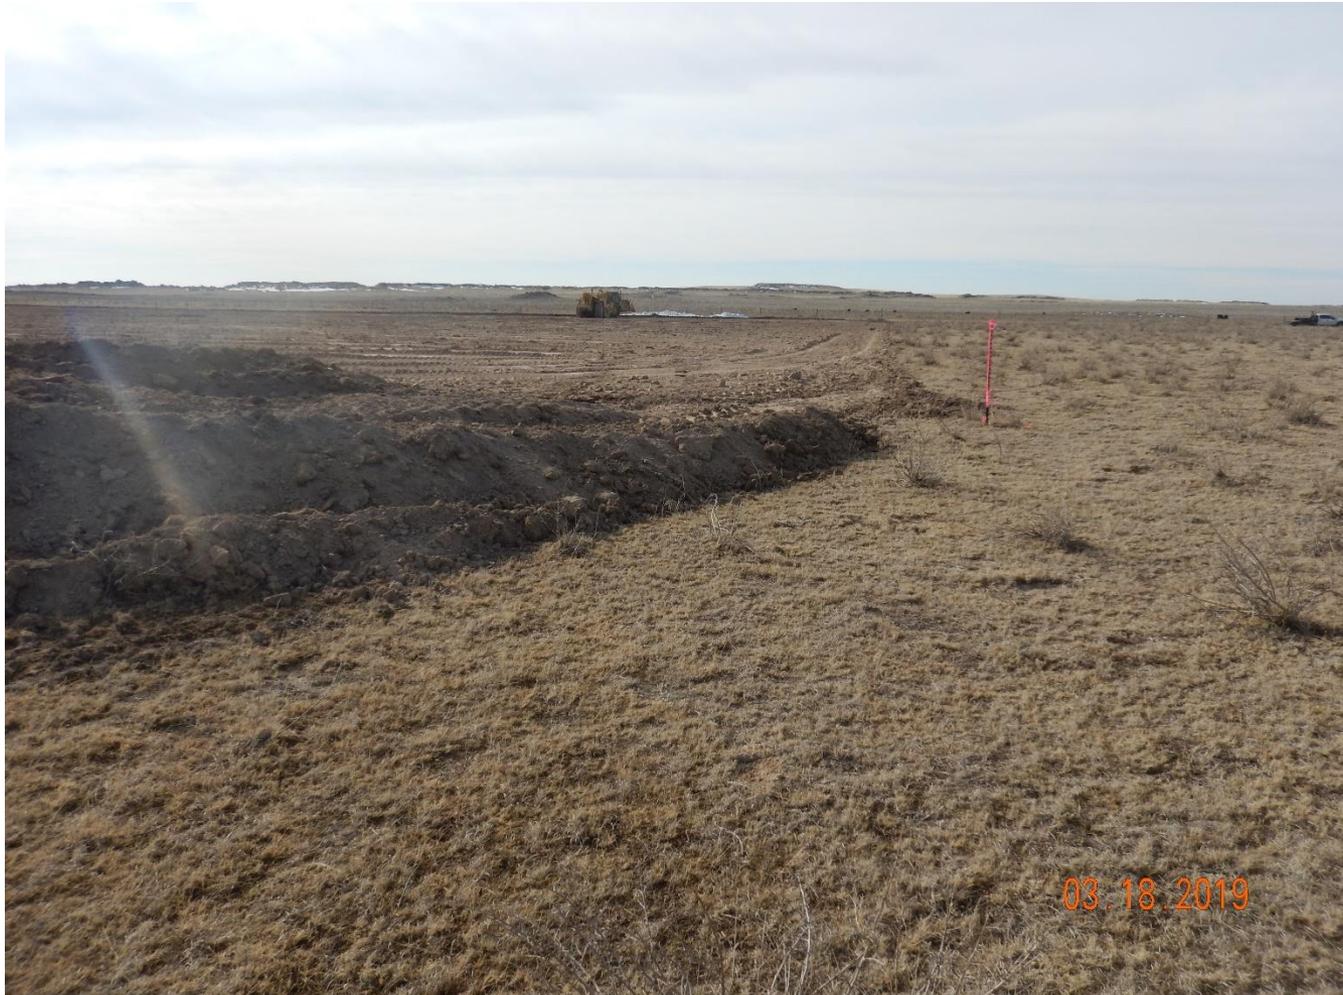
**Photo 8:** Photo taken from the northwest corner of the location, facing south. See comments under photo 1.

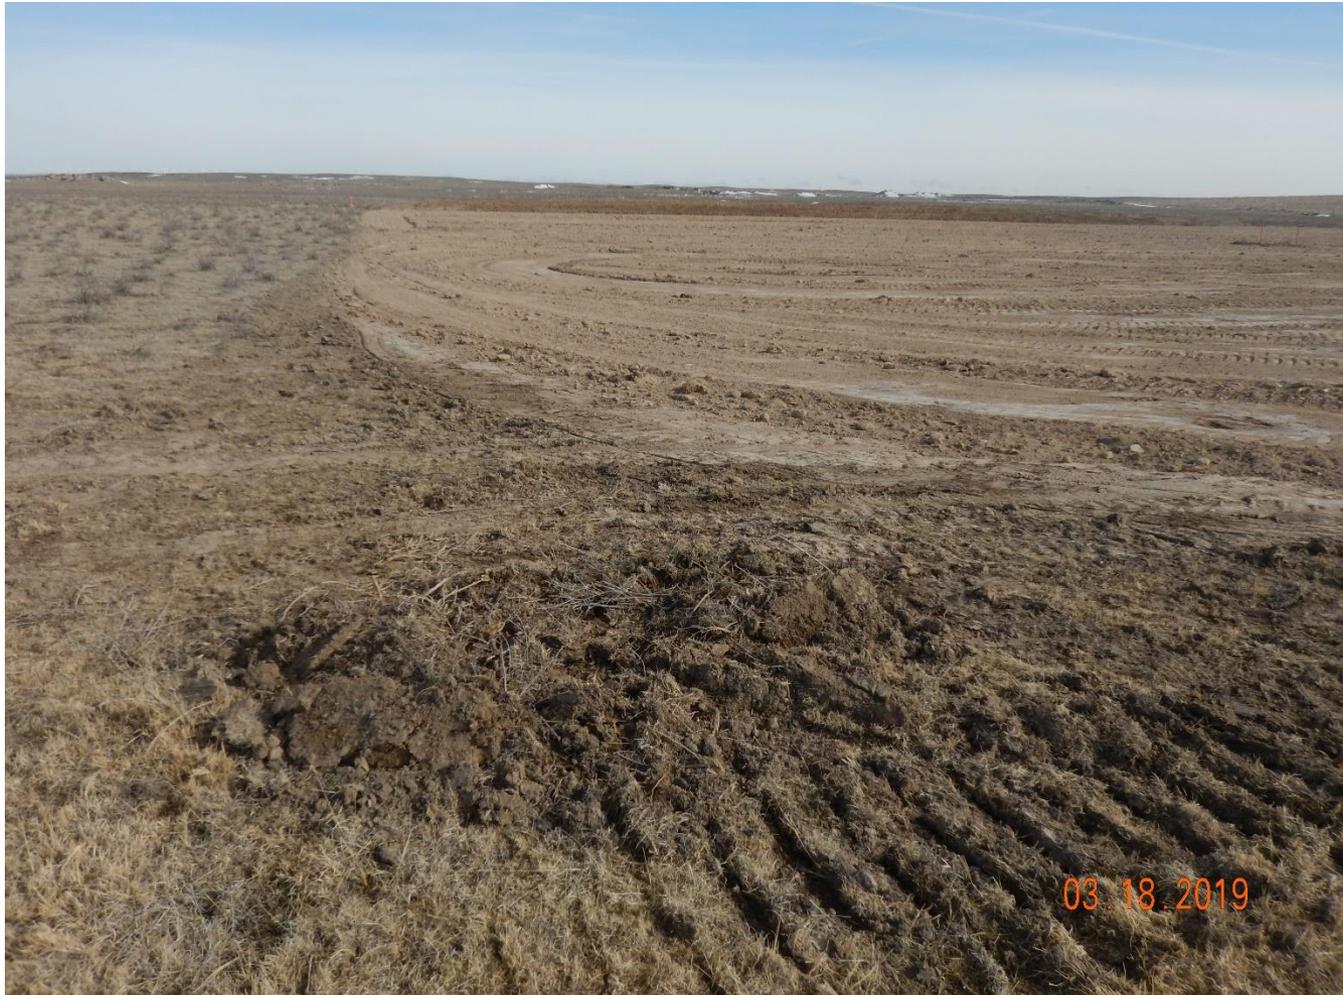
**Photo 9:** Photo taken from the southwest corner of the location, facing north. See comments under photo 1.

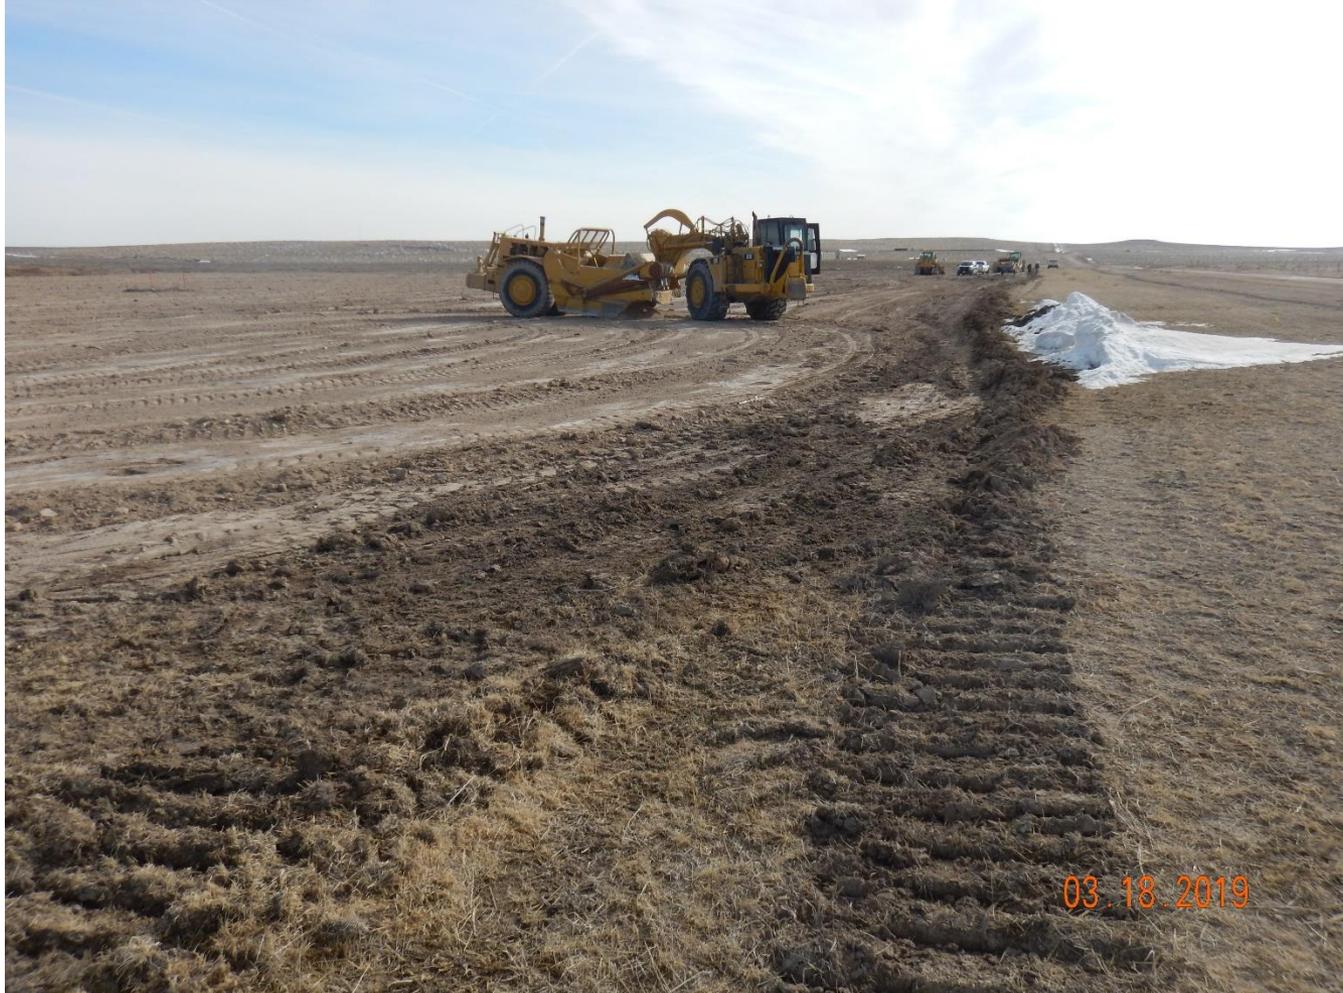
**Photo 10:** Photo taken from the southwest corner of the location, facing east. See comments under photo 1.
