PIT STATUS EVALUATION FORM

Facility ID: 115117

Pit Name: MCCOY 32-5 1

COGCC Database Information

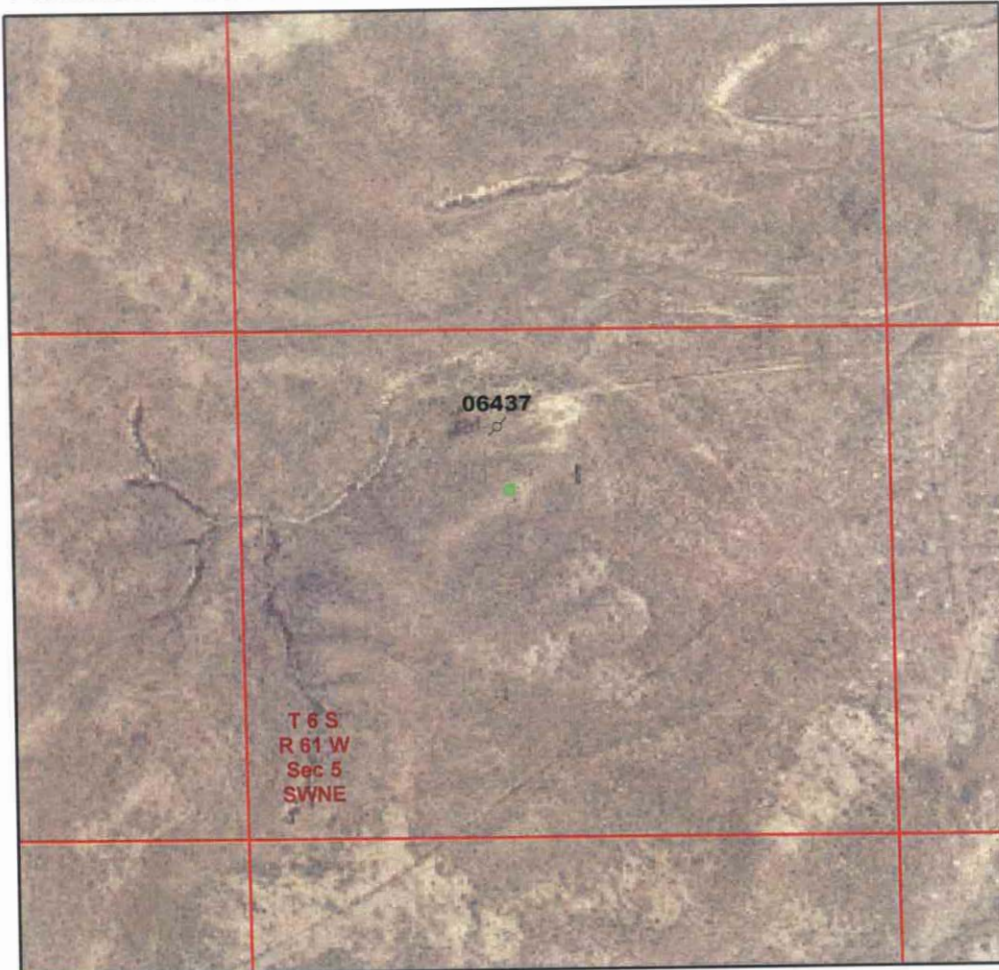
Notes: LIF (1987) 15'x15' skimpit.
WSIF (1988) pit backfilled & site clean.
