Inspection Photos
Operator: Hilcorp Energy
Location/API #: 067-09929
Date: 2-18-2019

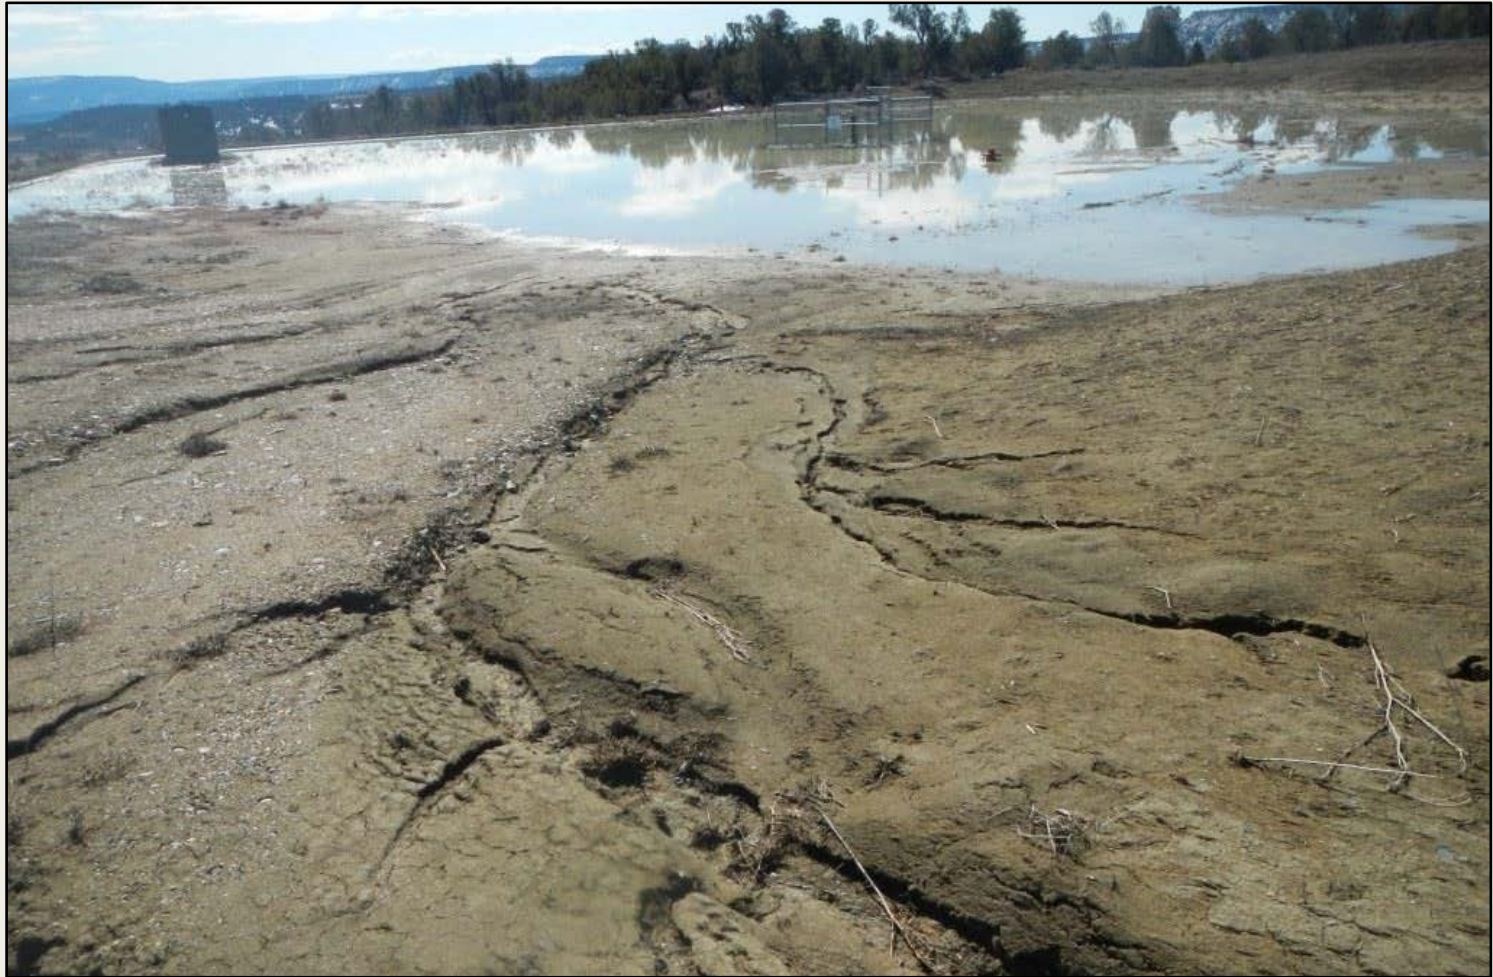
Photo 1. View of the project area from the project entrance facing center. Erosion is occurring at the entrance and water is ponded on the well pad.

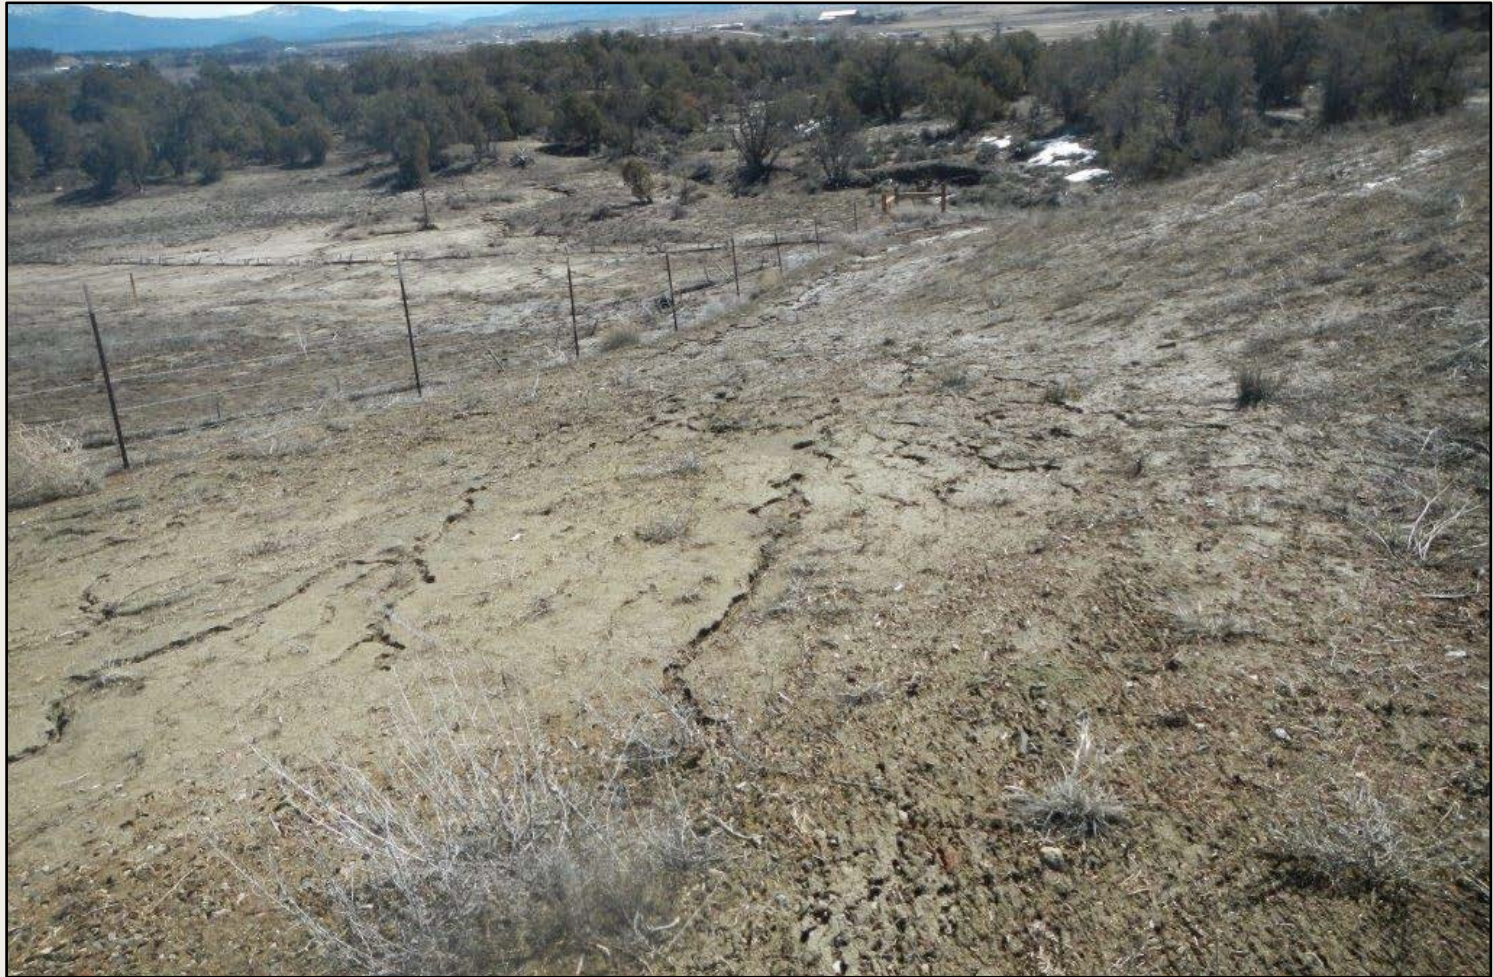
Photo 2. View of erosional rilling occurring within the northern project area, facing eastward.

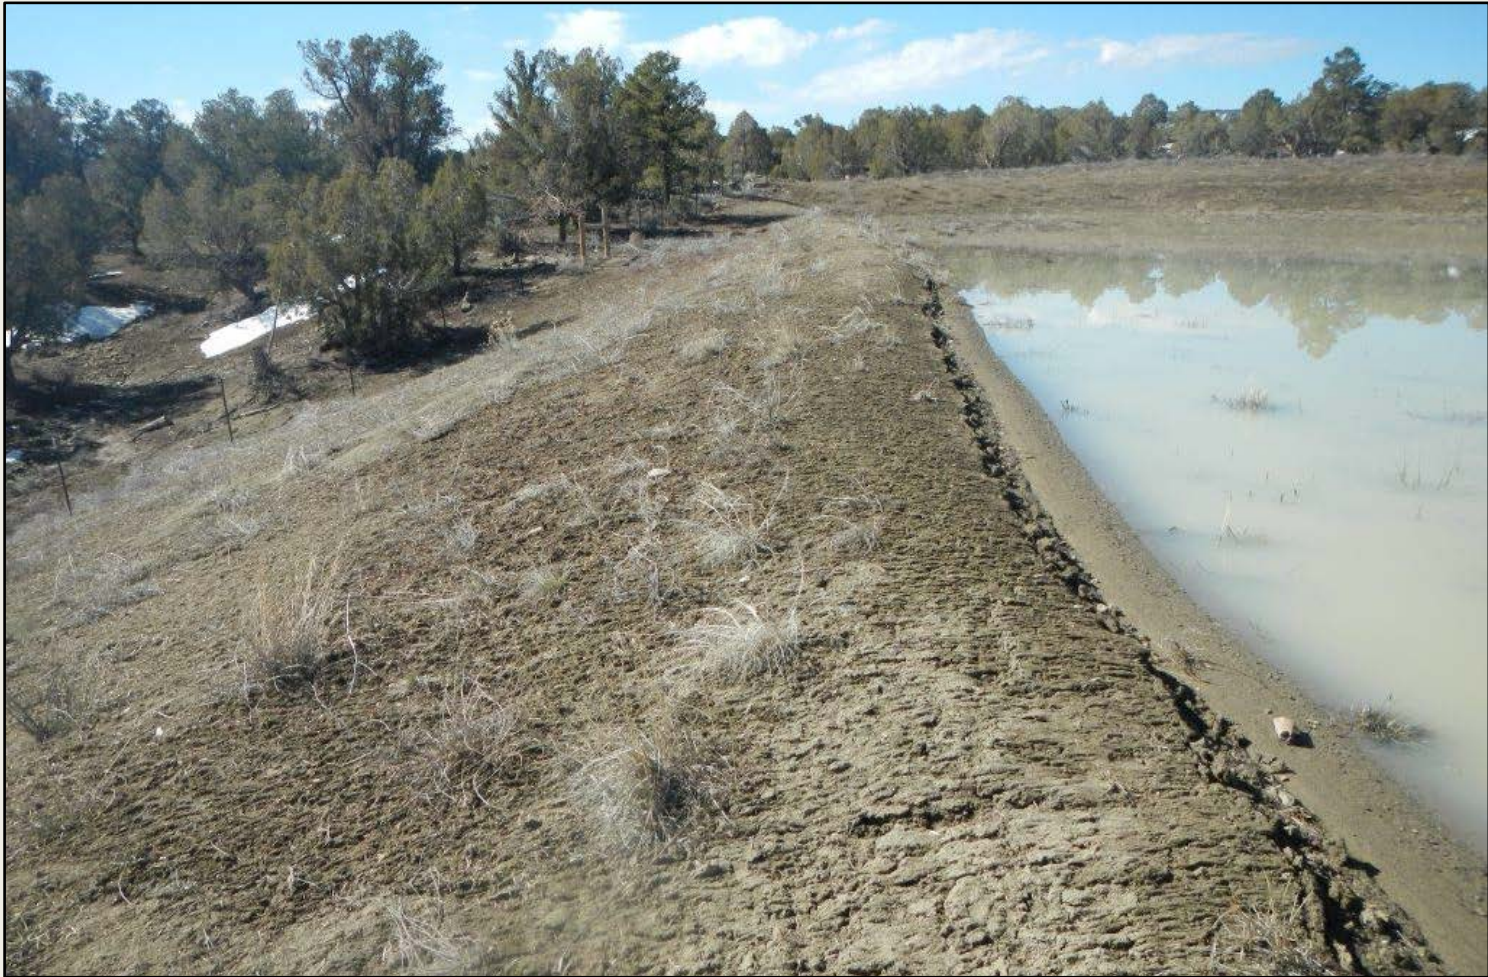
Photo 3. View of the eastern fill slope from the northeastern edge facing southward.

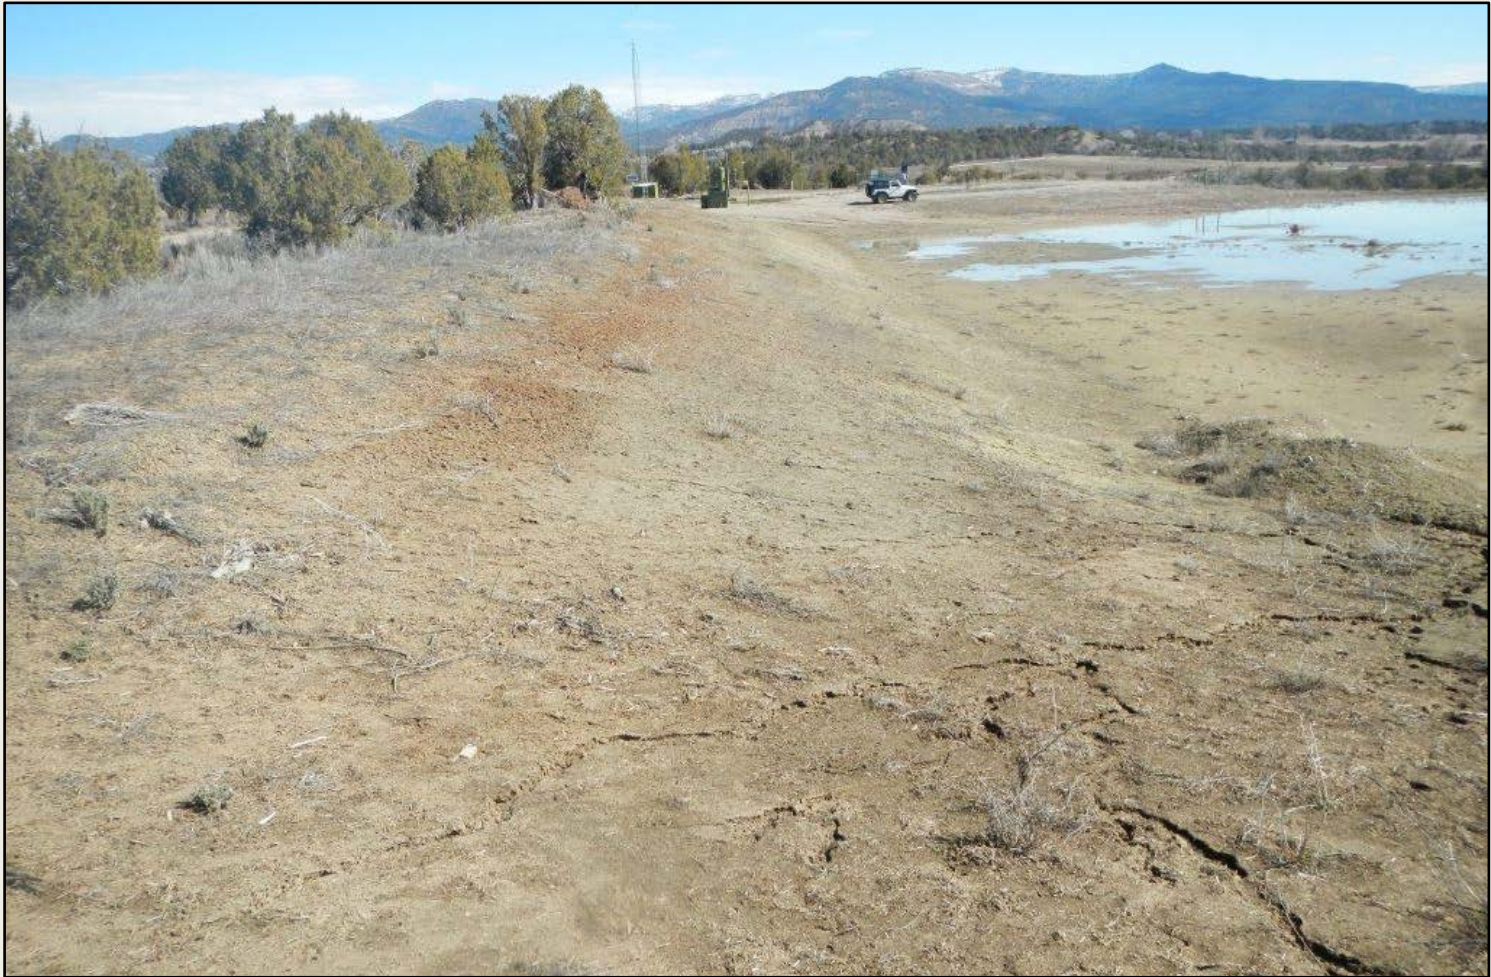
Photo 4. View of the western project area from the southwestern corner facing northward. Interim reclamation has not been conducted.

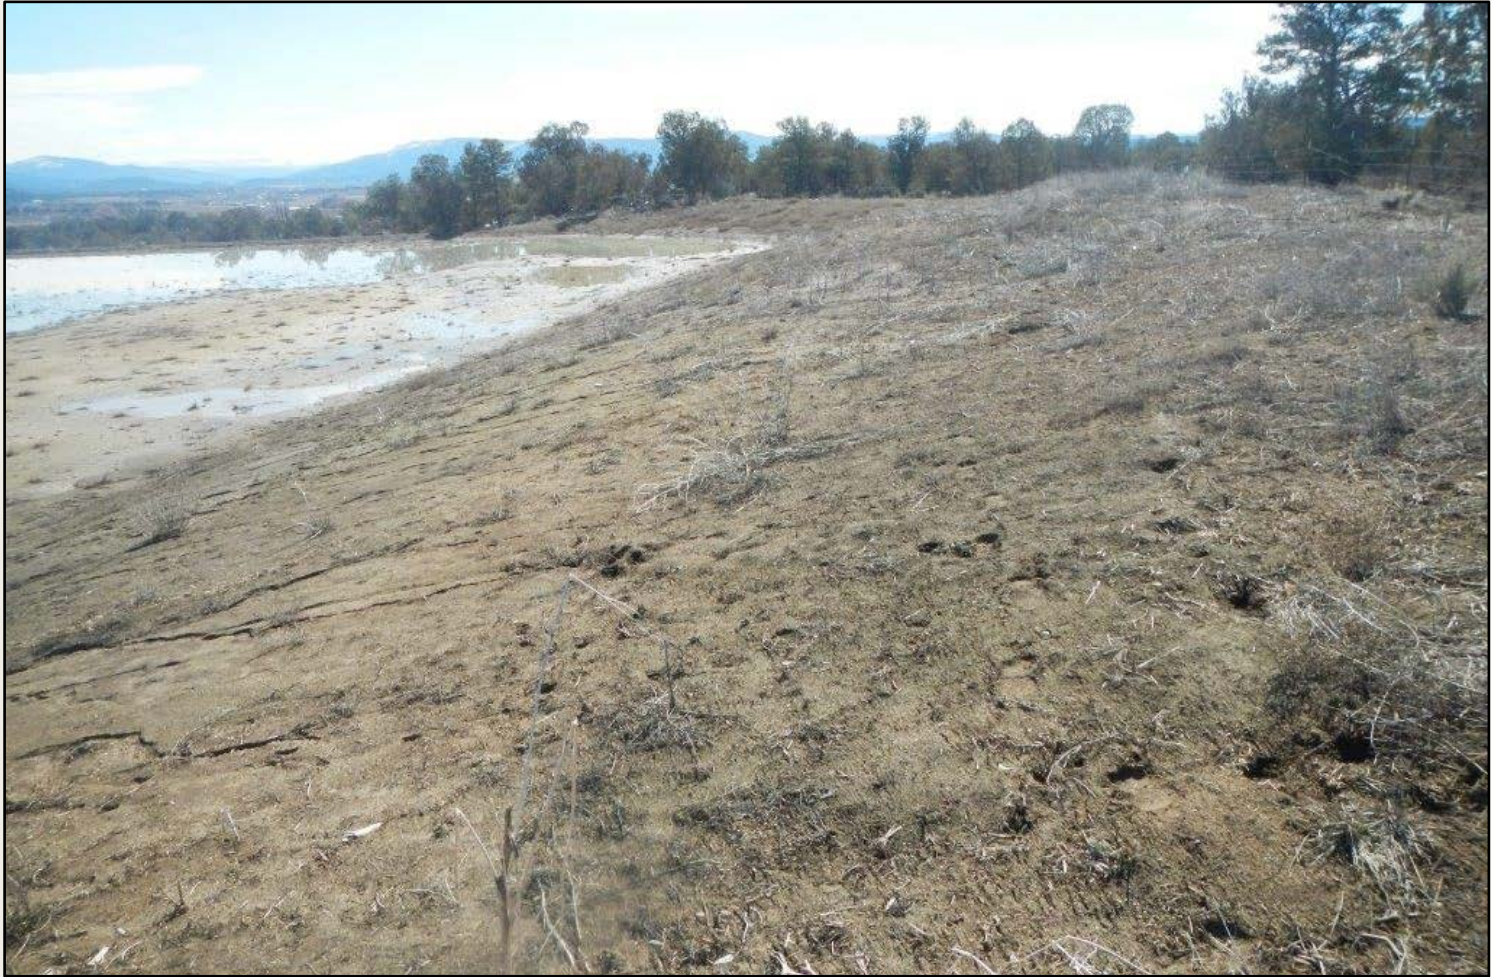
Photo 5. View of the southern project area from the southwestern edge facing eastward.
