# Inspection Photos

Operator: Rim Operating  
Location/API #: 067-08933  
Date: 2-18-2019

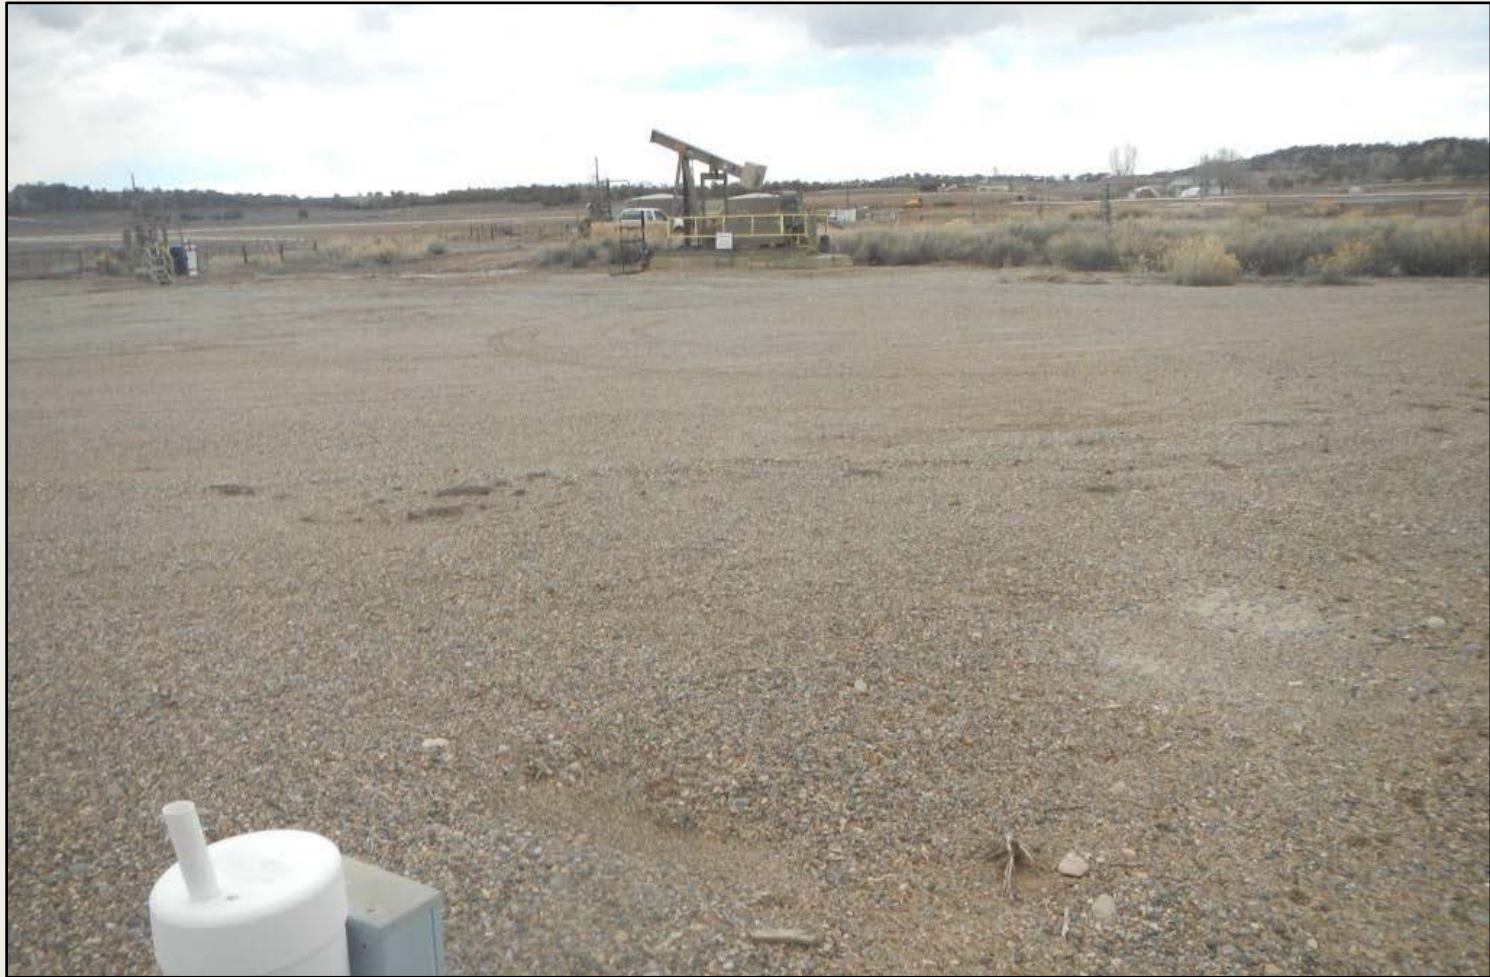
Photo 1. View of project area from the southeastern corner facing center.

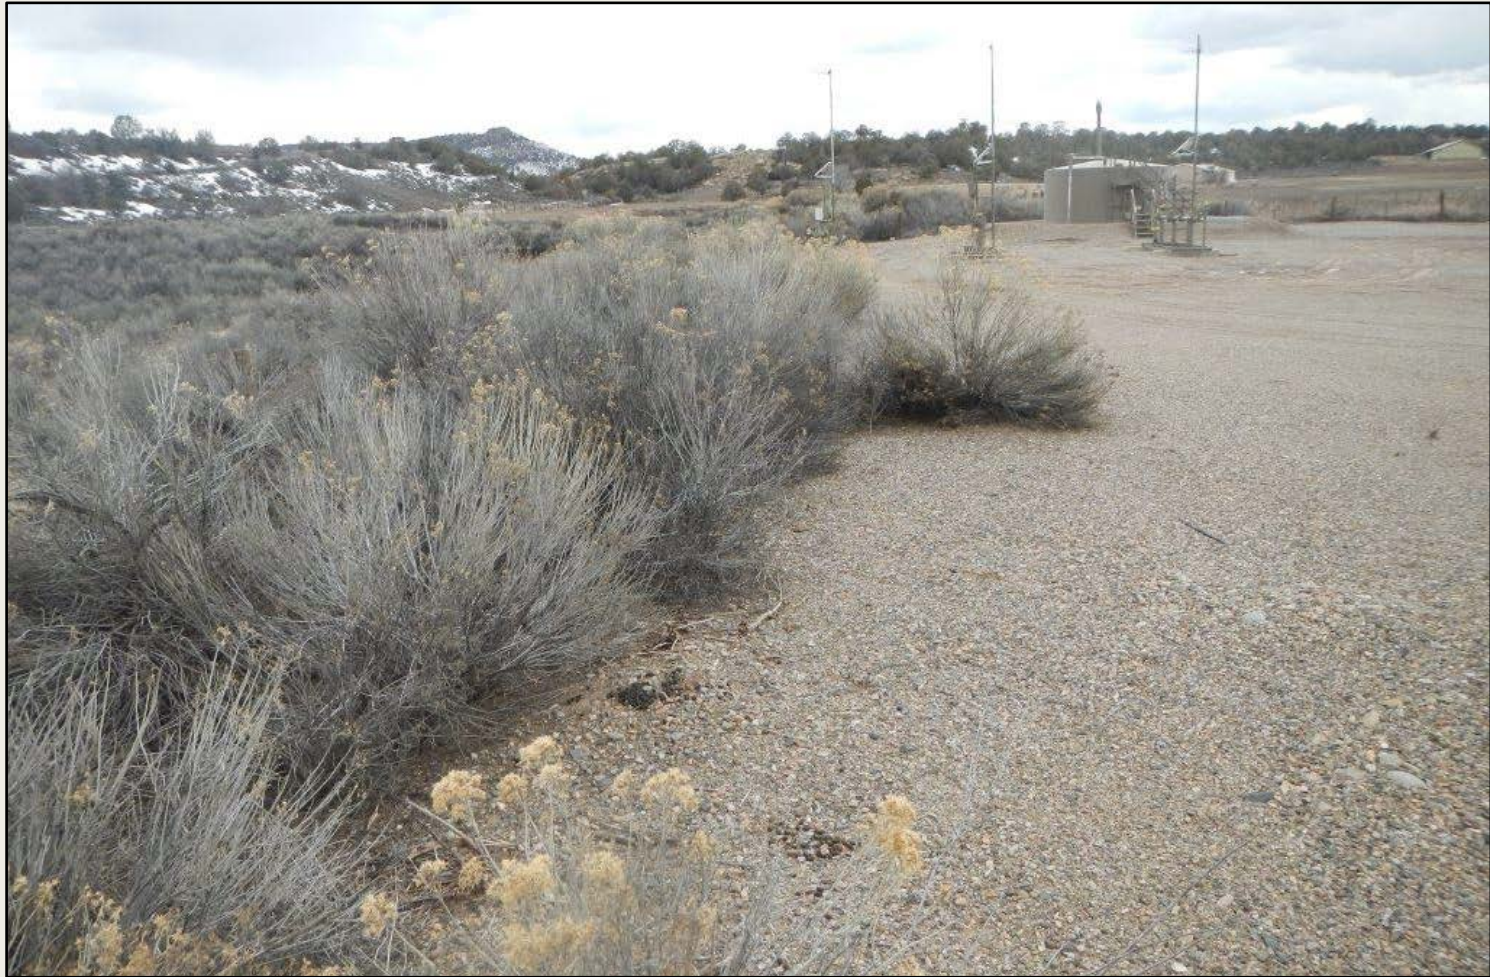
Photo 2. View of the southern project area from the southeastern edge facing westward. Revegetation is comprised of dense rubber rabbitbrush (*Chrysothamnus nauseosus*).

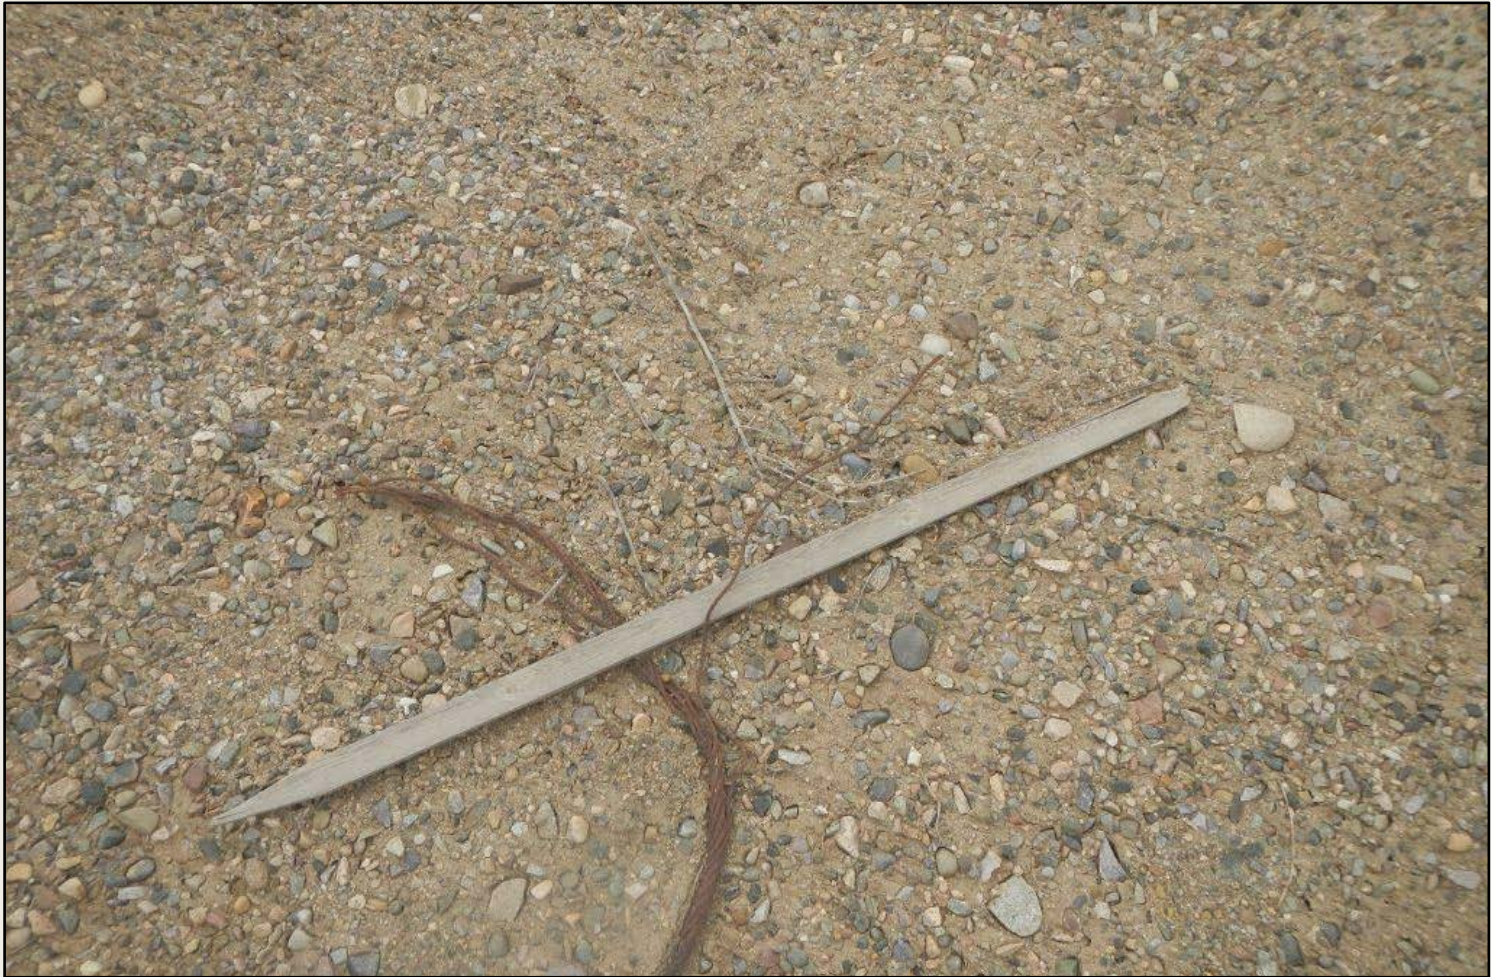
Photo 3. View of metal and wood debris within the project area.

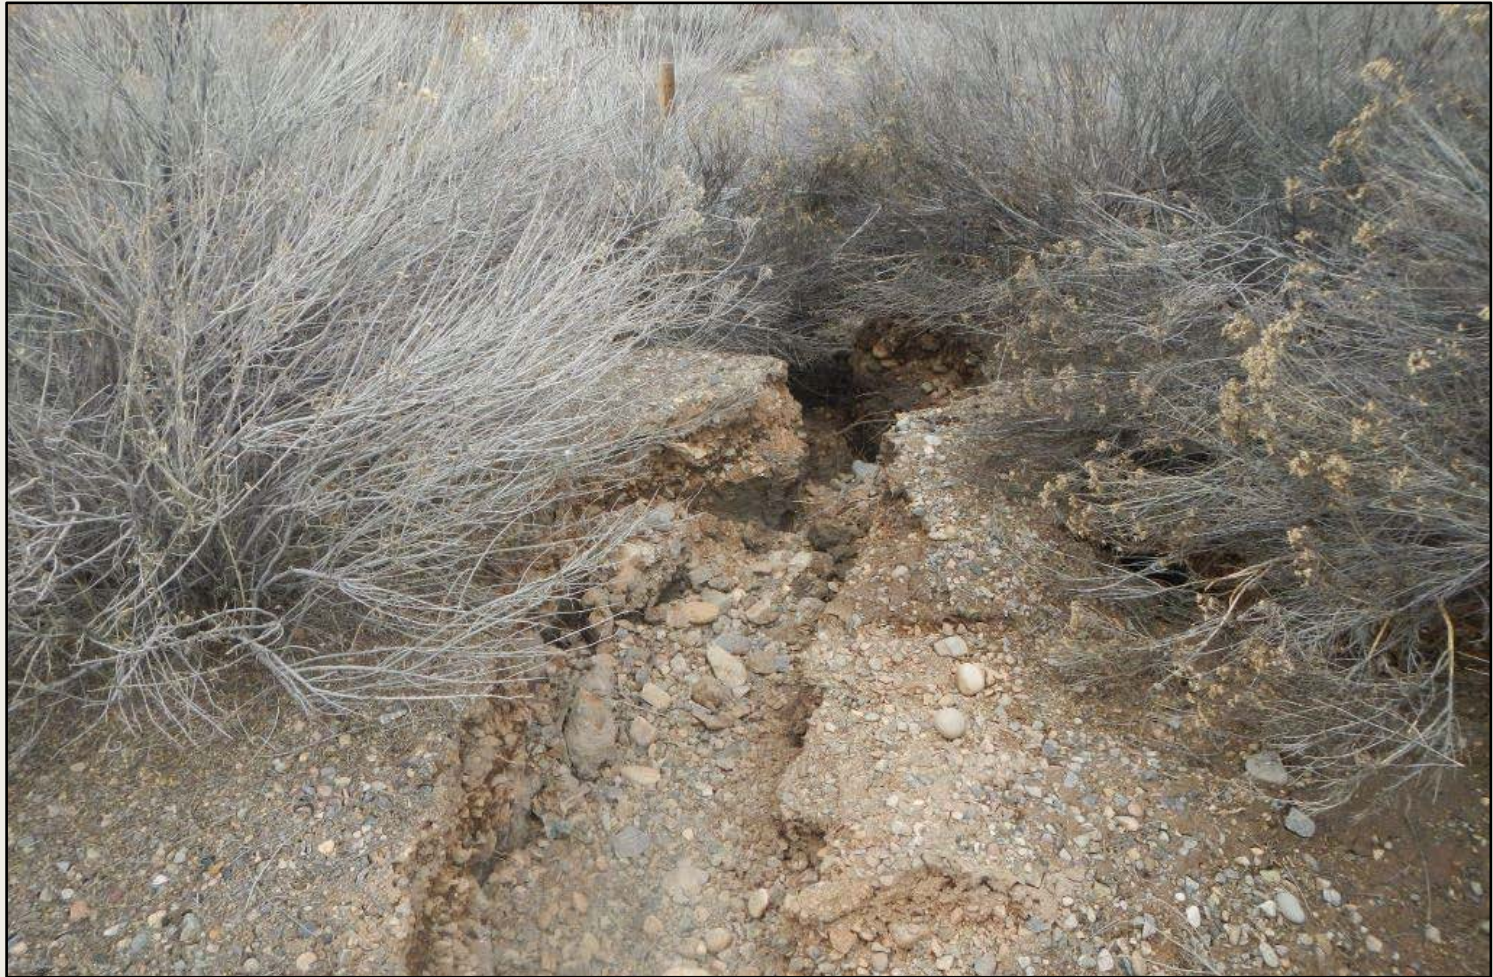
Photo 4. View of erosional channel approximately 1.5 feet wide and deep within the eastern project area.

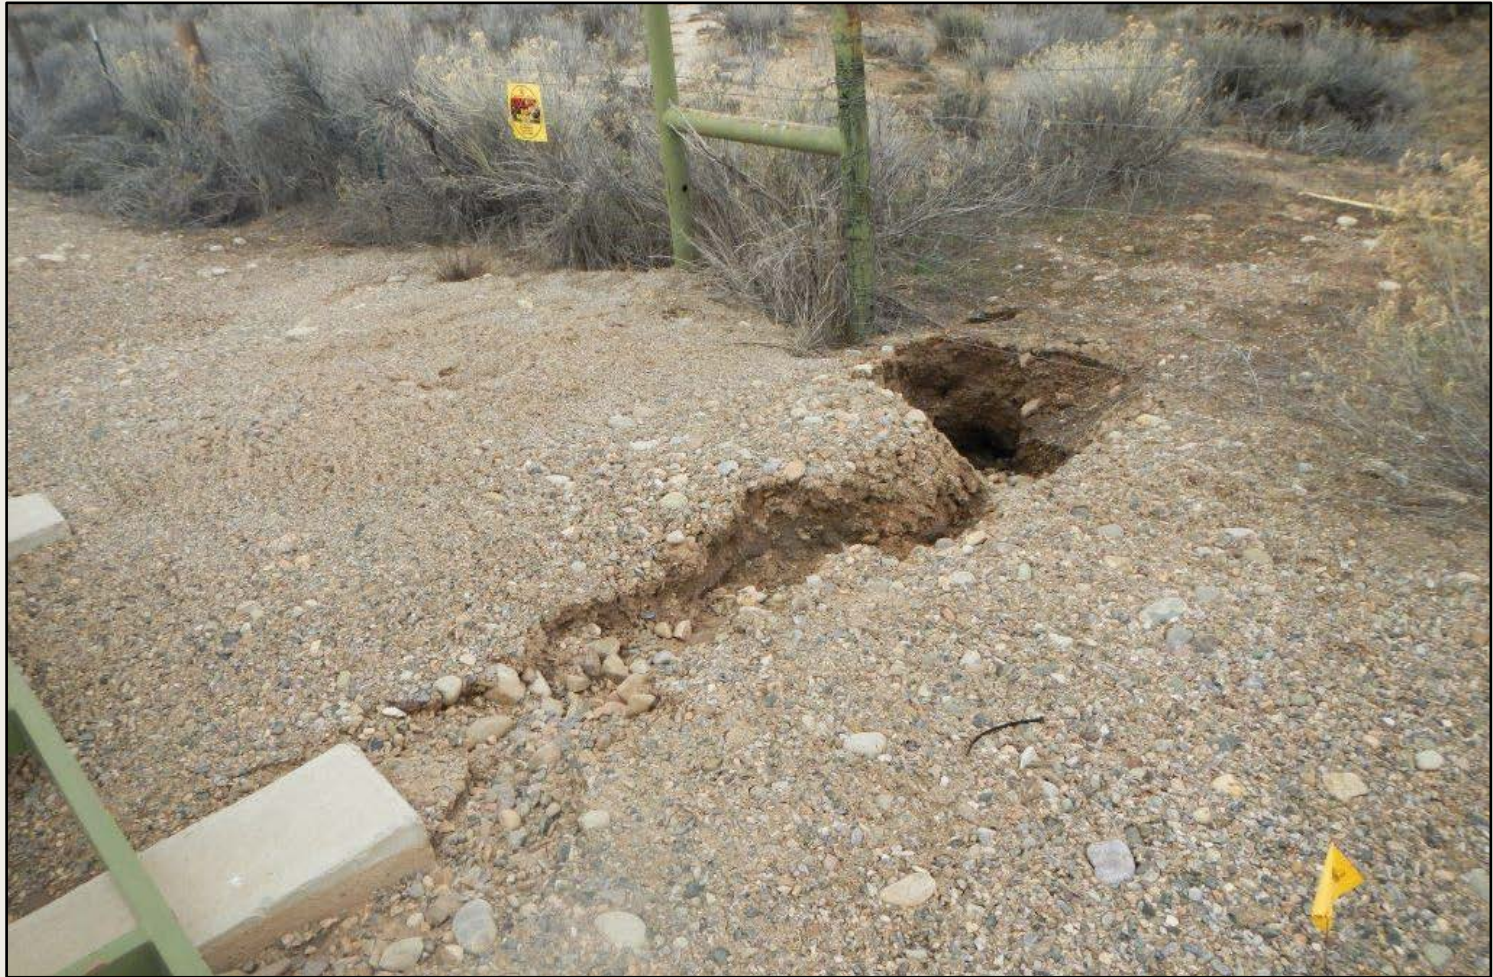
Photo 5. View of an erosional channel approximately 1.5 feet wide and deep within the southern project area.
