Inspection Photos

Location Name: ZUESS FEDERAL 11-10

API #: 05-071-09529

Insp. Doc. # 695100399

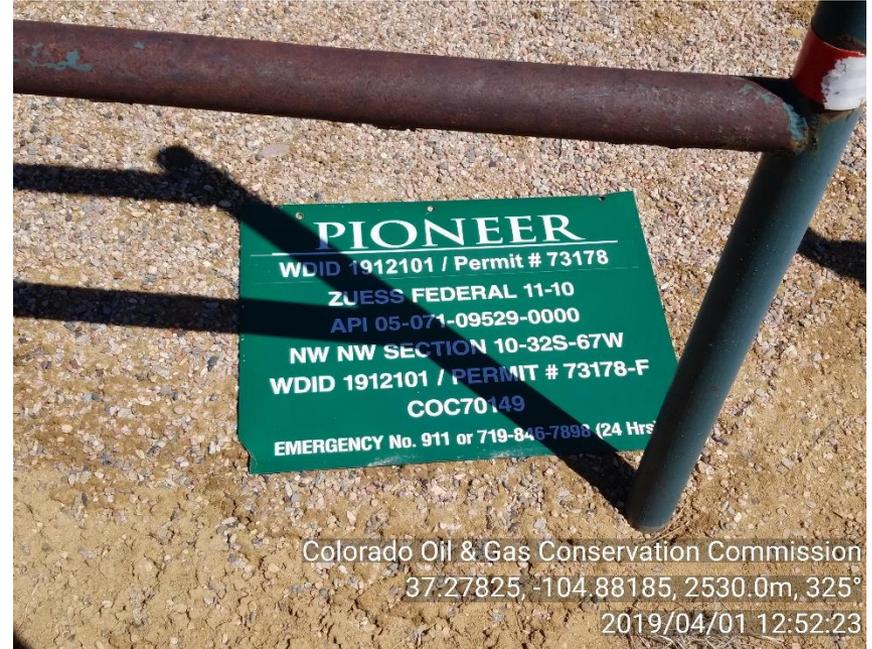
**PHOTO 2: WELL SIGN IS BROKE OFF MOUNTING POINT
LAYING OF LOCATION NEAR METER RUN**

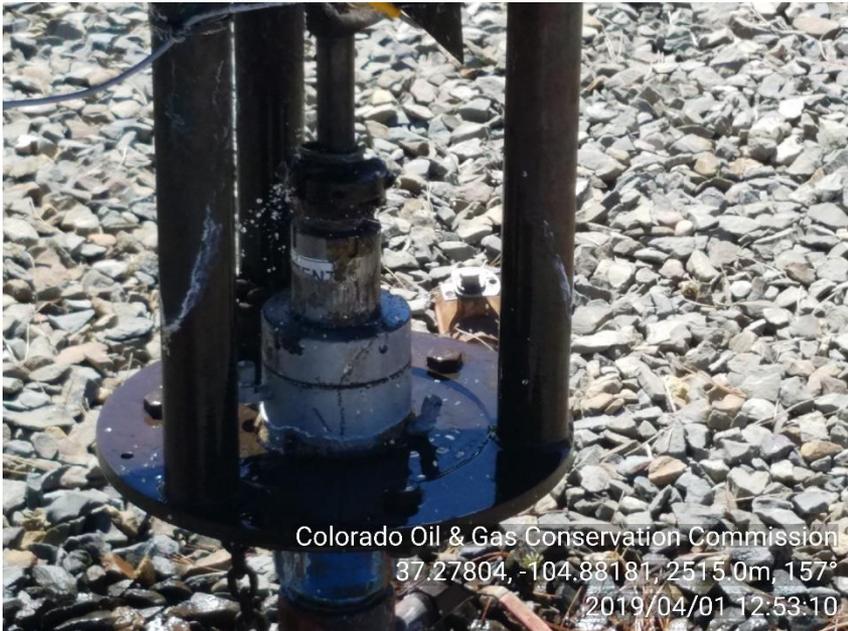
PHOTO 3: PACKING IS SPRAYING PRODUCED WATER OUT ON LOCATION.

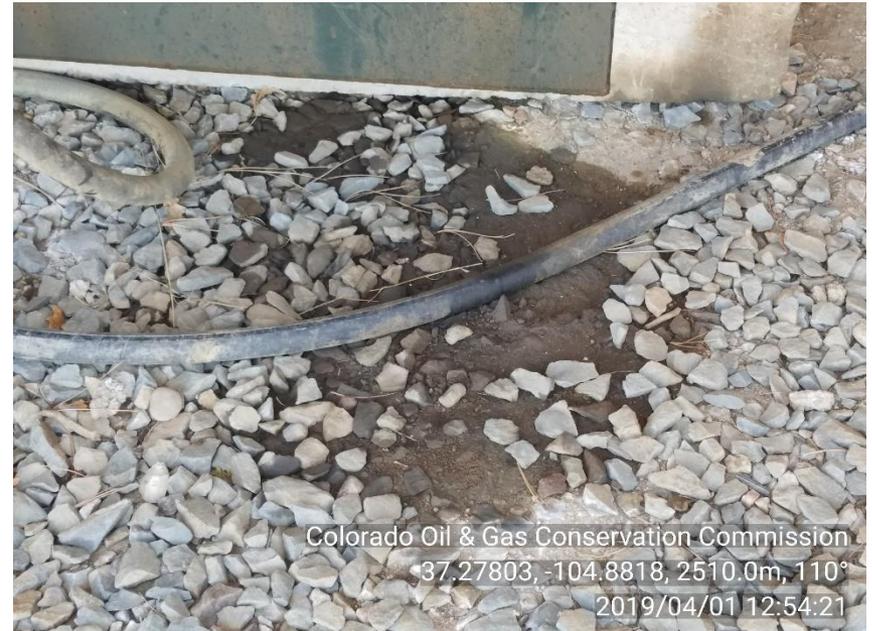
PHOTO 4: IMPACTED SOIL ON NORTH SIDE NEAR ENGINE SKID

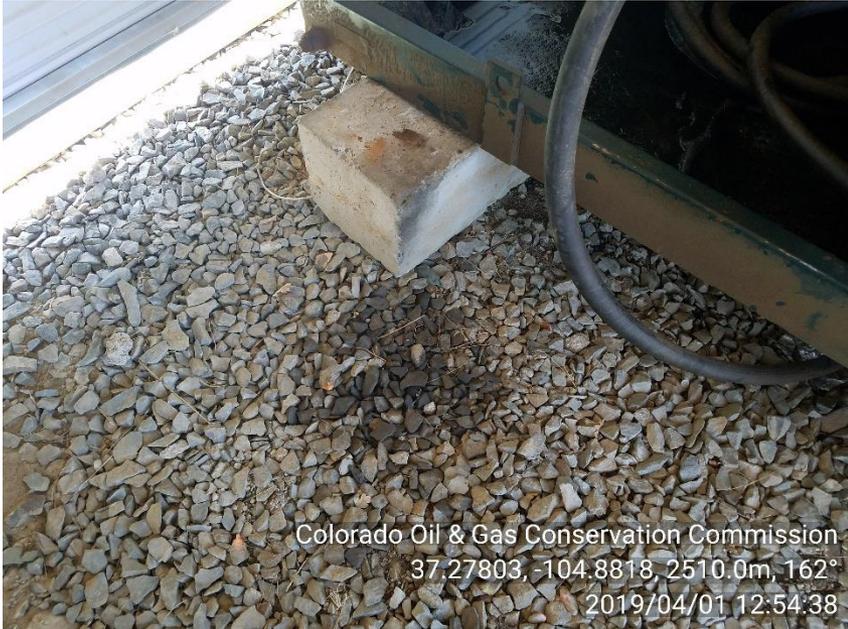
PHOTO 5: IMPACTED SOIL NEAR BACK (SOUTHEAST) SIDE OF ENGINE SKID

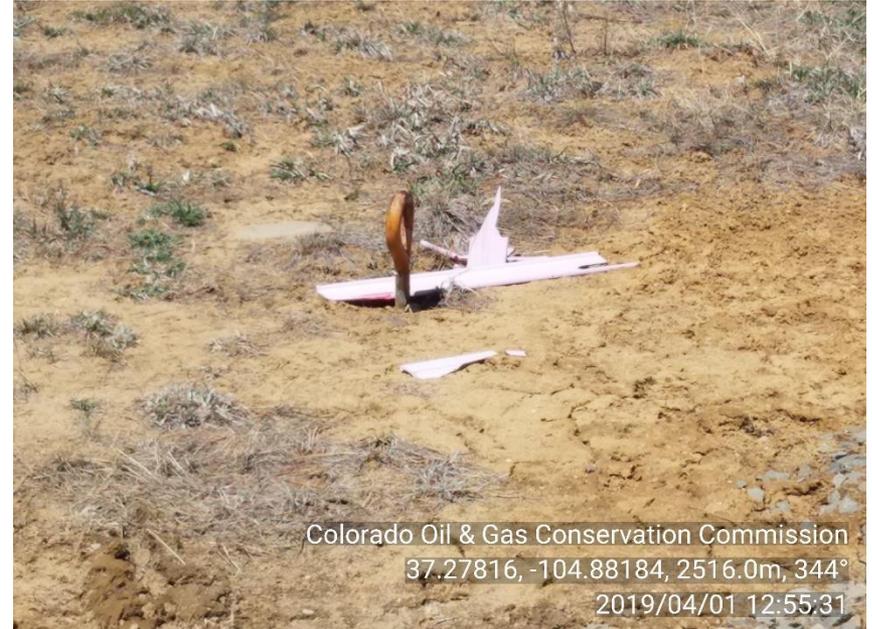
PHOTO 6: NORTHEAST ANCHOR MARKER IS DOWN
