Inspection Photos
Location Name: Thomas Jacquez E #1
API: 05-067-07590

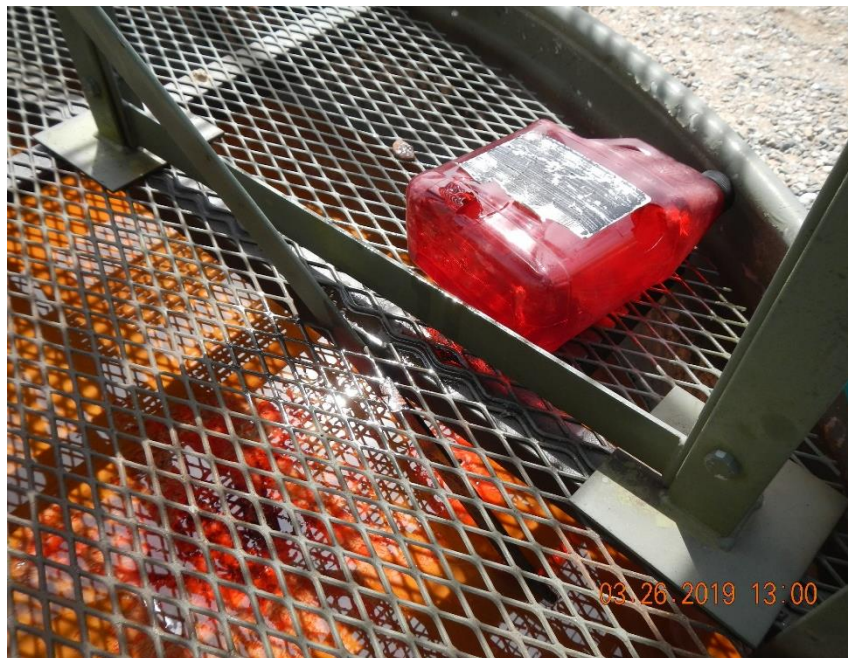
Broken jug of oil additive dripping into secondary containment.

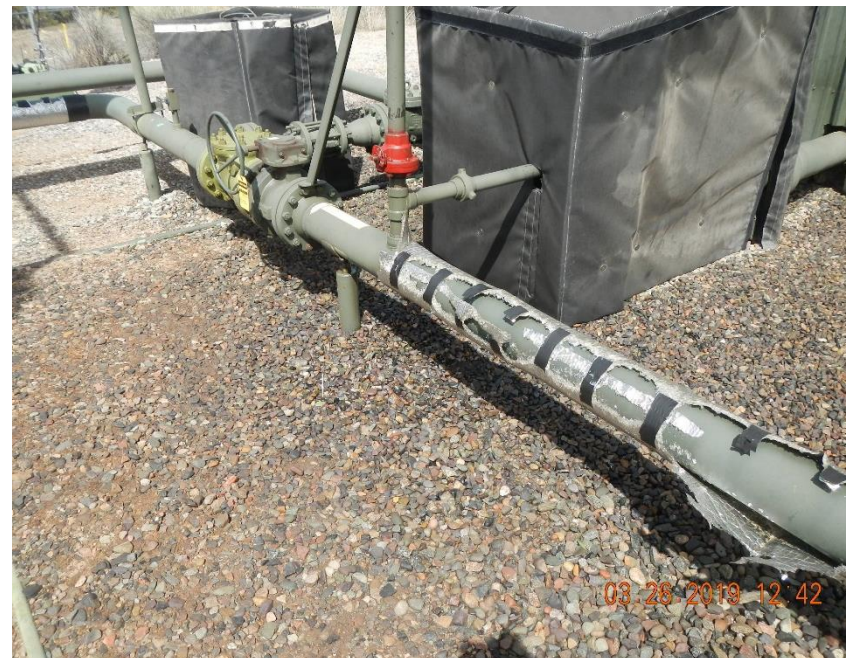
Area of stained gravel and wet area beneath valve.

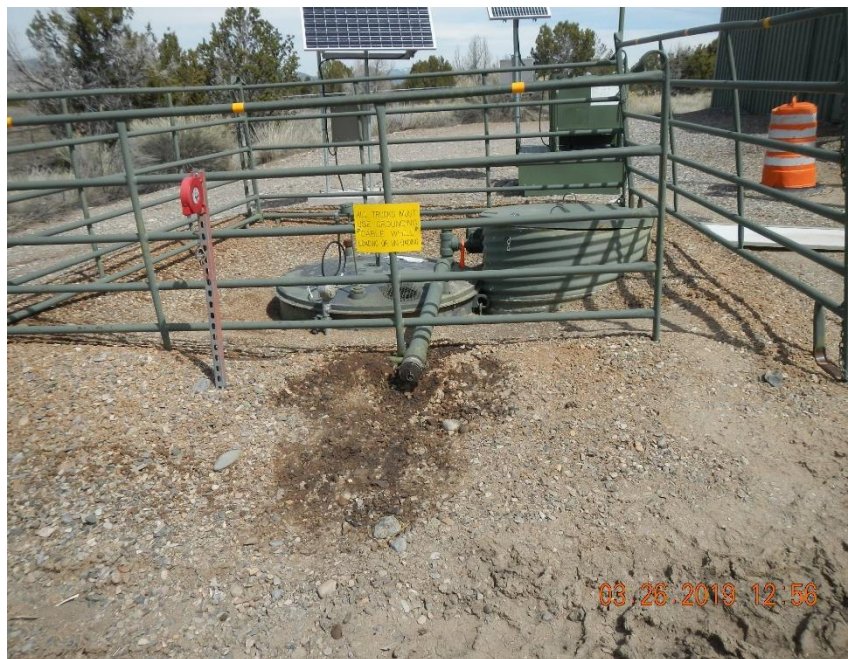
Stained soil at truck load out valve.

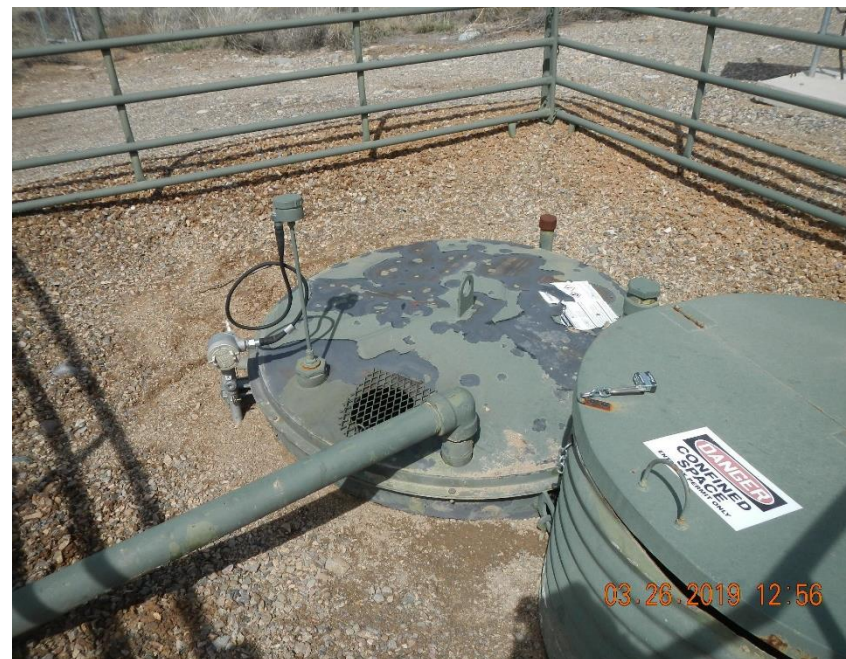
Paint on tank is peeling off.

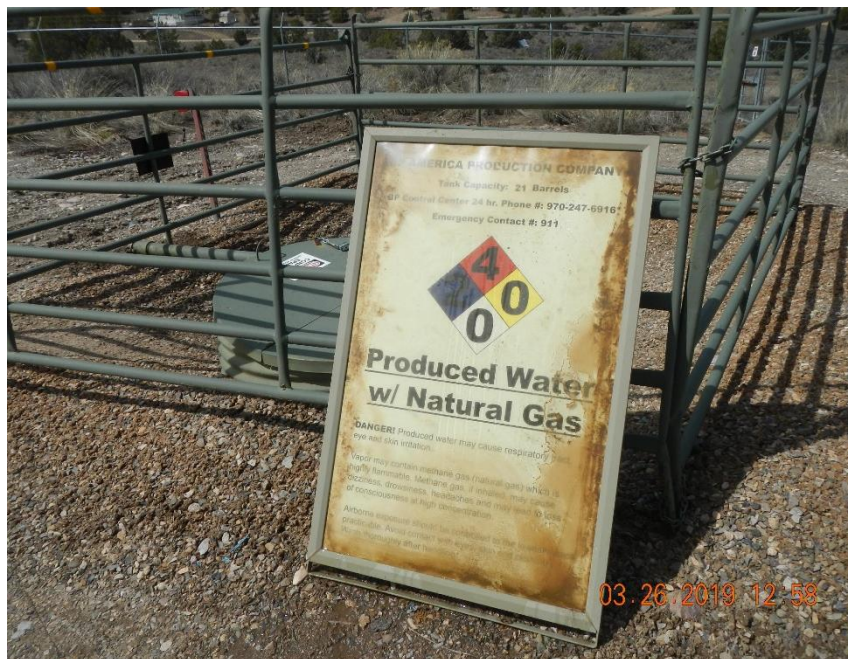
Sign for 21 bbl. was laying face down upon arrival.

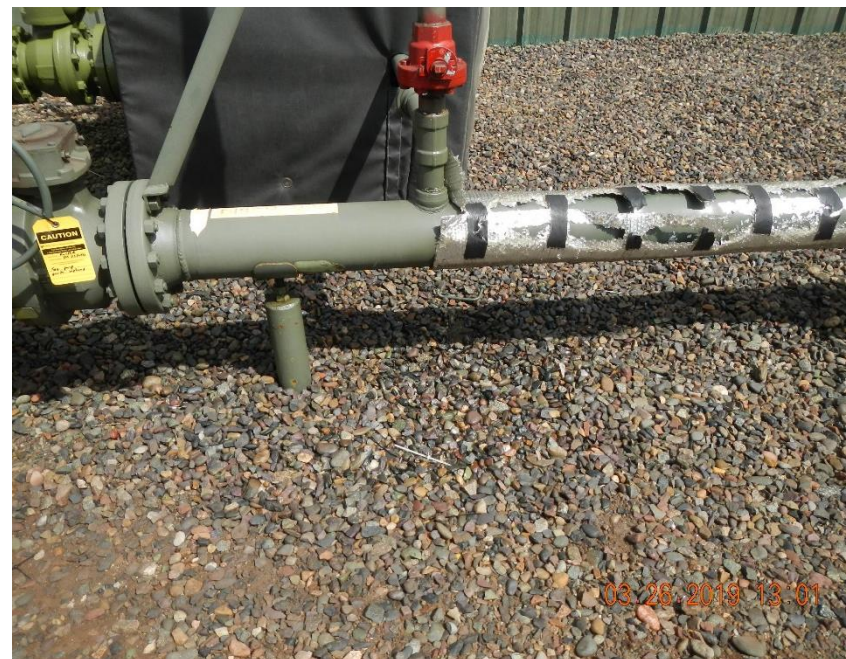
Area beneath valve is wet and surrounding area is stained.

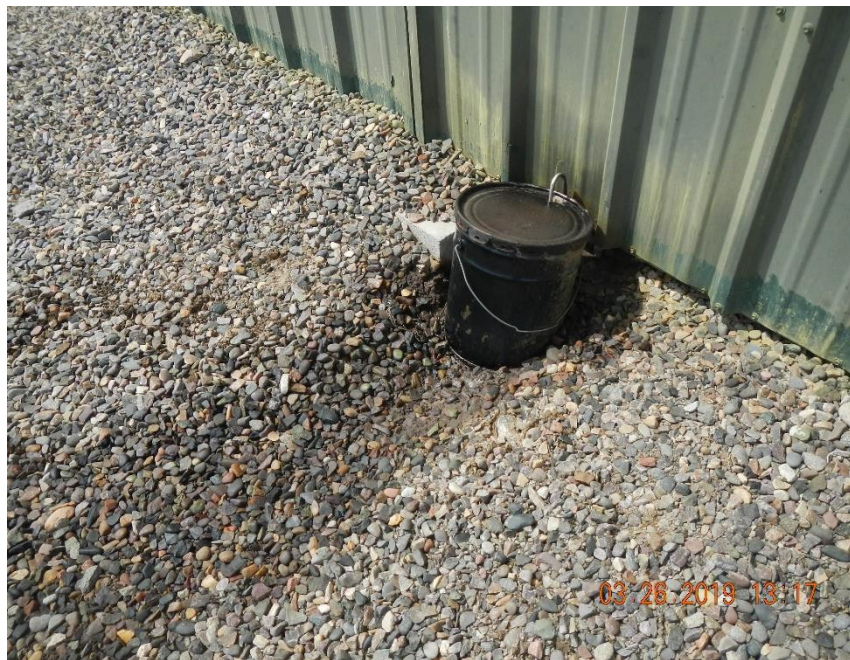
Overflowing 5 gallon bucket.

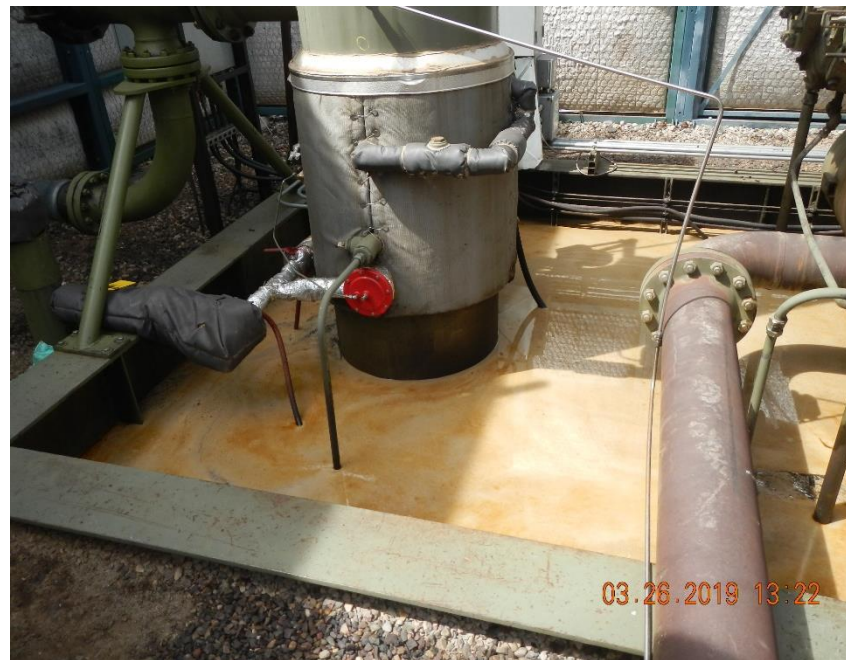
Oil underneath compressor.
