Inspection Photos

Location Name: COLUMBINE SPRINGS FEDERAL 3-14-4-104

Location ID: 05-103-08566

Inspection: 679703543

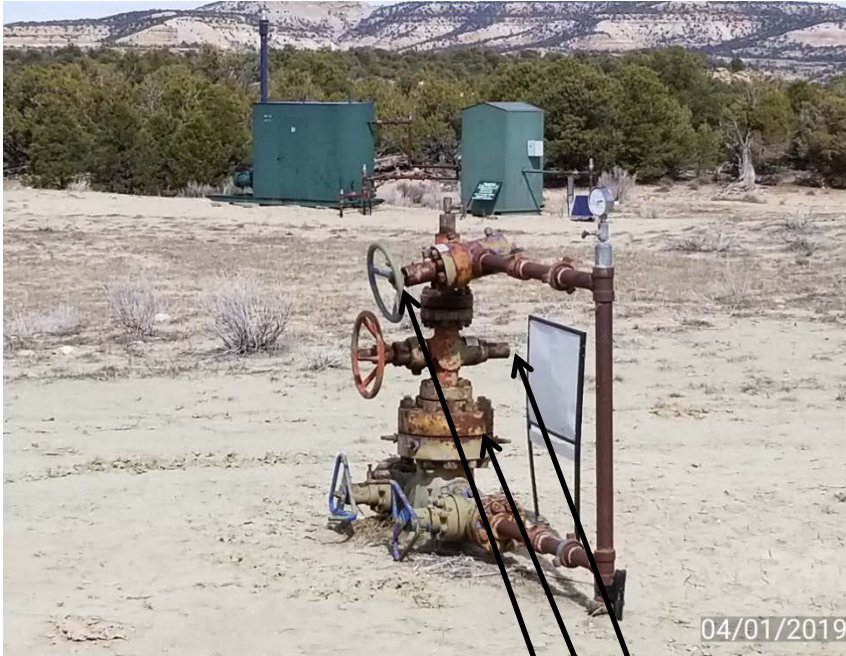
Photo 1. Location looking northeast.

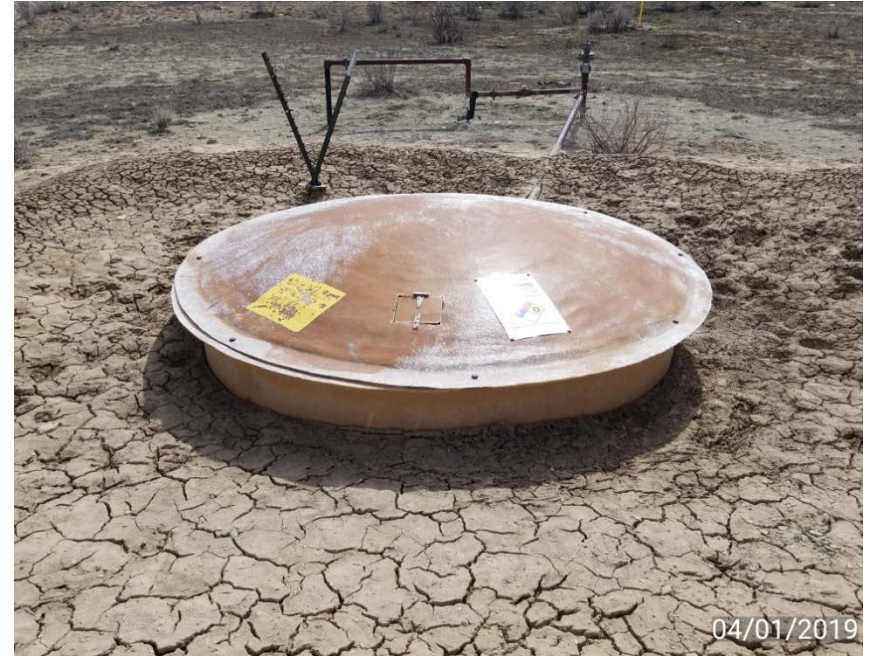
Photo 2. Blow down tank.

Gas leaks

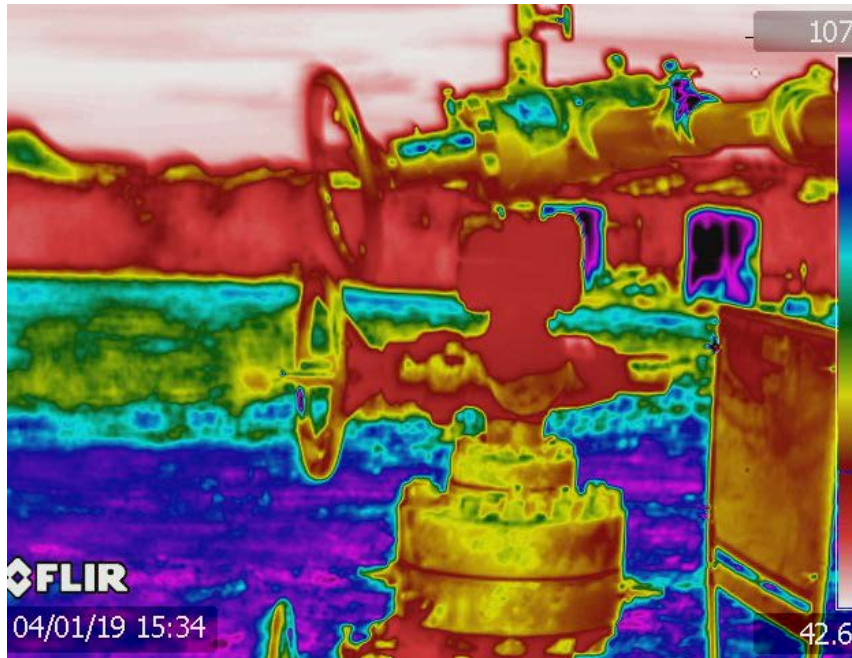
Photo 3. Well head on infrared with a FLIR GF320 camera.

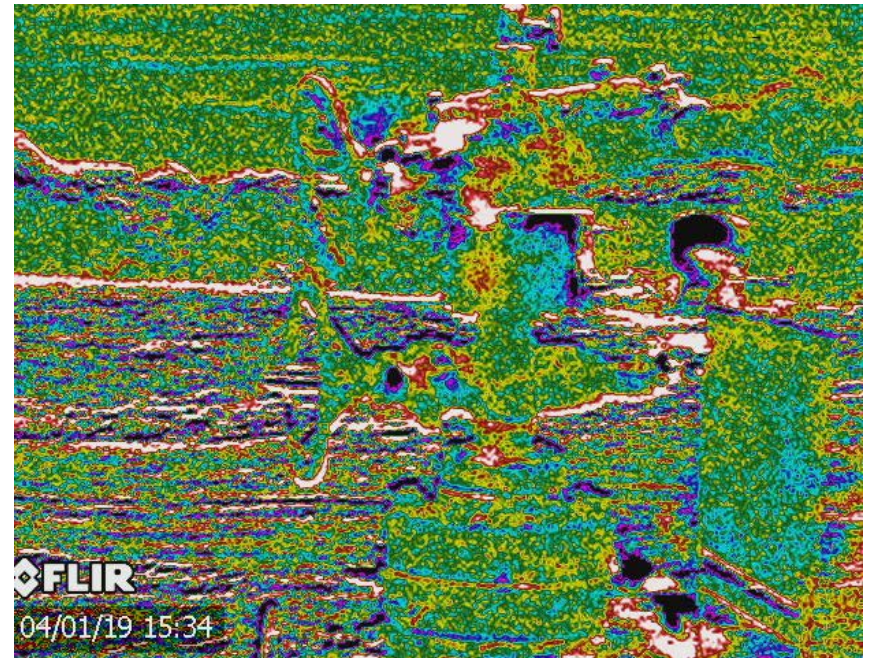
Photo 4. Well head in infrared HSM with a FLIR GF320 camera.

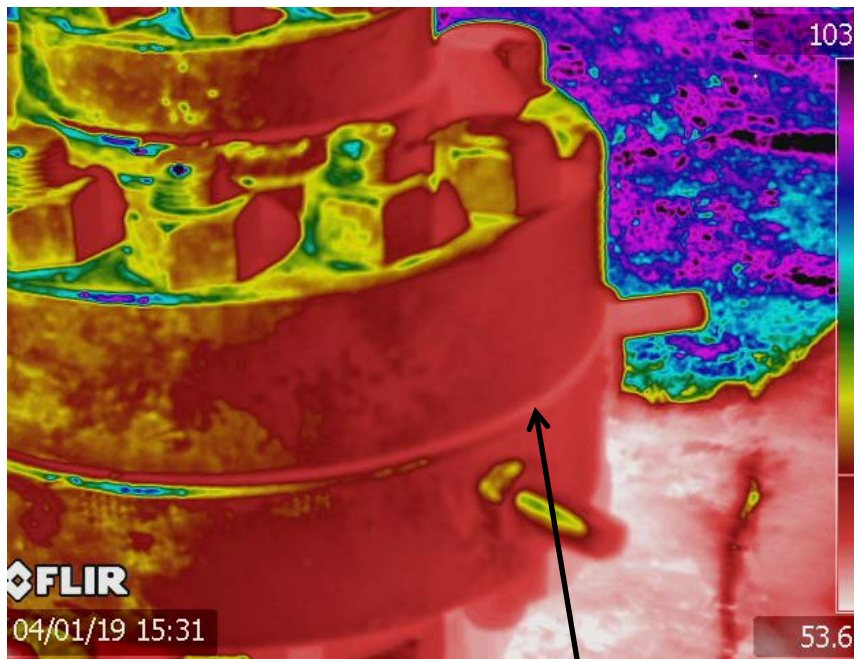
Photo 5. Well head on infrared with a FLIR GF320 camera.

Gas leak

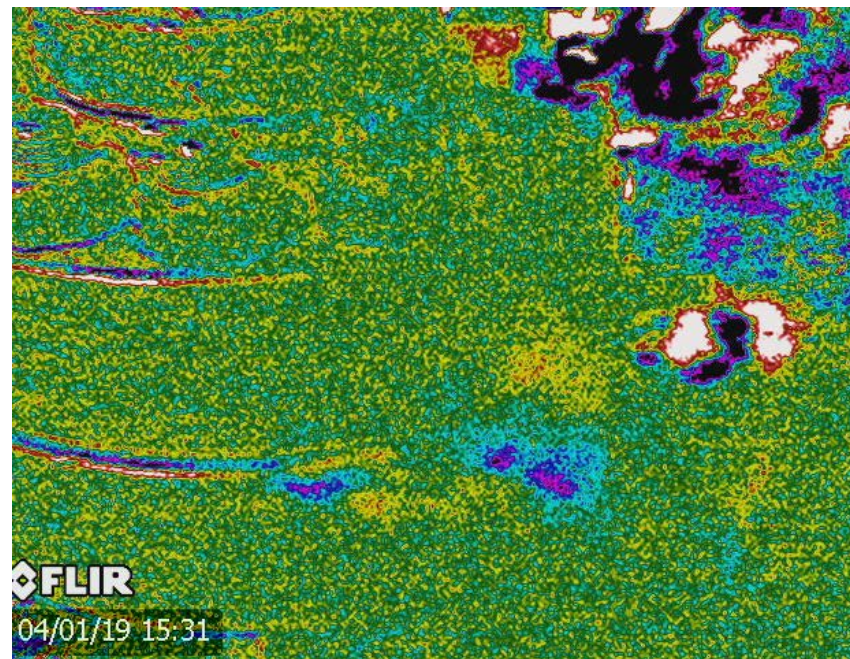
Photo 6. Well head in infrared HSM with a FLIR GF320 camera.

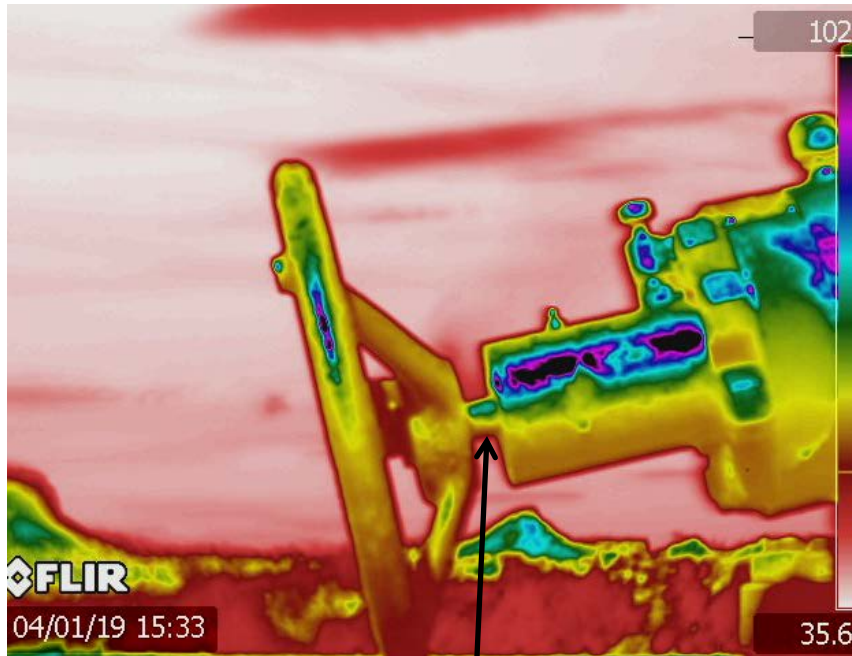
Photo 7. Tubing valve on infrared with a FLIR GF320 camera.

Gas leak

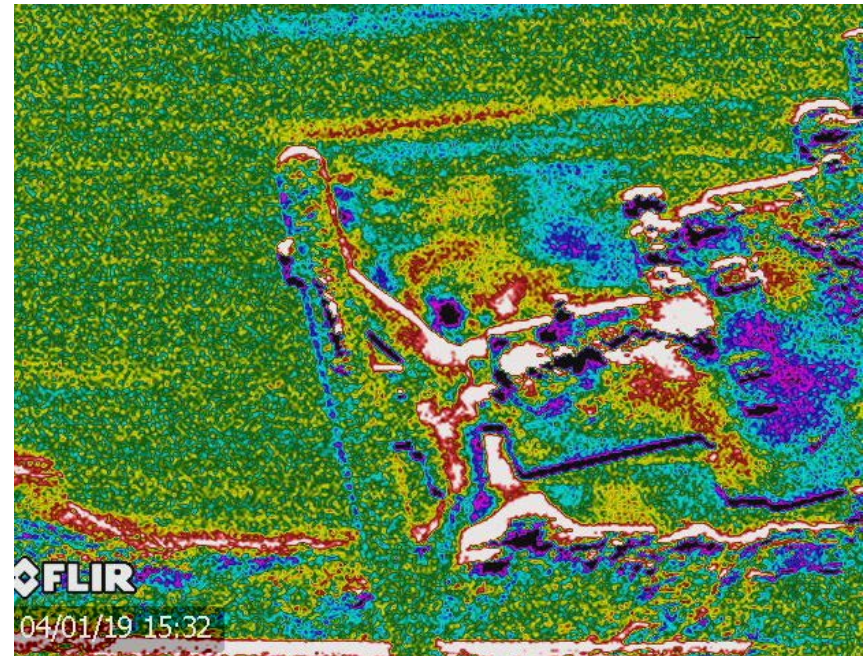
Photo 8. Tubing valve in infrared HSM with a FLIR GF320 camera.

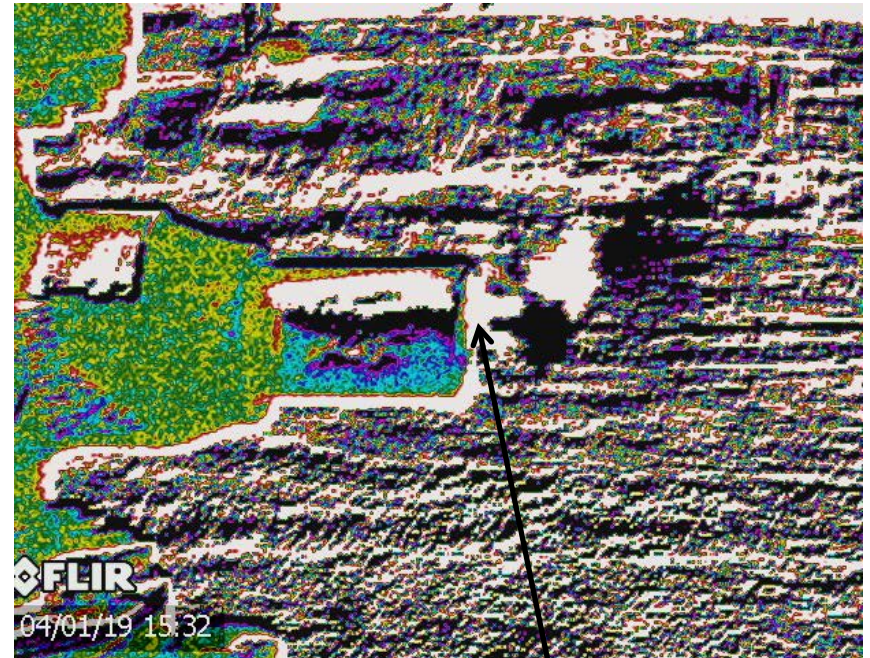
Photo 9. Casing valve end in infrared HSM with a FLIR GF320 camera.

Gas leak
