# PIT STATUS EVALUATION FORM

Facility ID: 115188

Pit Name: SABO 31-19 1

S.S. PAPADOPOULOS & ASSOCIATES, INC.

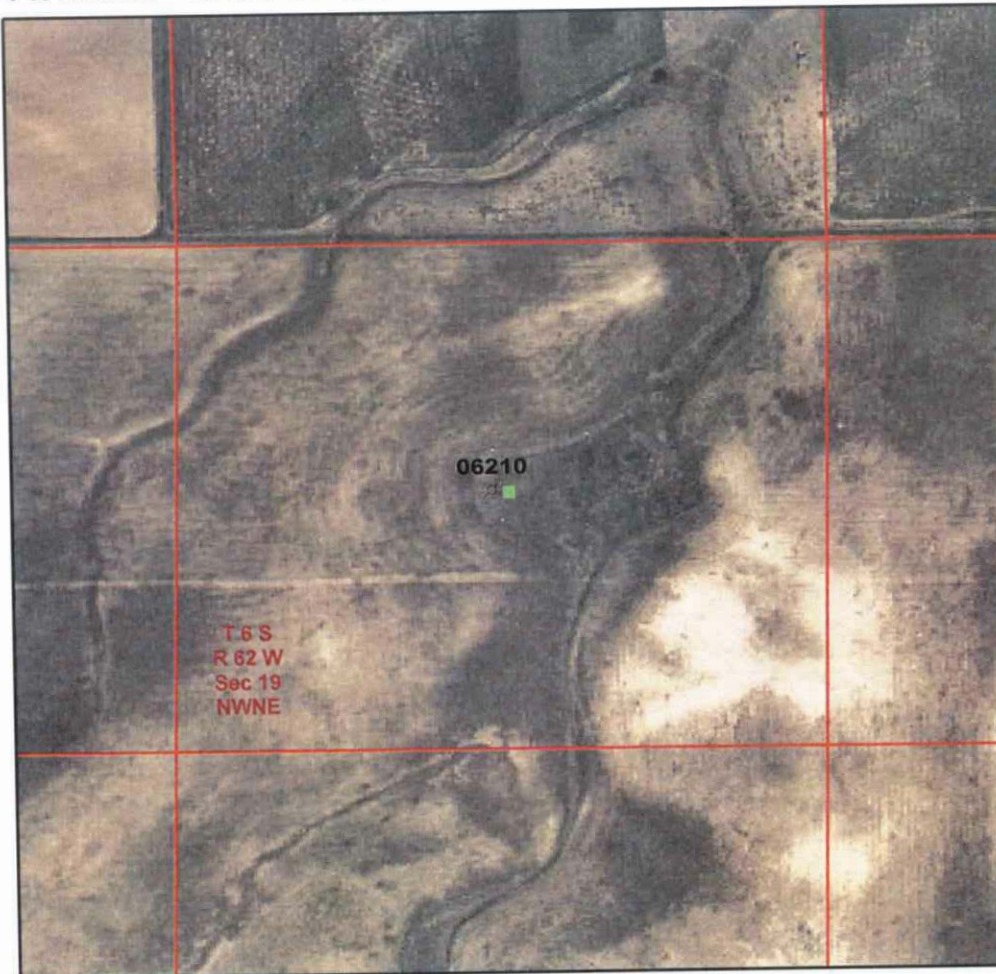
Notes: LIF (1987) 30'x30' pit. Common Use for SABO #1, #2, #3  
WSIF (1988) pits backfilled & site clean.

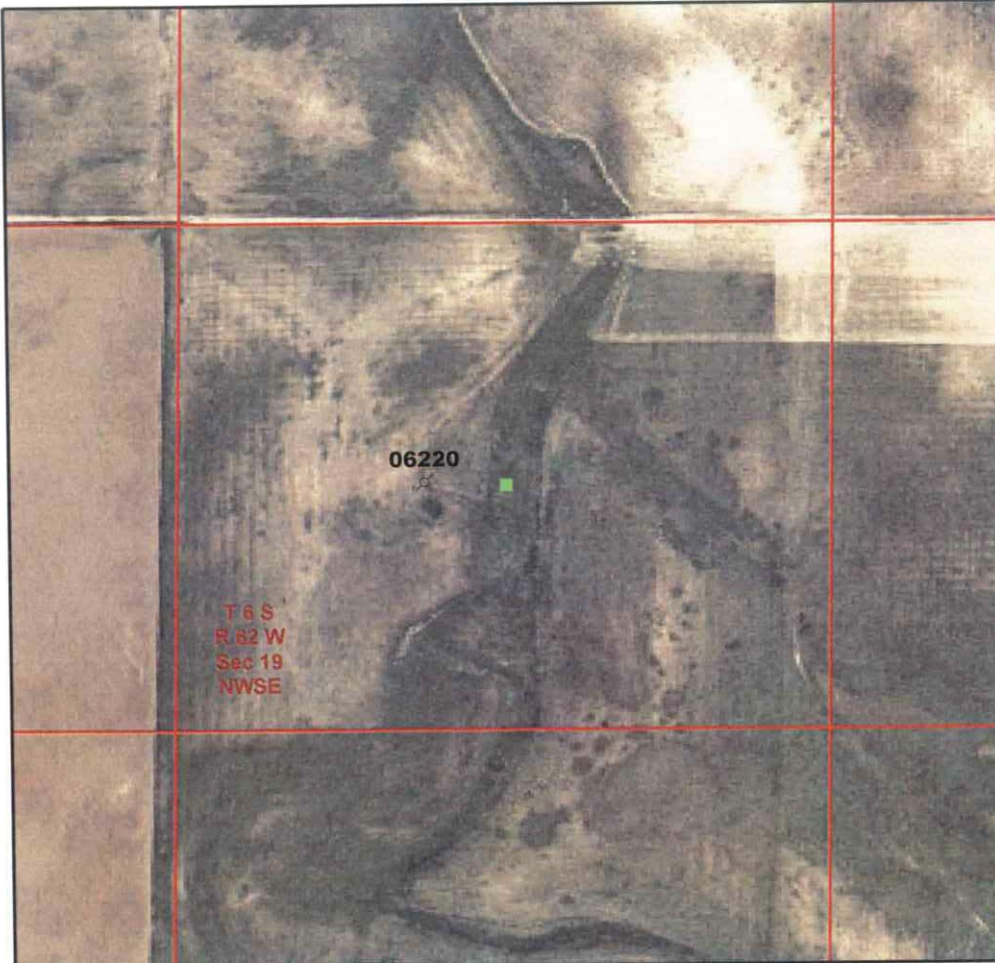
Pit Name: SABO 33-19 2

Notes: Pit Status & documentation under Pit ID # 115188.  
Common Use for SABO #1, #2, #3.

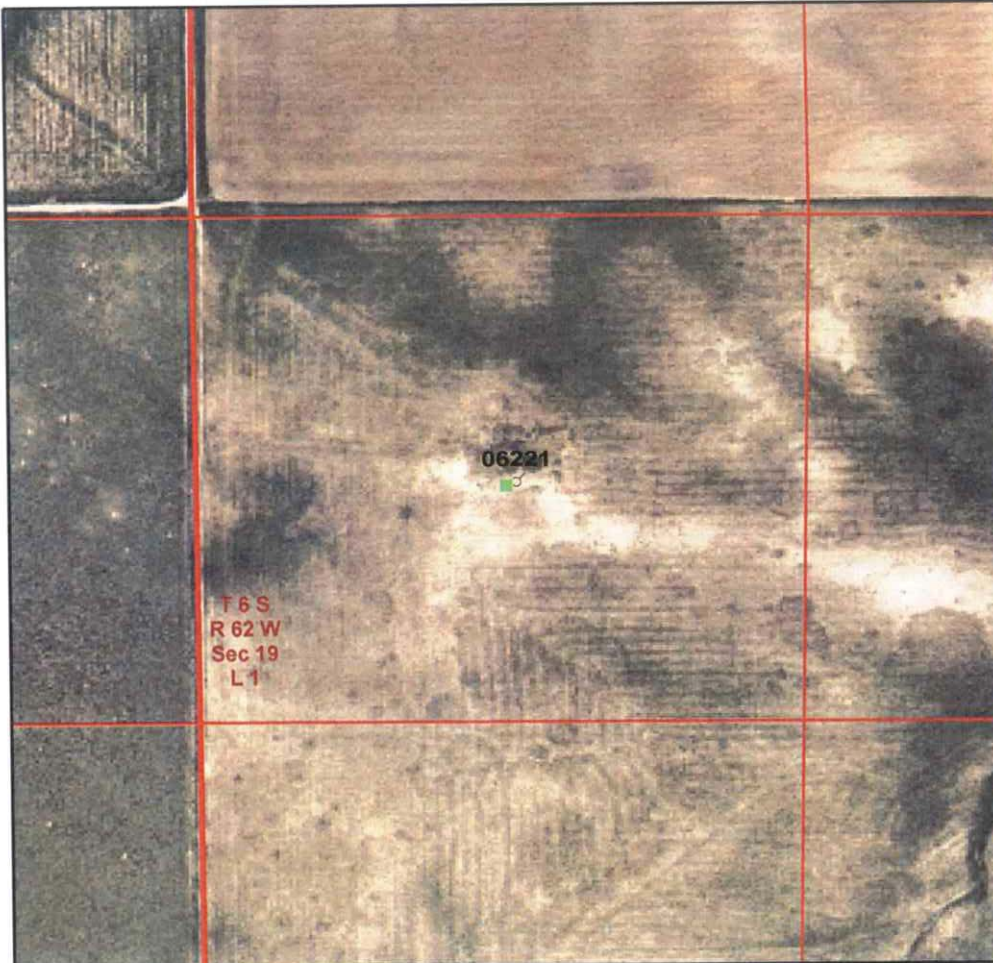
Pit Name: SABO 11-19 3

Notes: Pit status & documentation under Pit ID # 115188.  
Common use for Sabo #1, #2, #3.
