Inspection Photos

API: 05-071-07413

Operator: TIMBER CREEK OPERATING LLC

Inspection Date: 4/2/2019

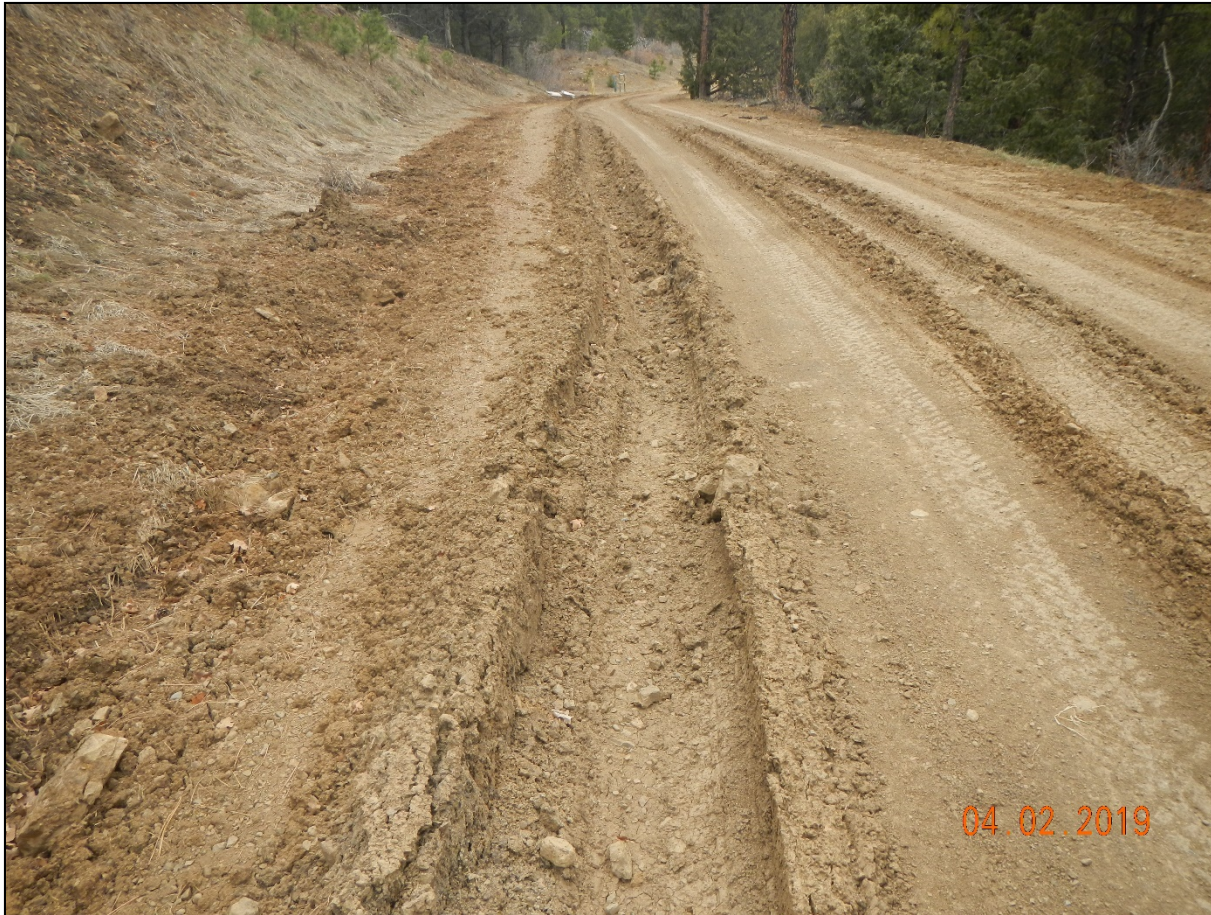
Photo 1. There is signs of erosion and vehicle rutting along the road that travels up to the location.

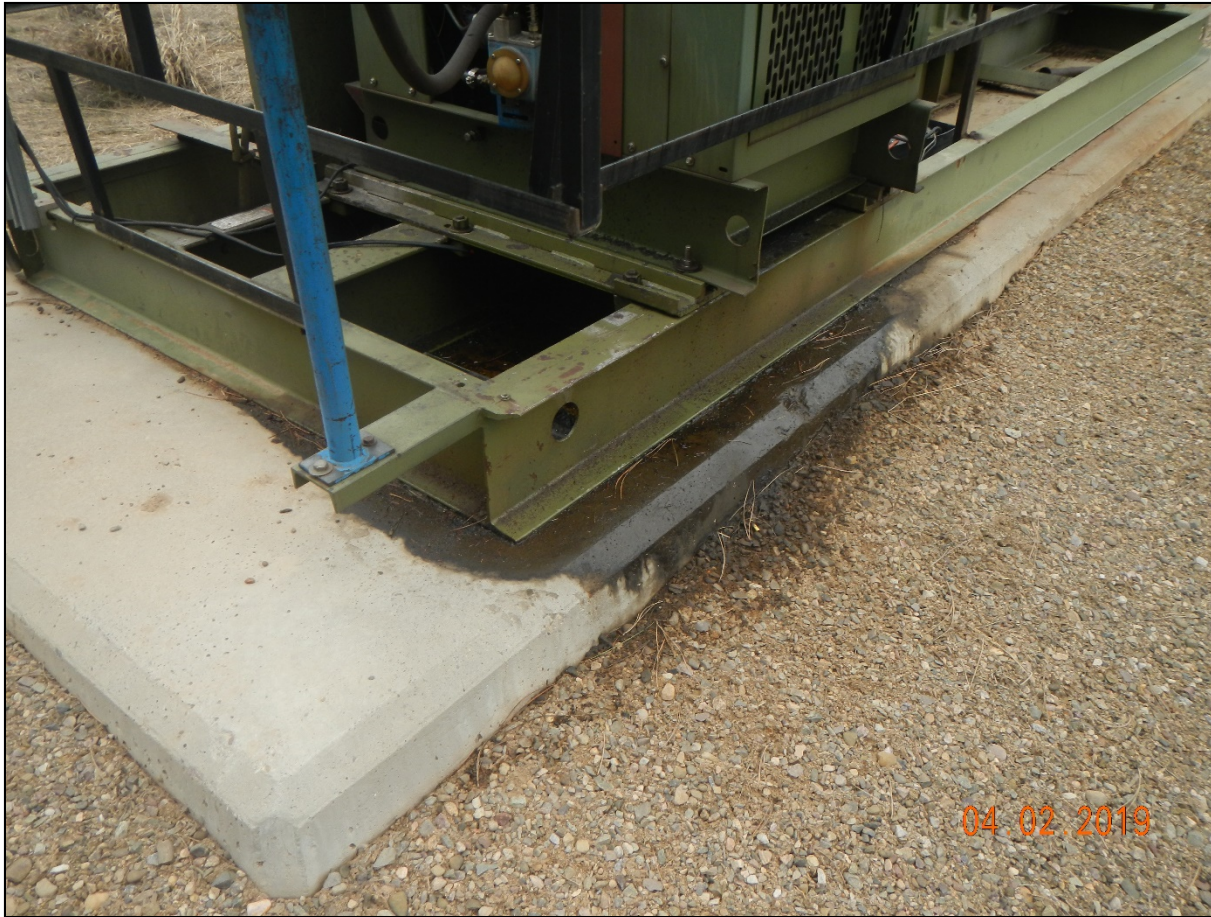
Photo 2. There is some oil on the engine skid.

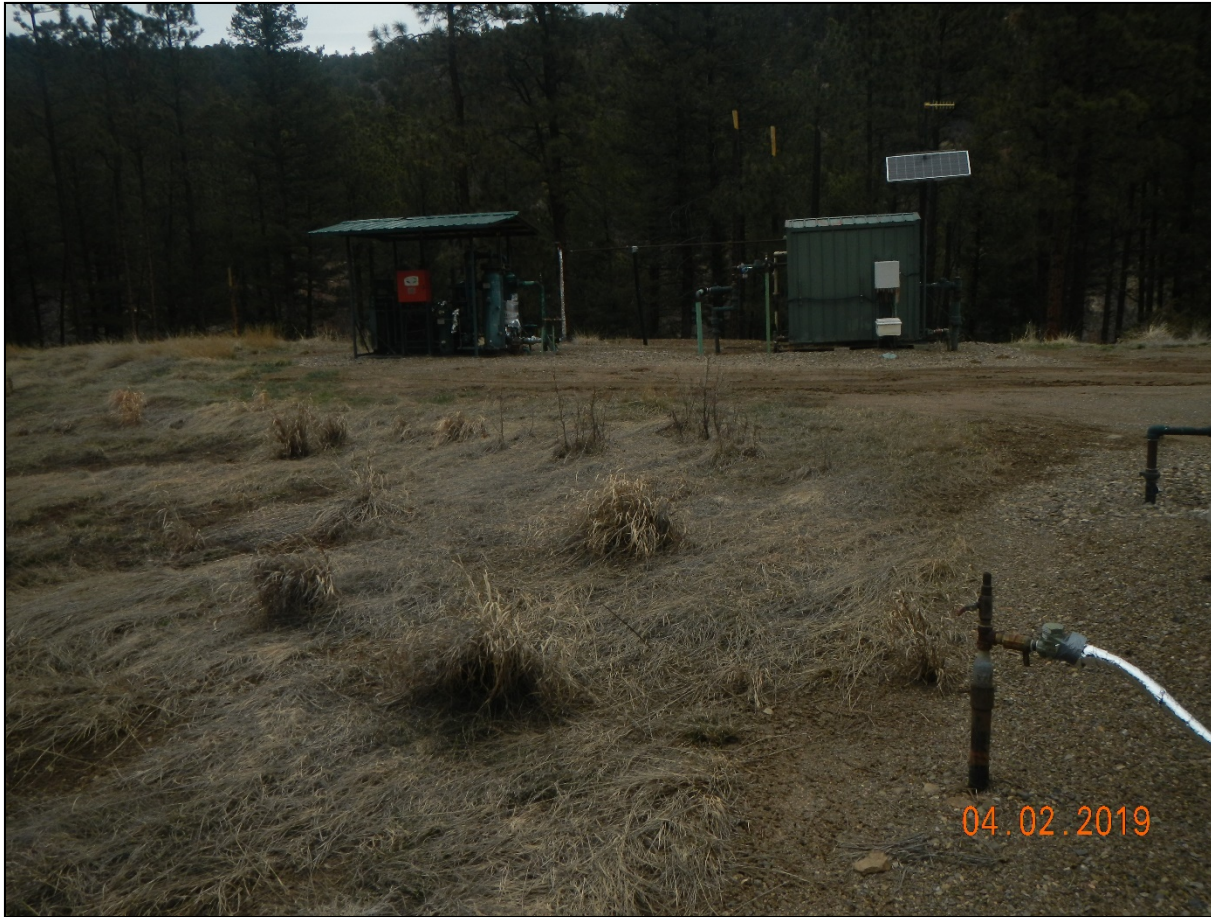
Photo 3. Facing toward the location. Vegetation is well established in the interim reclamation area.
