Maralex Resources Inc. .

Api # 05-077-08622

Inspection # 675002120

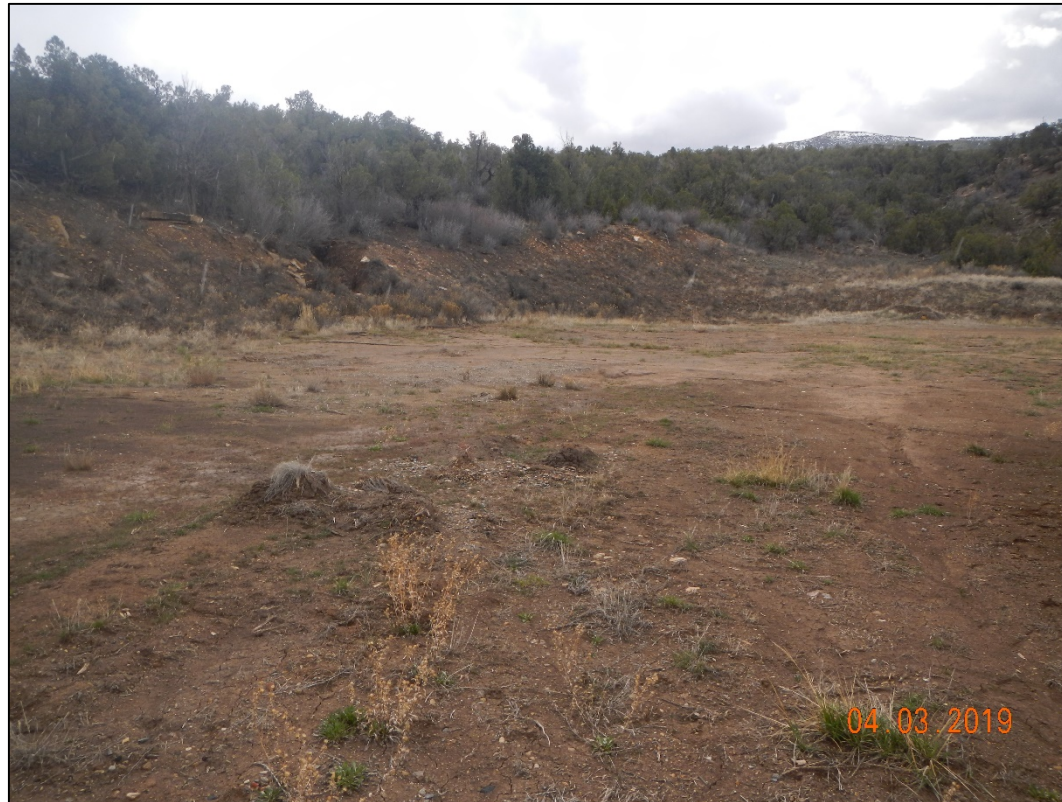
Photo of location From NW corner of the location

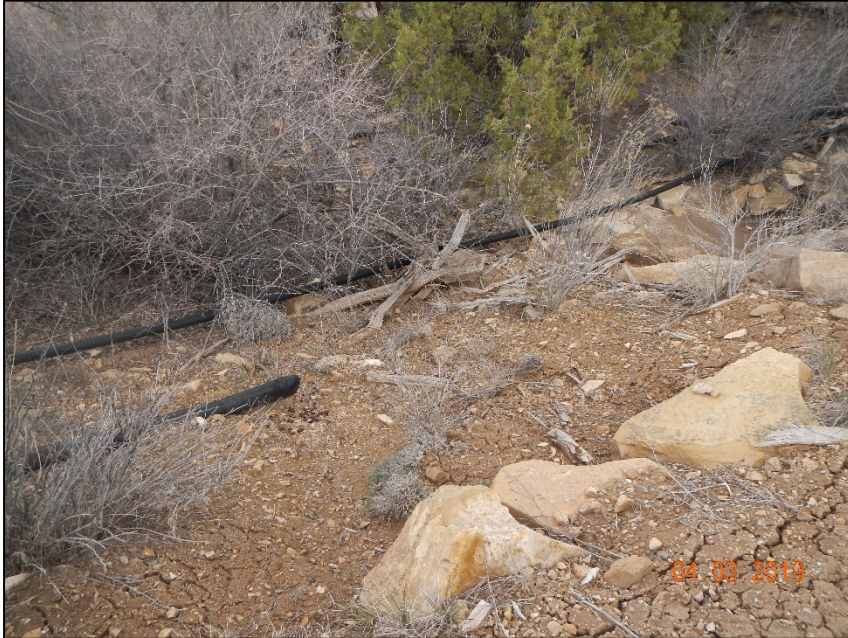
**Photo #2. Unused poly pipe along side of upper access road
East of location**

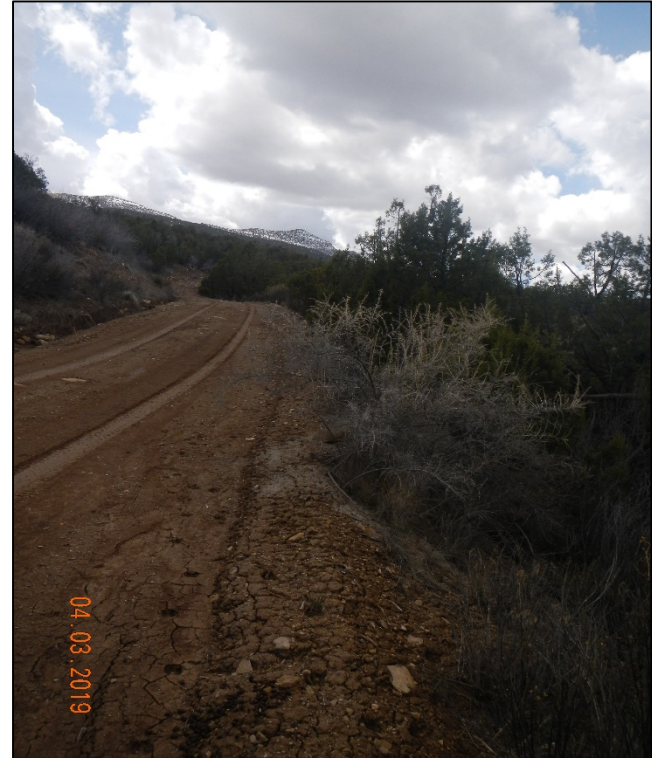
**Photo # 3. Unused poly pipe along side of upper access road.
Poly line runs along access road east of location going south
toward location 077-09438 location for a different Operator**

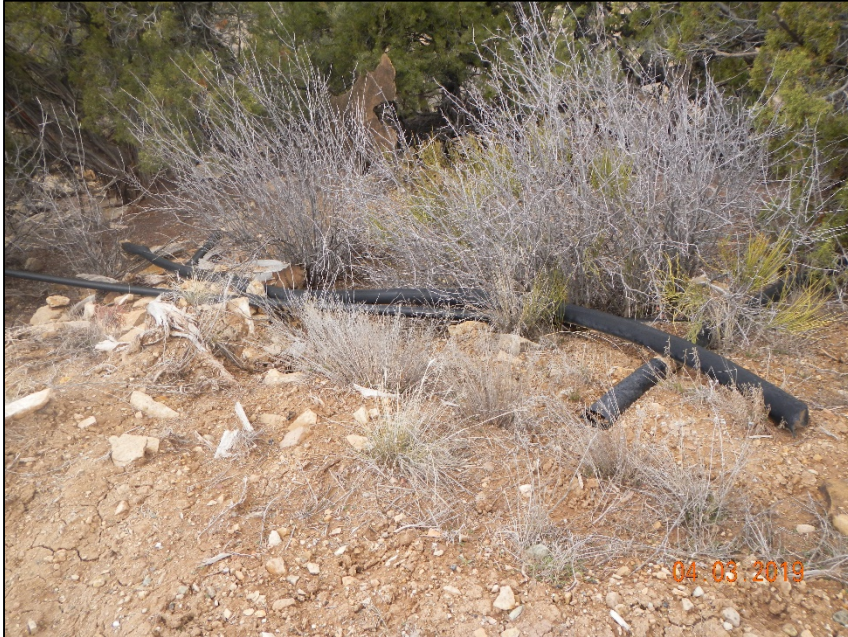
Photo #4. Unused poly pipe along side of upper access road East of location

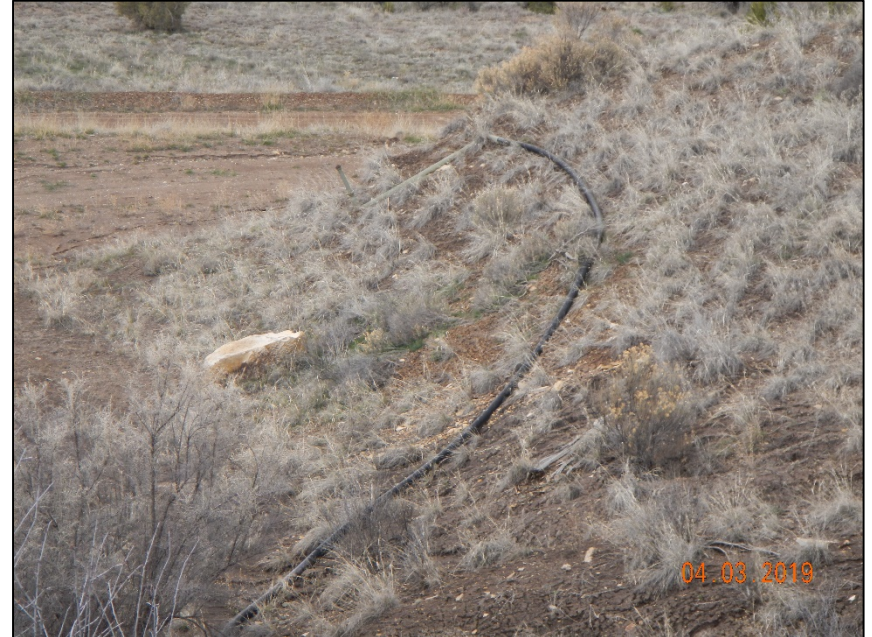
Photo #5 Looking West onto location from upper access road. Unused poly pipe along North side of location

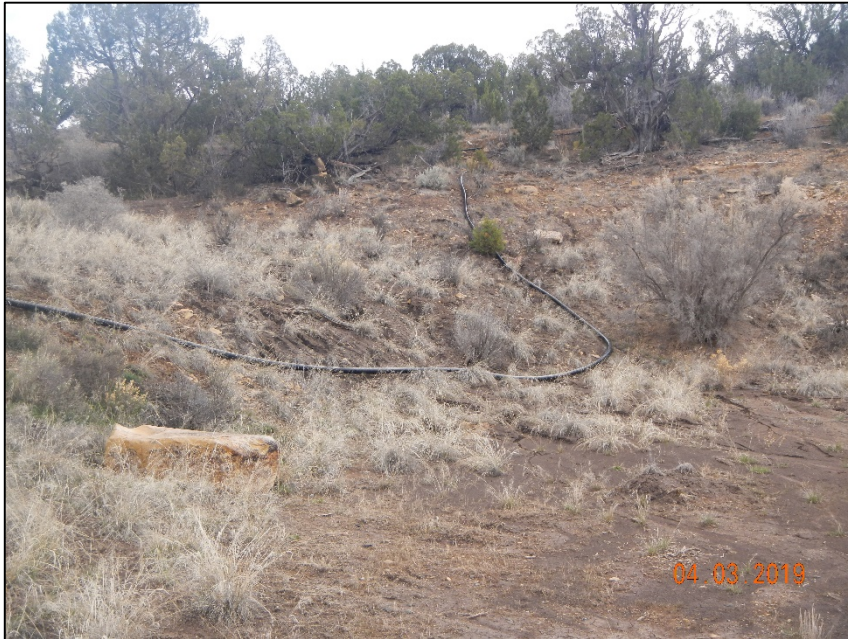
Photo #6 . Unused poly pipe along North side of location, up the hill headed East off location

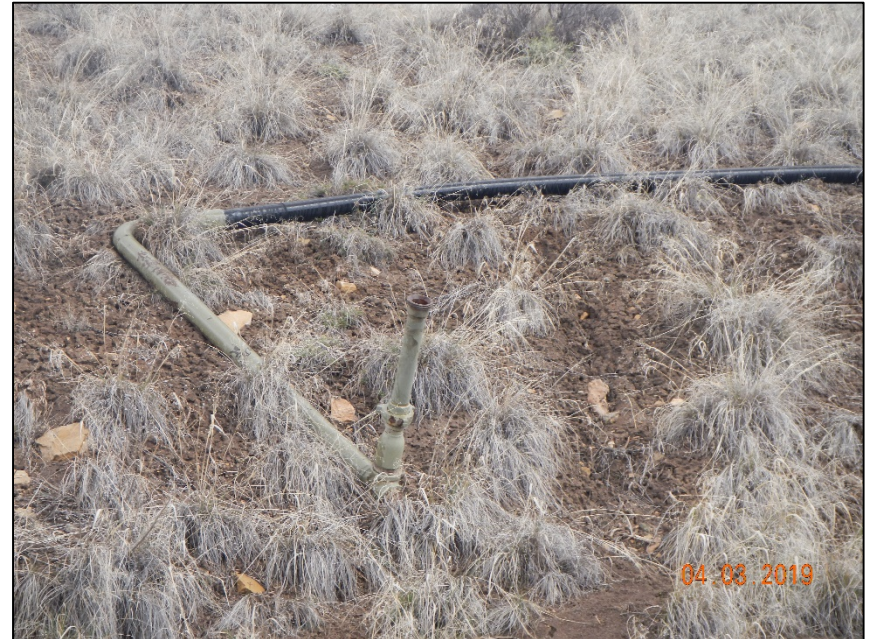
Photo #7. Unused poly pipe along North side of location with unmarked riser.

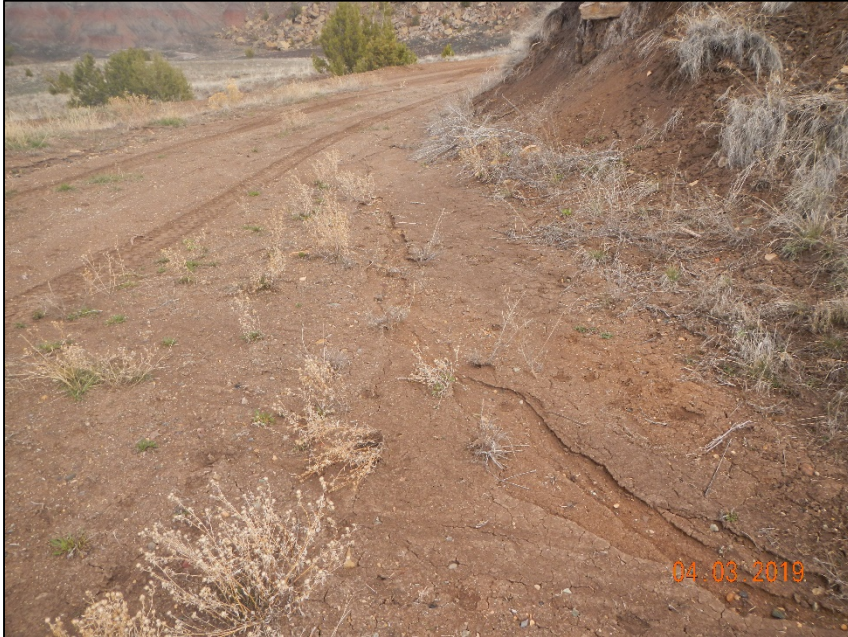
Photo #8. Storm Water Erosion moving sediment off location from NW access entrance. Sediment moving onto main access road.

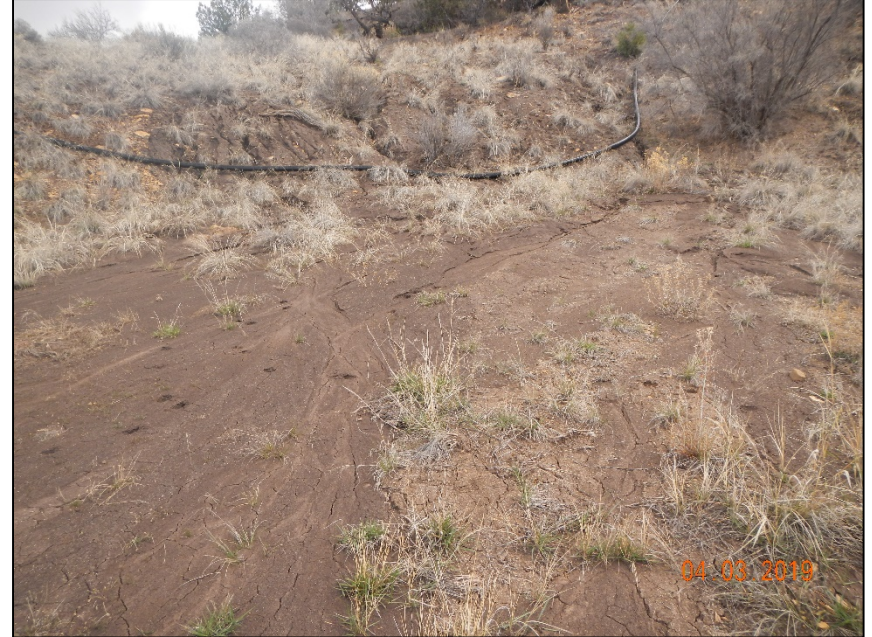
Photo #9. Erosion is evident along unsterilized slope on the north side of location .

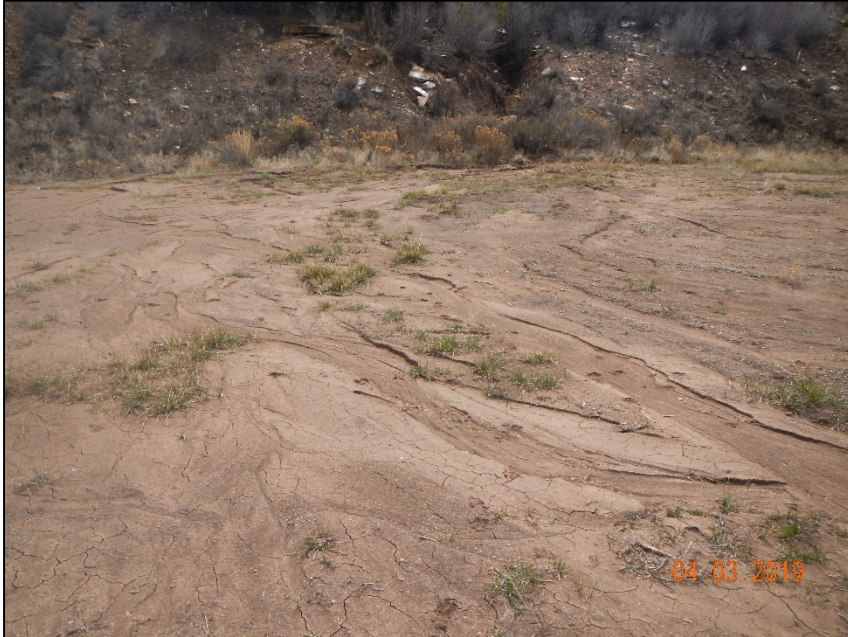
Photo #10. Storm Water Erosion moving sediment across location from east hillside onto access road below

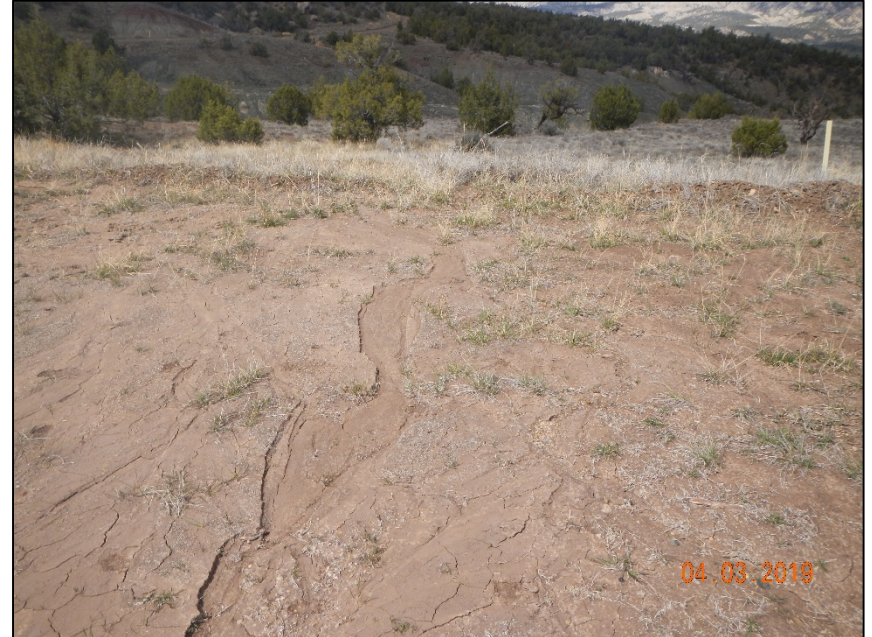
Photo #11. Storm Water Erosion moving heavy sediment across location from east hillside onto access road below

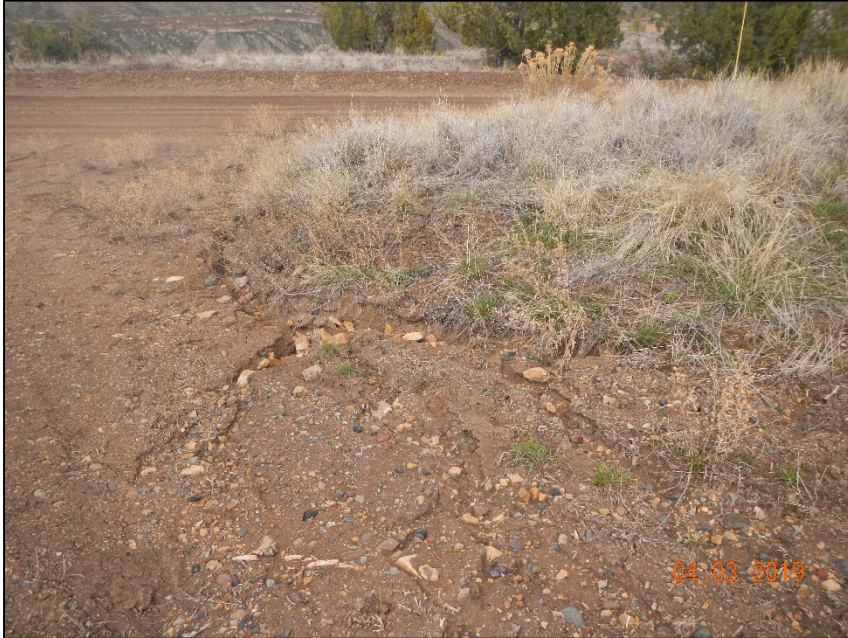
Photo #12. Storm Water Erosion moving sediment off the SW entrance of location onto main access road.

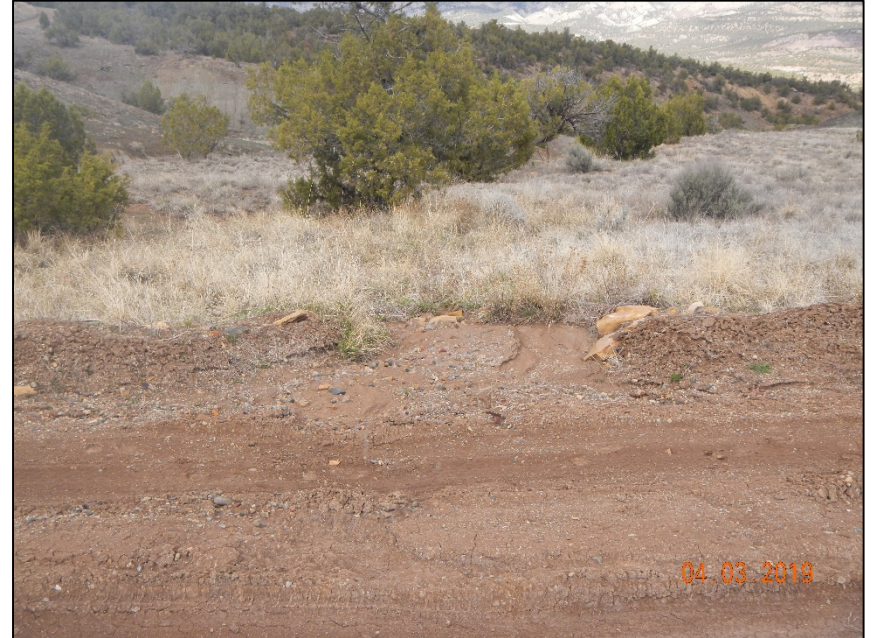
Photo #13. Storm water leaving location, crossing main access road and moving down valley into ravine. BMP not maintained.

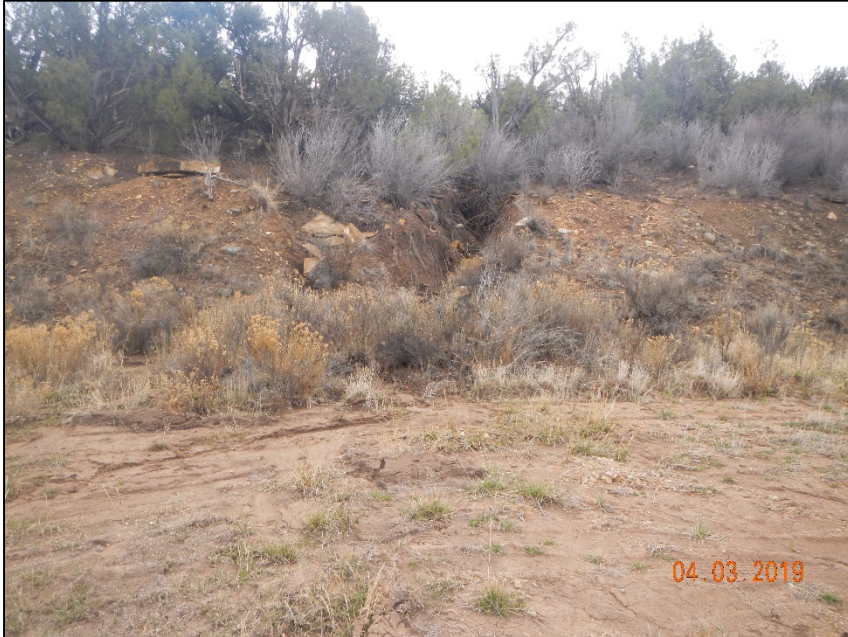
Photo #14. Storm Water Erosion moving sediment of hillside, across location and onto access road

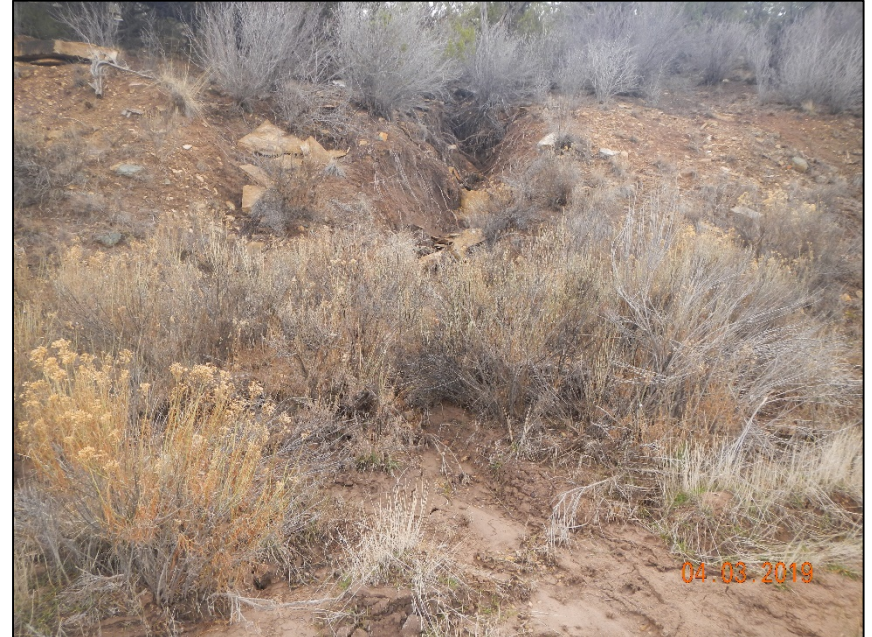
Photo #15. (close up of photo 14) Storm Water Erosion moving sediment of hillside, across location and onto access road
