PIT STATUS EVALUATION FORM

Facility ID: 111797
 Pit Name: DUFFY 10-3

S.S. PAPADOPULOS & ASSOCIATES, INC.

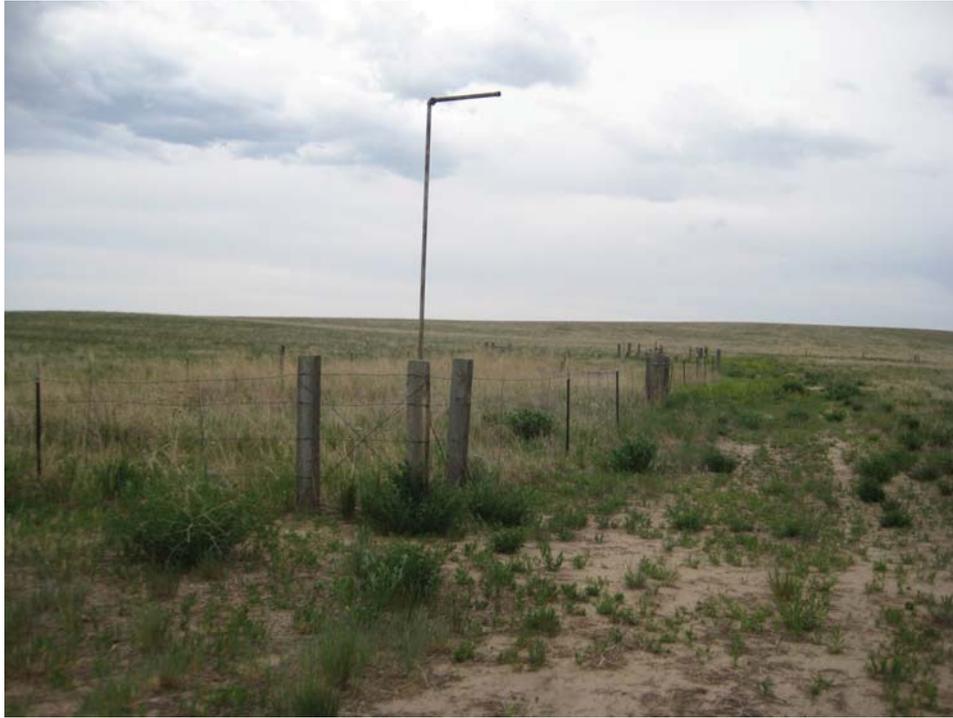
Photo 1. Well site - temporarily abandoned well status

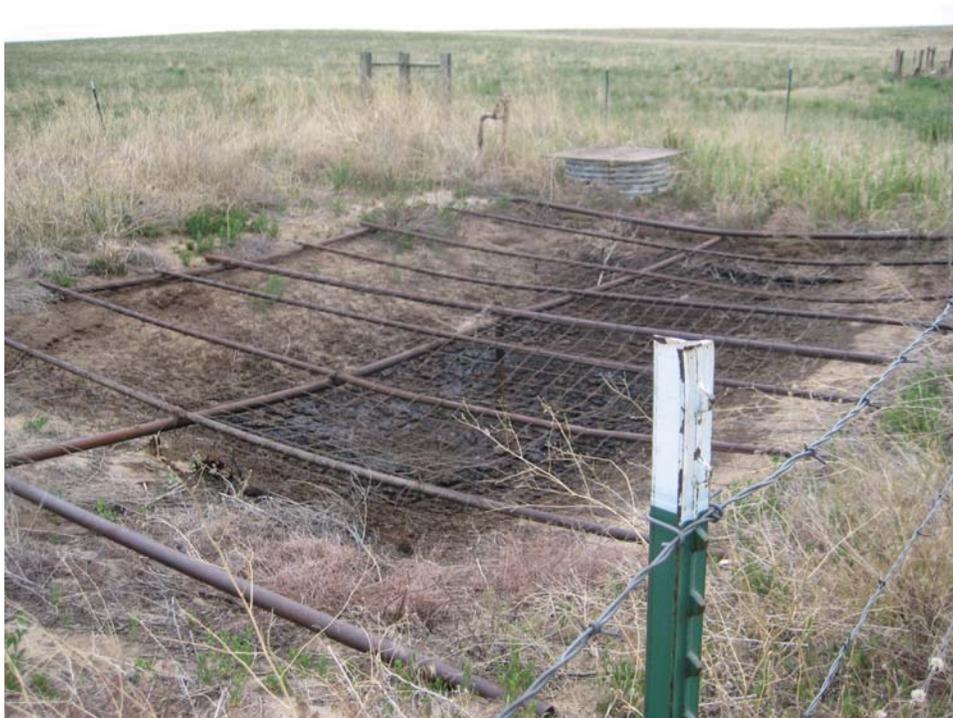
Notes: No lease inspections for Facility ID#111797. NOVA #119754 (2004) indicates well maintain TA status until 4-20-2010.
Field Visit 6-4-2008: Earthen Pit & Culvert found. Heavily oil saturated soils & pit cover / berm unsatisfactory.

Photo 2. Earthen pit and culvert

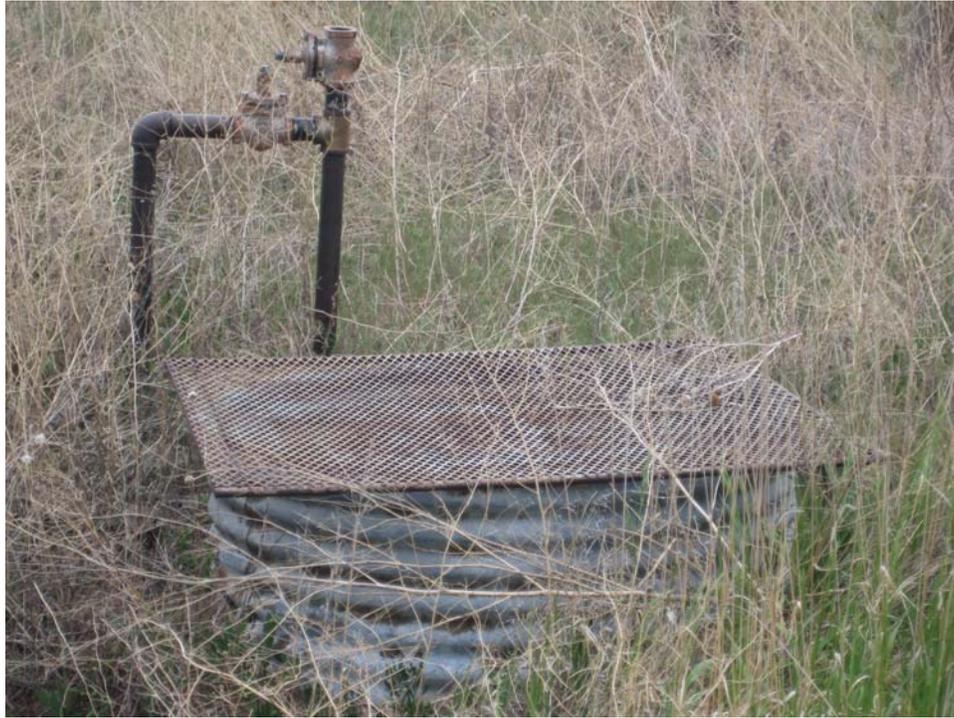
Photo 3. Culvert and cover

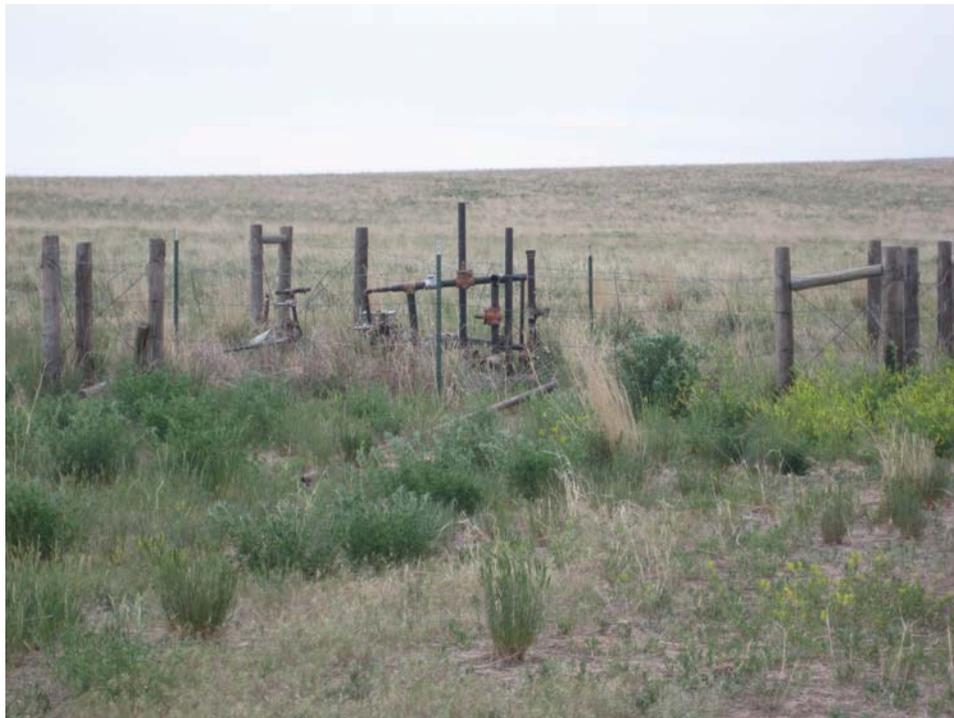
Photo 4. Wellhead equipment
