**Inspection Photos**  
**Location Name: UPRR 43 Pan AMB#11**  
**Location ID: 318578**

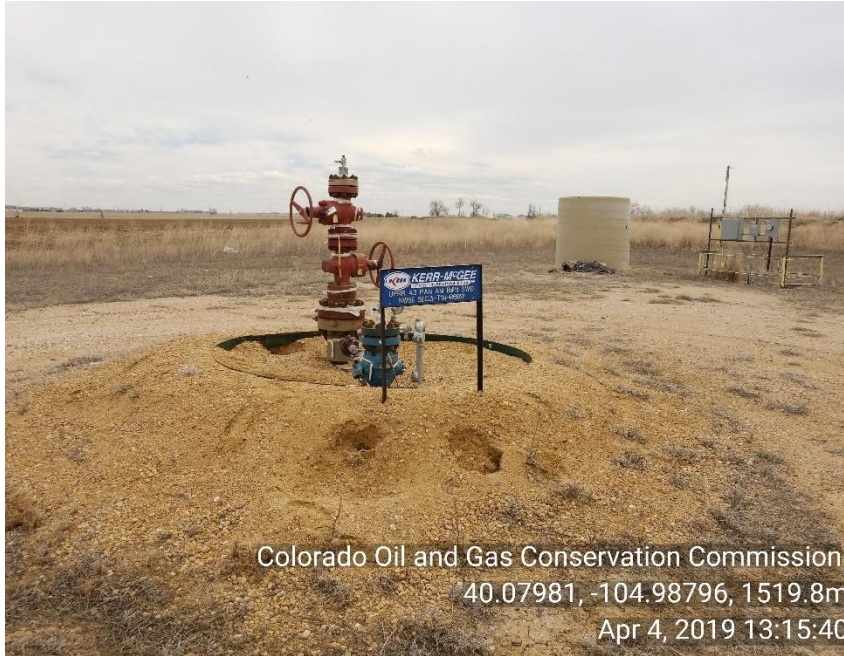
**Photo 1 WH piping from injection line to WH has been removed no gauge on tubing on top of WH**

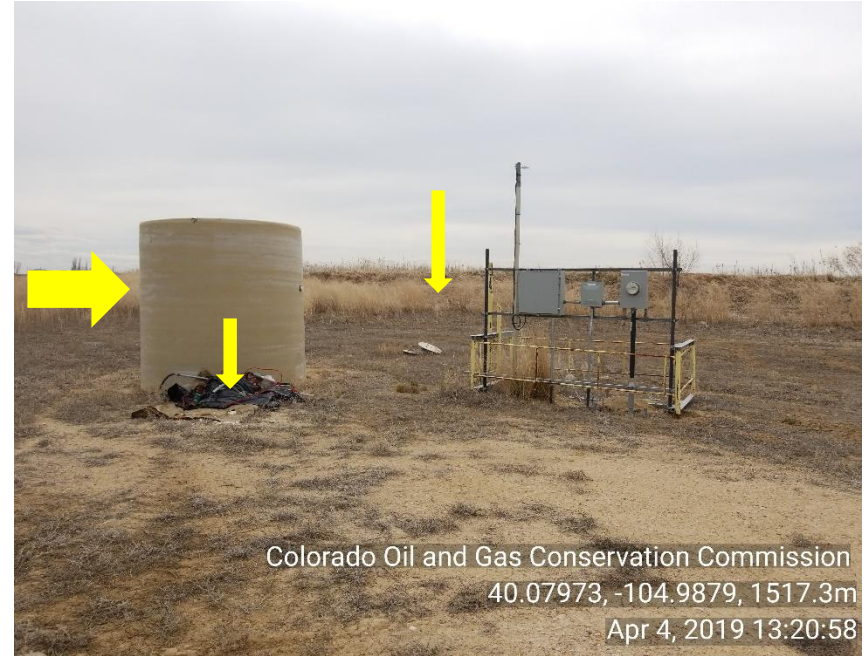
**Photo 2 Unused equipment: unknown tank, misc parts and roll of wire**

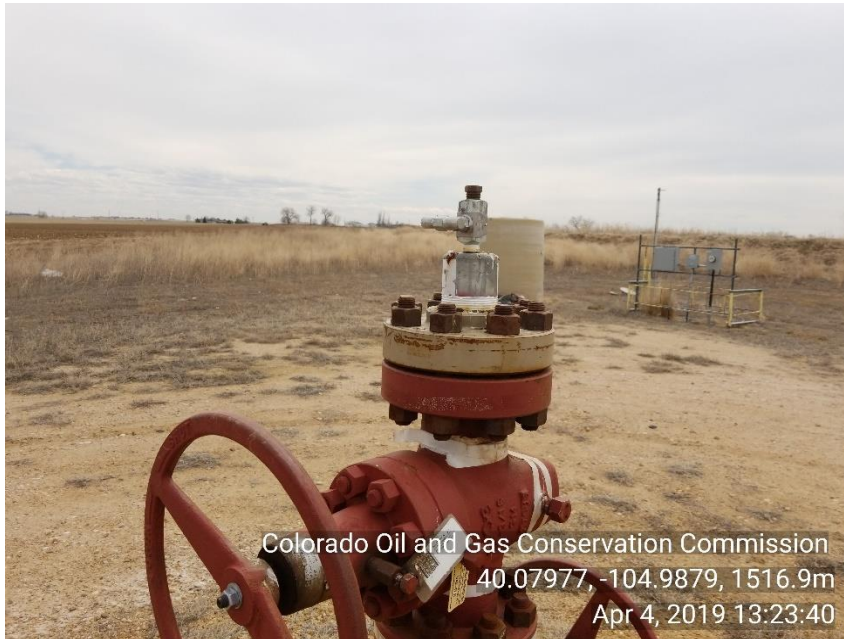
**Photo 3 no gauge on top of WH**

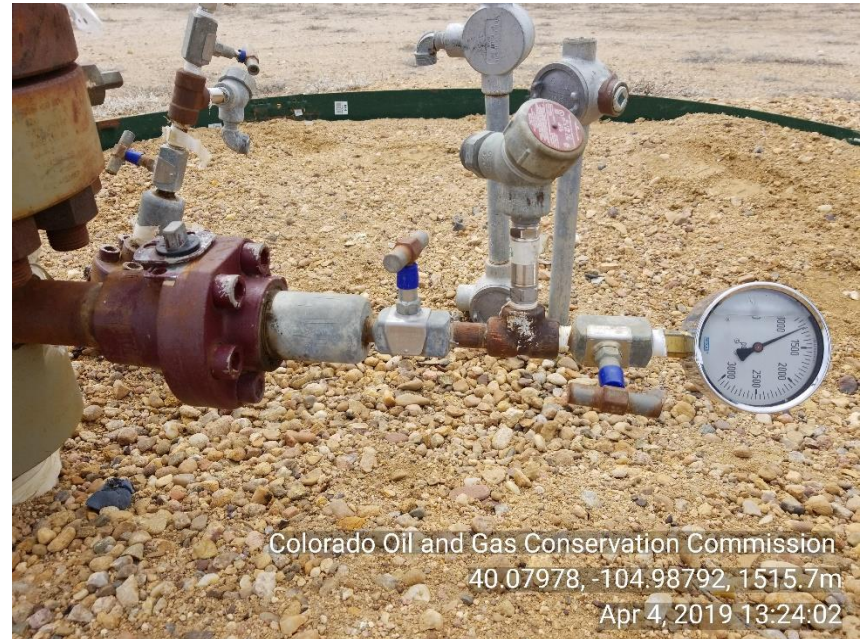
**Photo 4 casing 1150psig**

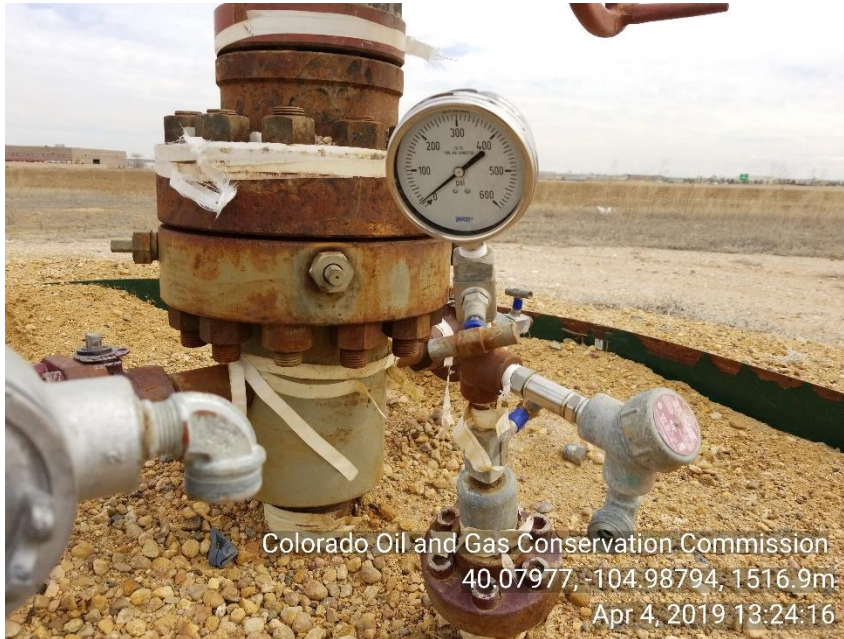
**Photo 5 Braden head 0 psig**
