Inspection Photos
Location Name: Evans 0780 21
Location ID: 438250

COLORADO
Oil & Gas Conservation
Commission
Department of Natural Resources

Inspection Number: 689802462

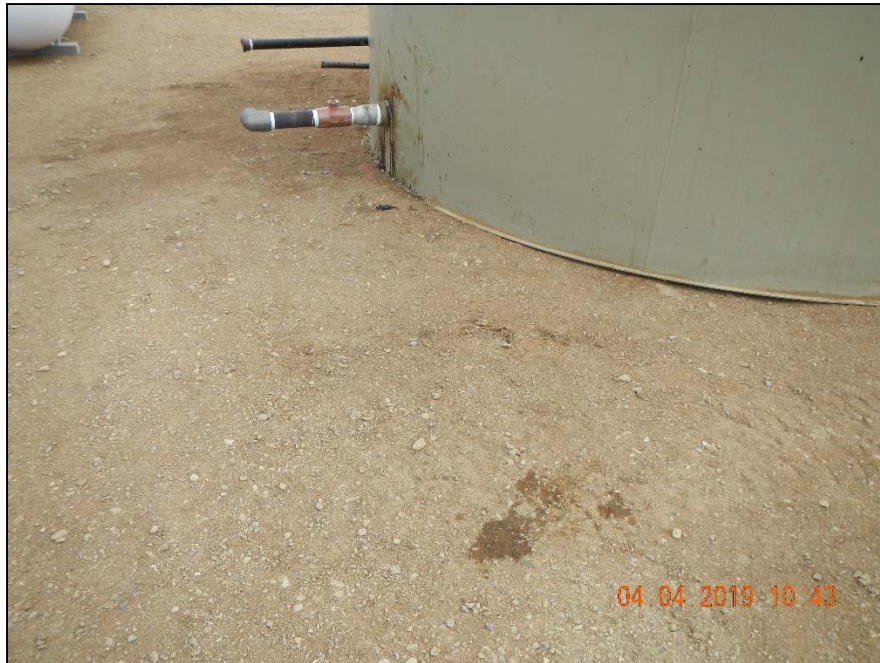
Photo 1. No liner apparent under tank install. Non-reportable spills, stained soil in foreground and background.

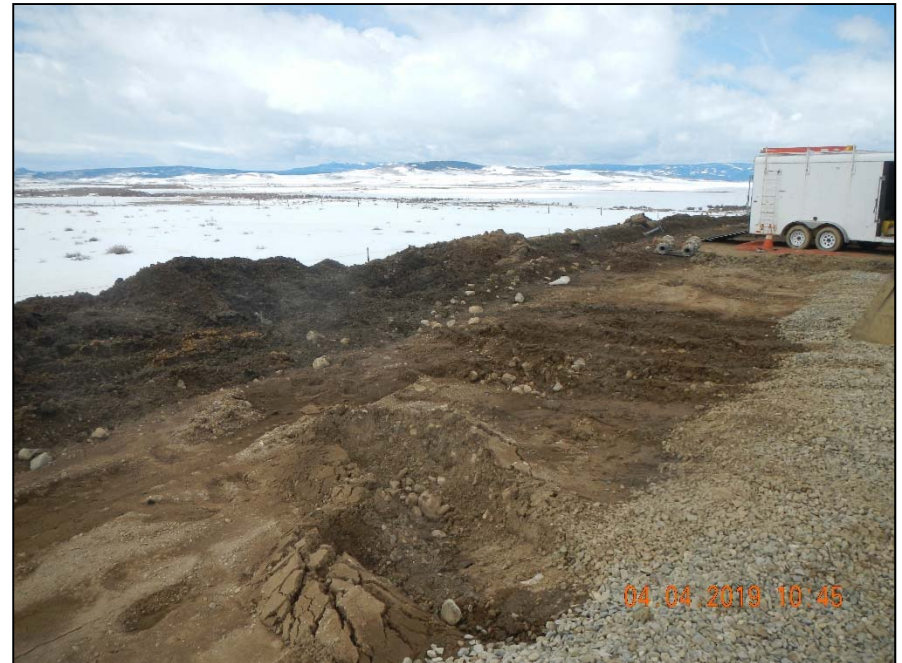
Photo 2. Example of cuttings on location perimeter berm.

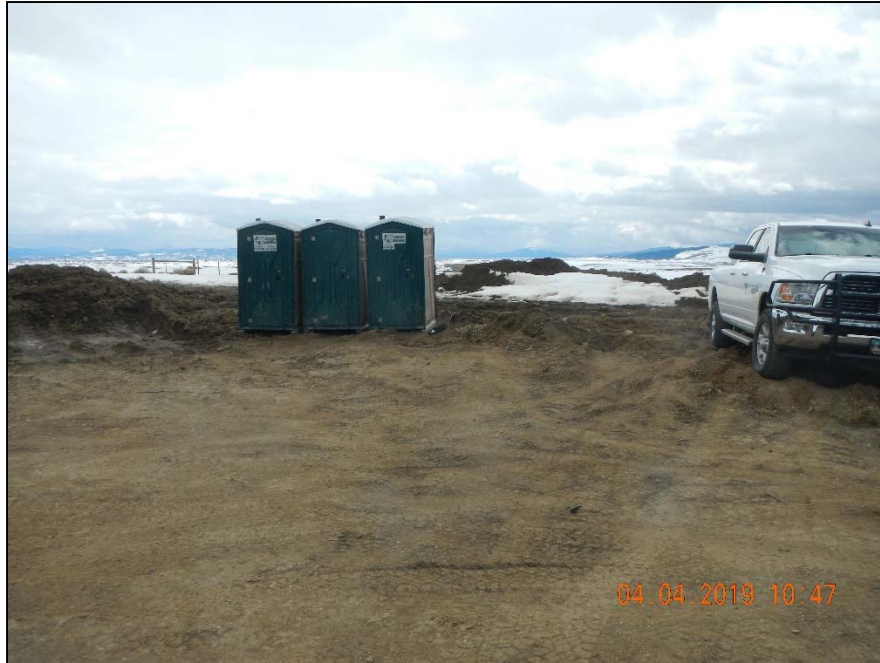
Photo 3. Example of cuttings on location perimeter berm.

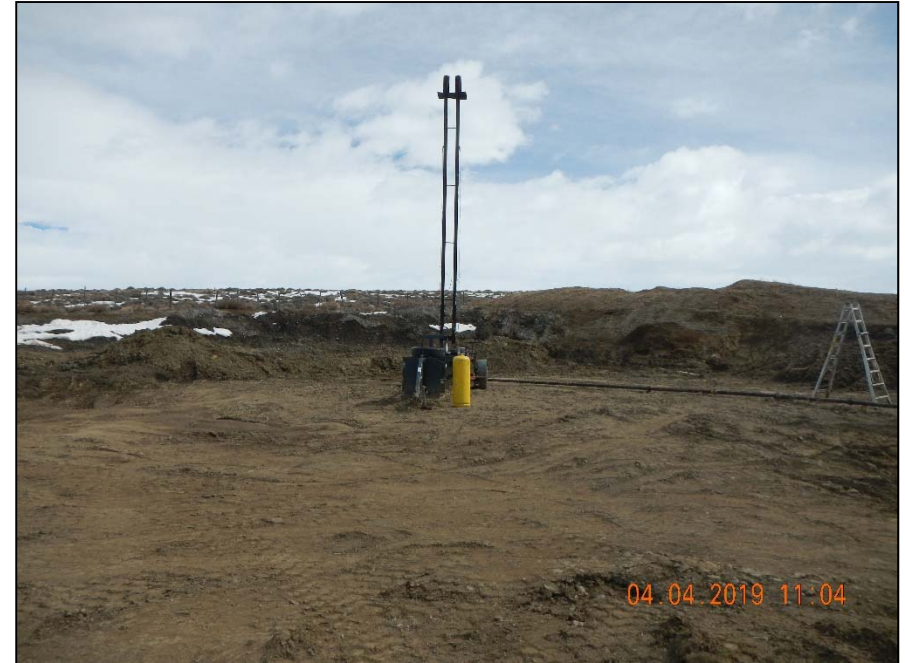
Photo 4. Example of cuttings on location.

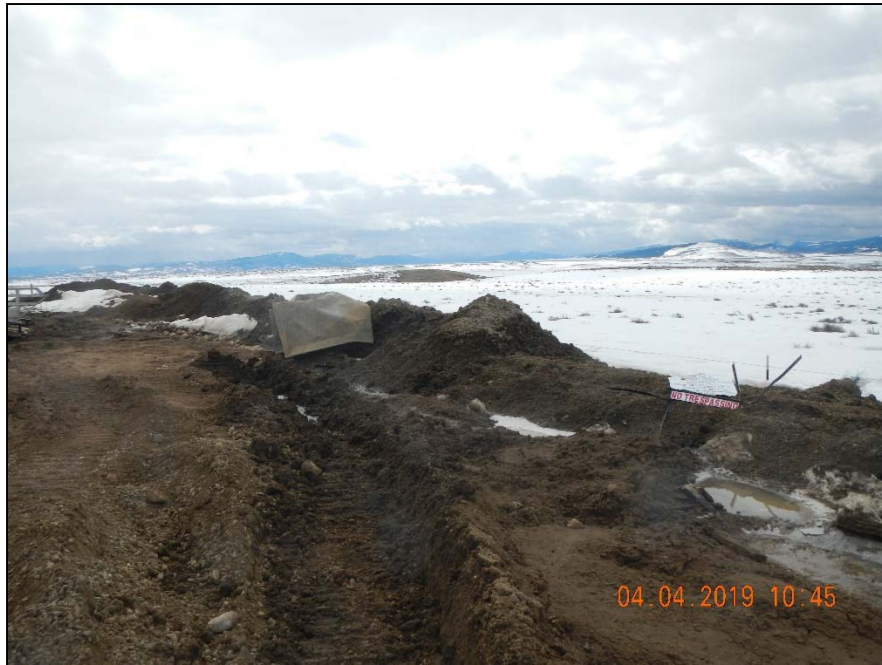
Photo 5. Example of cuttings on location perimeter berm, debris and trash also present on berm.

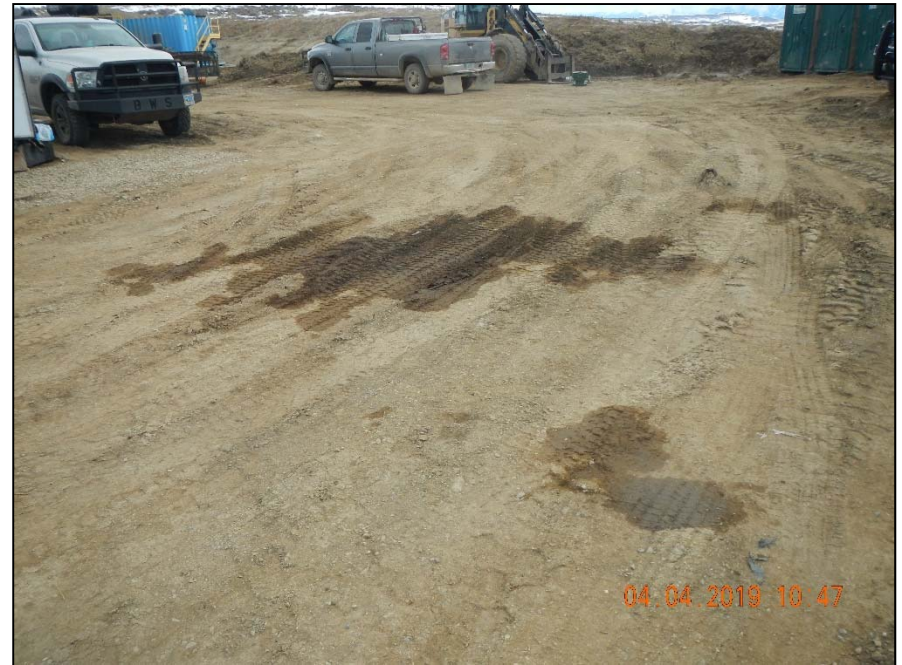
Photo 6. Non-reportable spill, stained soil.

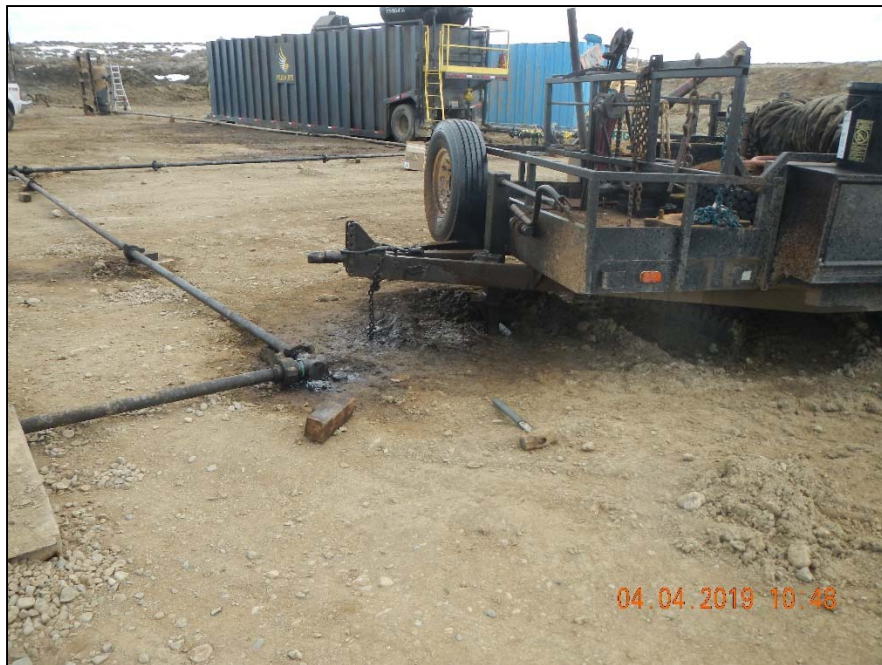
**Photo 7. Non-reportable spill at hammer union.
Free product and stained soil.**

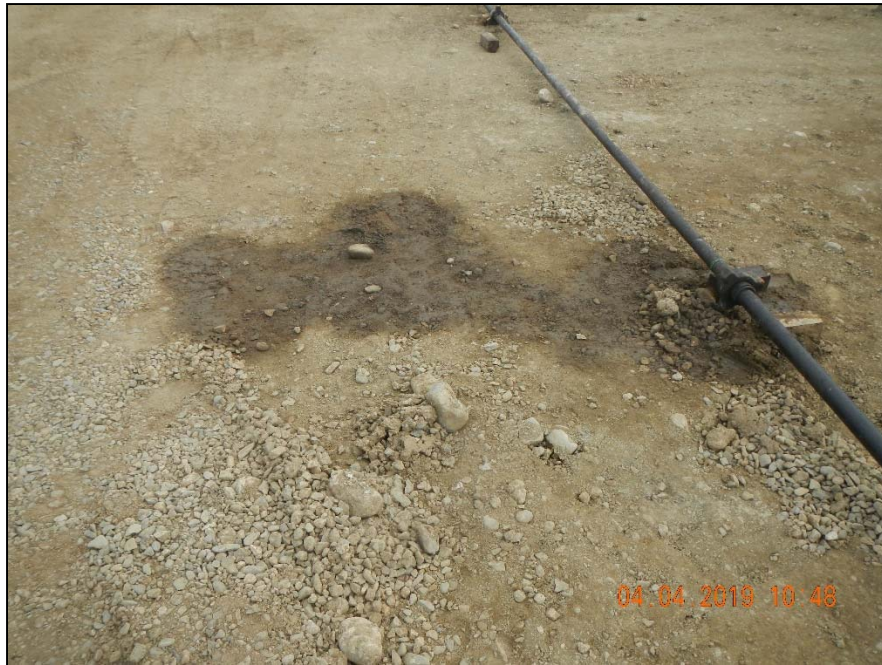
Photo 9. Non-reportable spill at hammer union. Stained soil.

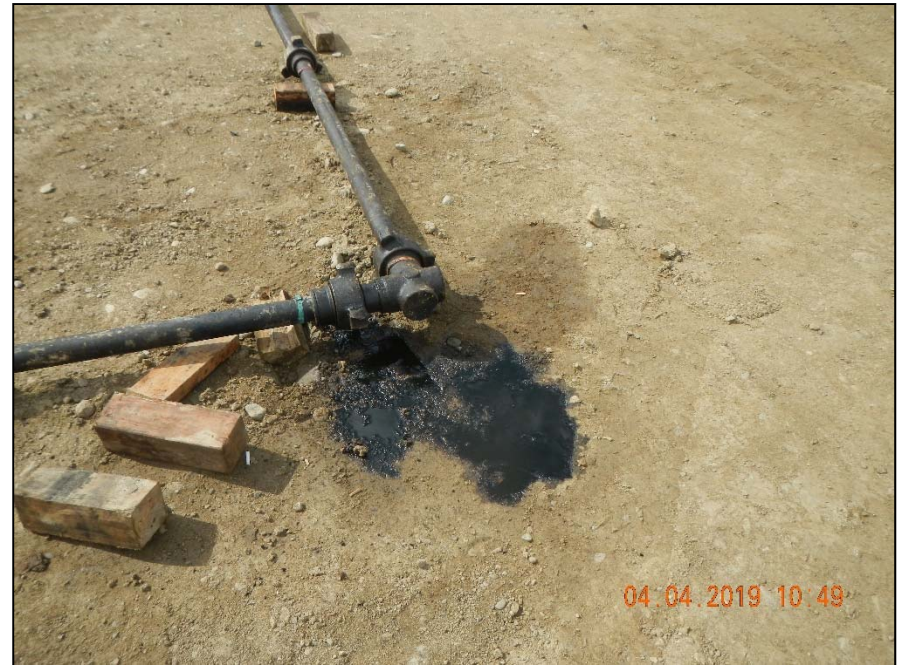
Photo 10. Non-reportable spill at hammer union. Free product and stained soil.

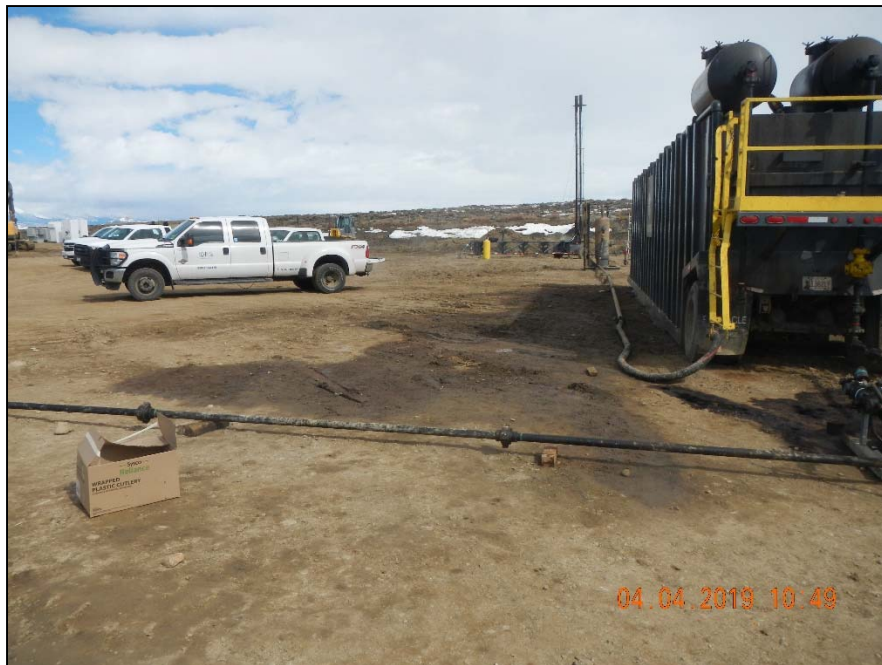
Photo 11. Non-reportable spil. Stained soil.

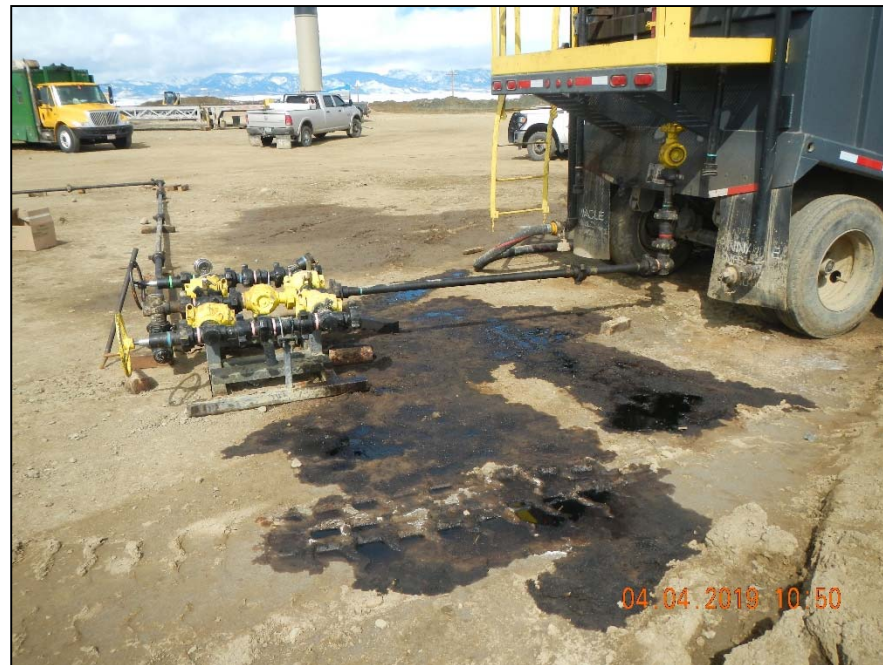
Photo 12. Non-reportable spill. Free product and stained soil.

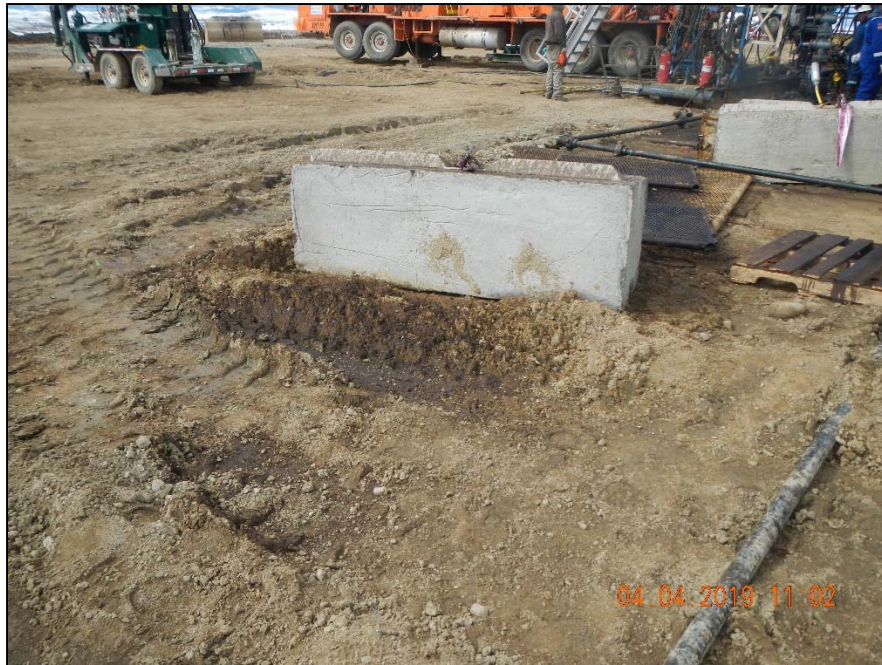
Photo 13. Non-reportable spil. Stained soil.

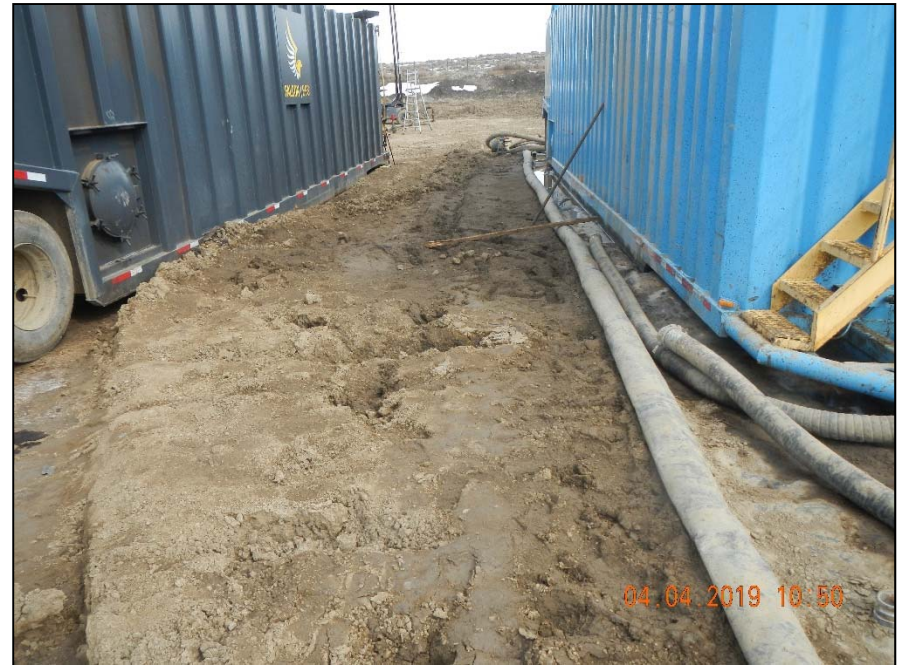
Photo 14. Non-reportable spill. Stained soil.
