**GORDON ENGINEERING INC**

**Api # 05-077-08508**

**Inspection # 675002122**

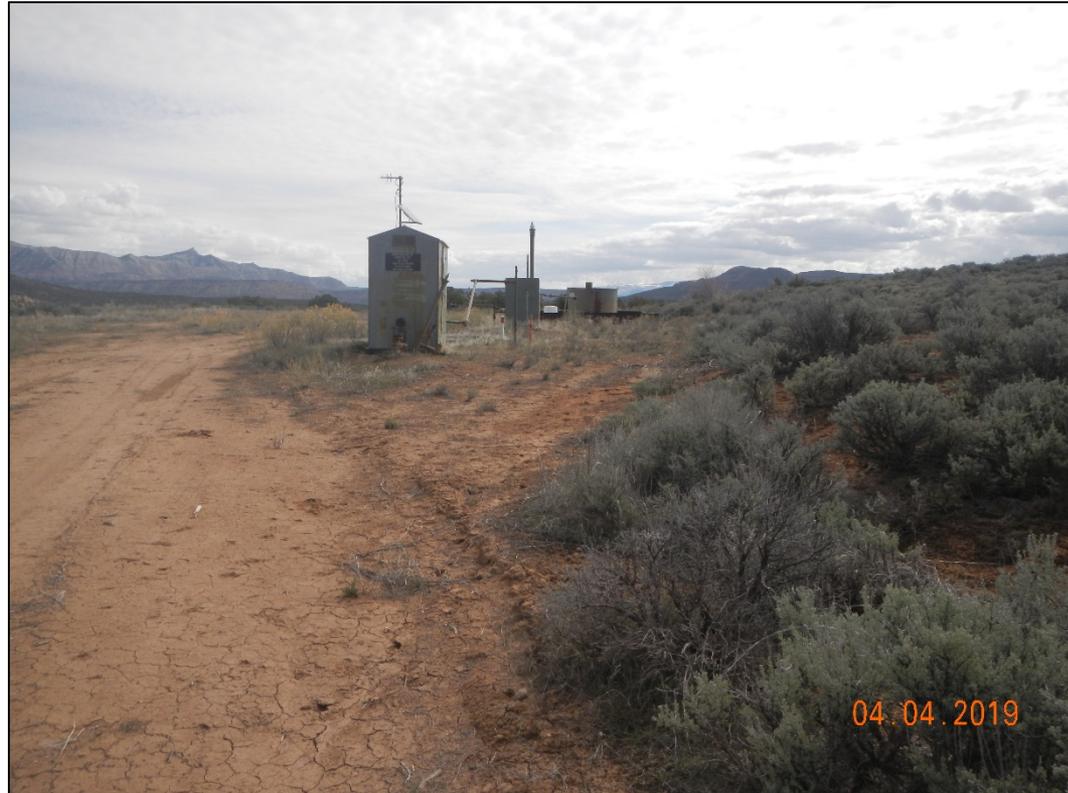
**Photo of location From NW corner of the location**

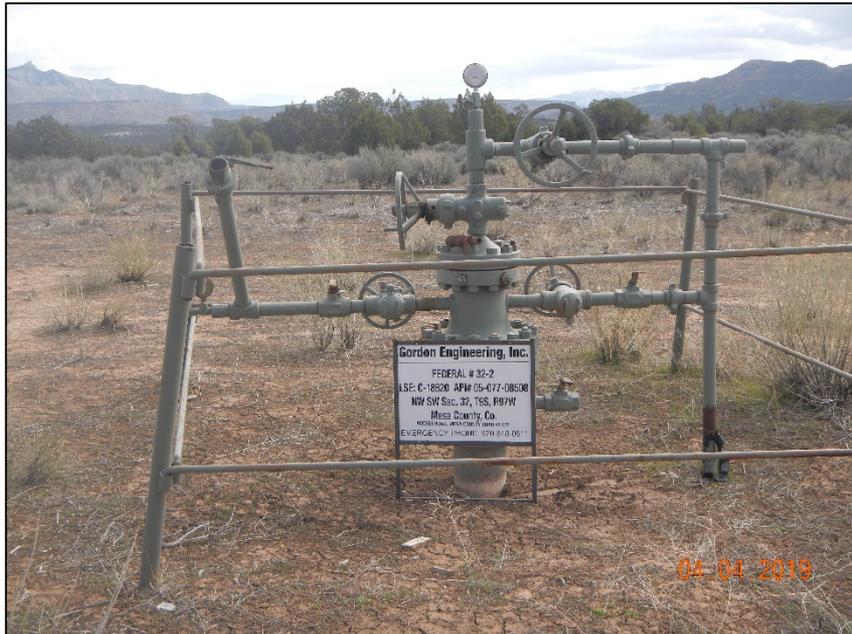
**Photo #2. Wellhead sign.**

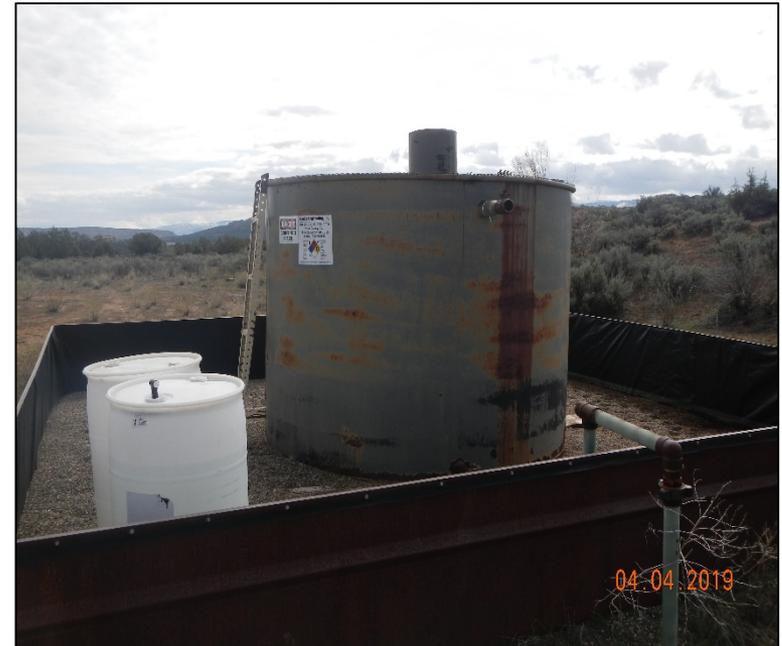
**Photo # 3Tank Battery**

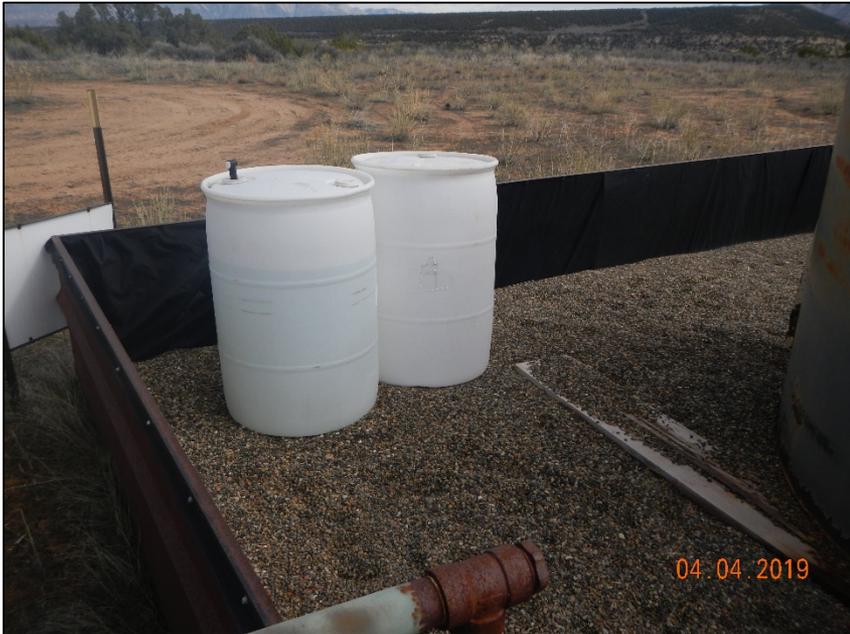
**Photo #4. Unused, unmarked white chemical containers with no labels.**

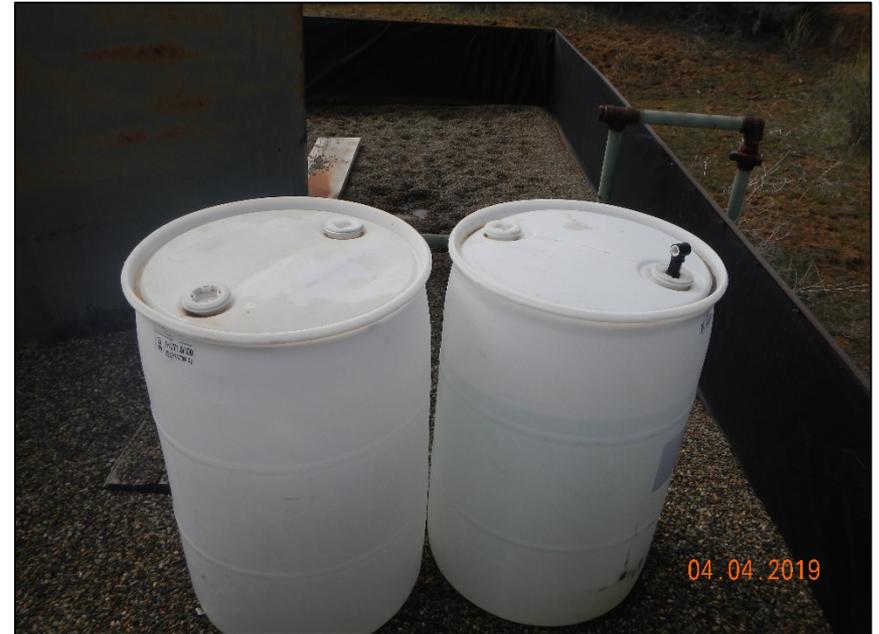
**Photo #5 Unused, unmarked white chemical containers with no labels.**

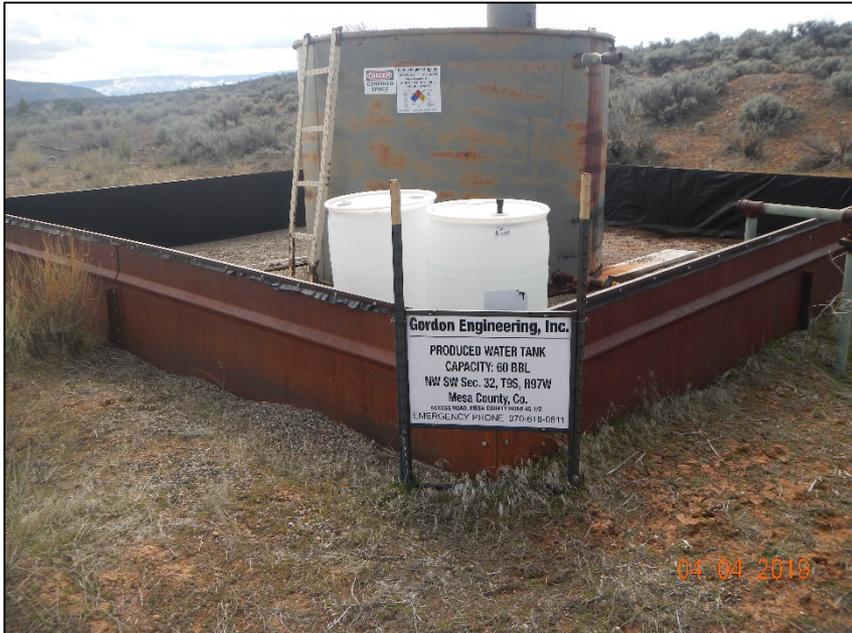
**Photo #6 . Tank battery sign. 911 not posted on sign,**

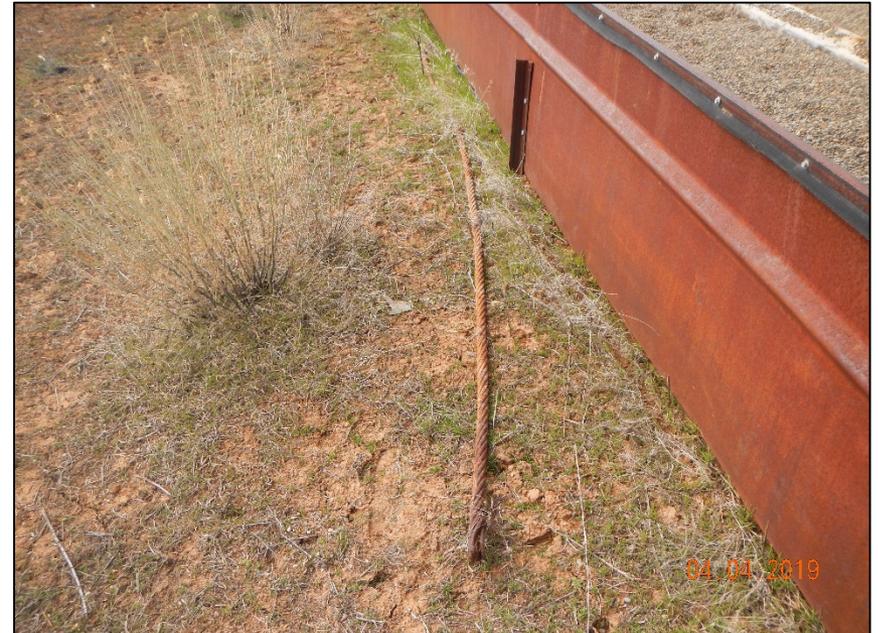
**Photo #7 Unused equipment stored on location**

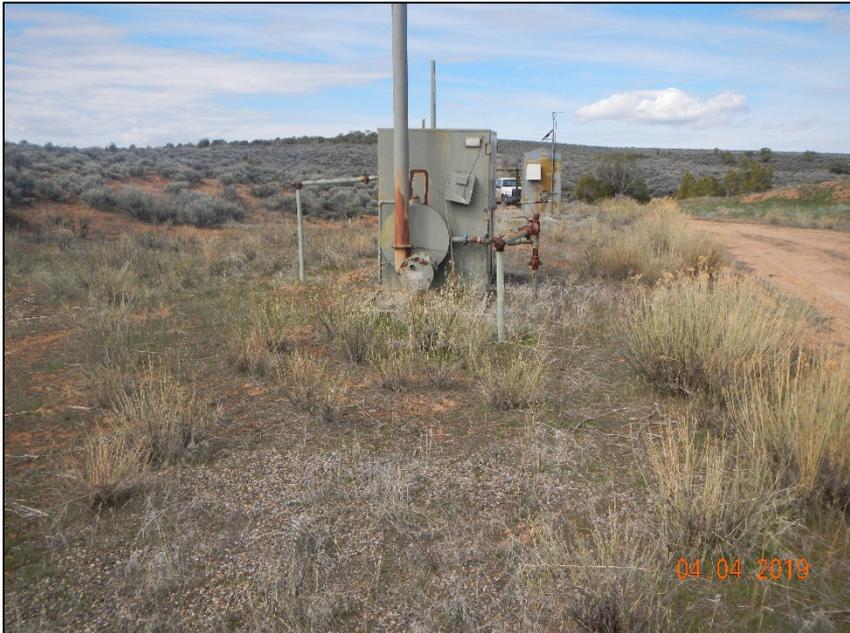
**Photo #8. Weeds and debris on location**

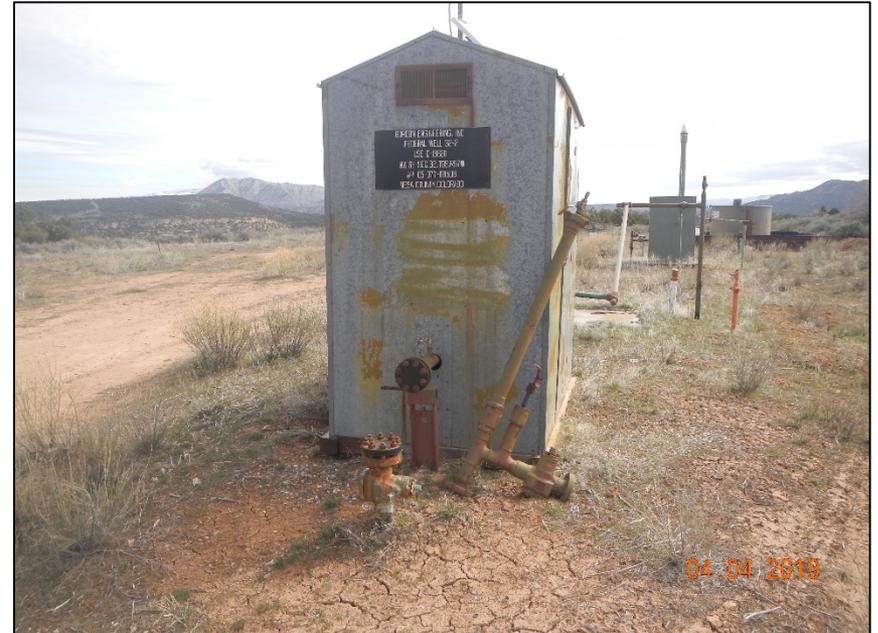
**Photo #9. Unused equipment. Gas Meter appears to be disconnected. Risers are not marked or locked out tagged out.**

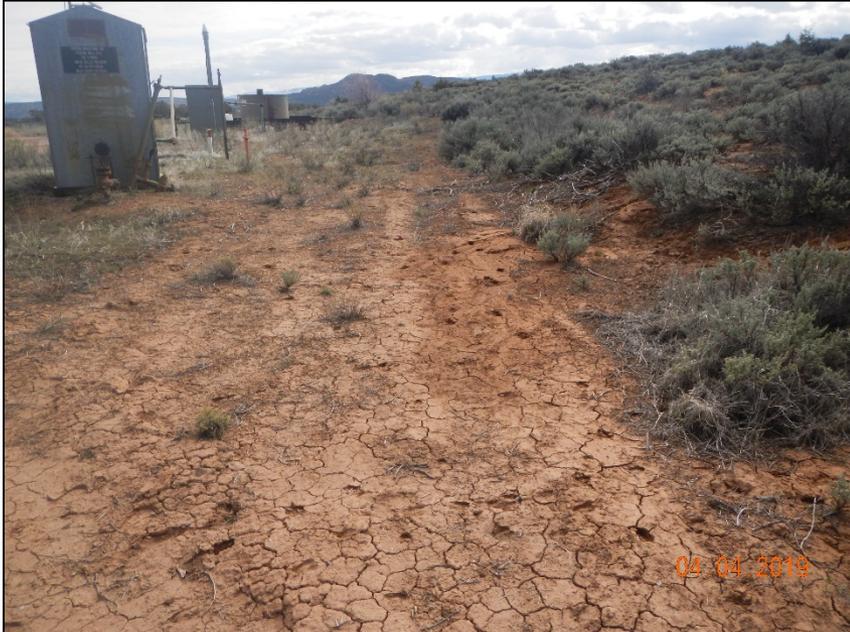
**Photo #12. Storm Water Erosion moving sediment off the SW entrance of location onto main access road. No BMP's in place**

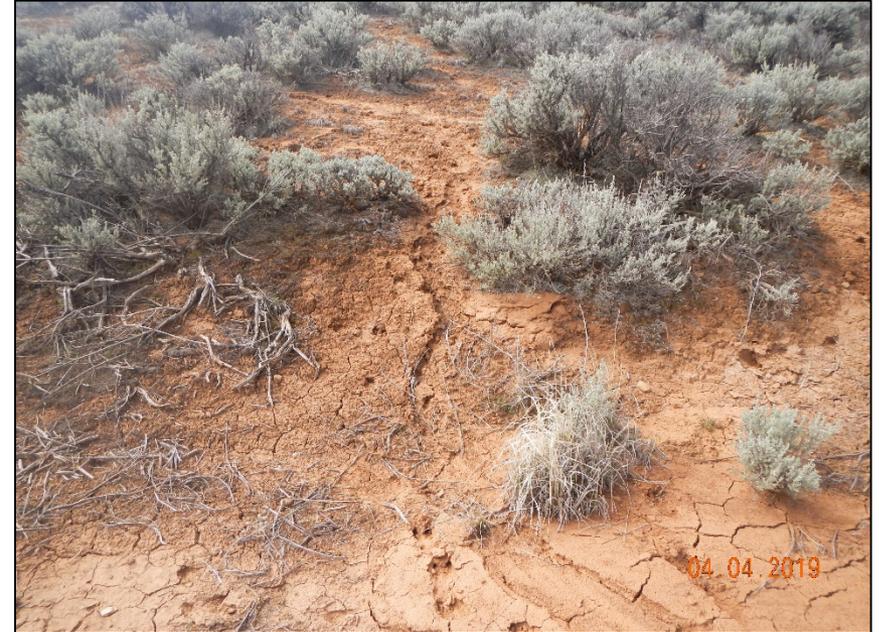
**Photo #13. Storm water moving onto location from south hillside of location. No BMP's in place**

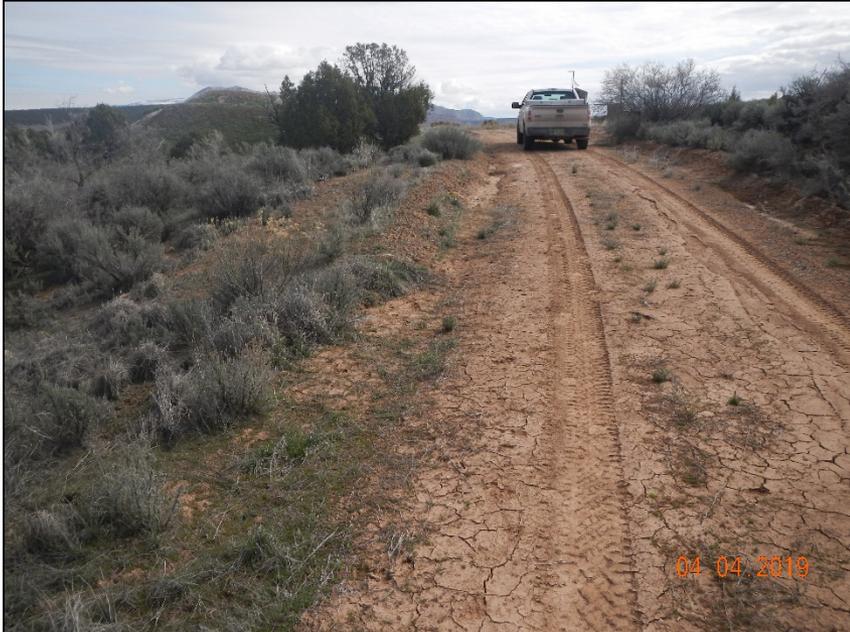
**Photo #10. Storm water Erosion moving sediment along north side of access road**

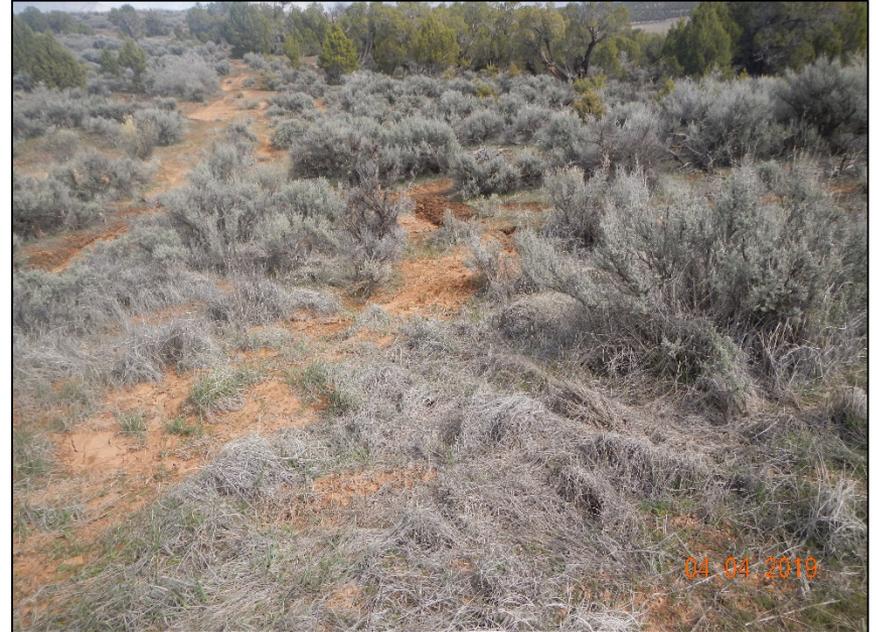
**Photo #11. Storm water Erosion moving heavy sediment off access road, into ravine.**
