PA 22-34 Production Facility

Location id. # 444624

Inspection # 689702991

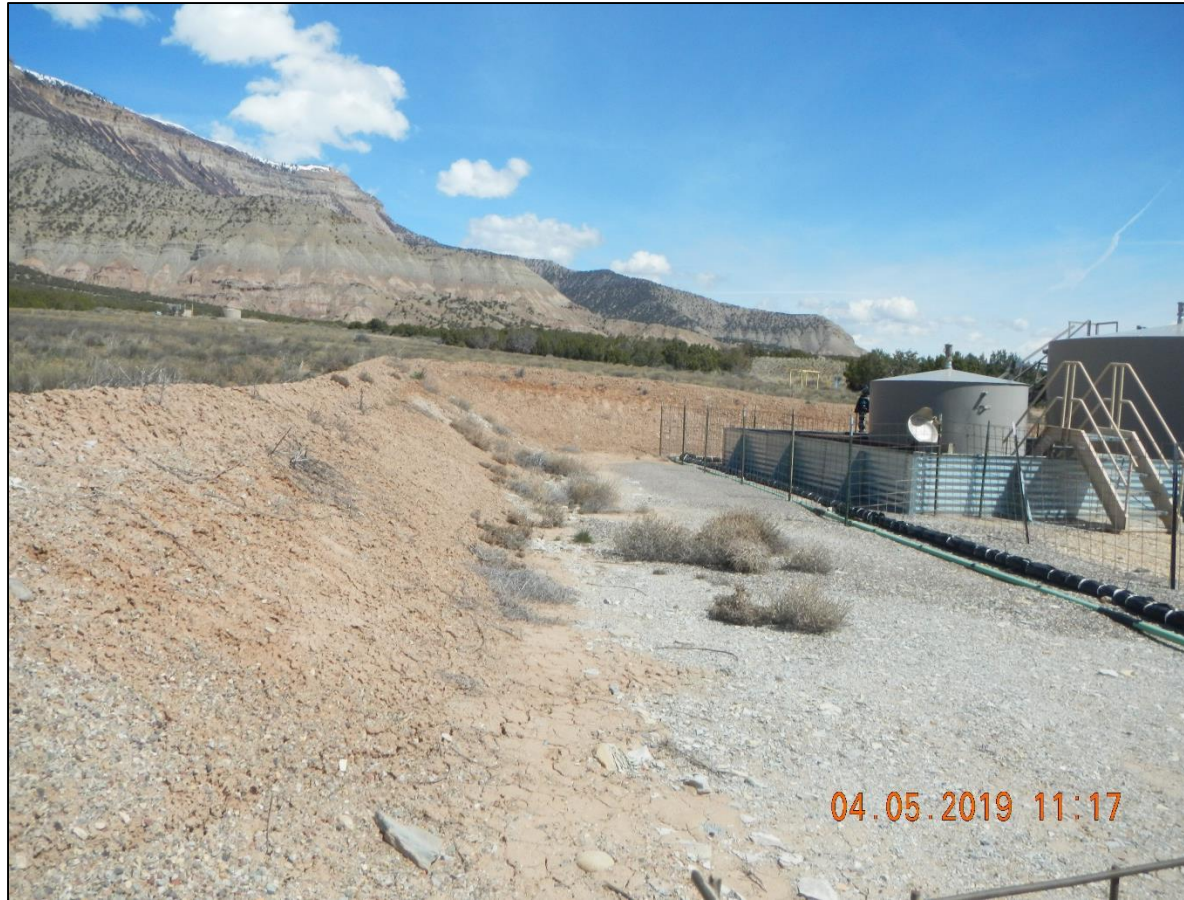
Dead weed rubbish between separators and tanks.

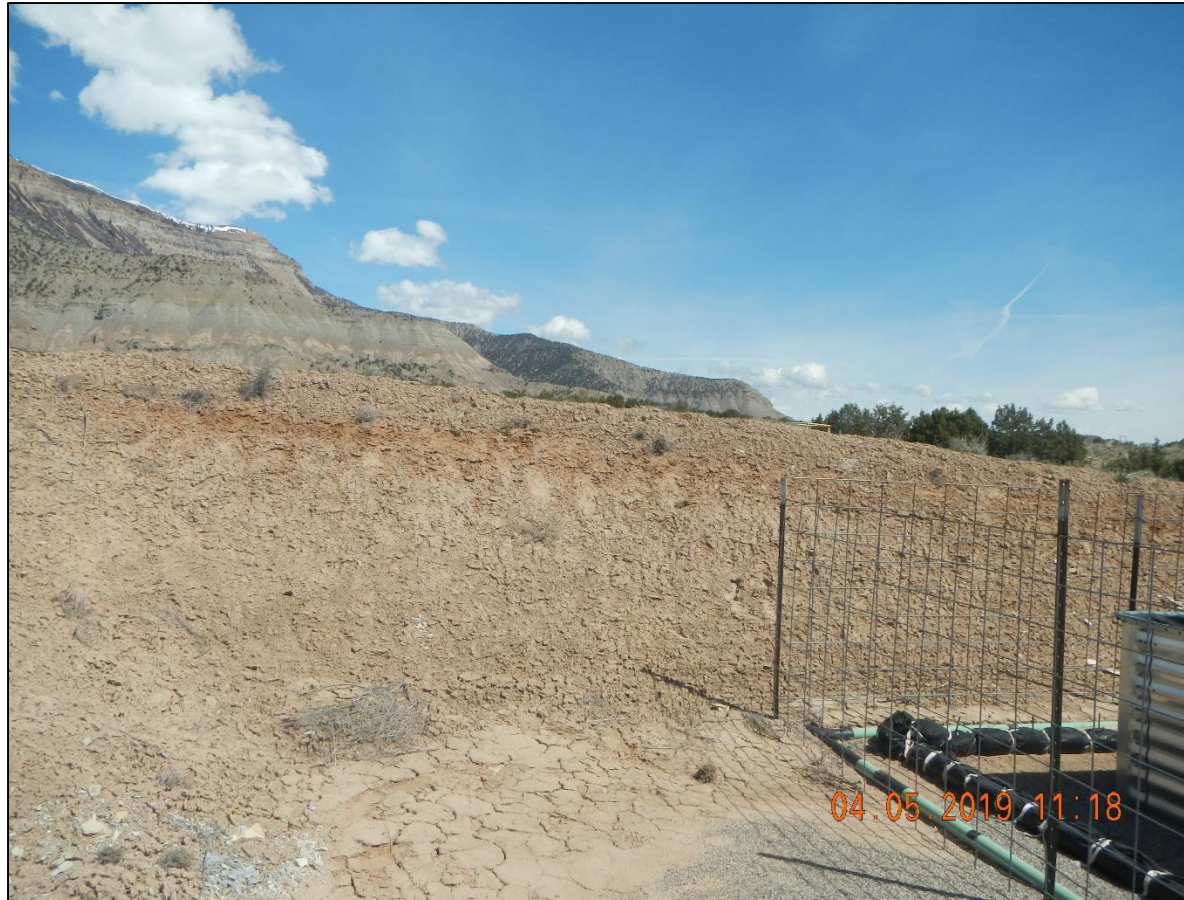
Slope behind equipment and tanks is sloughing sediment.

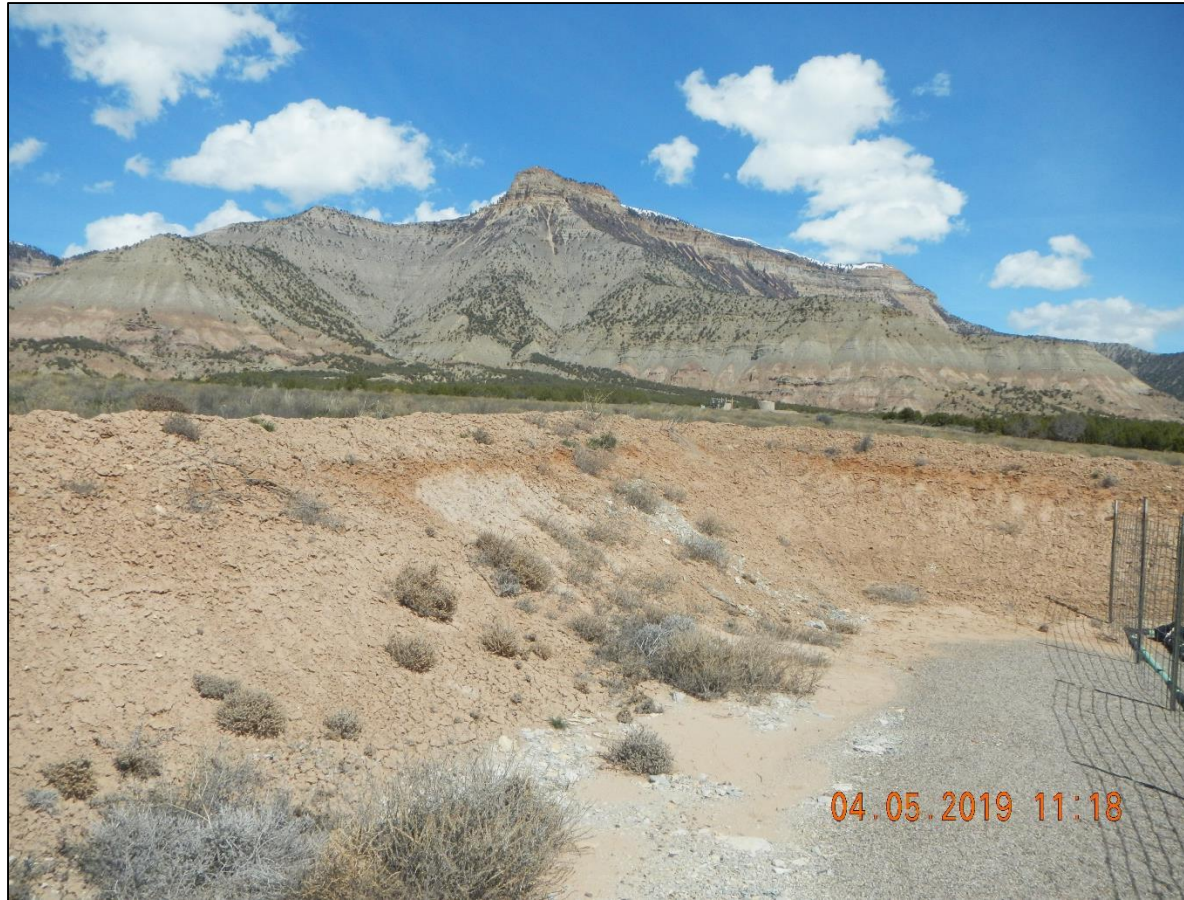
Slope behind equipment and tanks is sloughing sediment.

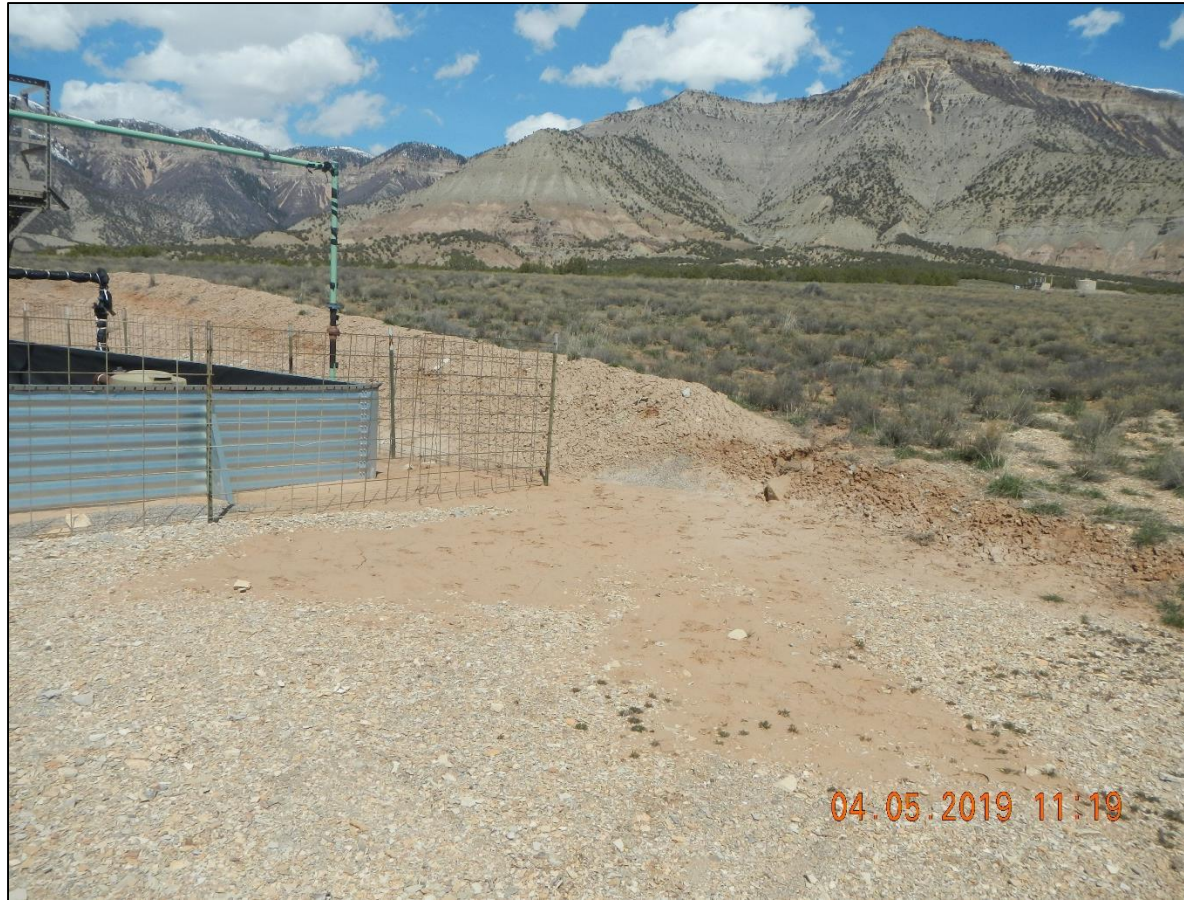
Slope behind equipment and tanks is sloughing sediment. Sediment washing along tank berm towards the road.

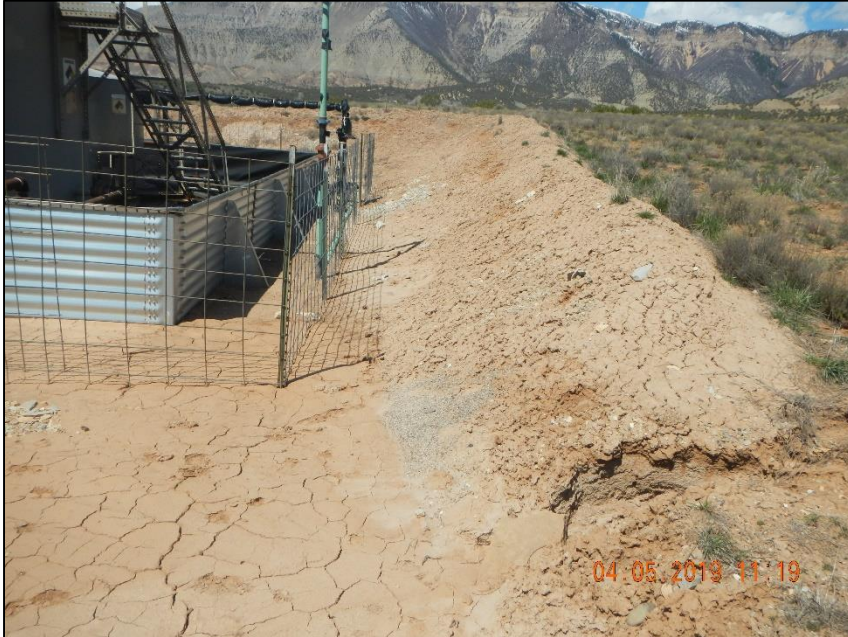
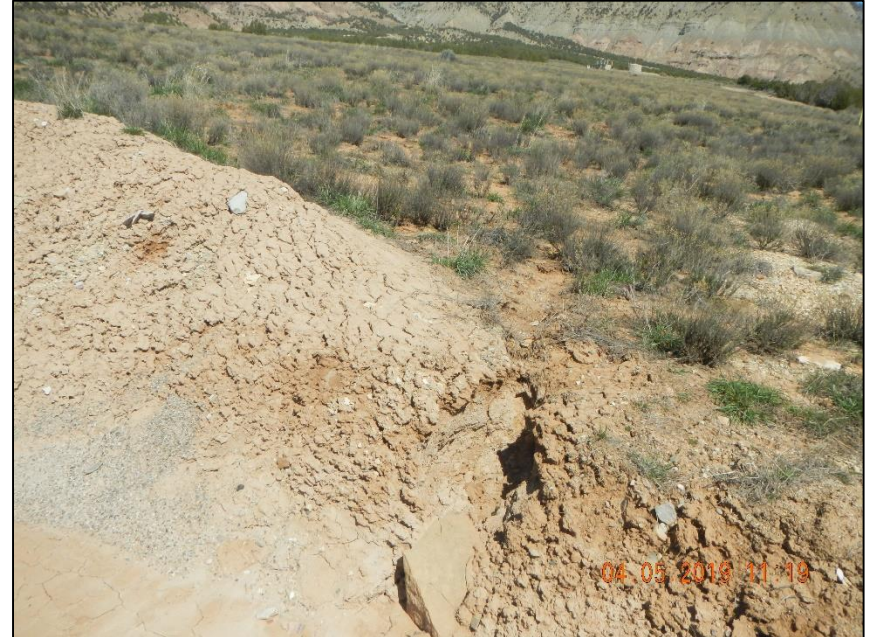
Berm is washed out at the front of tank berm.

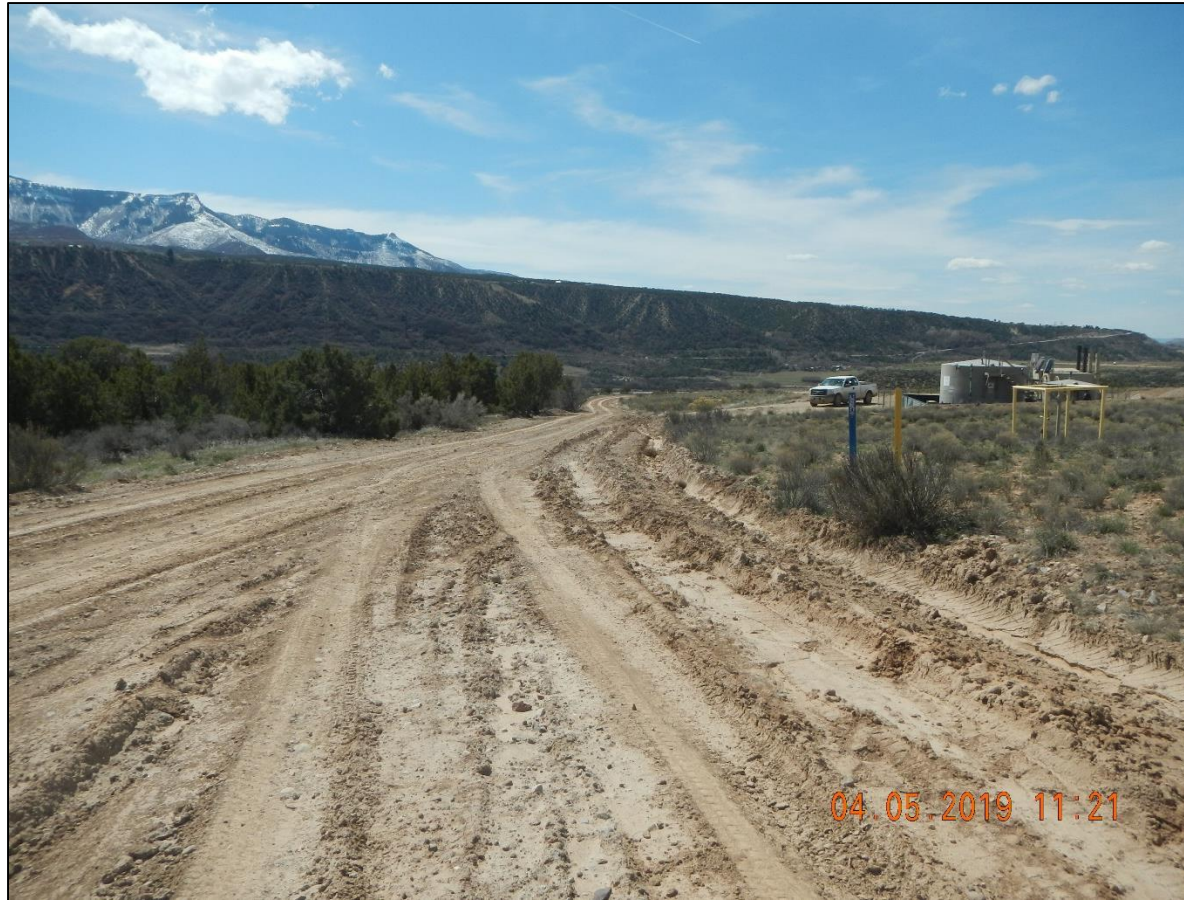
Road and ditch are rutted and damaged from traffic.

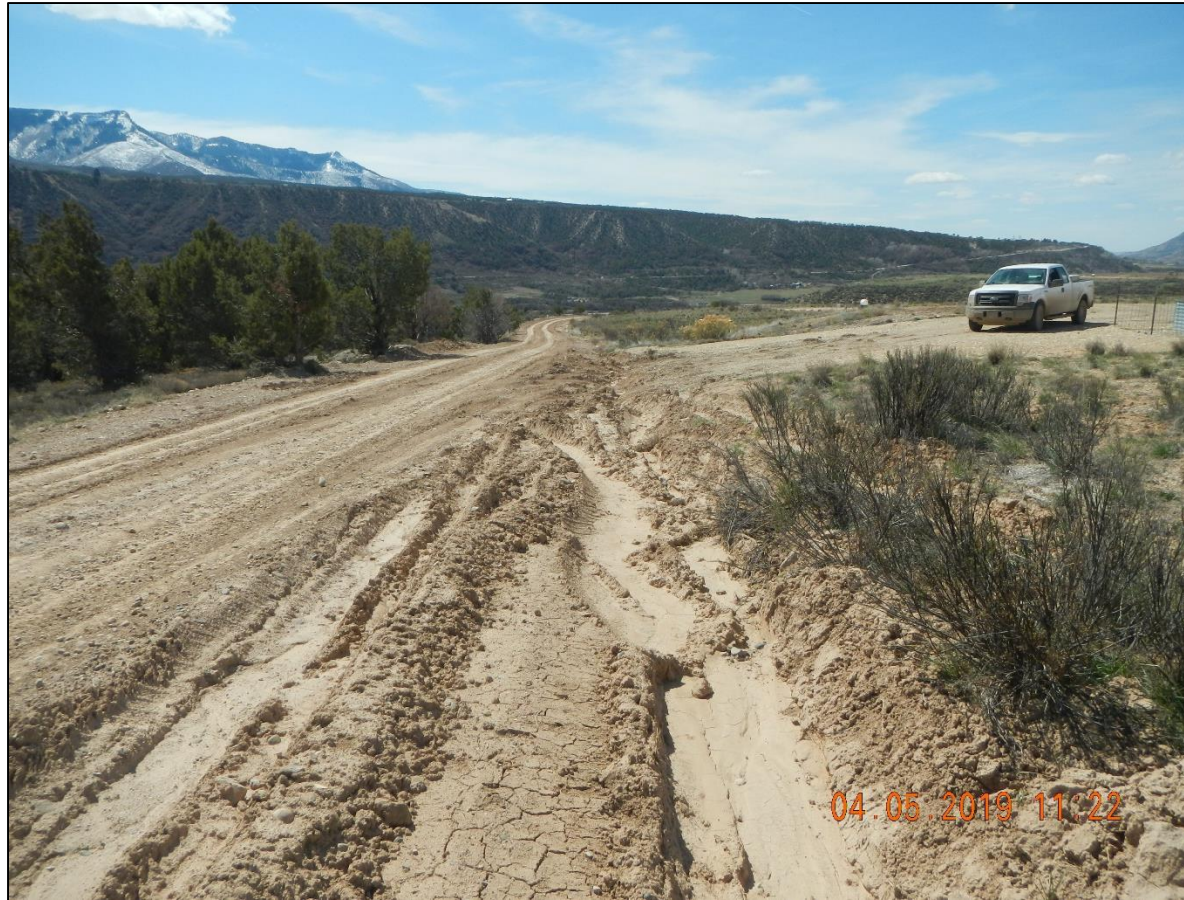
Road and ditch are rutted and damaged from traffic.
