Inspection Photos
Location Name: NGL C2
Location ID: 330267

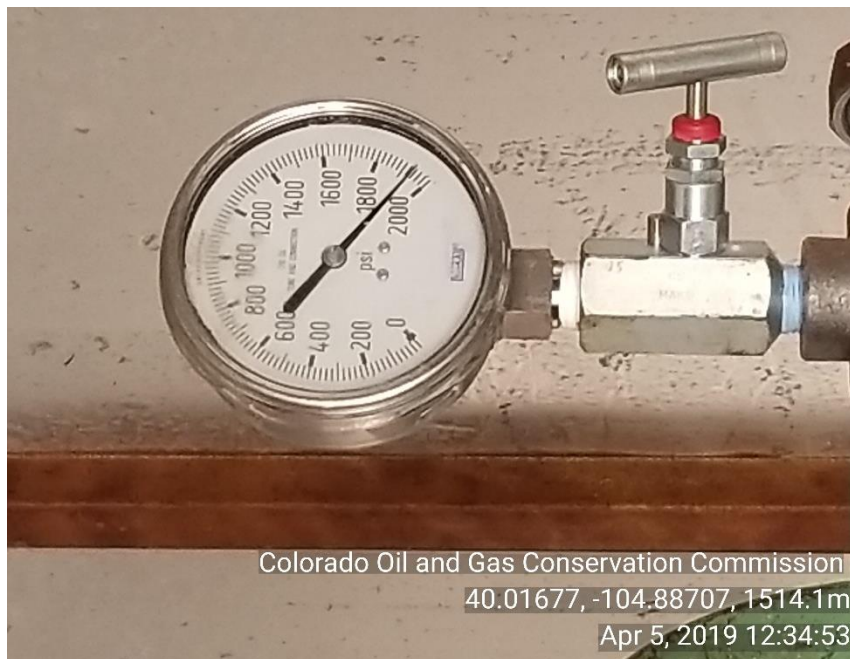
Photo 1 Tubing pressure 1900psig

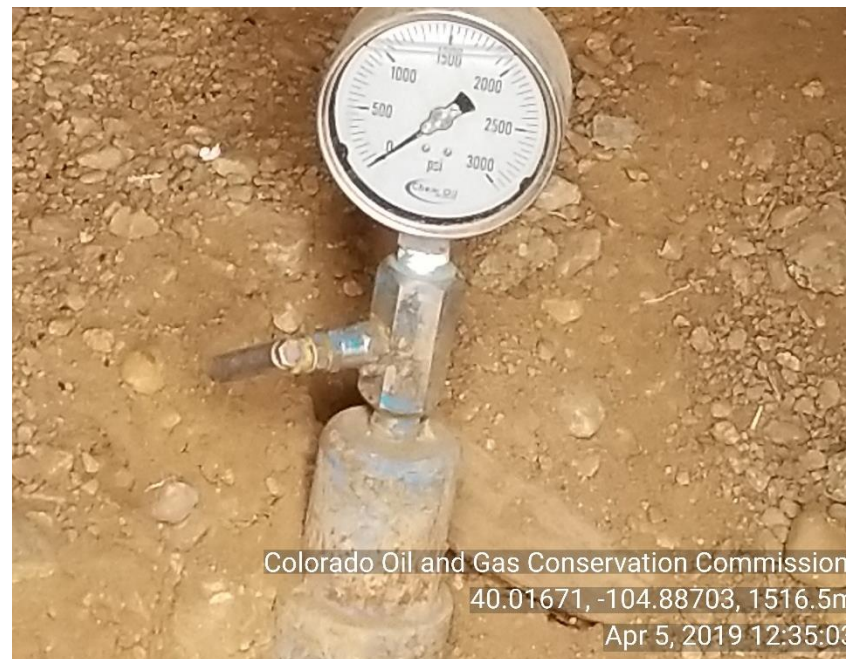
Photo 2 Braden head pressure 0psig

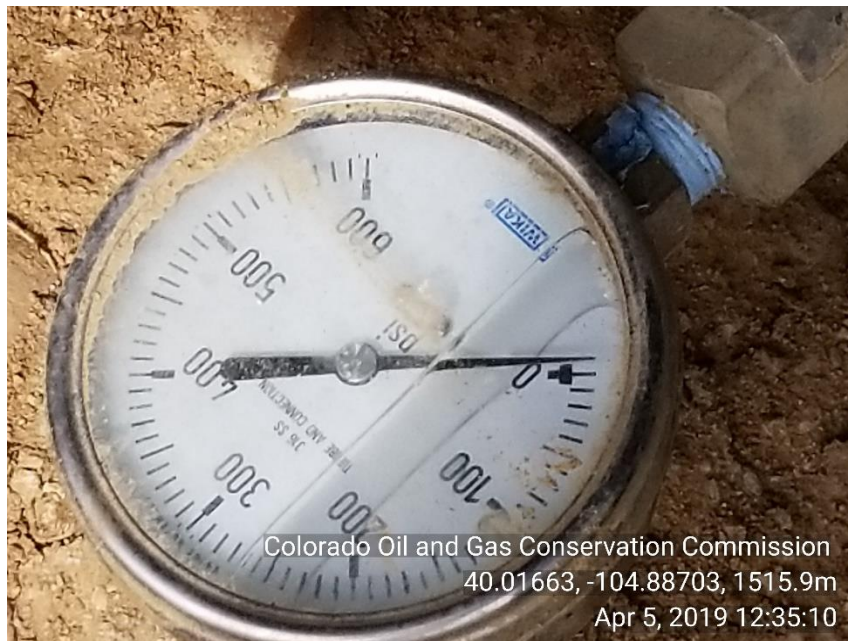
Photo 3 casing pressure Opsig

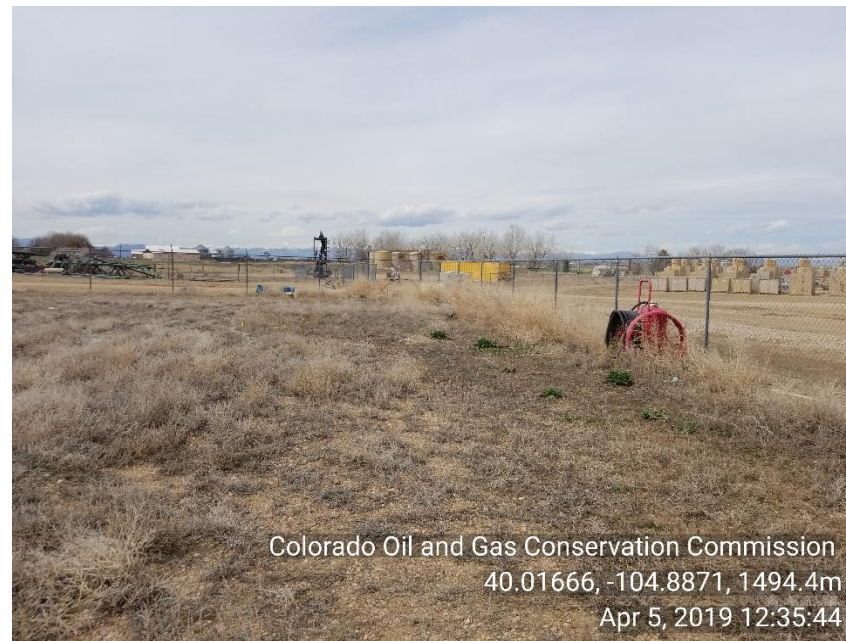
Photo 4 Unused equipment, trash and weeds on outer edge of location

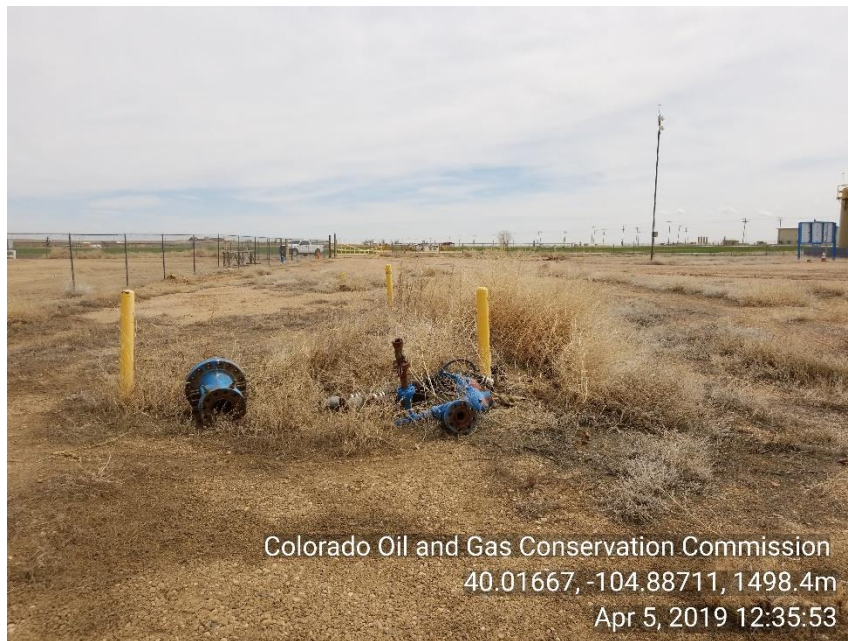
Photo 5 Unused equipment and weeds

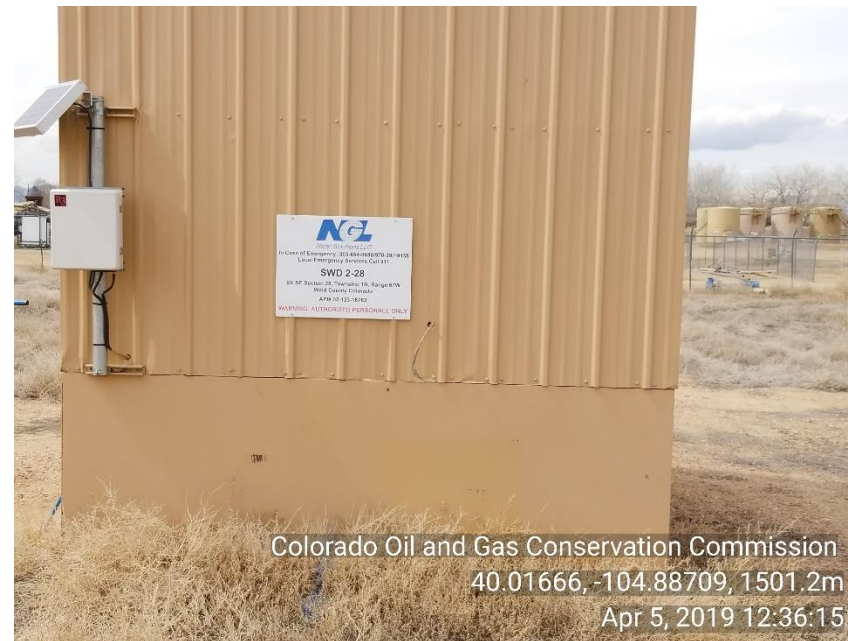
Photo 6 sign not posted with correct well name on sign

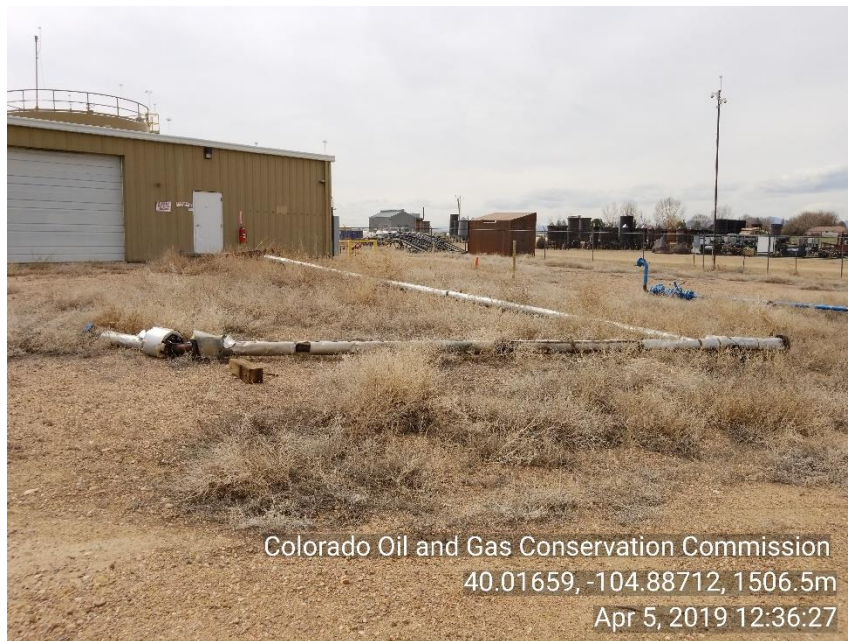
Photo 7 Unused equipment trash and weeds in front of pump building

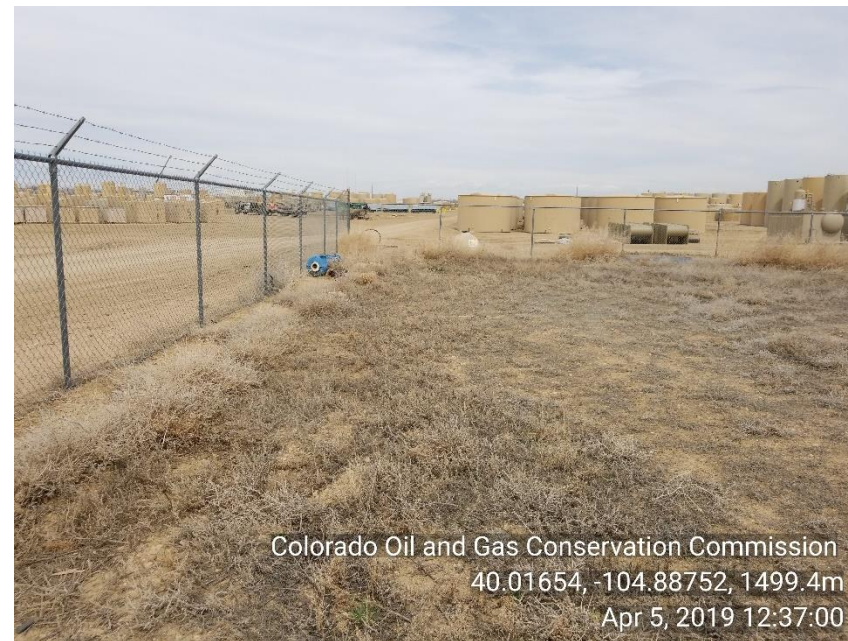
Photo 8 Weeds and unused equipment along fence

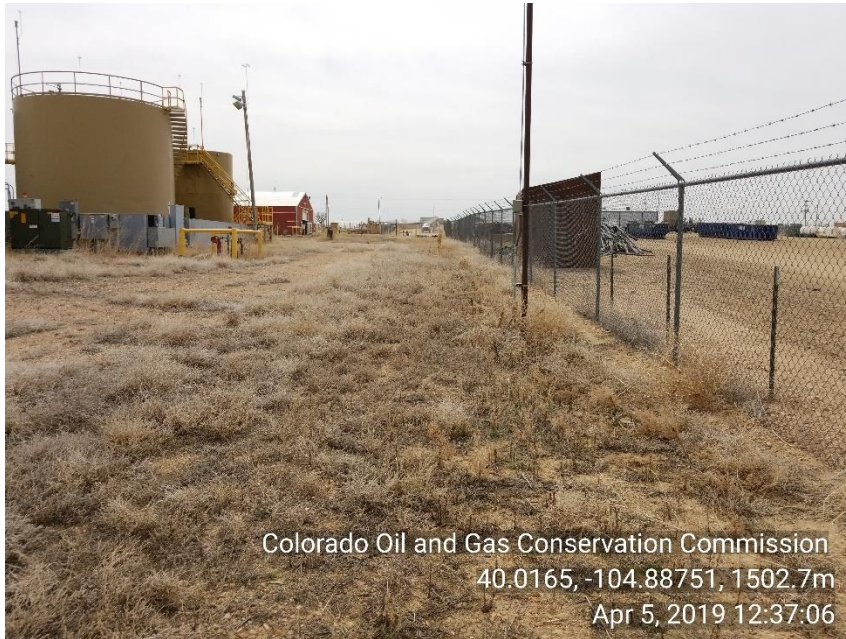
Photo 9 Weeds around electric panels and fence line

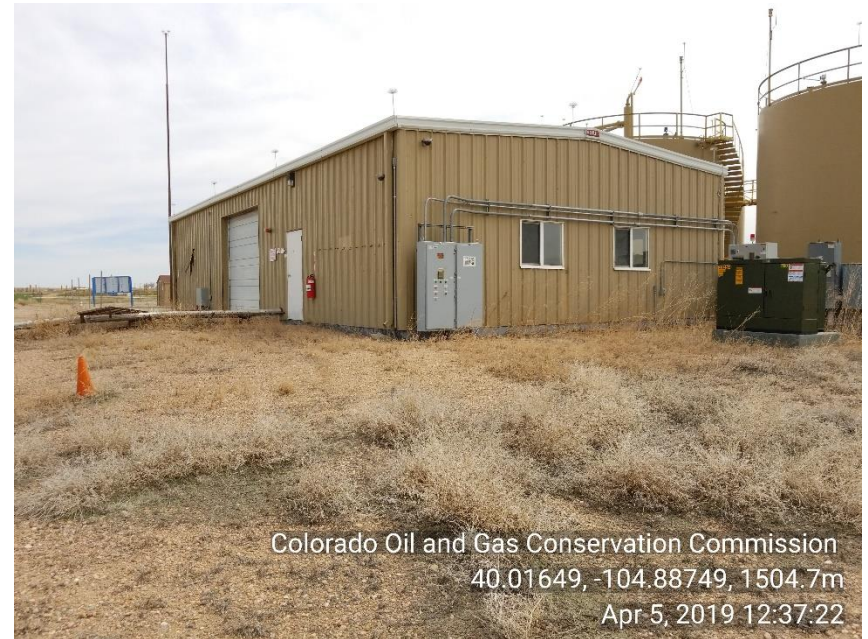
Photo 10 Weeds and unused equipment (pump building)

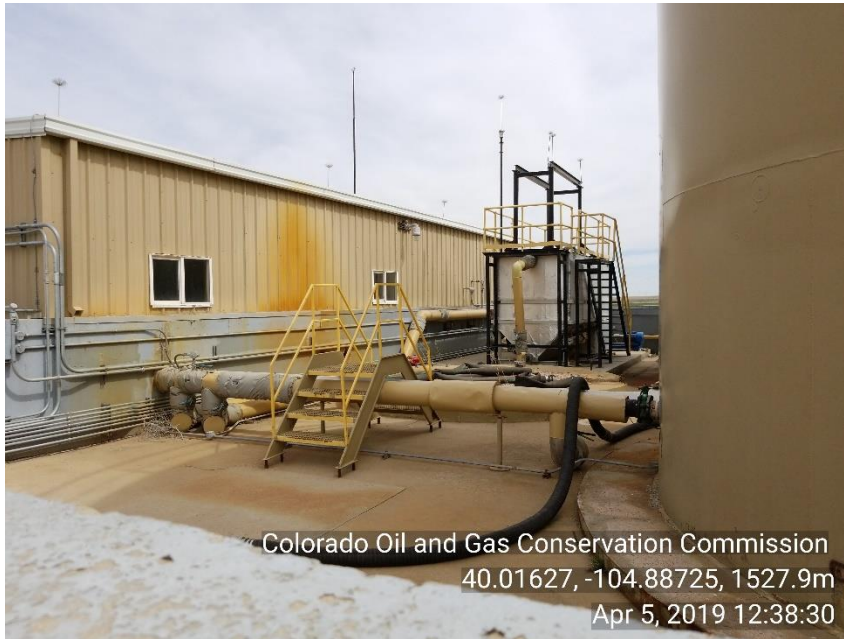
Photo 11 Unused equipment piping and tanks

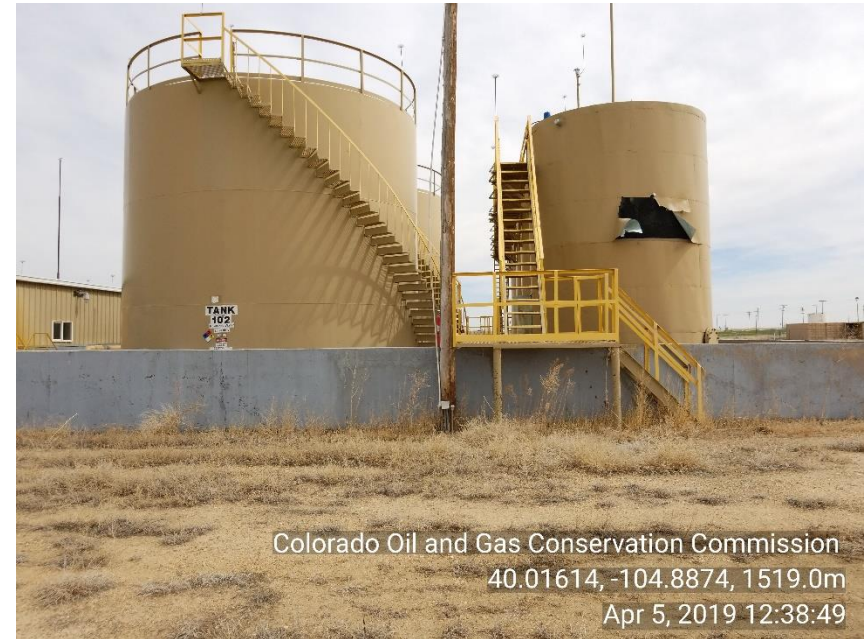
Photo 12 Weeds and unused equipment tanks that are in disrepair

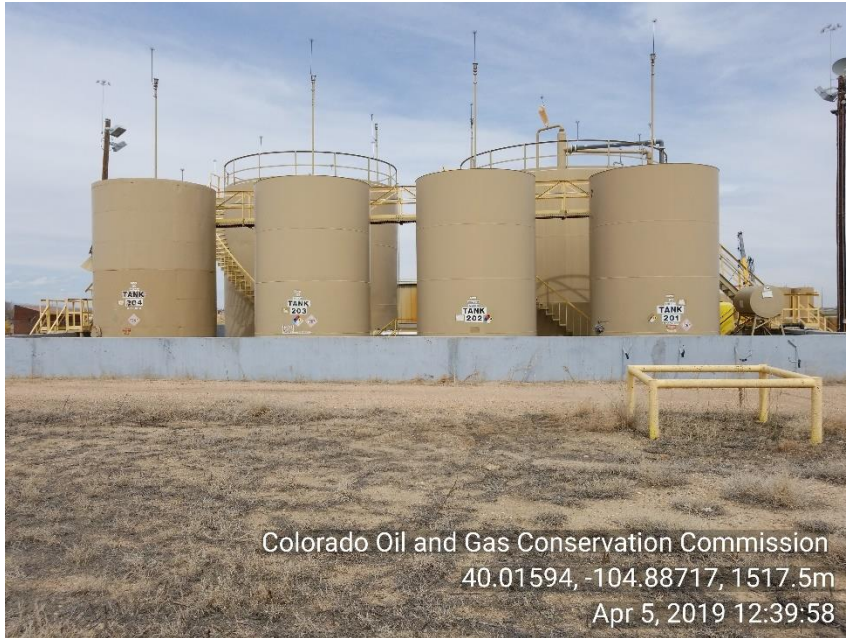
Photo 13 Unused equipment piping and tanks

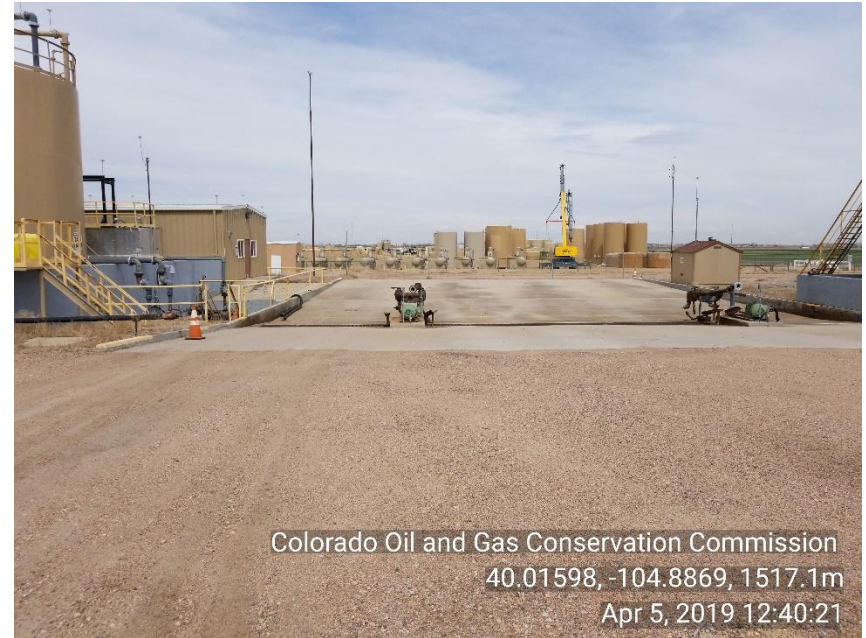
Photo 14 Unused equipment Pumps and load out equipment

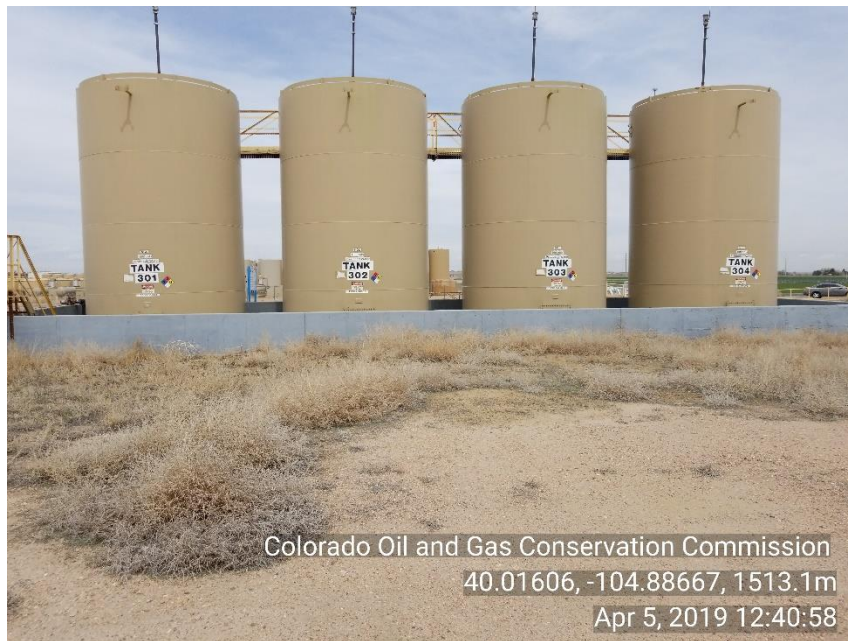
Photo 15 Unused equipment piping and tanks and weeds

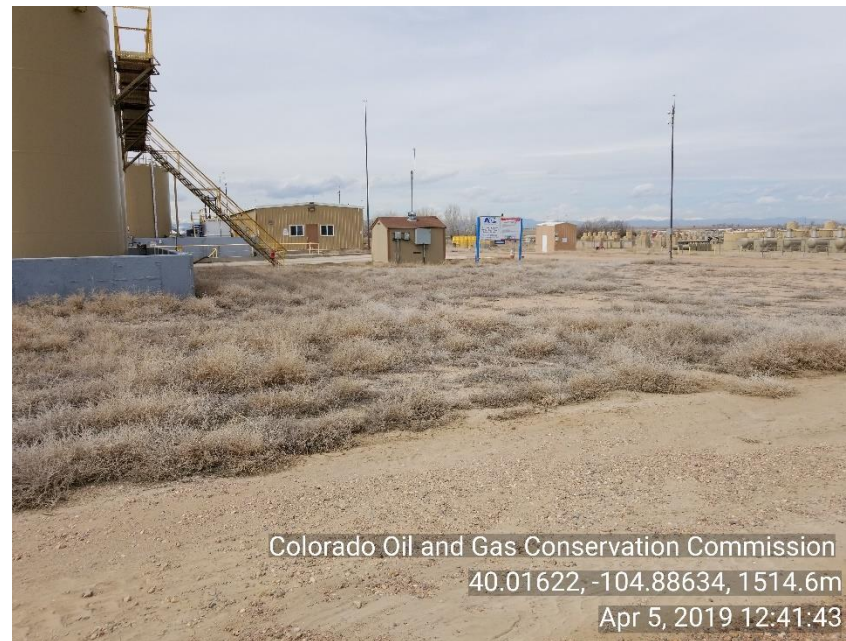
Photo 16 weeds
