PIT STATUS EVALUATION FORM

Facility ID: 115063

Pit Name: NORDMAN 10-7

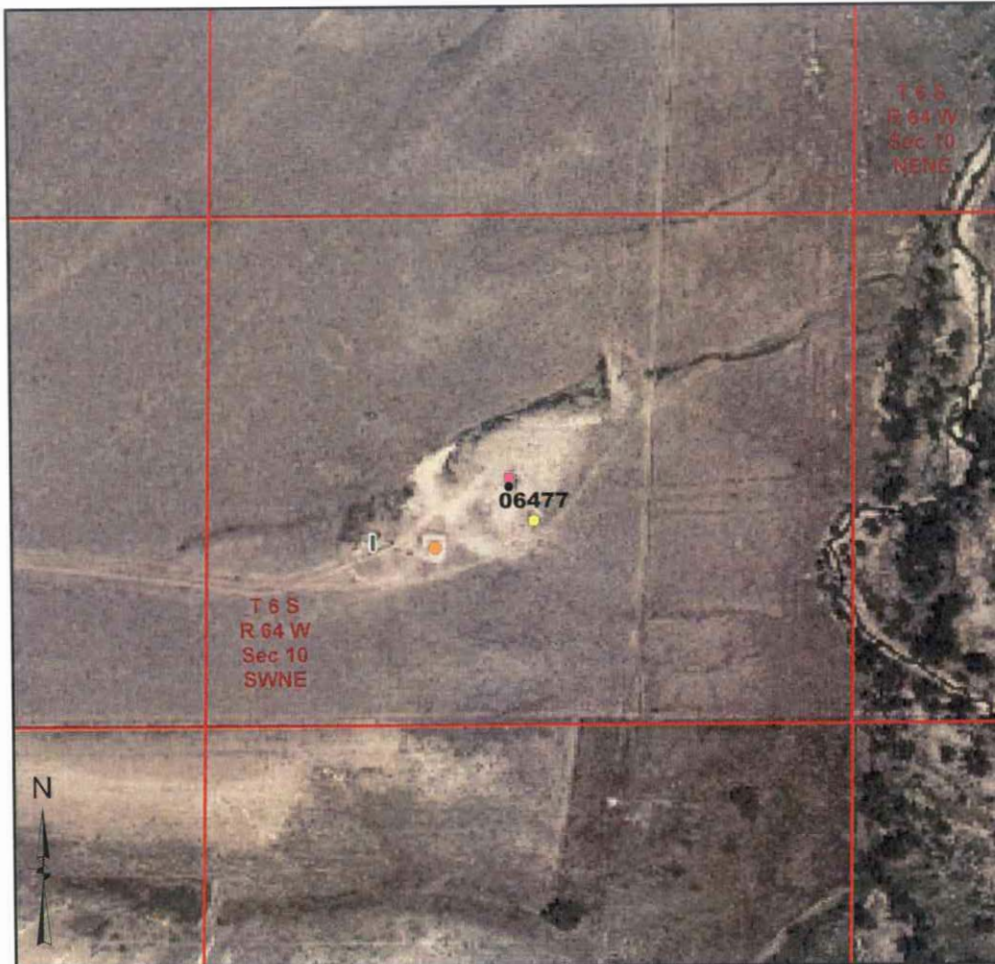
Notes: LIF (1987) for ID # 115139 indicates 4' diameter culvert. FIR (1995) concrete coffin.
FIELD VISIT 6-3-2008: LOCATION AND EQUIPMENT VERIFIED BY
FIELD INSPECTOR USING AERIAL PHOTO MAPS.
