Inspection Photos
Operator: BP America
Location/API #: 067-08843
Date: 3-26-2019

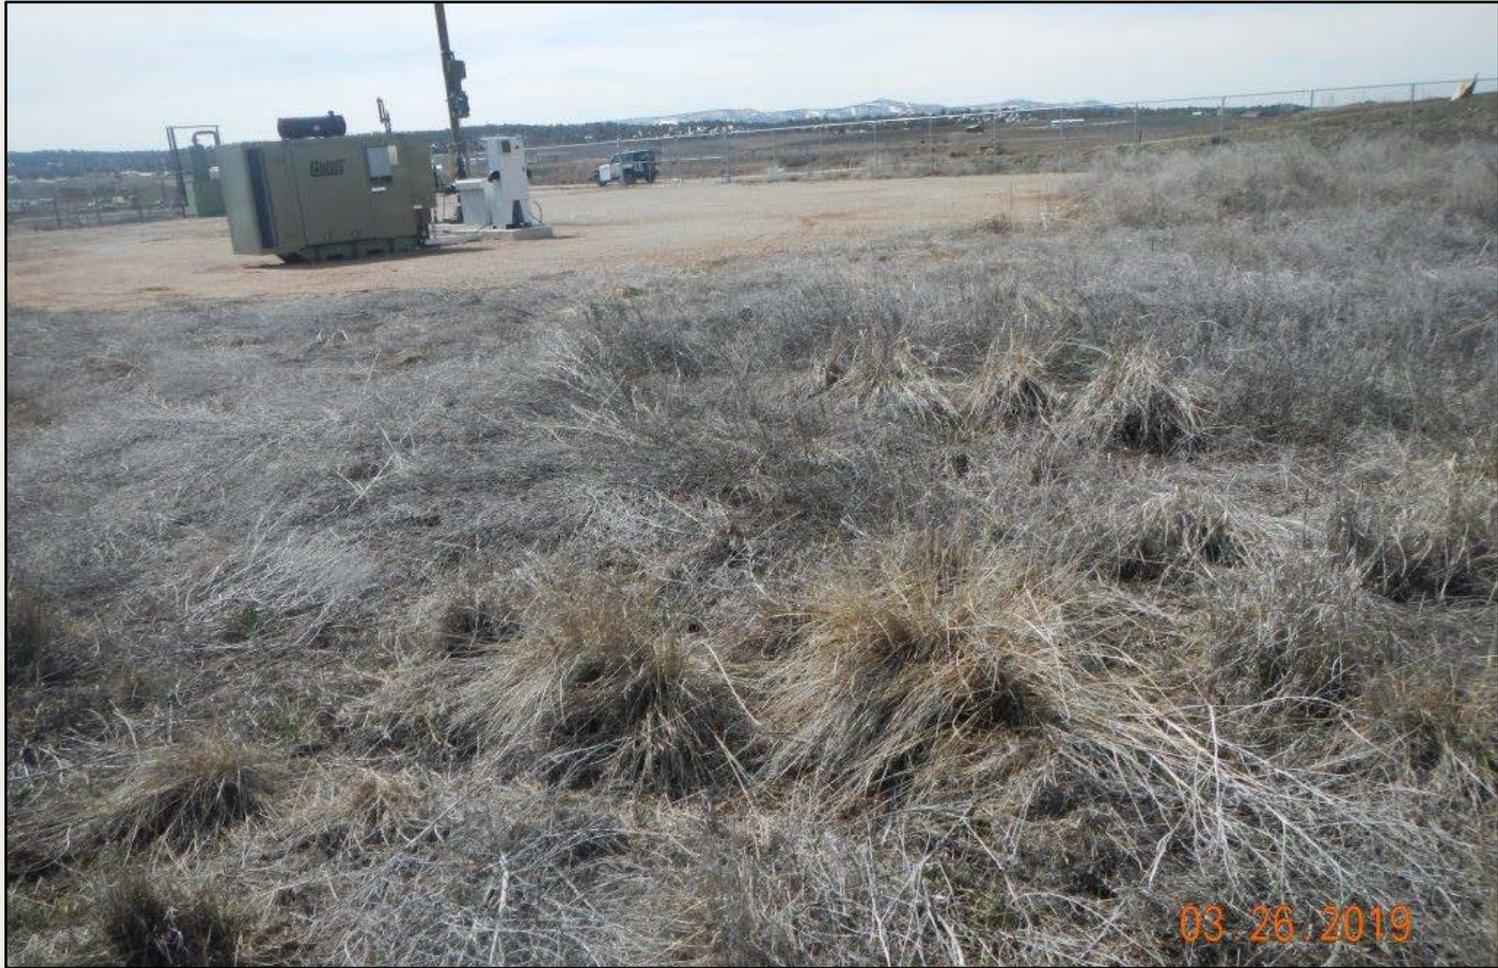
Photo 1. View of the project area from the northeastern corner of the working area facing center.

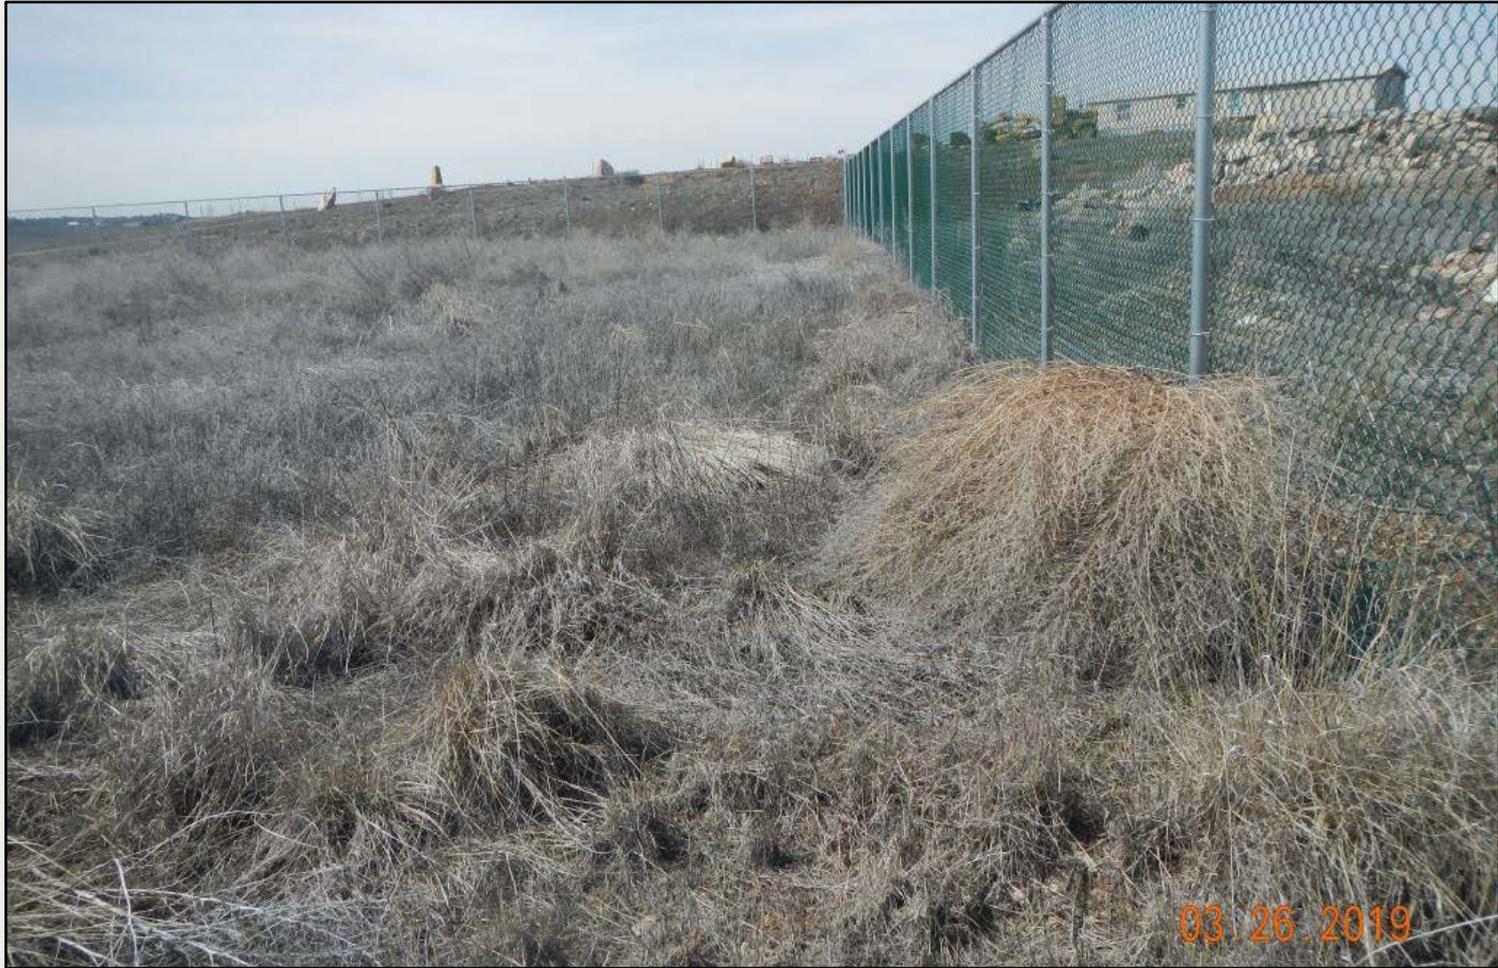
Photo 2. View of the northern project area from the northeastern corner facing westward. Large kochia (*Kochia scoparia*) debris identified within the outer revegetation areas.

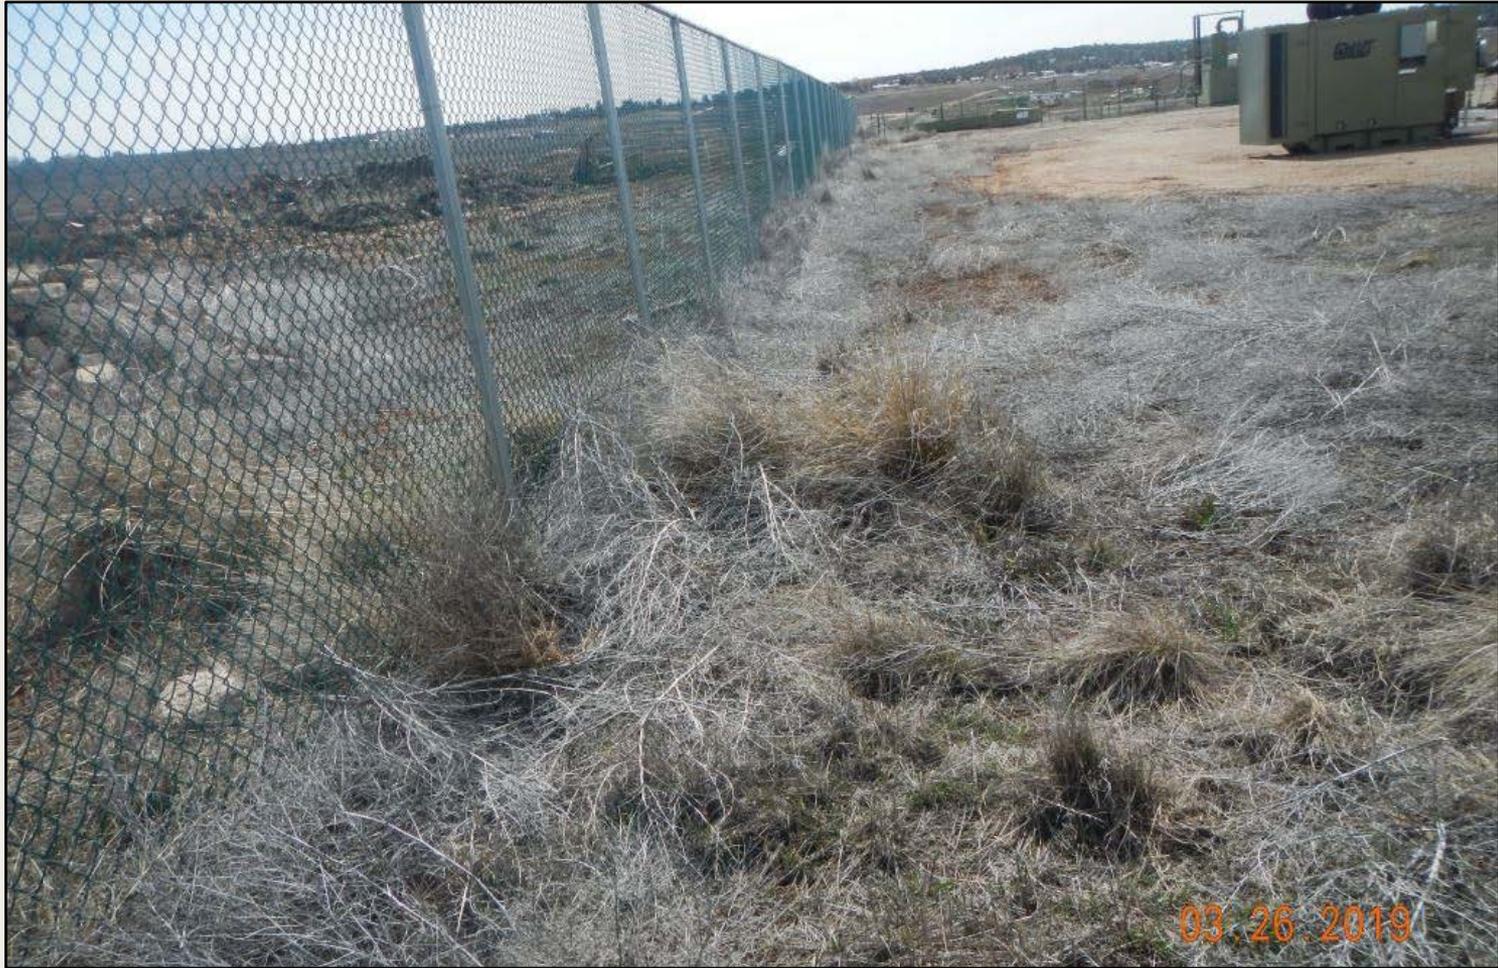
Photo 3. View of the eastern project area from the northeastern corner facing southward.

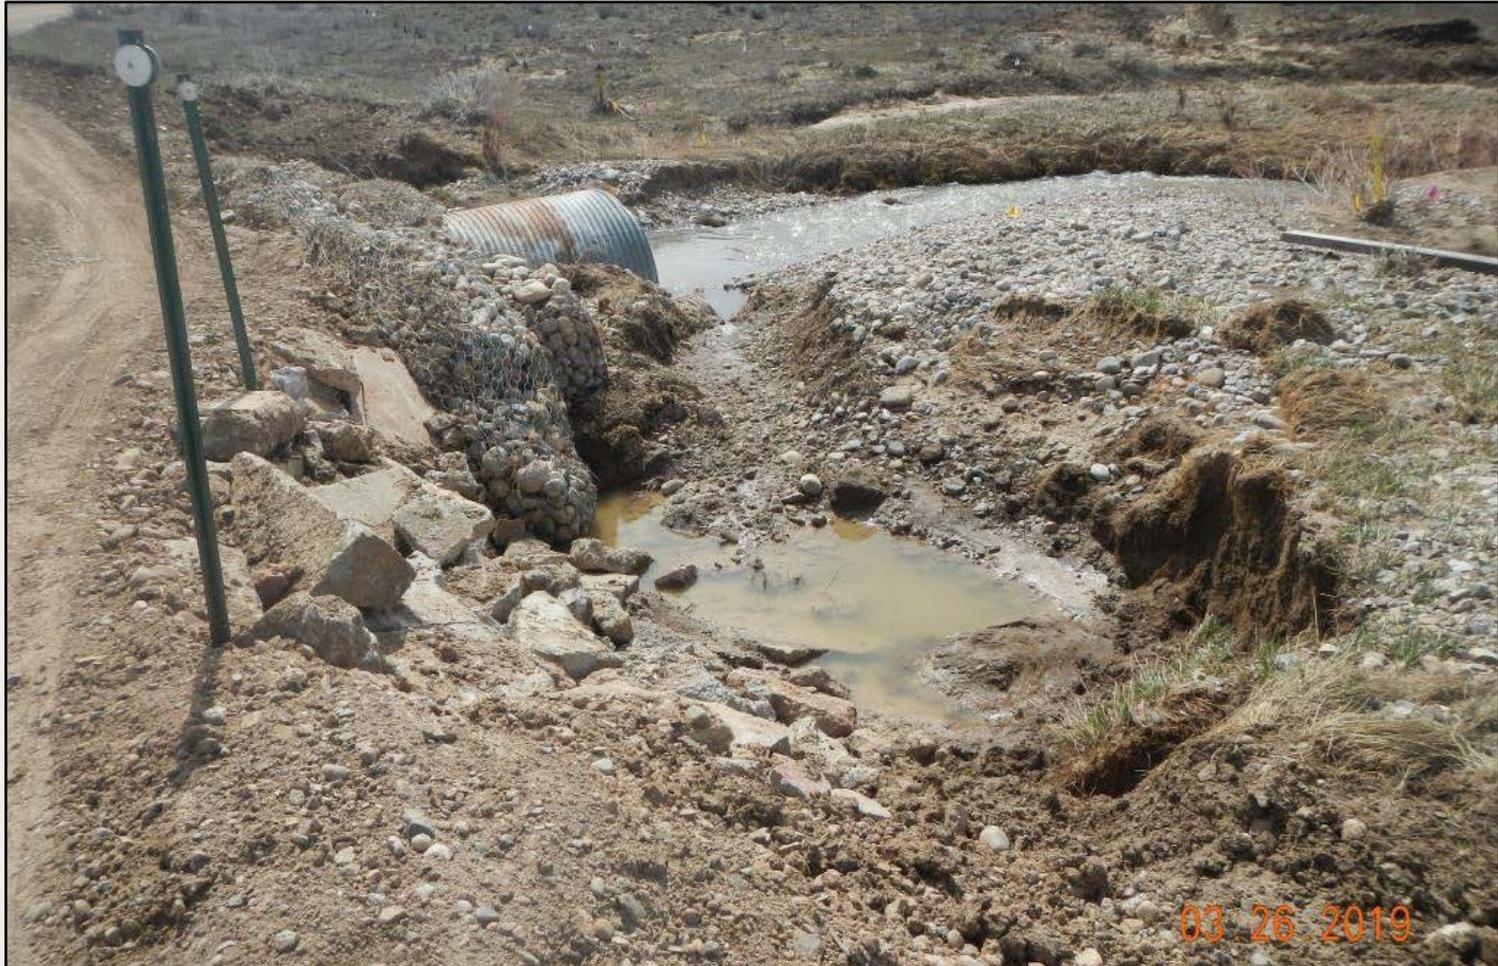
Photo 4. View of area along access at stream crossing that is eroding around culverts and is not stabilized. Culverts do not appear sufficiently sized to contain high flows and runoff events.

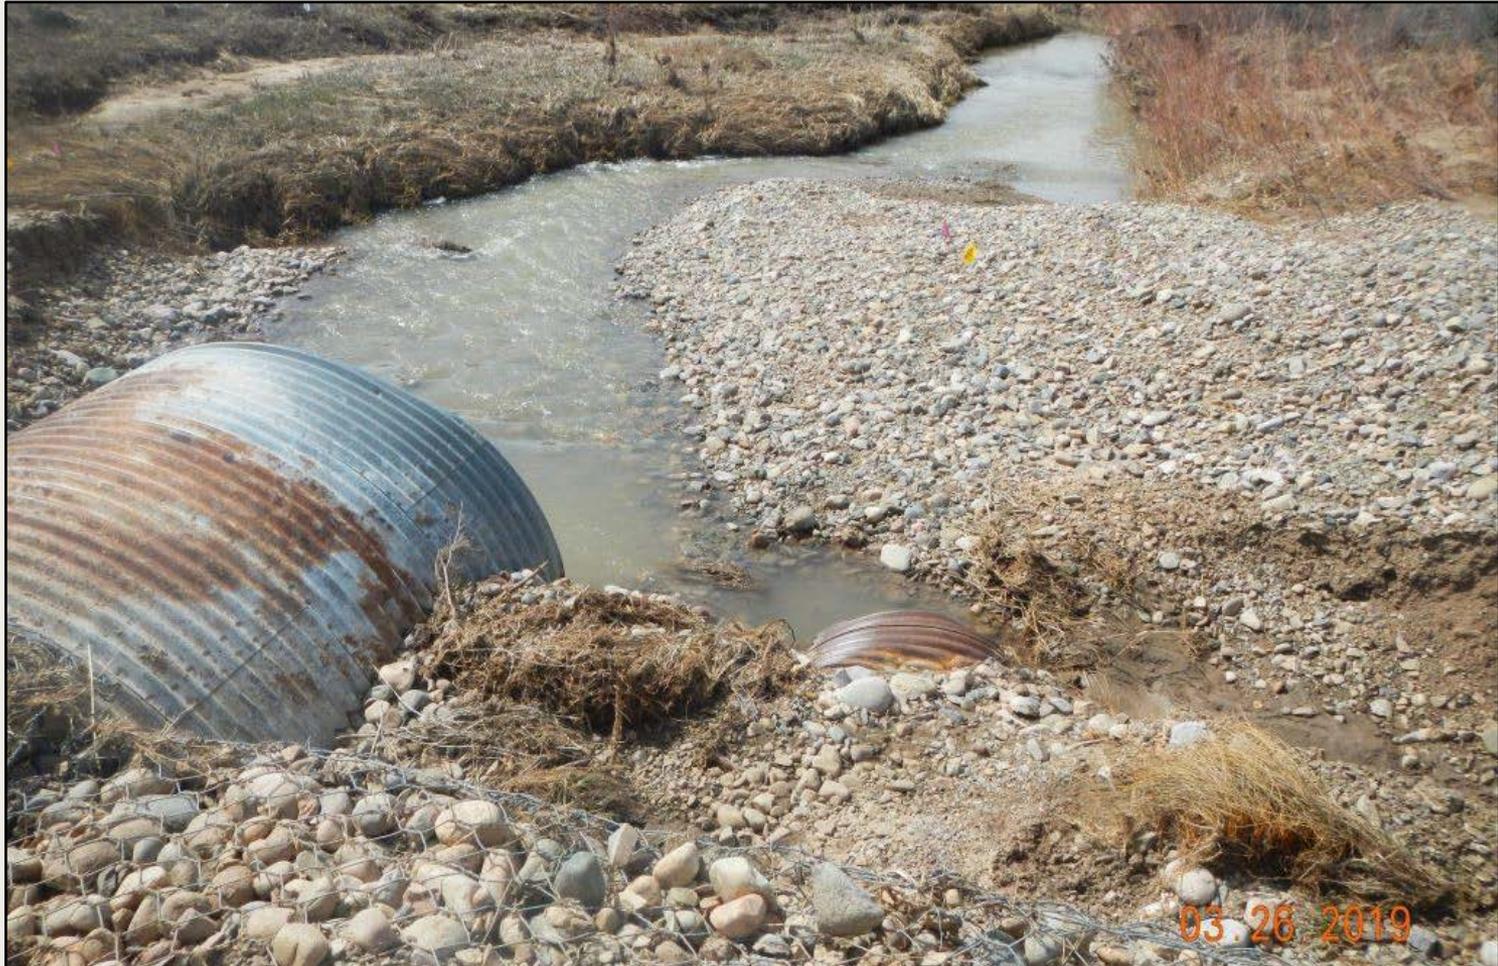
Photo 5. View of stream crossing where it appears significant sediment was recently discharged. Crossing is not stabilized, and culvert size is not adequate.

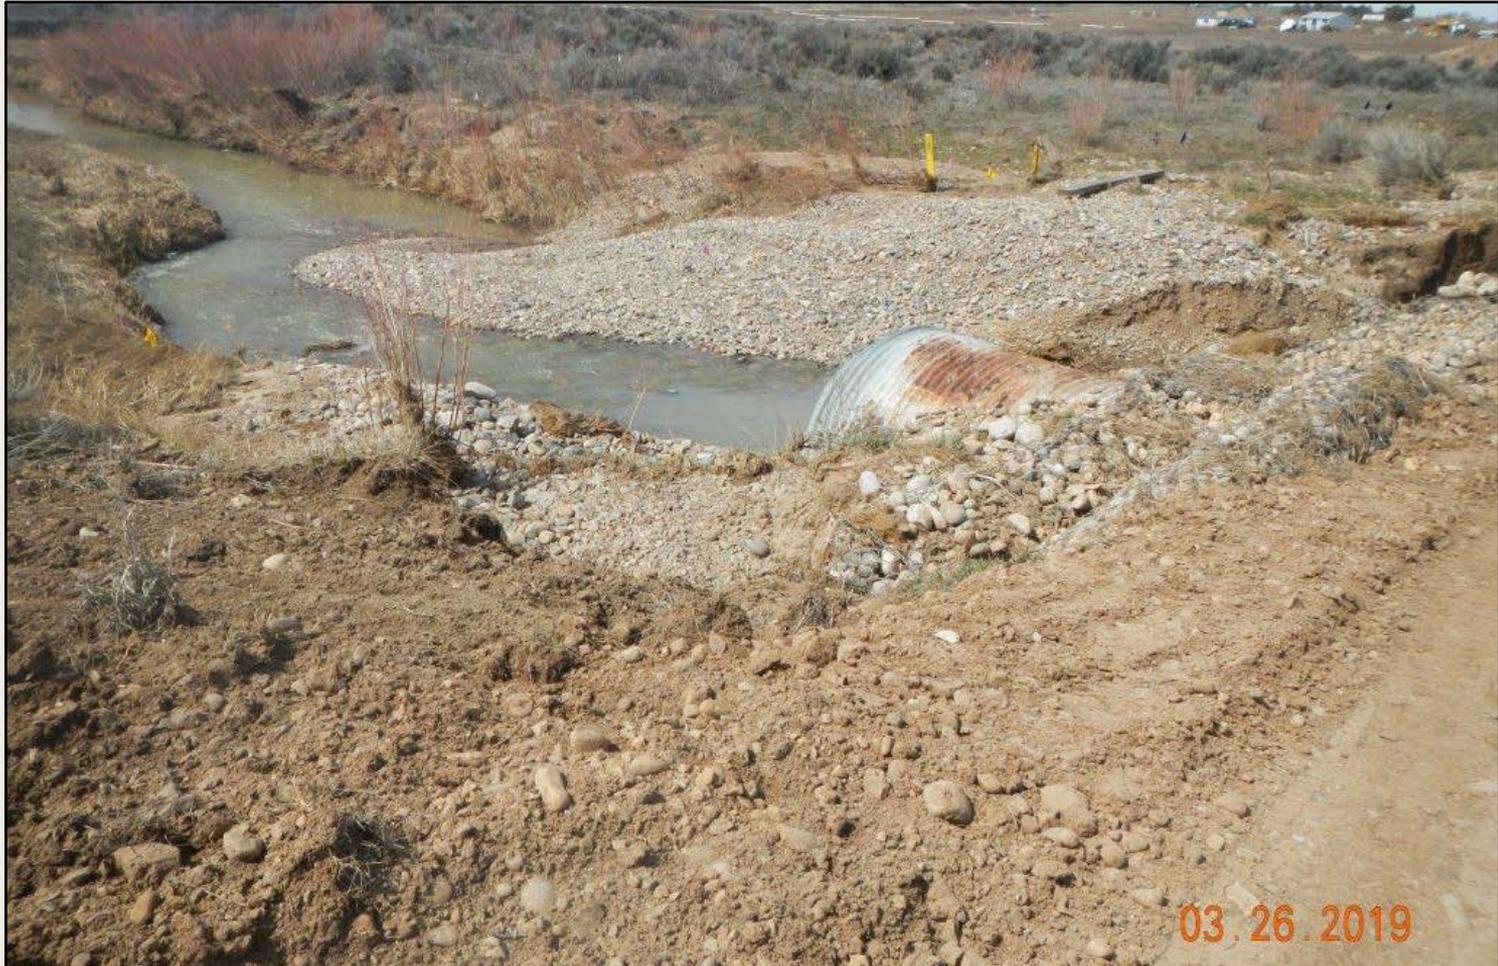
Photo 6. Another view of stream crossing showing loose soils and sediment/rock that appear to have recently been washed downstream.
