Final Reclamation and Stormwater Inspection

March 28, 2019

Operator: GREAT WESTERN OPERATING COMPANY LLC # 10110

Location ID: 310458

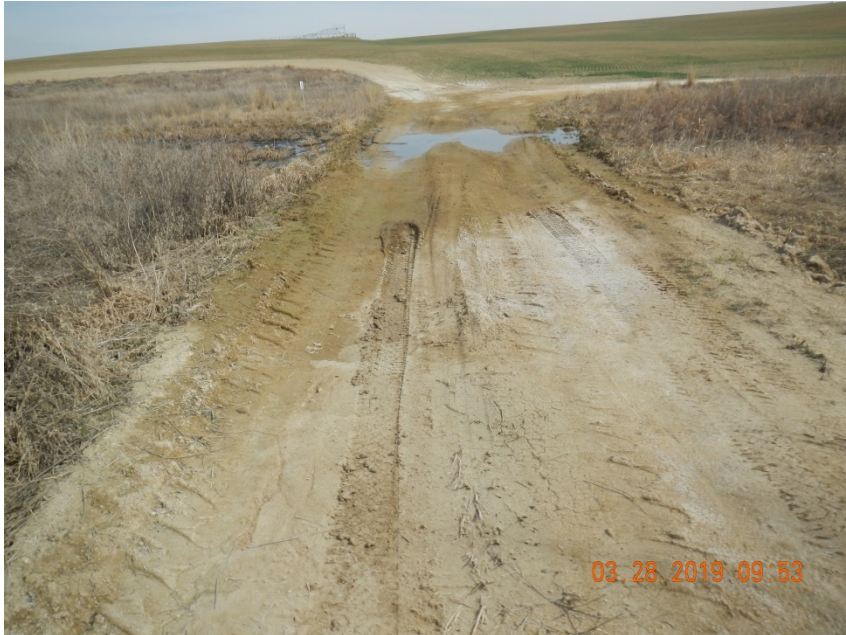
Photo 1. Photo taken from the access road, facing North. Appears the access road remains to the location and facility. Appears the culvert has failed and water is traversing the access road.

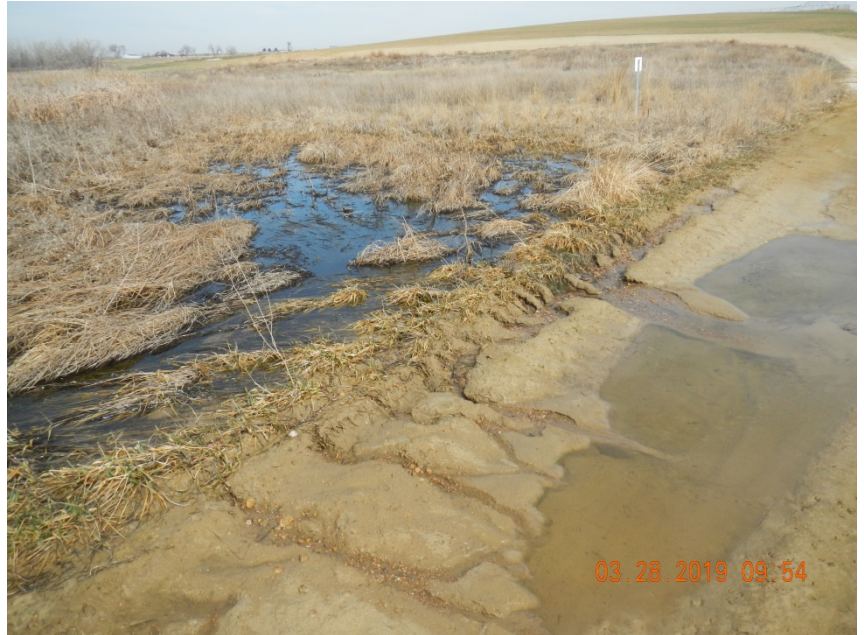
Photo 2. Photo taken from the access road, facing Northwest. See comments from Photo 1.

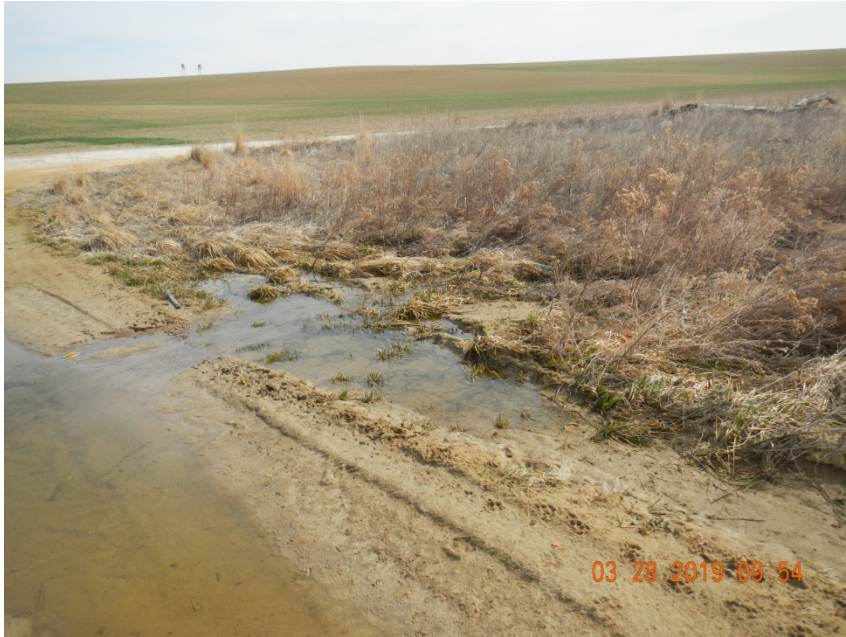
Photo 3. Photo taken from the access road, facing Northeast. See comments from Photo 1.

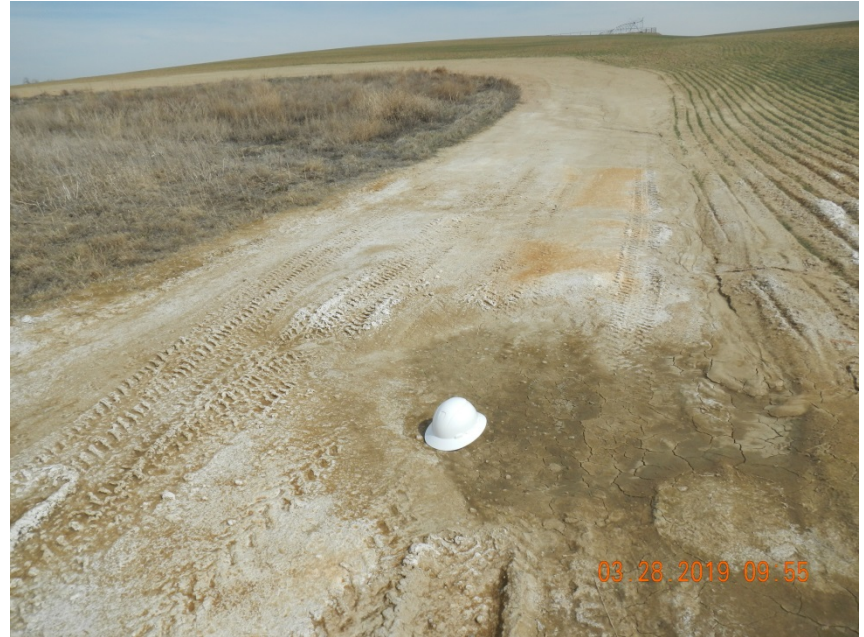
Photo 4. Photo taken from the access road, facing North. See comments from Photo 1.

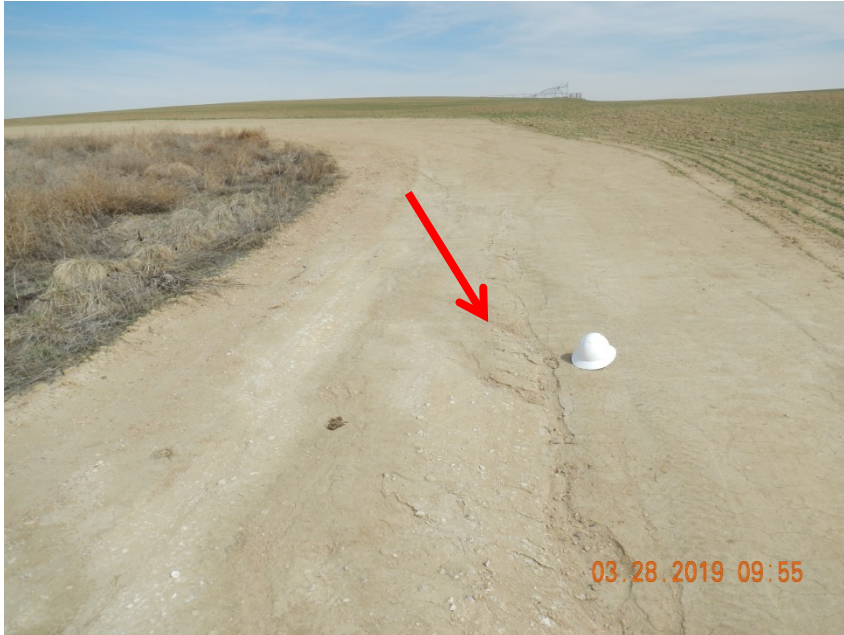
Photo 5. Photo taken from the location, facing North. Photo depicts the erosion observed on location.

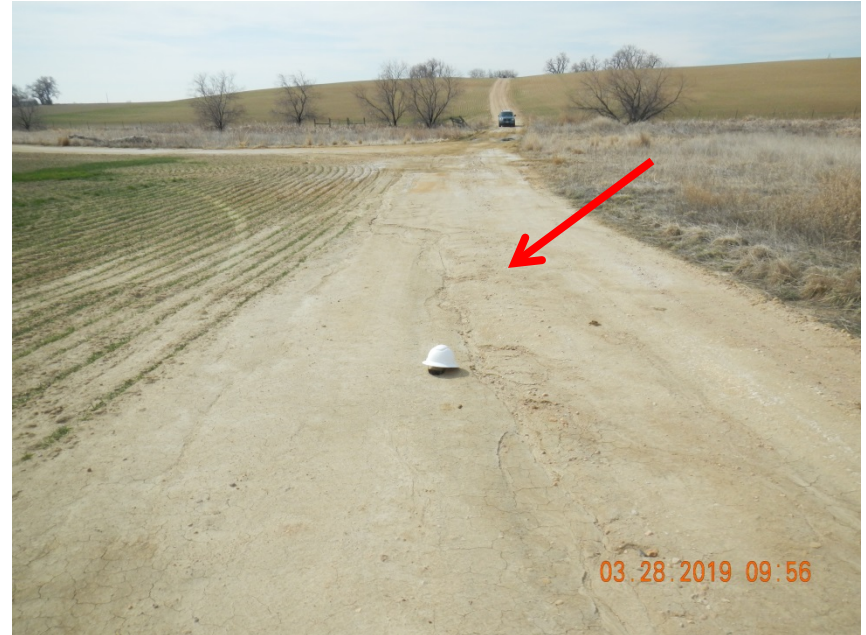
Photo 6. Photo taken from the location, facing South. See comments from Photo 5.

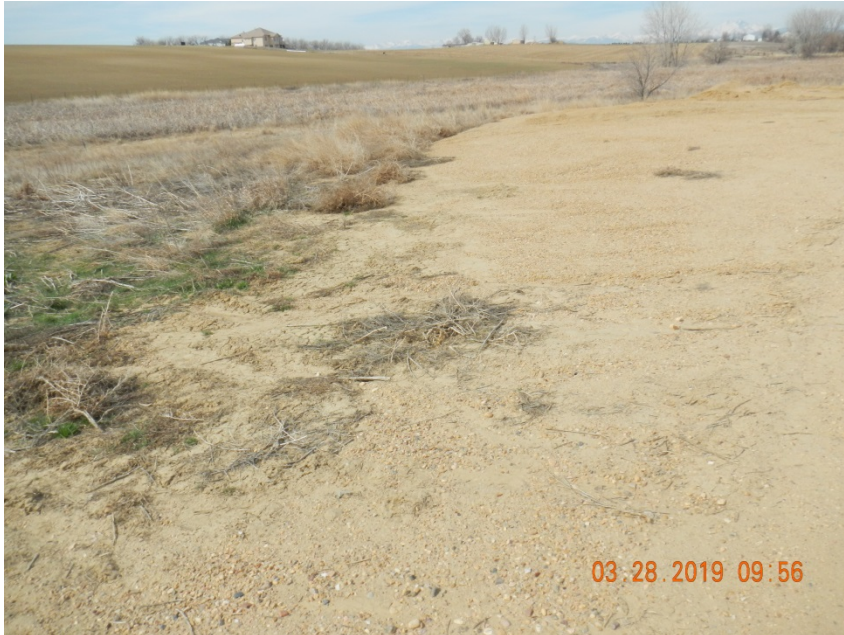
Photo 7. Photo taken from the location, facing West. Photo depicts the removal of all equipment has been performed. The gravel remains on location and no other reclamation activities were observed.

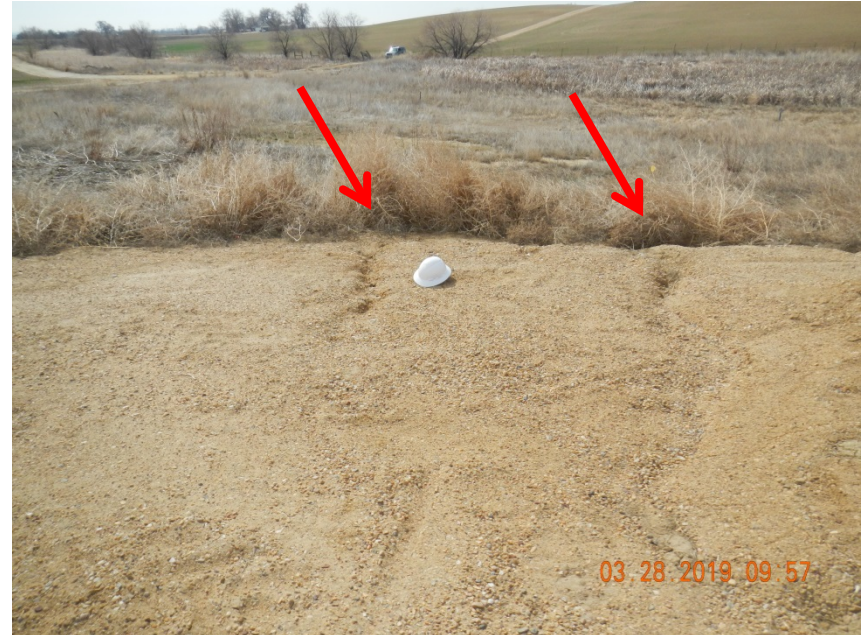
Photo 8. Photo taken from the location, facing South. See comments from Photo 5.

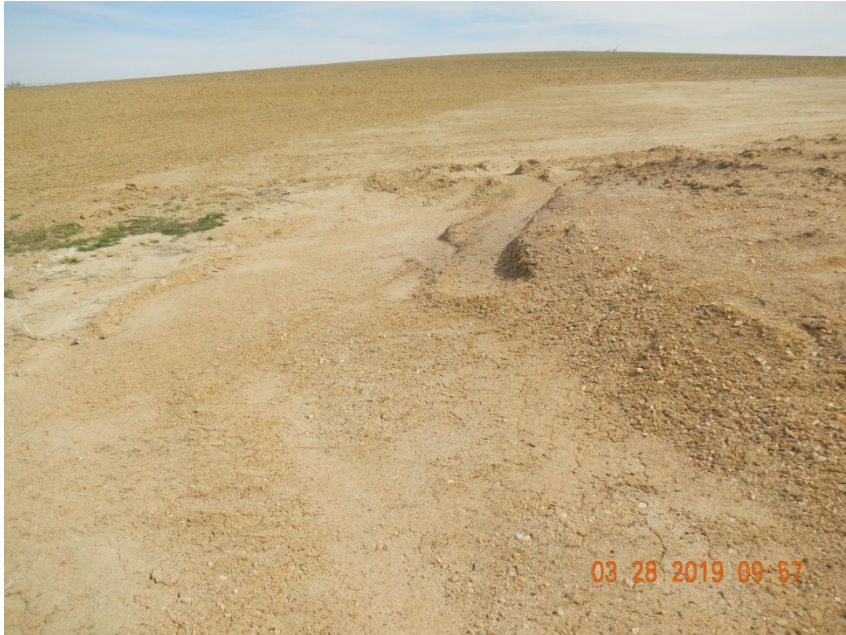
Photo 9. Photo taken from the location, facing North.
See comments from Photo 7.

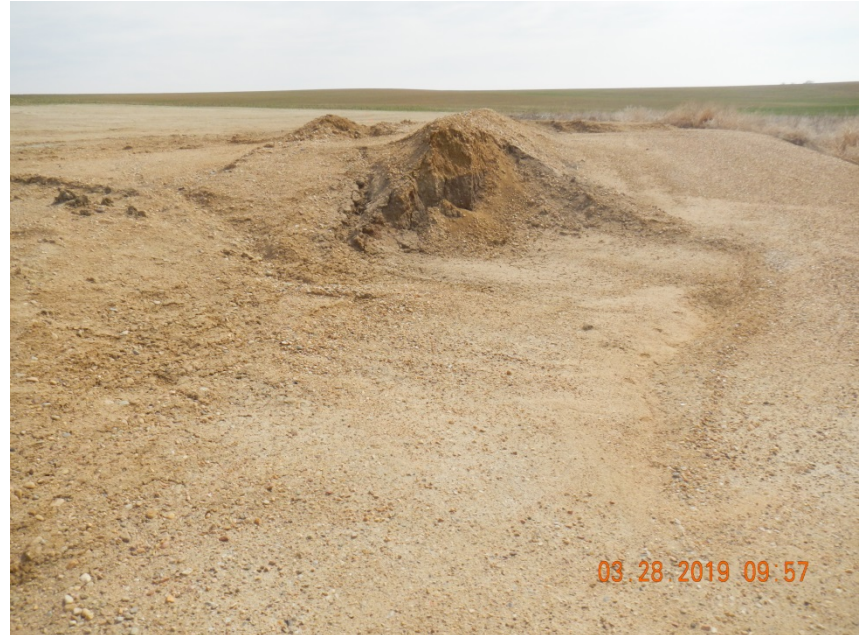
Photo 10. Photo taken from the location, facing East.
See comments from Photo 7.

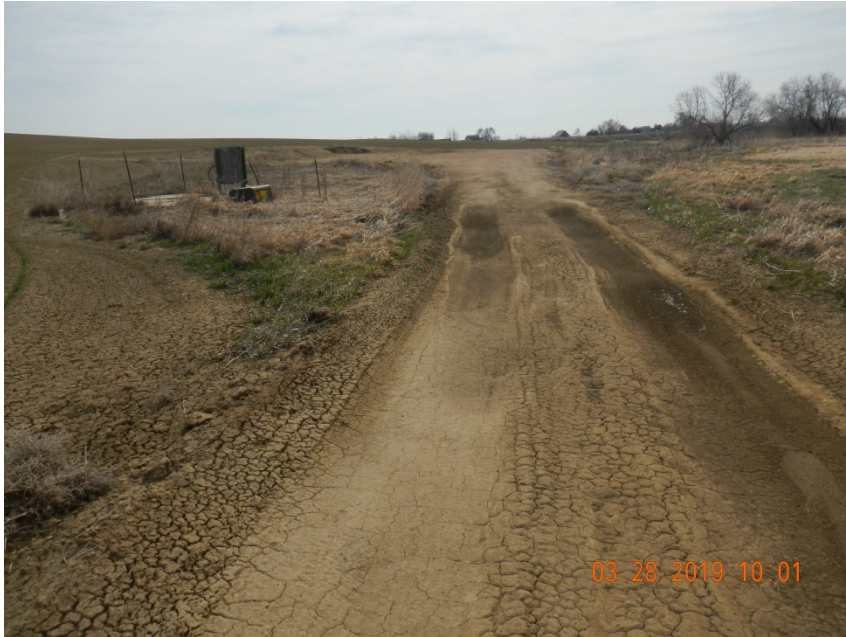
Photo 11. Photo taken from the access road to the facility, facing East. Photo depicts equipment remains on site.

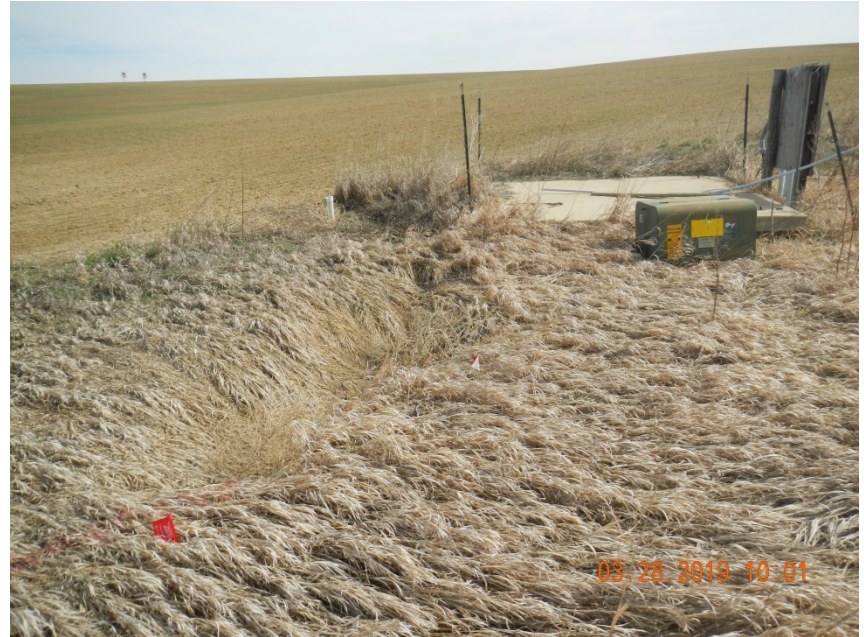
Photo 12. Photo taken from the facility, facing Northeast. See comments from Photo 3.

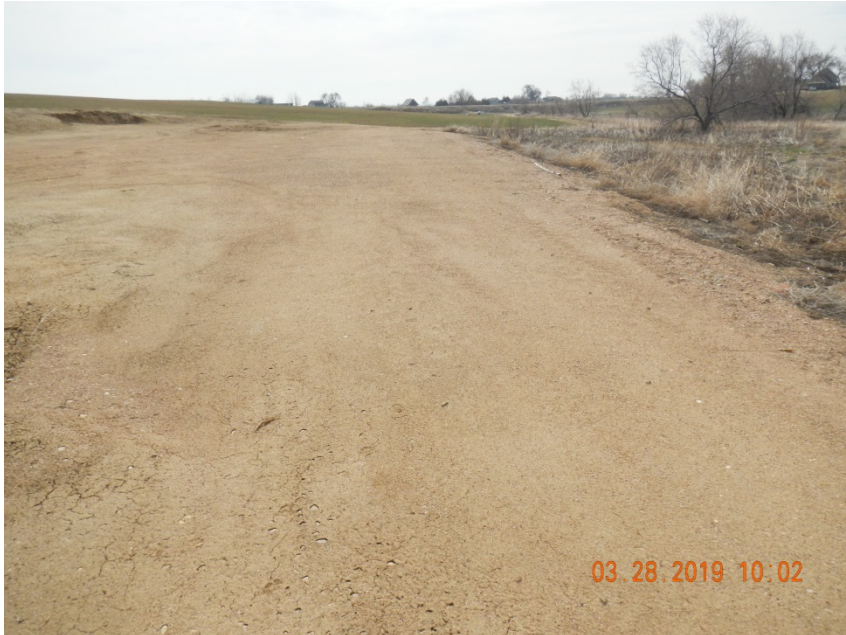
Photo 13. Photo taken from the facility, facing East. The gravel remains on the facility and no other reclamation activities were observed.

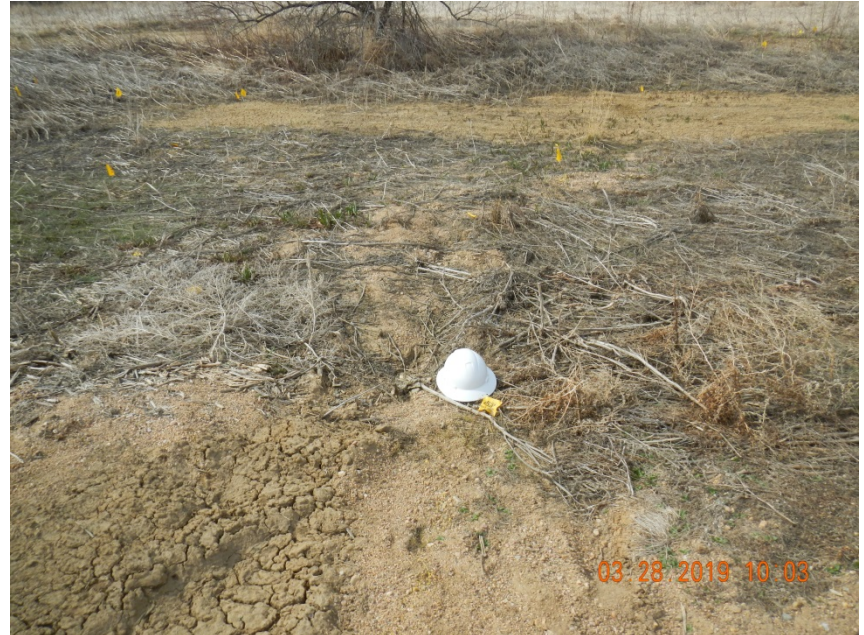
Photo 14. Photo taken from the facility, facing South. Photo depicts the erosion observed on location.
