PIT STATUS EVALUATION FORM

Facility ID: 115084
 Pit Name: MILLER 6-11

S.S. PAPADOPOULOS & ASSOCIATES, INC.

Miller 6-11, 6-7, 6-13 & 6-15
Miller 6-11
Miller 6-7
Miller 6-13
Miller 6-15

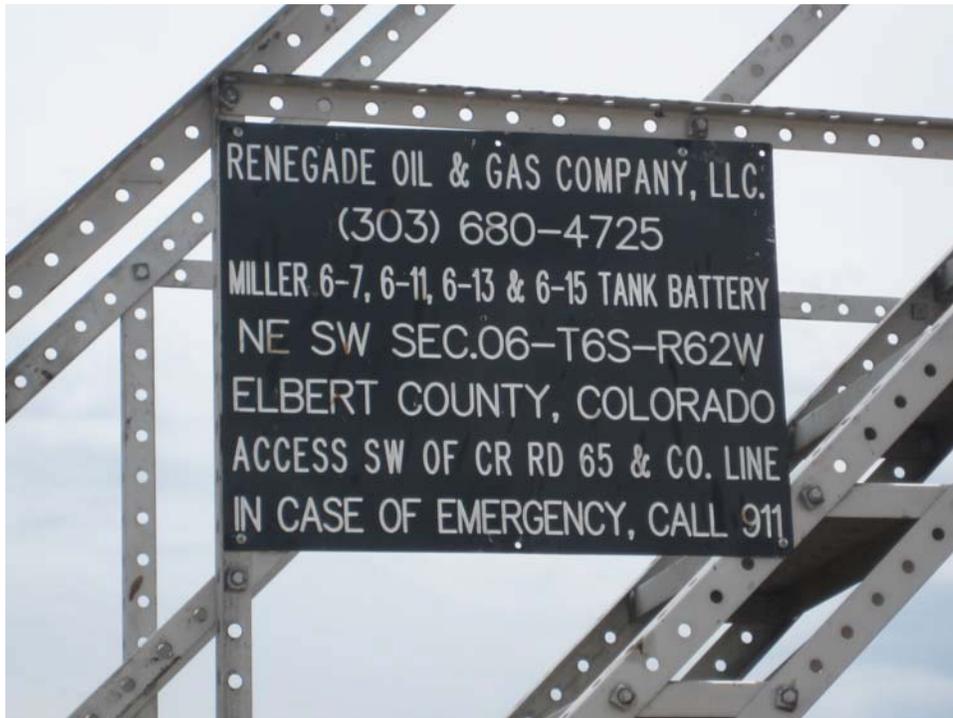
Photo 1. Battery tank lease sign

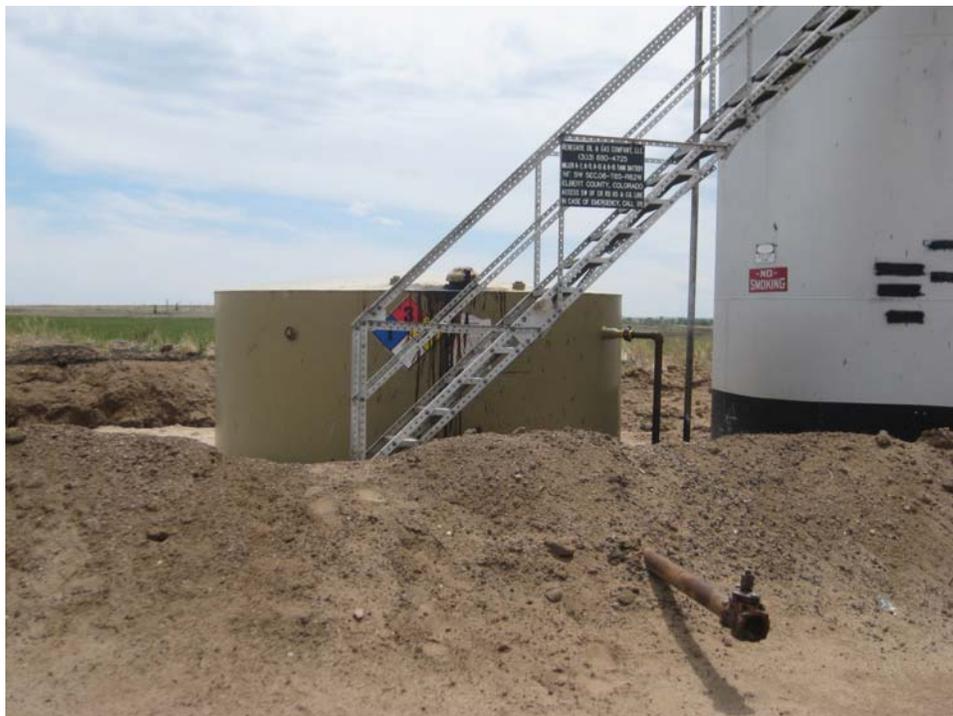
Covered steel tank

Photo 2. Covered steel water tank

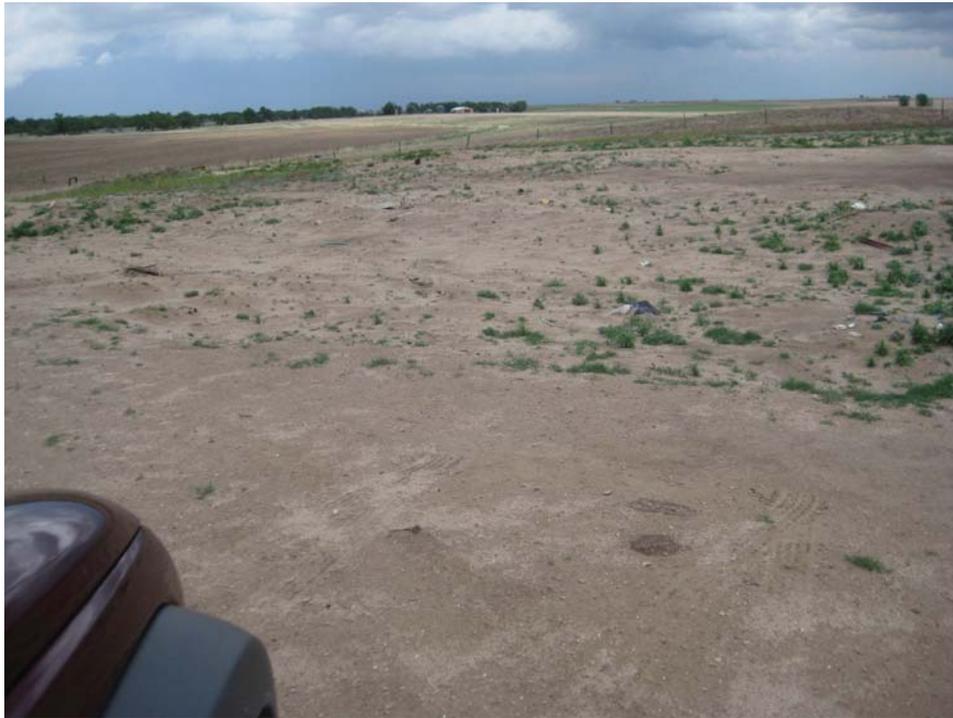
Notes: FIR(2008) indicates no closure documents for pit and excessive area disturbed. corrective action due 5-19-08.
FIELD VISIT 6-4-2008 : PIT BACKFILLED, SITE NOT CLEAN. Debris Found.

Photo 3. Looking north at pit site

Recommend Remediation

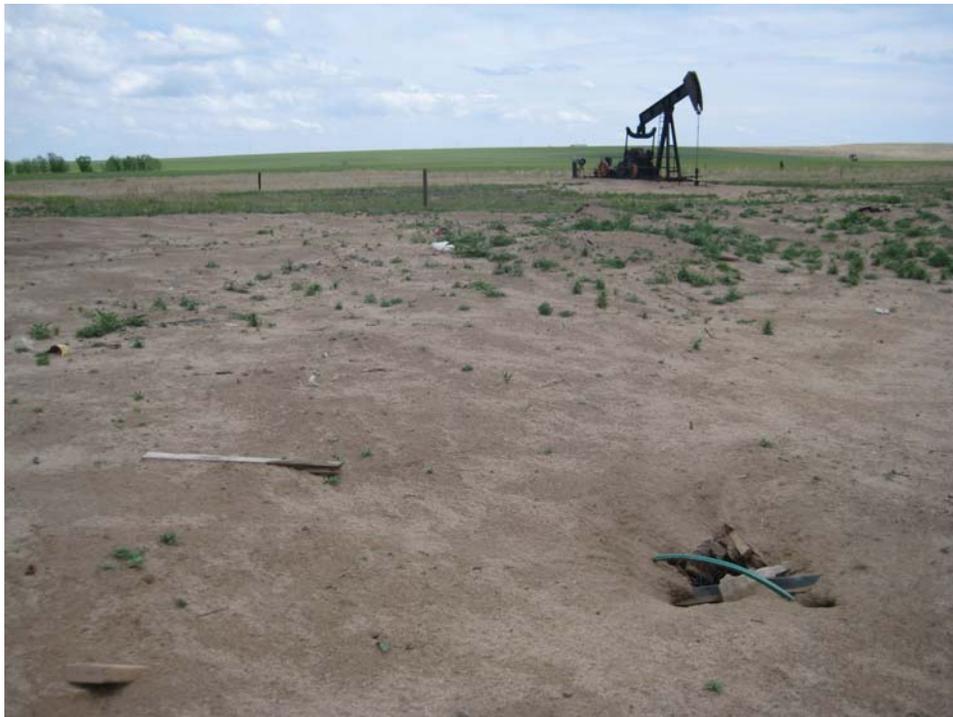
Photo 4. Looking southeast at Miller 6-11 wellhead from pit site
