**Inspection Photos**  
**Location Name: Millard #1**  
**Location ID: 333131**

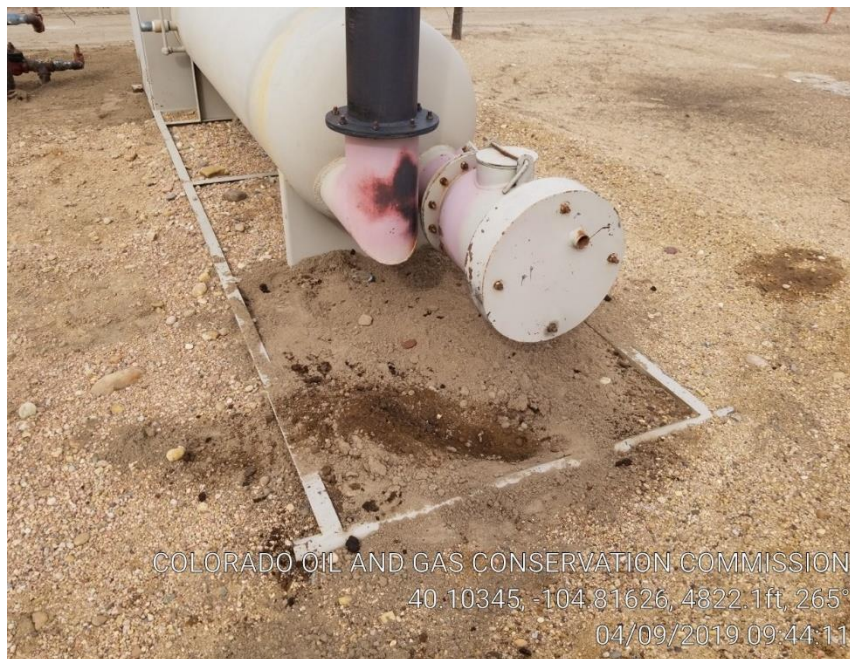
**Pic 9 Appears to have stained soil under new soil.**

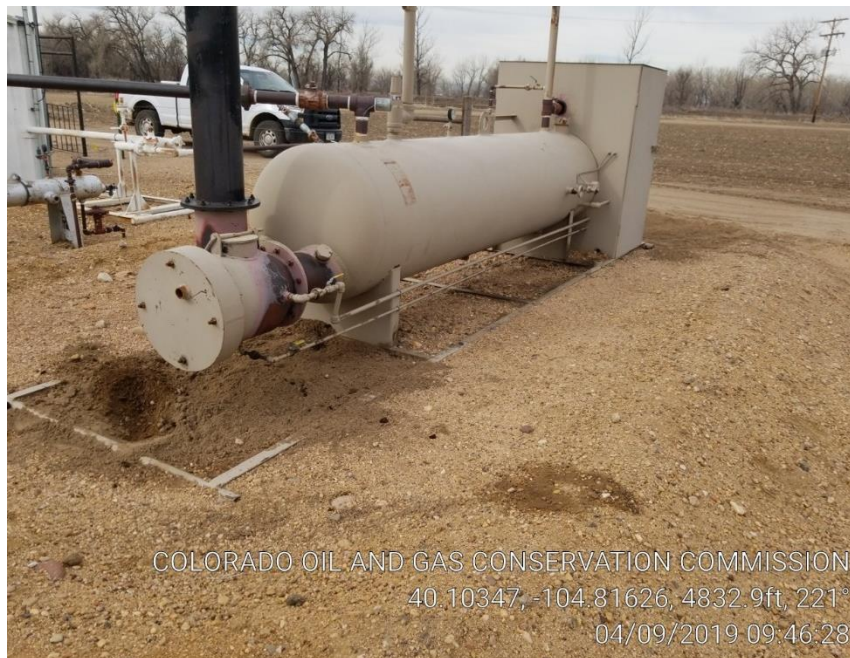
**Pic 11** Appears to be stained soil covered with new soil.

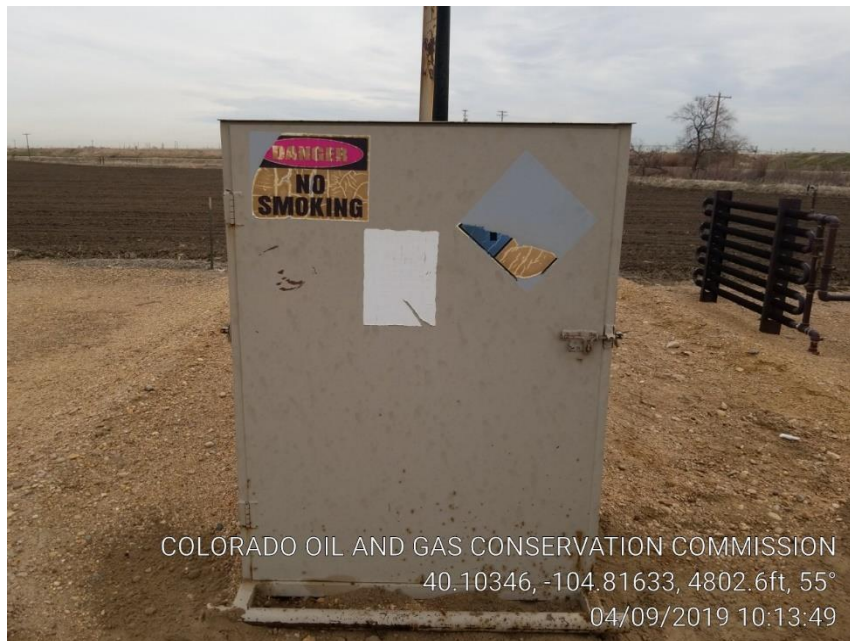
**Pic 13 No NFPA Placard on Separator.**

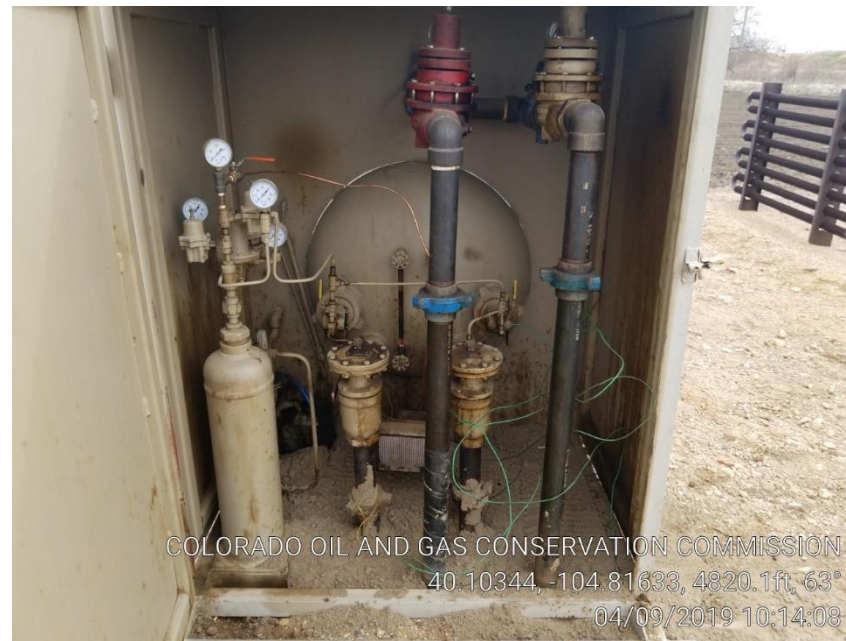
**Pic 14 Inside of separator, leaking pipes appear to still be leaking. New soil appears to be covering stained soil.**
