Inspection Photos

Location Name: APACHE CANYON 35-07

API #: 05-071-09320

Insp. Doc. # 695100451

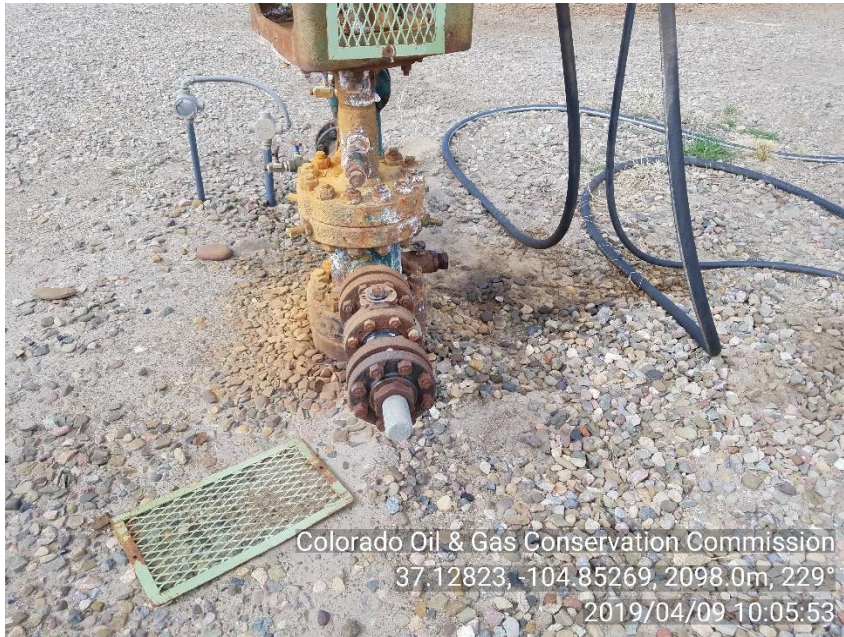
PHOTO 3: IMPACTED SOIL AROUND WELLHEAD A CHALKY RUST COLLARD IMPACTION TO THE LEFT OF WELLHEAD AND AN OILY IMPACTION TO THE RIGHT (WEST) OF WELLHEAD. DRIVEHEAD IS NOT RUNNING AT TIME OF INSPECTION.

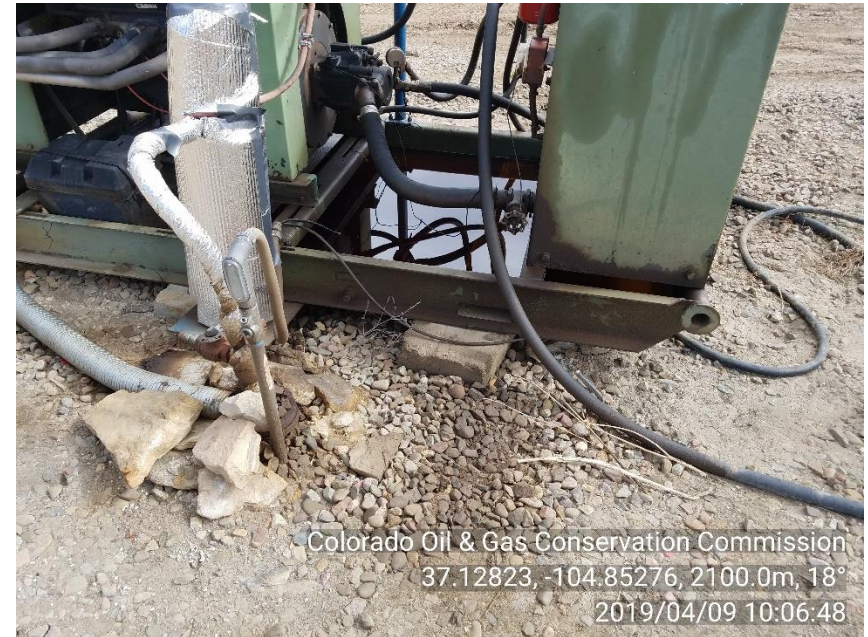
PHOTO 4: ENGINE SKID HAS ROUGHLY 1 TO 1.5" OF OIL. IMPACTED SOIL ON SOUTH SIDE OF ENGINE SKID.

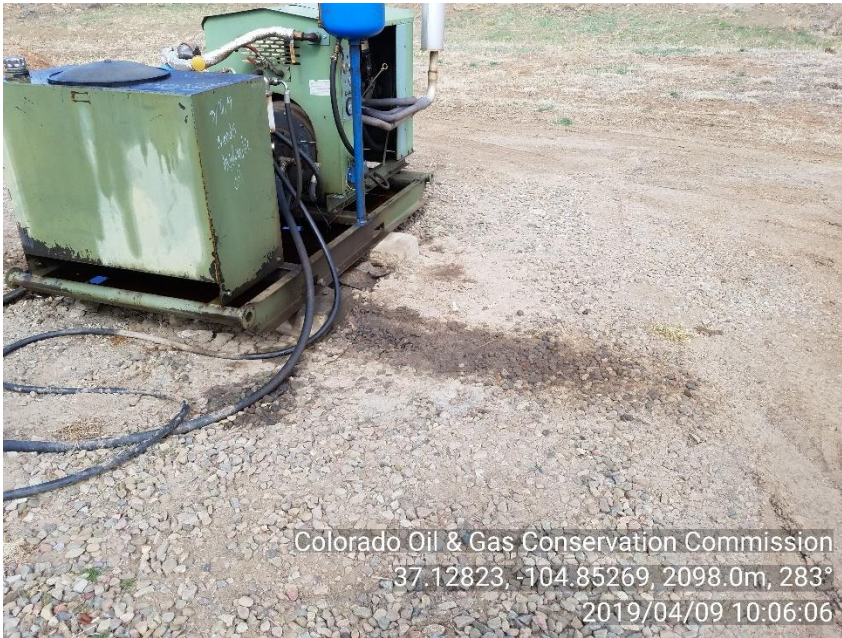
PHOTO 5: IMPACTED SOIL TO NORTH OF SKID AND ALONG HYDRAULIC HOSES LEADING FROM SKID TO WELLHEAD

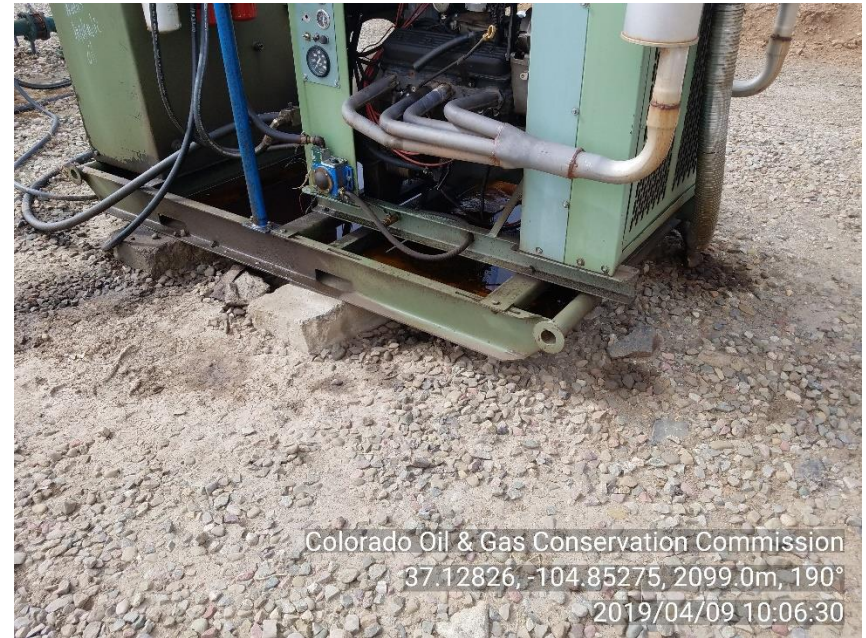
PHOTO 6: MOR IMPACTED SOIL ON NORTH SIDE OF SKID AND ON THE WEST SIDE OF SKID.

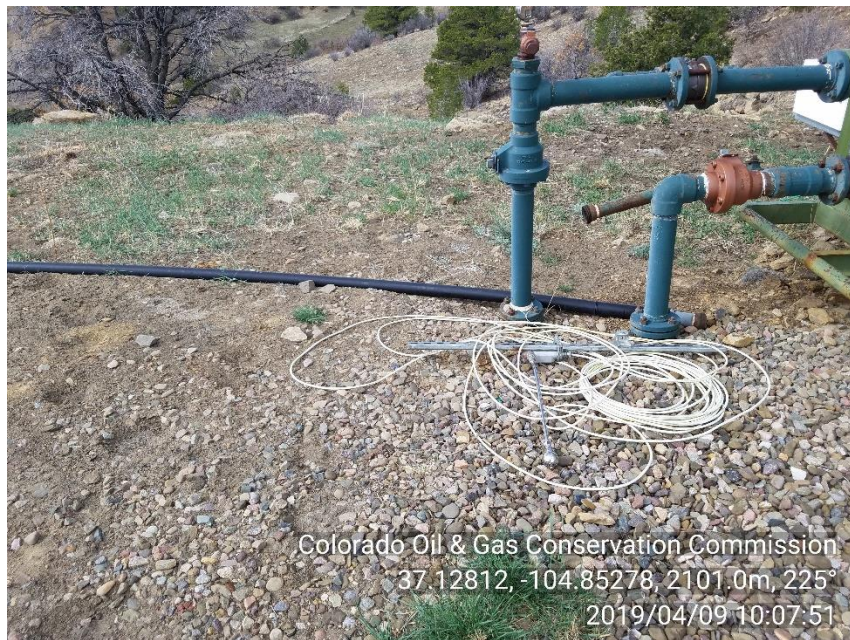
PHOTO 7:UNUSED EQUIPMENT STORED ON LOCATION NEAR METER HOUSE. (2" POLLEY PIPE AND APPEARS TO BE SOME TELEMETRY EQUIPMENT).
