**Inspection Photos**  
**Location Name: APACHE CANYON 35-06**  
**API #: 05-071-08540**  
**Insp. Doc. # 695100455**

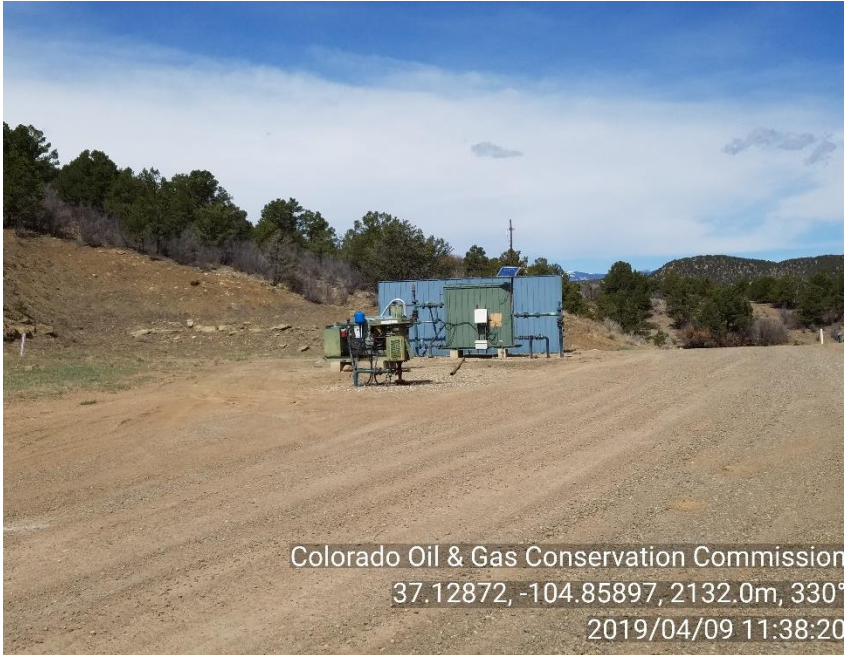
**PHOTO 1: LOCATION**

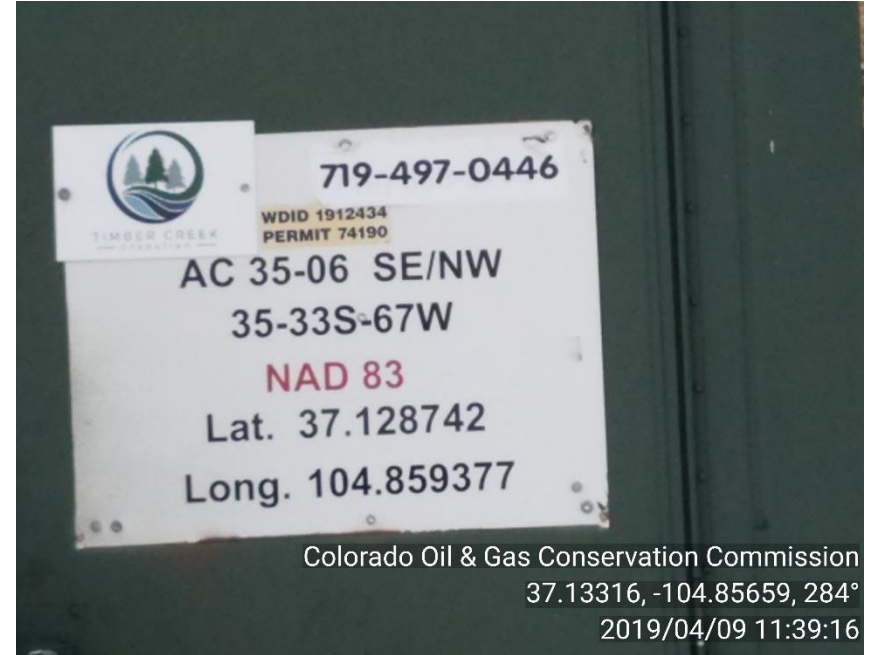
**PHOTO 2: METER HOUSE/WELL SIGN**

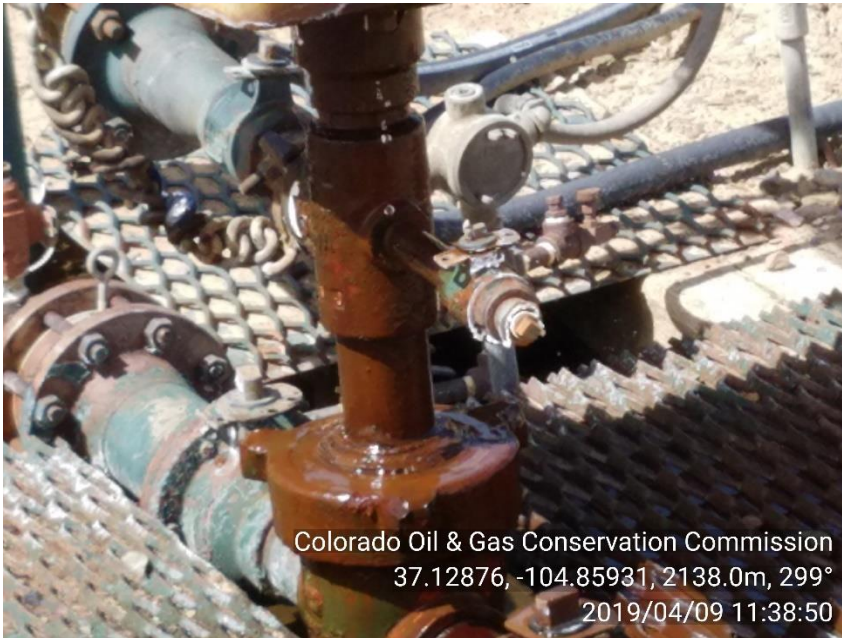
**PHOTO 3: PRODUCED WATER LEAKING FROM TBG PACKING INTO WELL CELLAR.**

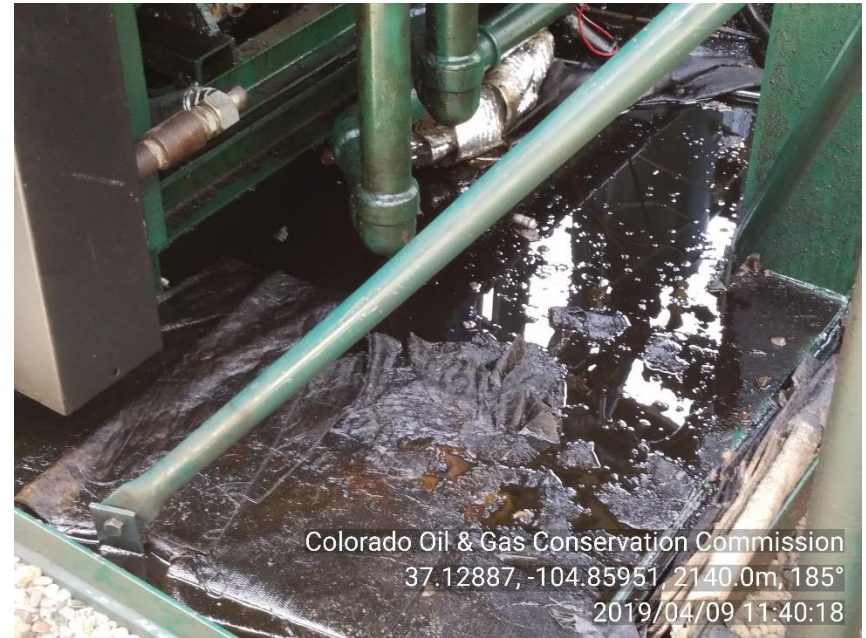
**PHOTO 4: COMPRESSOR SKID IS FULL OF OIL AND TRASH CASING SUBSTANTIAL IMPACTED SOIL AROUND SKID. ENTIRE SKID AND ITS COMPONENTS ARE SATURATED WITH OIL.**

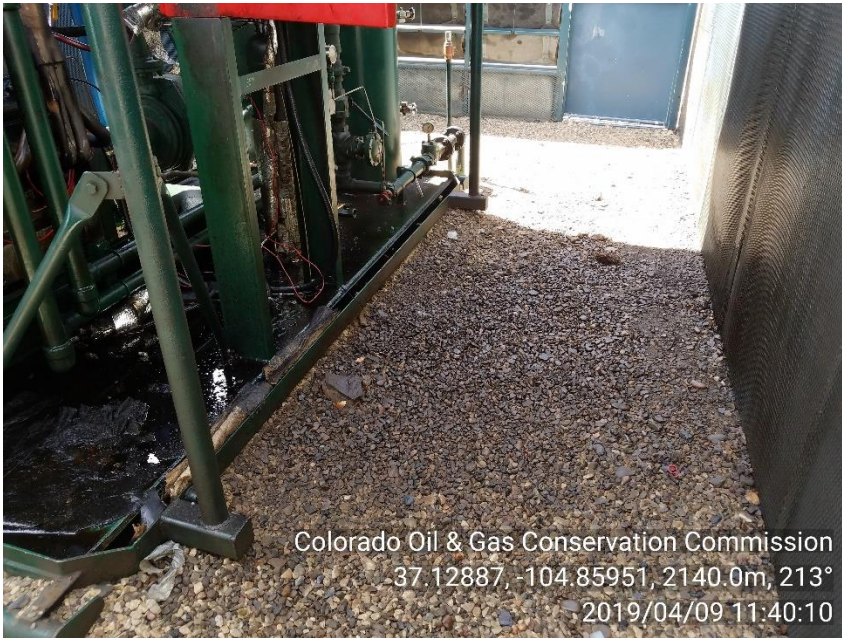
**PHOTO 5: IMPACTED SOIL EXTENDING THE ENTIRE LENGTH OF COMPRESSOR SKID FROM SKID TO THE SOUND WALL, WALL IS ALSO COATED WITH A SKIM OF OIL.**

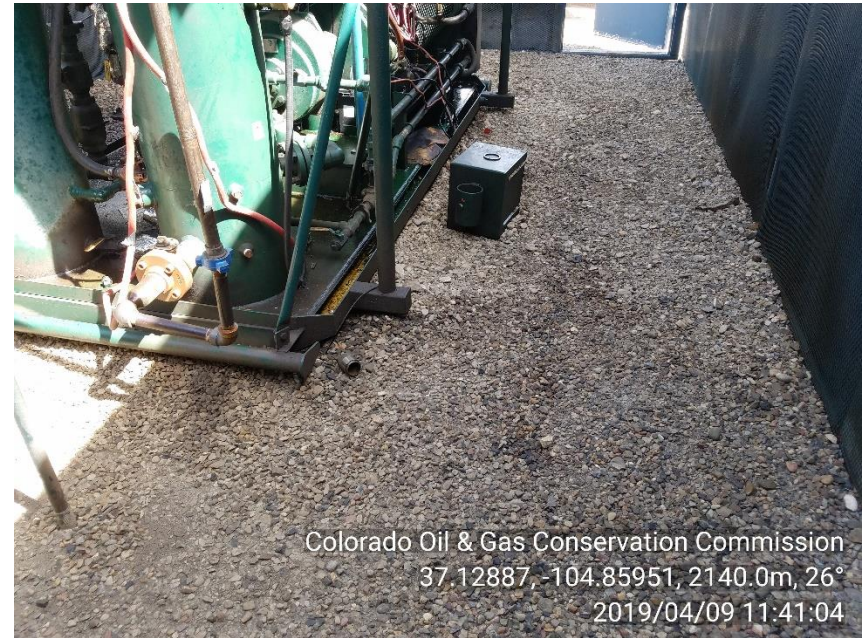
**PHOTO 6: IT APPEARS THAT OIL IS BEING TRACKED FROM OTHERSIDE BY FOOT. ALL THE GRAVEL INSIDE SOUND WALLS IS IMPACTED.**

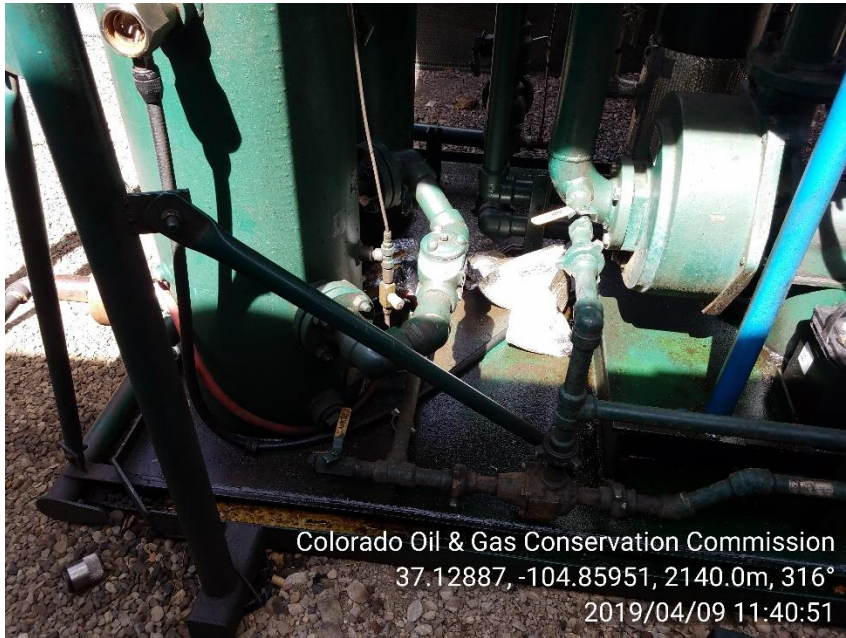
**PHOTO 7: MOR TRASH ON COMPRESSOR SKID.**
