Inspection Photos
Location Name: APACHE CANYON 35-05
API #: 05-071-08542
Insp. Doc. # 695100457

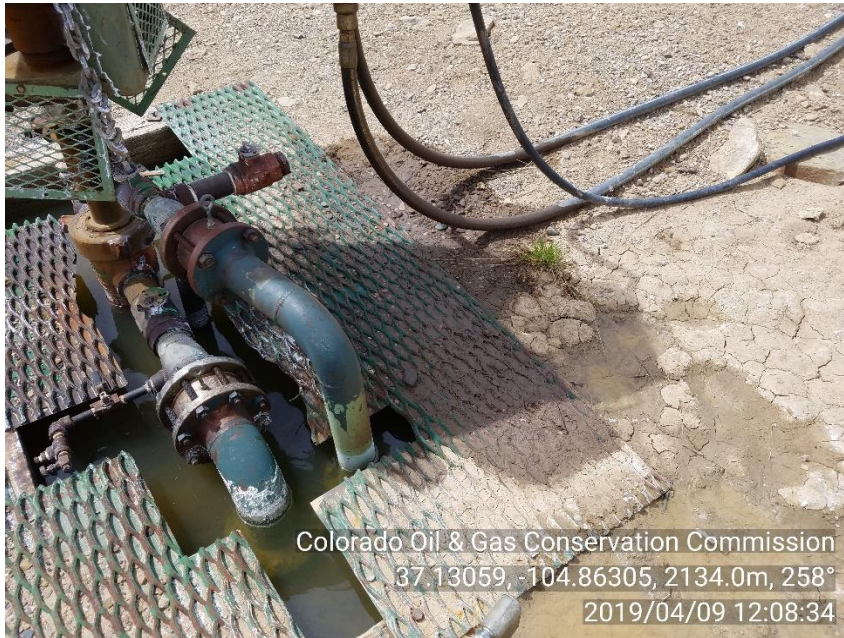
PHOTO 3: APPROXIMATELY 4' BY 2' AREA OF IMPACTED SOIL ON WEST SIDE OF WELLHEAD WITH WHAT APPEARS TO BE HYDRAULIC OIL FROM DRIVEHEAD OR HYDRAULIC HOSED

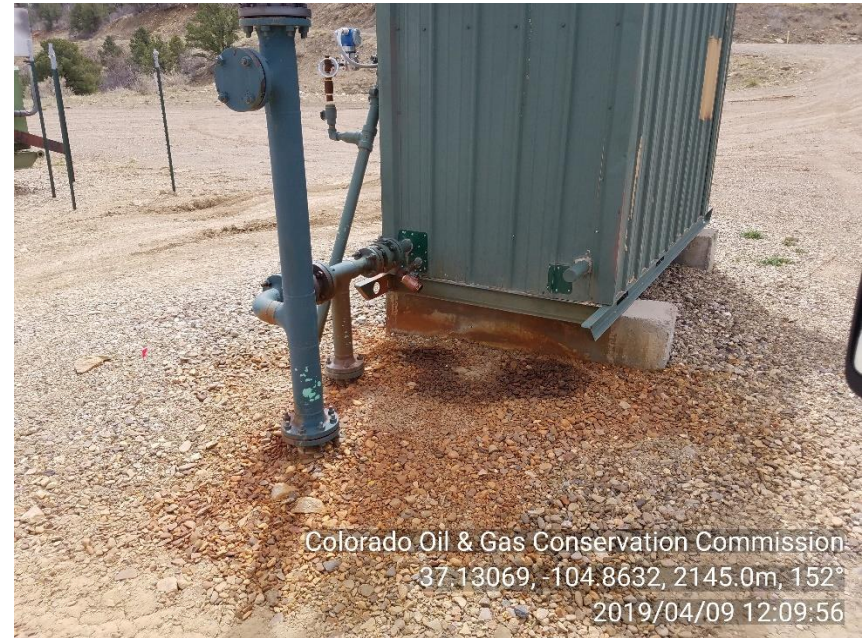
PHOTO 4: APPROXIMATELY 4' AREA OF IMPACTED SOIL ON NORTH SIDE OF METER HOUSE BENEATH SEPARATOR DRAIN. APPEARS BRODUCED CBM WATER IS BEING RELEASED FROM SEPARATOR.

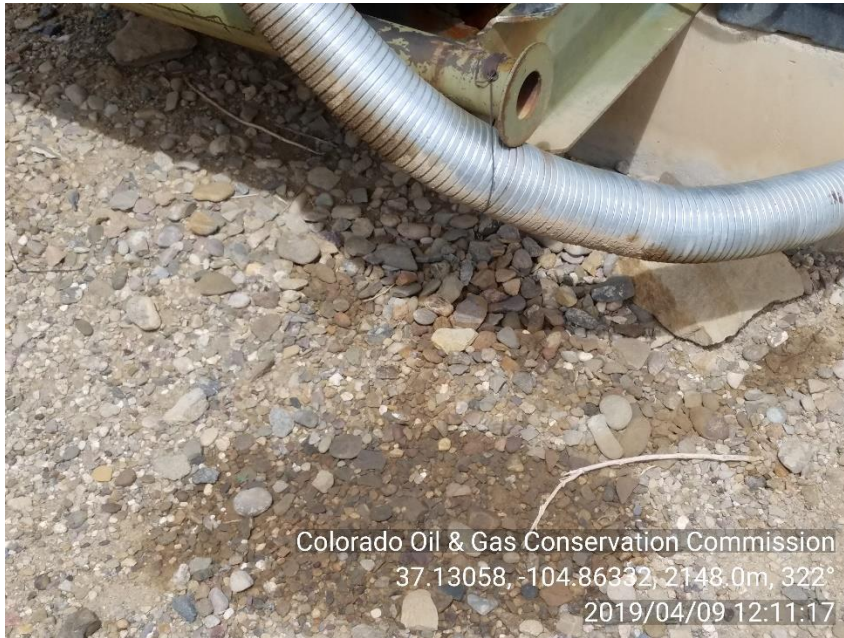
PHOTO 5: APPROXIMATELY 2' BY 2' AREA OF IMPACTED SOIL ON SOUTHEAST CORNER OF ENGINE SKID.

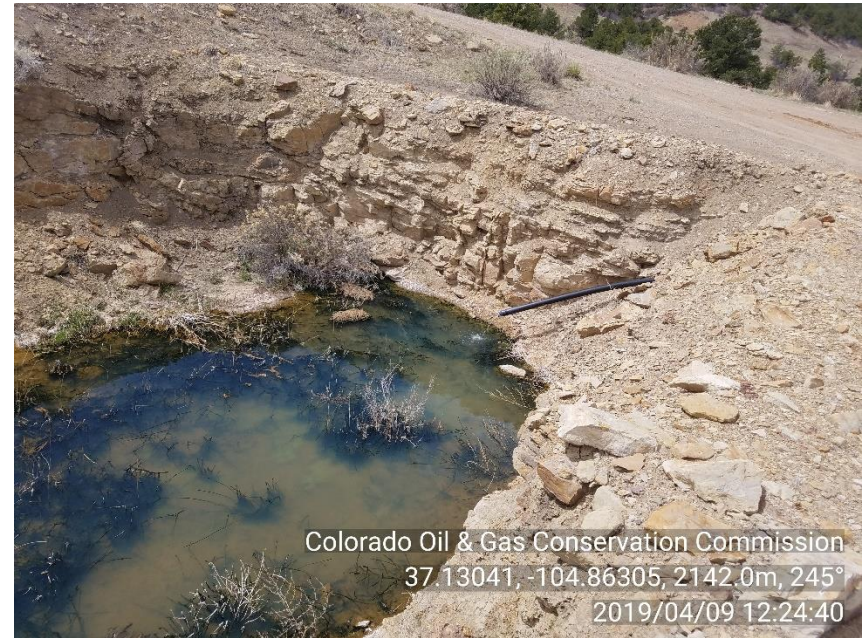
PHOTO 6: PHOTO SHOWING PIT LEVEL NOT FLUCTUATING DISPIE A SMALL STEADY STREAM OF PRODUCED CBM WATER FROM WELL BEING DISCHARGED INTO PIT.

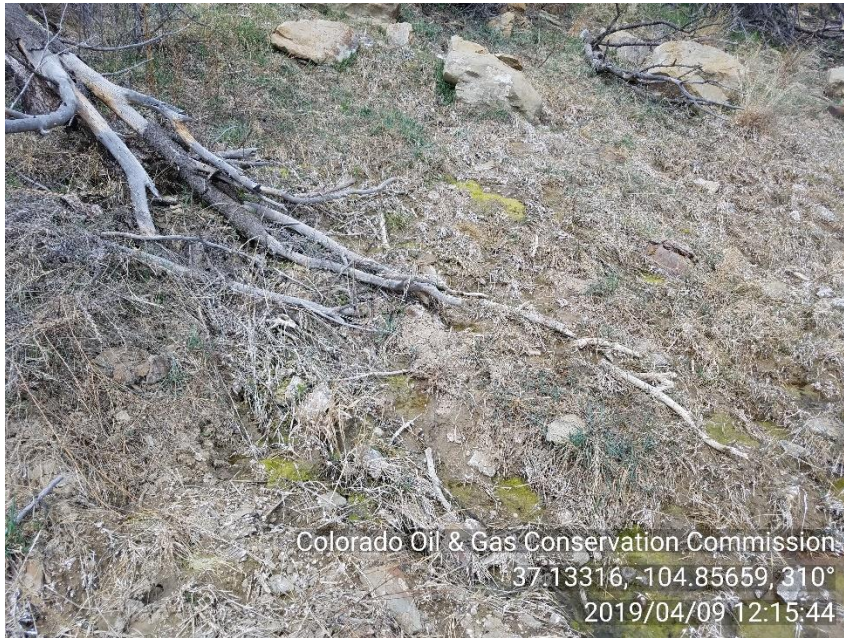
PHOTO 7: PHOTO SHOWING DISCARCH OF WATER BELOW LOCATION APPROXIMATELY 24 YDS OFF THE EAST SIDE OF LOCATION. IT APPEARS THAT PIT IS LEAKING PRODUCED CBM WATER.

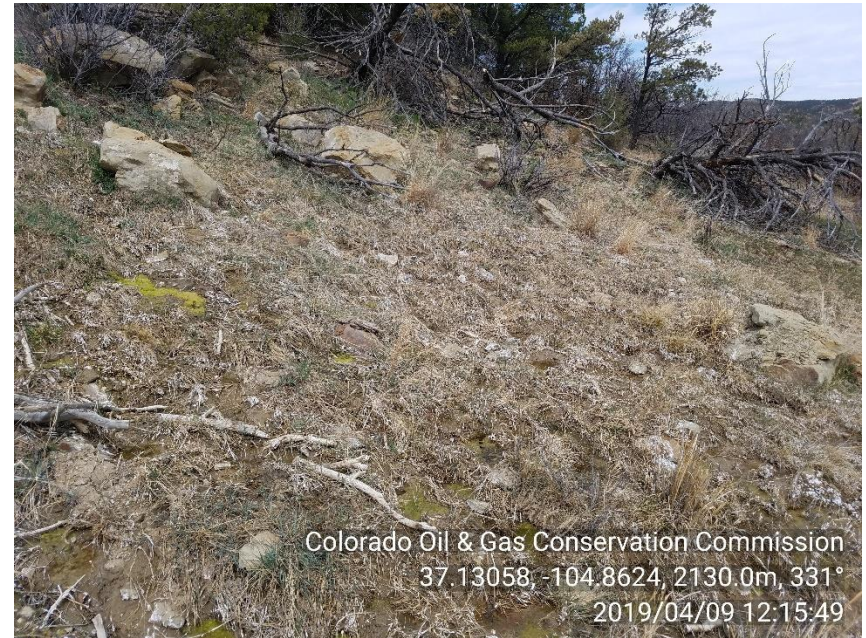
PHOTO 8: PHOTO SHOWING MORE IMPACTED AREA AND DEAD PINON TREES IN IMPACTED AREA.

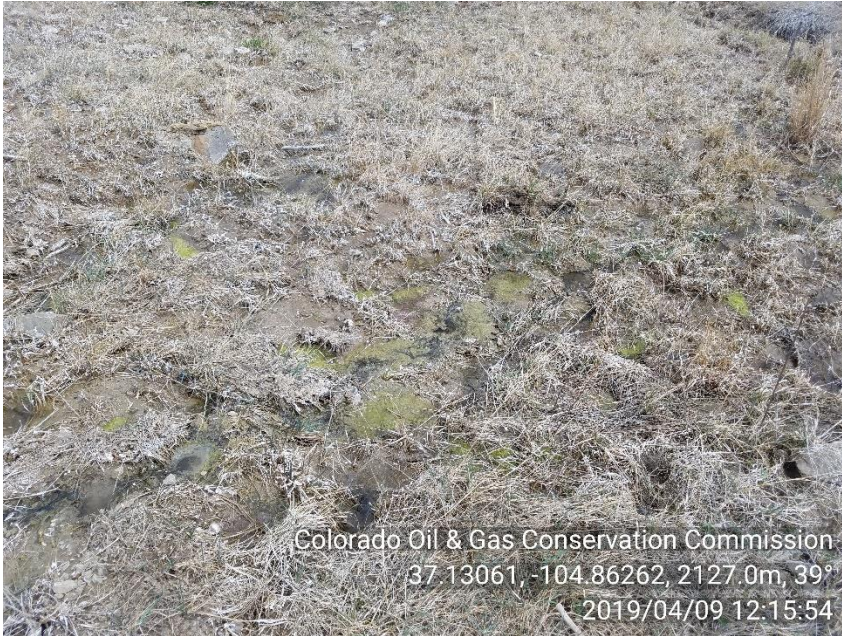
PHOTO 9: MORE AREA IMPACTED.

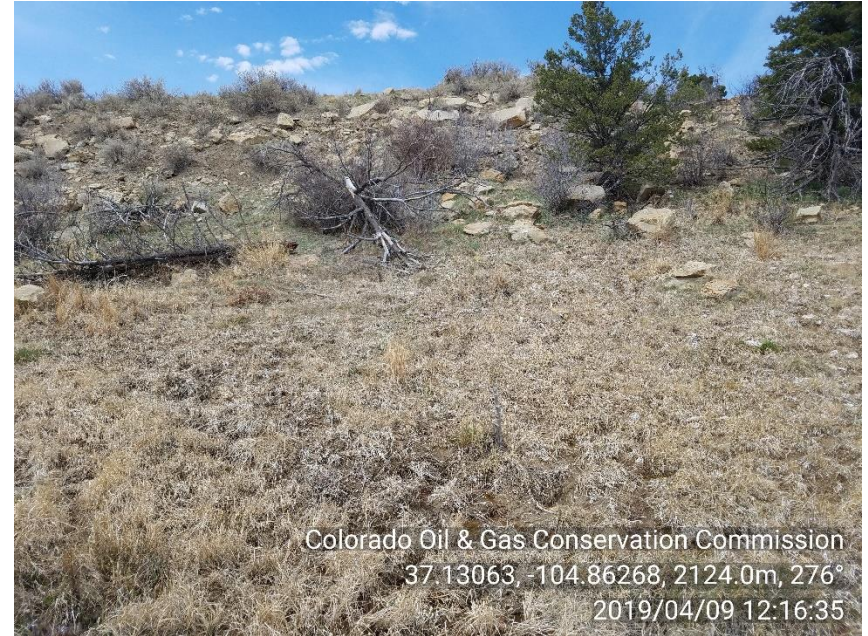
PHOTO 10: SAME AREA OF PHOTO #7 FROM FARTHER DOWN THE HILL.

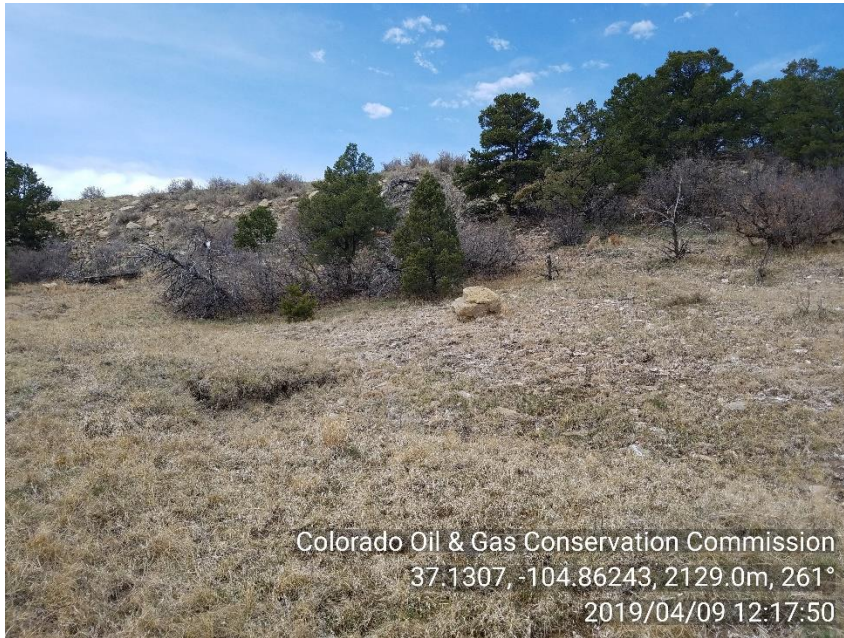
PHOTO 11: PHOTO LOOKING UP A SEVERAL POINTS OF DISCHARGE FROM NORTHEAST OF LOCATION.

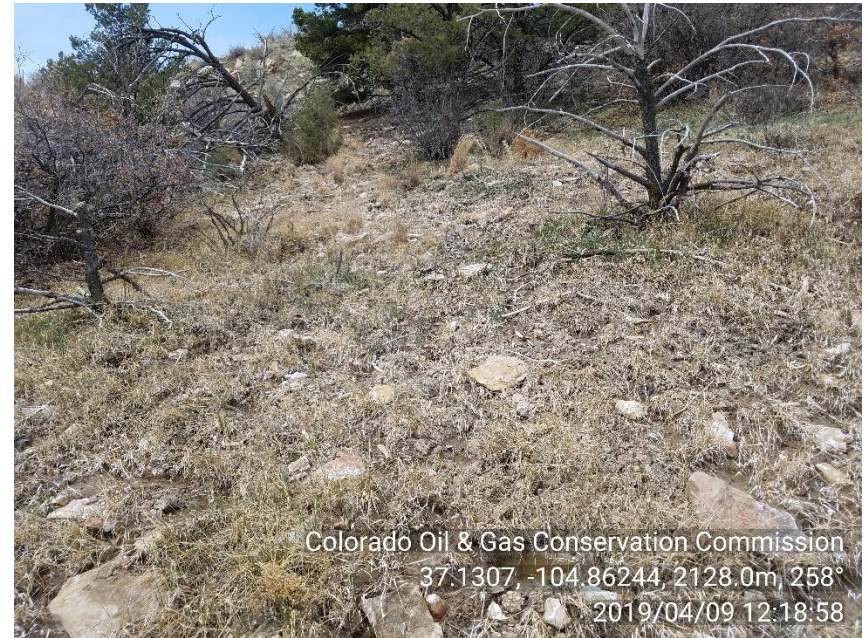
PHOTO 12: CLOSER PHOTO OF DISCHARGE TO THE NORTHEAST BELOW LOCATION.

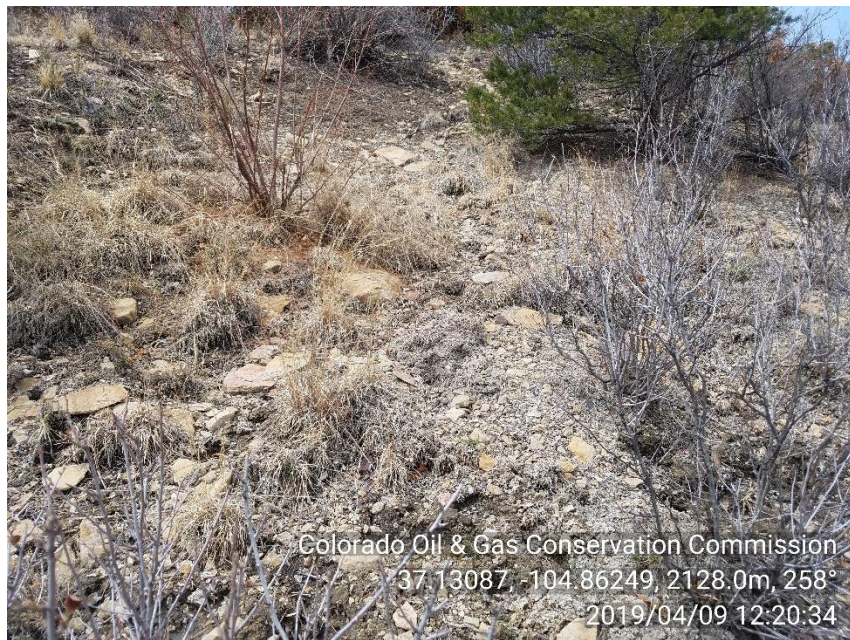
PHOTO 13: CLOSER VIEW OF DISCHARGE ON THE NORTHEAST SIDE BELOW LOCATION.

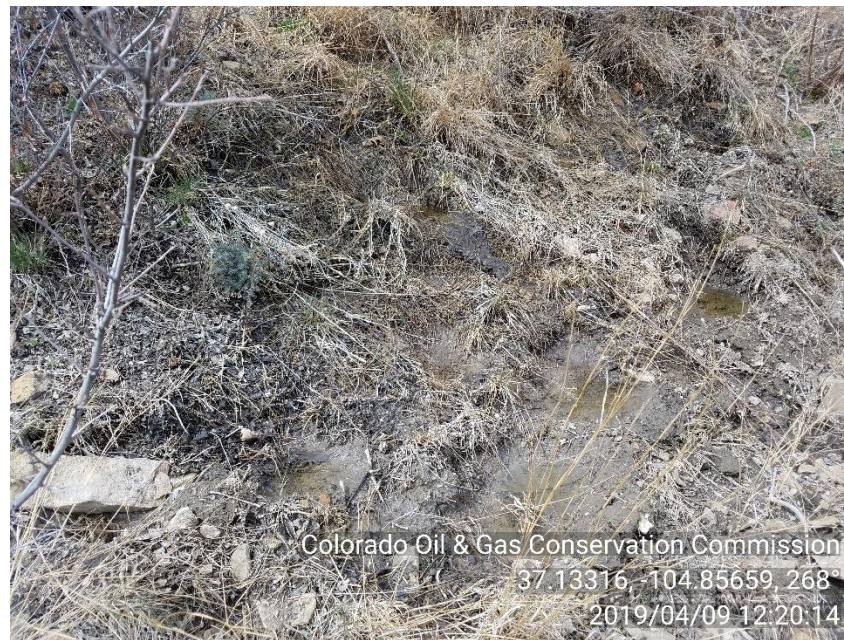
PHOTO 16: CLOSEST VIEW OF DISCHARGE ON NORTHEAST SIDE BELOW LOCATION.
