Inspection Photos
Location Name: GE #19-6
Location ID: 308830

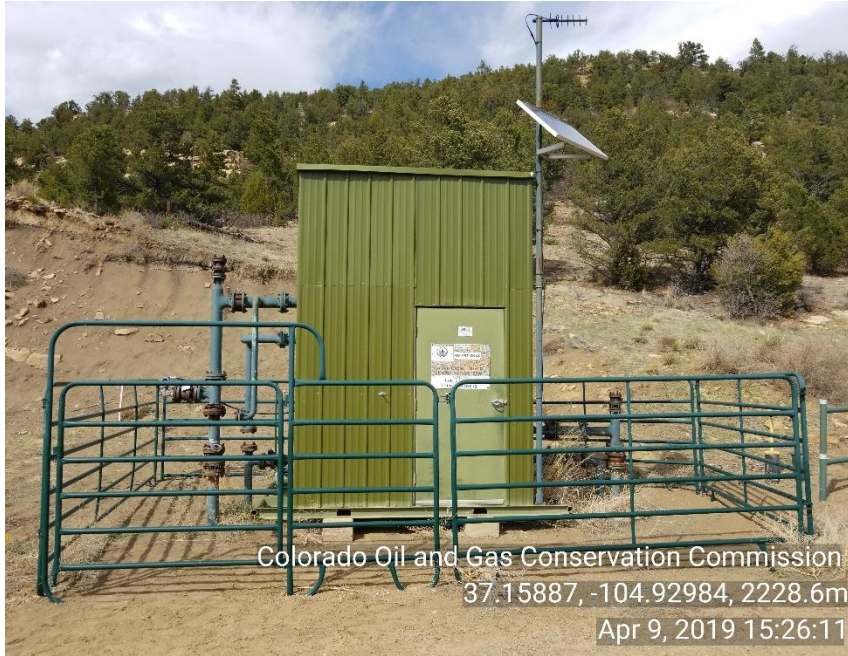
Photo 1 Sep/meter house

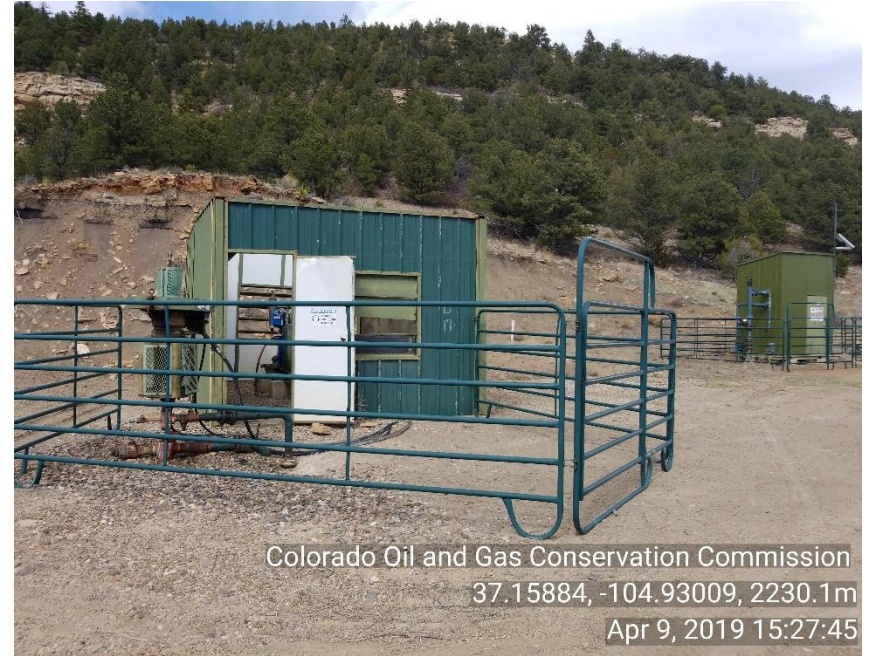
Photo 2 WH/HYD skid sound walls

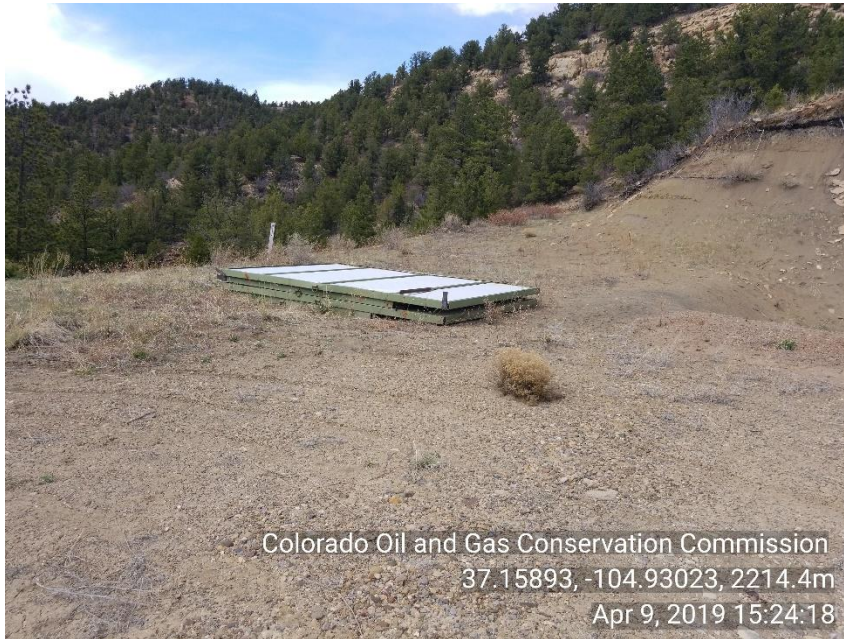
Photo 3 Unused equipment Sound walls

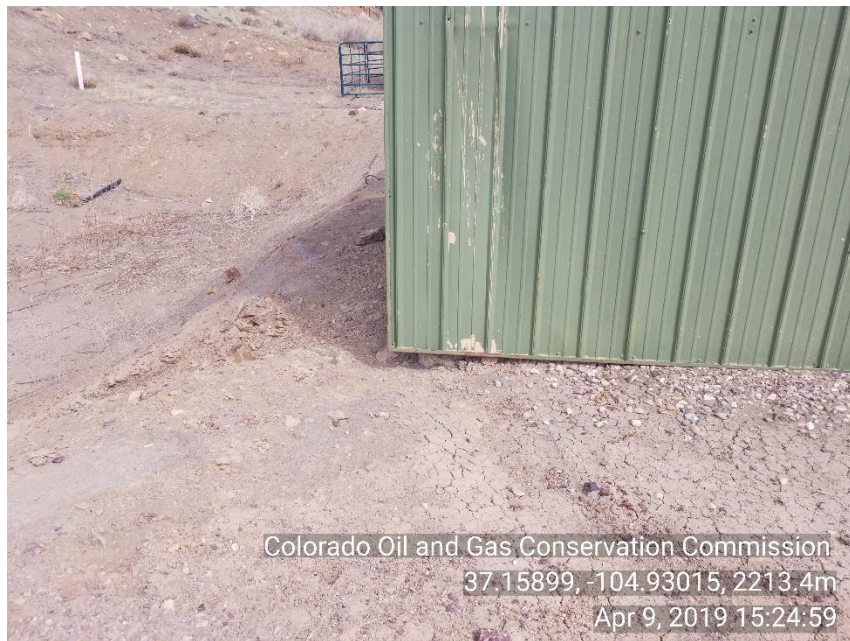
Photo 5 Storm water Location water and sediment going into pit

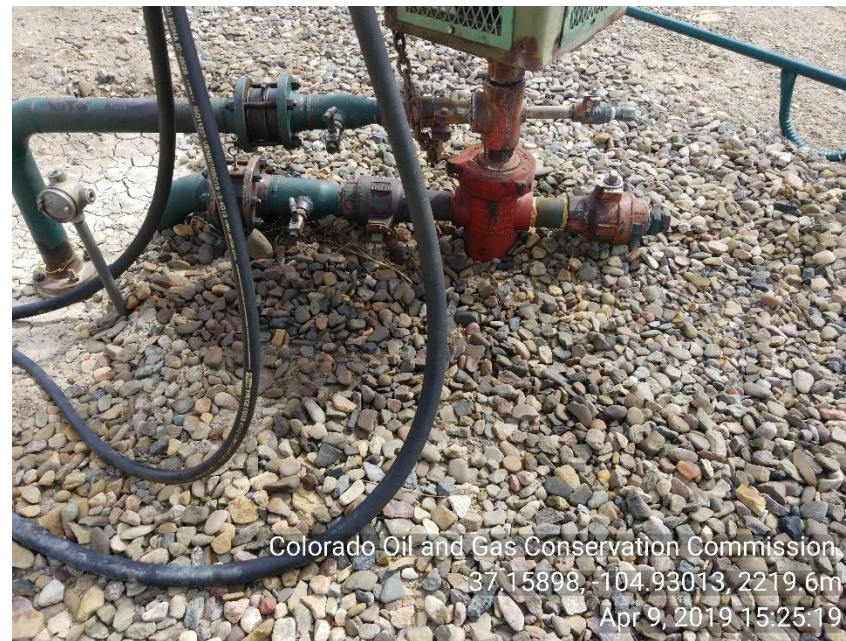
Photo 6 stained soil around WH

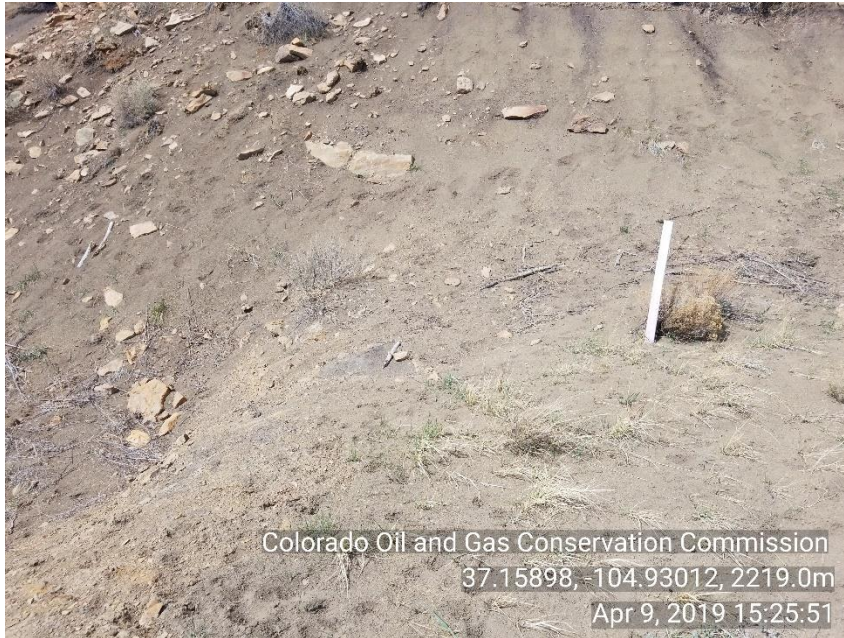
Photo 7 Storm water; sediment going into pit

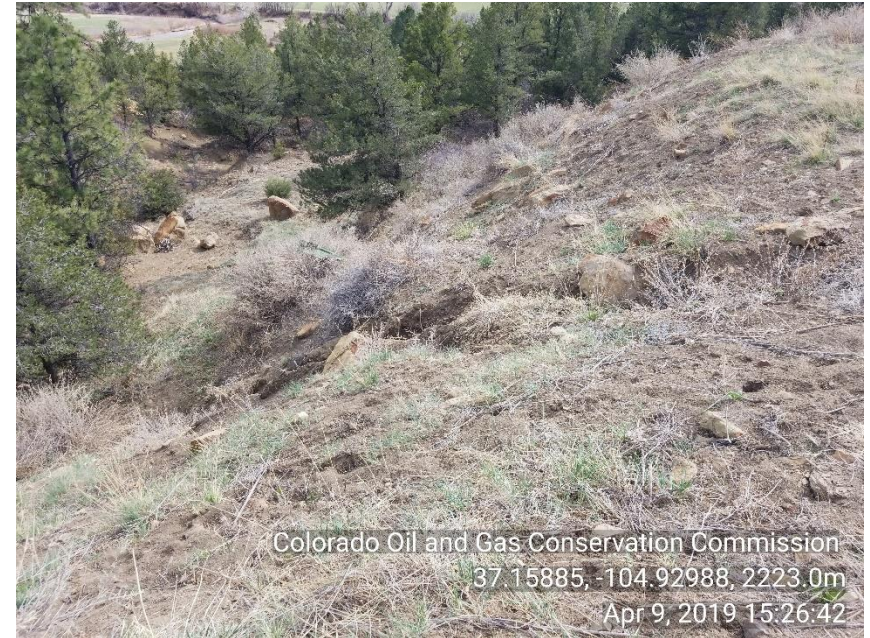
Photo 8 Reel on slope of location carrying sediment into drainage need to redirect into proper rocked location drain

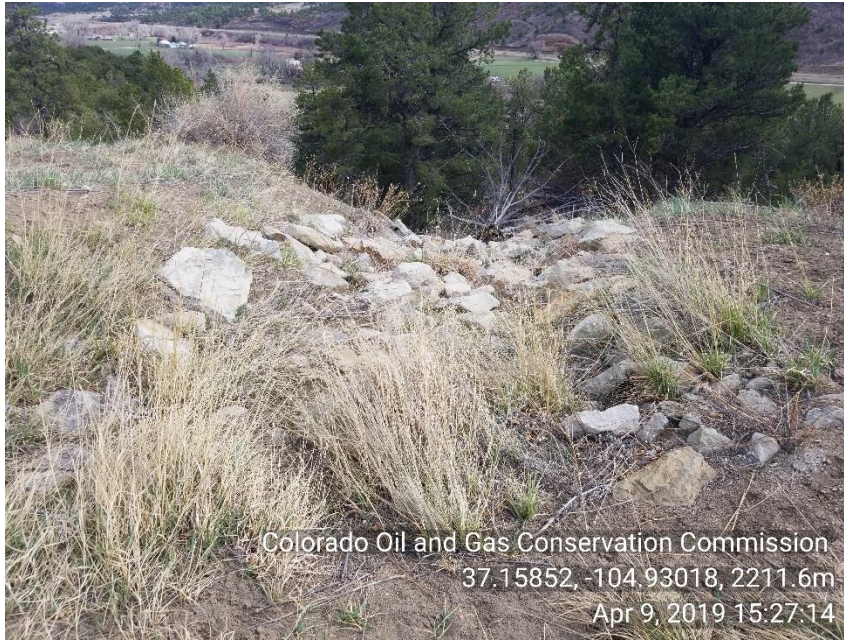
Photo 9 proper location rocked drainage
