Inspection Photos
Location Name: Hamil 19-16HA
API: 05-081-07822

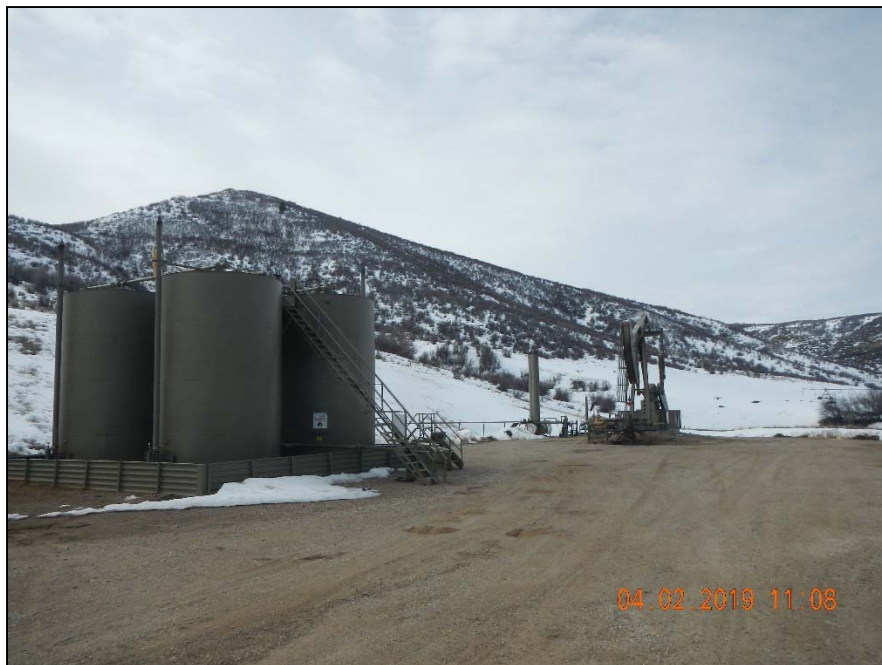
Photo 1. Overview of location taken at entrance facing southwest.

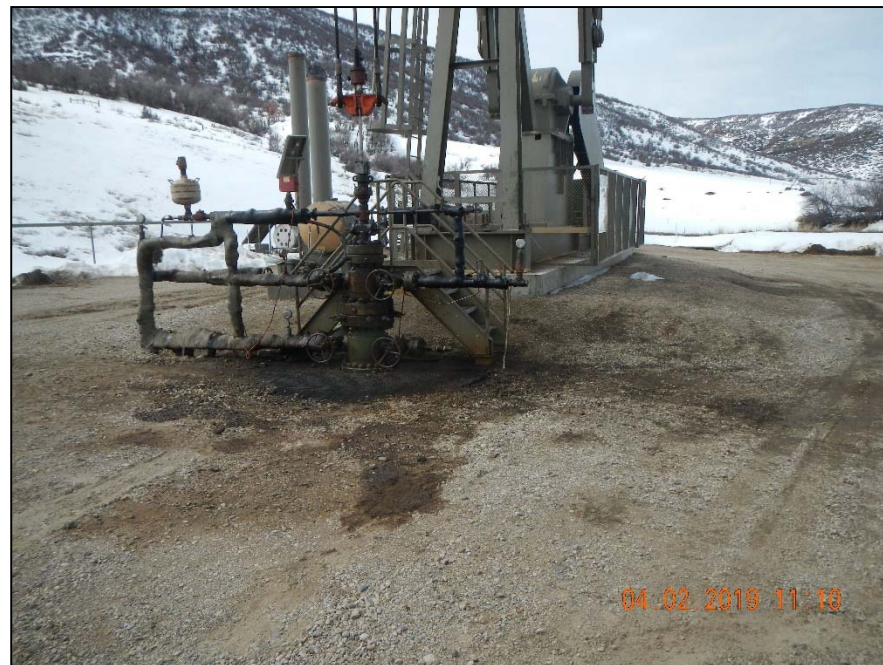
Photo 2. Stained soil at wellhead.

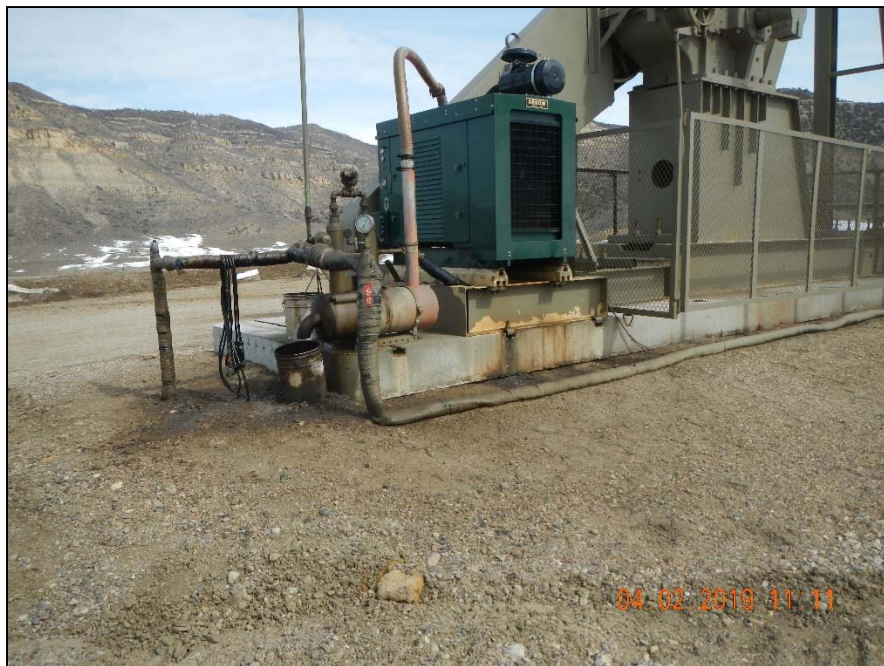
Photo 3. Bucket and stained soil at exhaust.

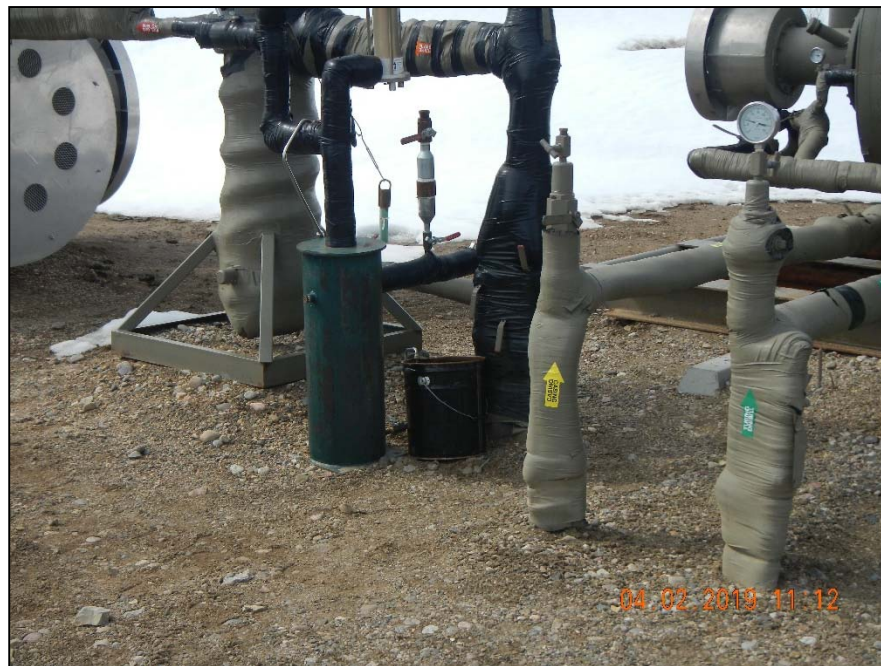
Photo 4. Bucket for drips in separation equipment.
