# PIT STATUS EVALUATION FORM

Facility ID: 115099

Pit Name: CHAMPLIN 416 AMOCO "C" 1

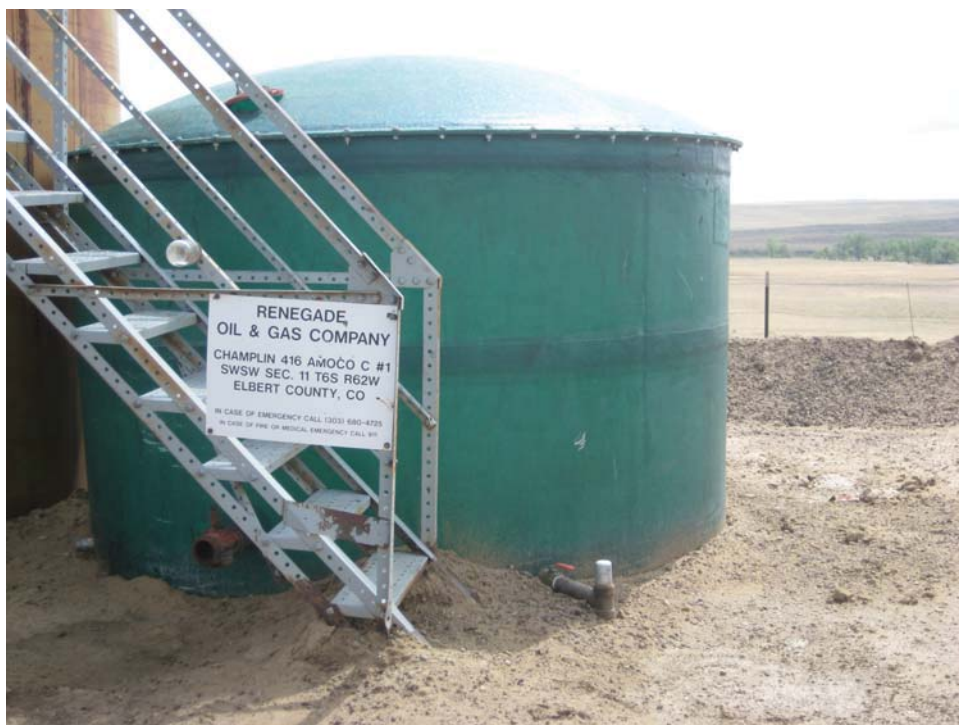
Photo 1. Covered fiberglass water tank

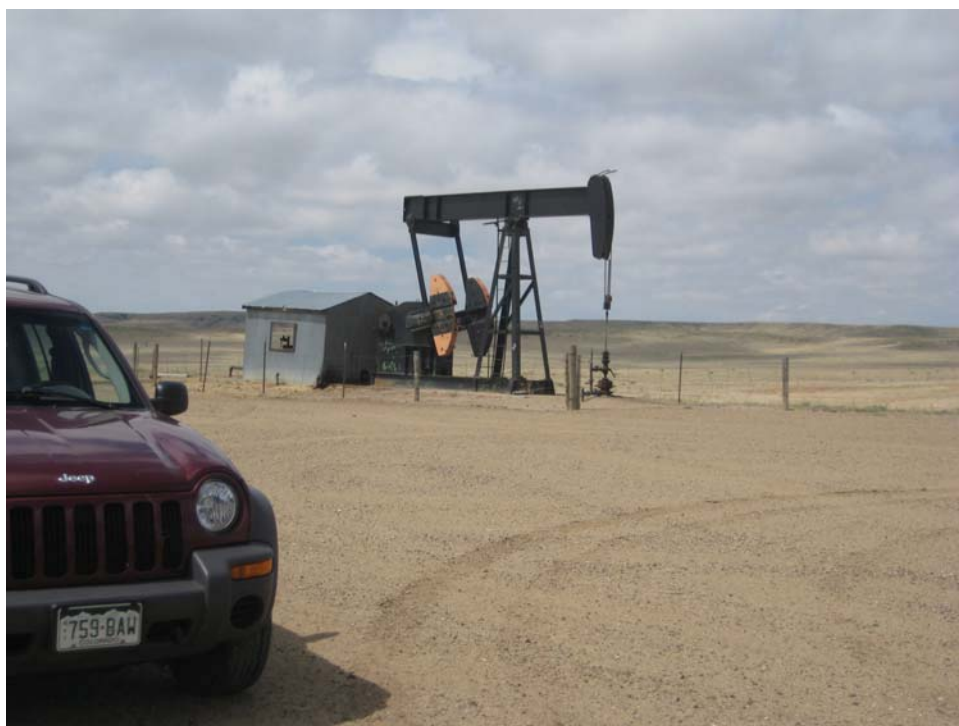
Photo 2. Champlin 416 Amoco "C" 1 wellhead

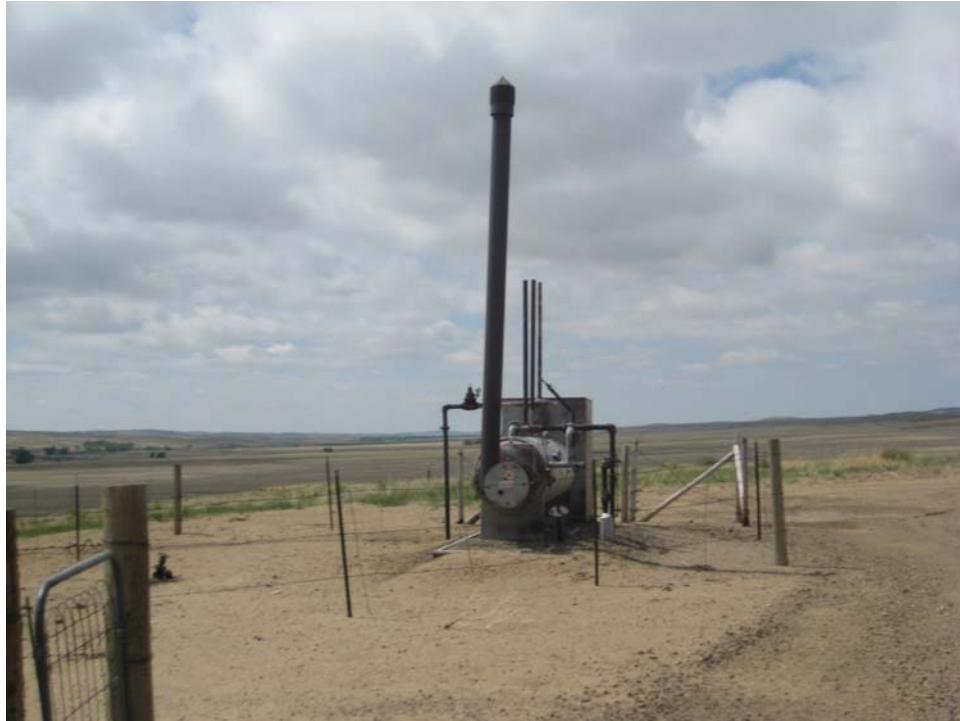
**Photo 3. Horizontal separator**

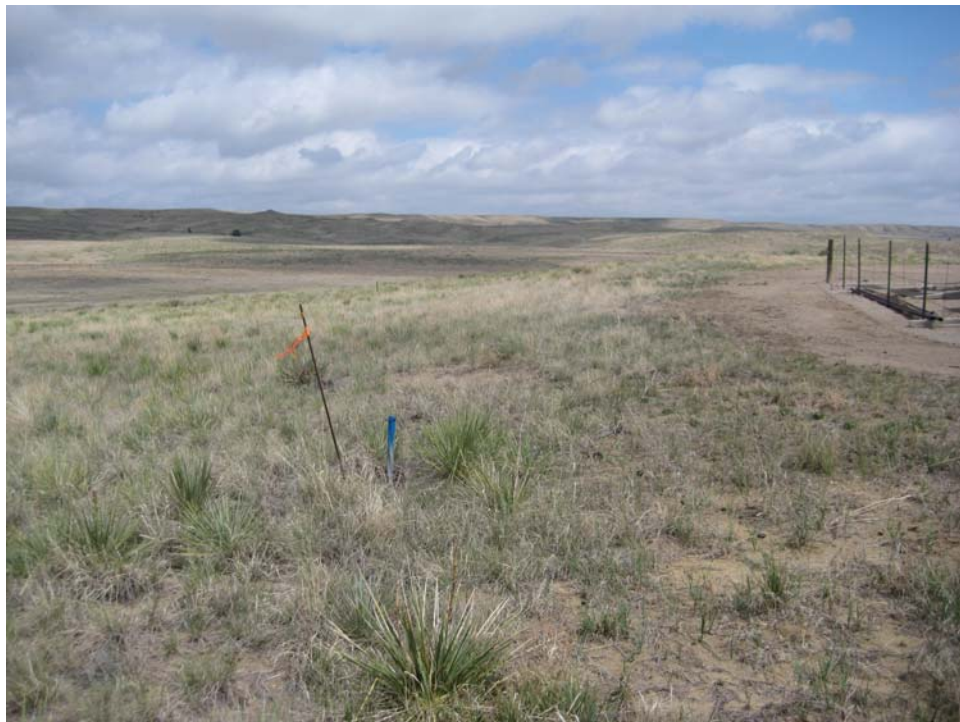
Notes: (1985) oil cleaned from pit 150' x 150', FIR (4-2-08) no mention of pit  
WSIF (1998) 1500 gal. plastic H<sub>2</sub>O tank  
FIELD VISIT 6-4-2008: NO PIT FOUND. SITE CLEAN & LEVEL. NO VEGETATION  
DISTURBANCE NEAR WELL PAD.

**Photo 4. Looking north from the southwest corner of the wellpad**

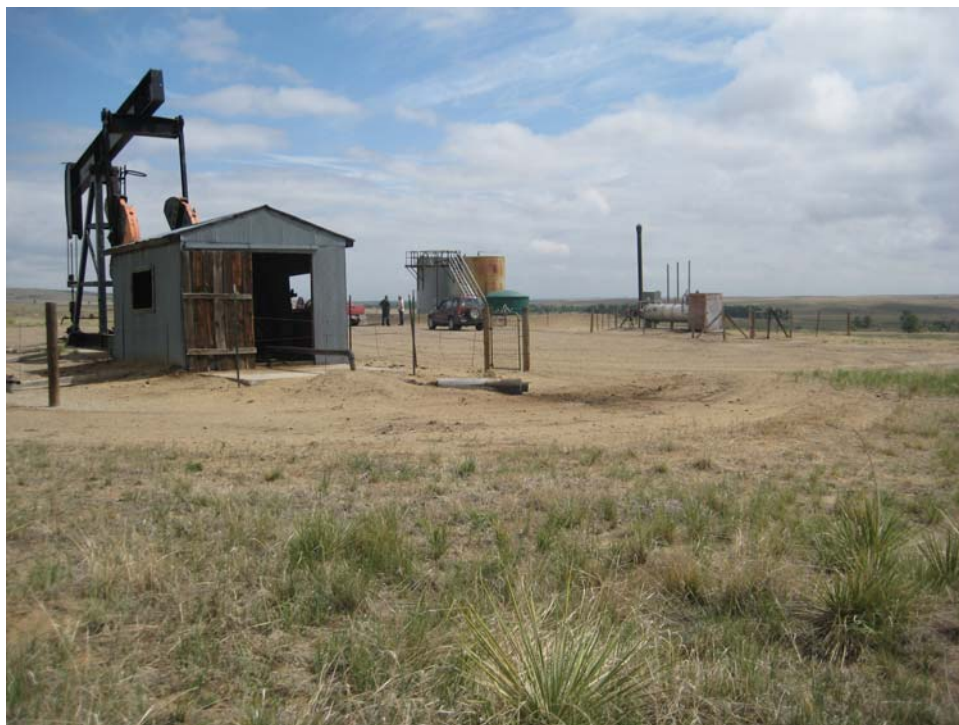
**Photo 5. Looking northeast from the southwest corner of well pad.  
The former pit site may have been at the southeast corner of the well pad (right in photo).**
