PIT STATUS EVALUATION FORM

Facility ID: 115104

Pit Name: EVERITT 43-19

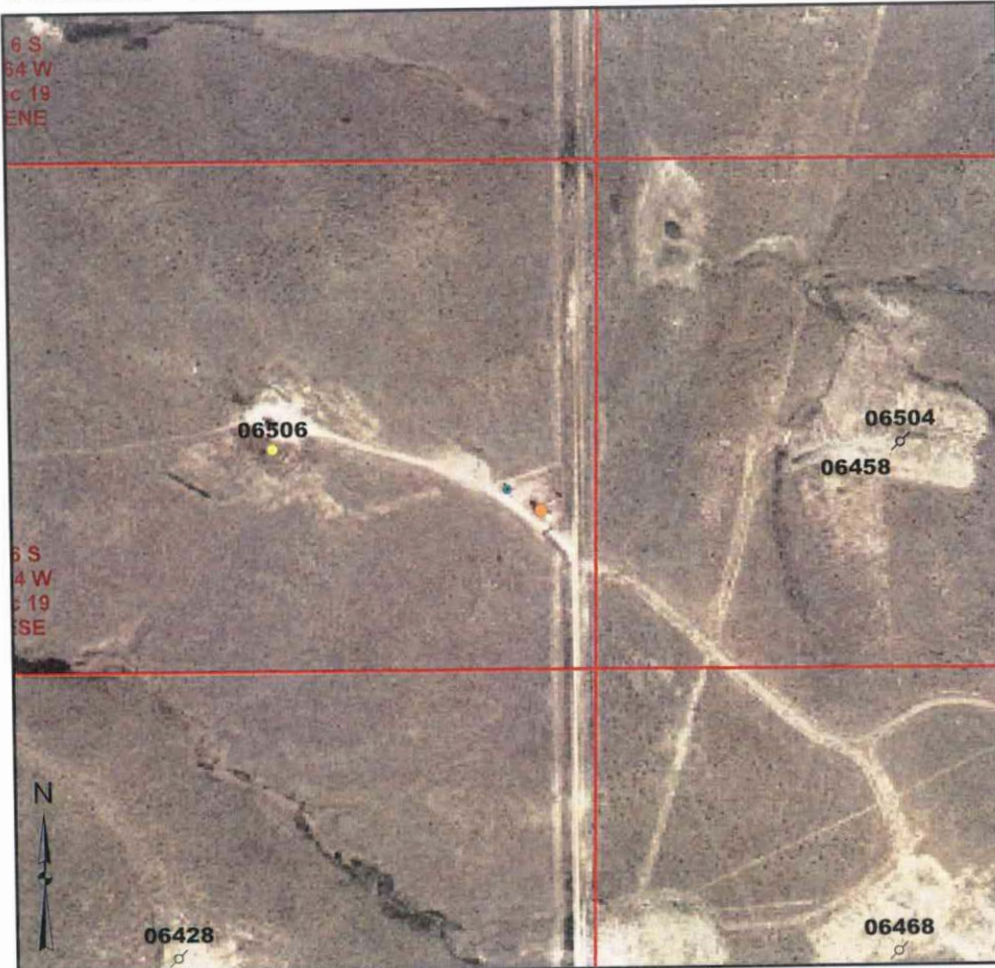
Notes: LIF (10-15-1985) skm 20'x20' FIR (10-31-1996) pit existing.

FIR (9-2007) #2001242278 no pit mentioned

FIELD VISIT 6-3-2008: PIT BACKFILLED. Using fiberglass tank
