PIT STATUS EVALUATION FORM

Facility ID: 115120

Pit Name: CHAMPLIN 548 "A" 1 & 2

Facility ID 115120
Well API 05-039-06353
Well API 05-039-06406

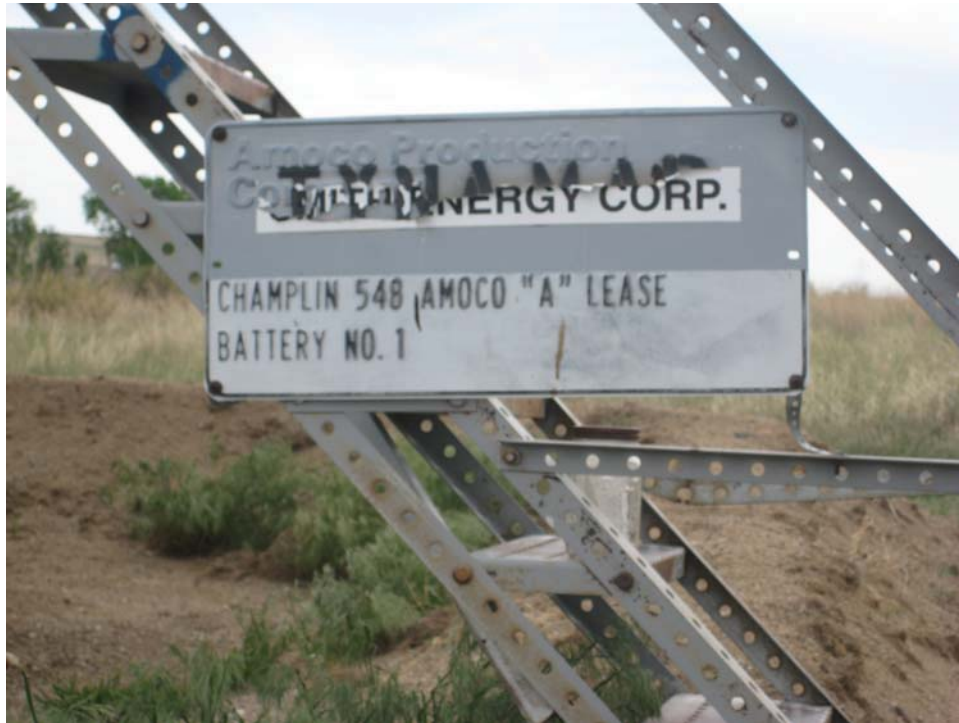
Photo 1. Champlin 548 1 & 2 battery tank sign

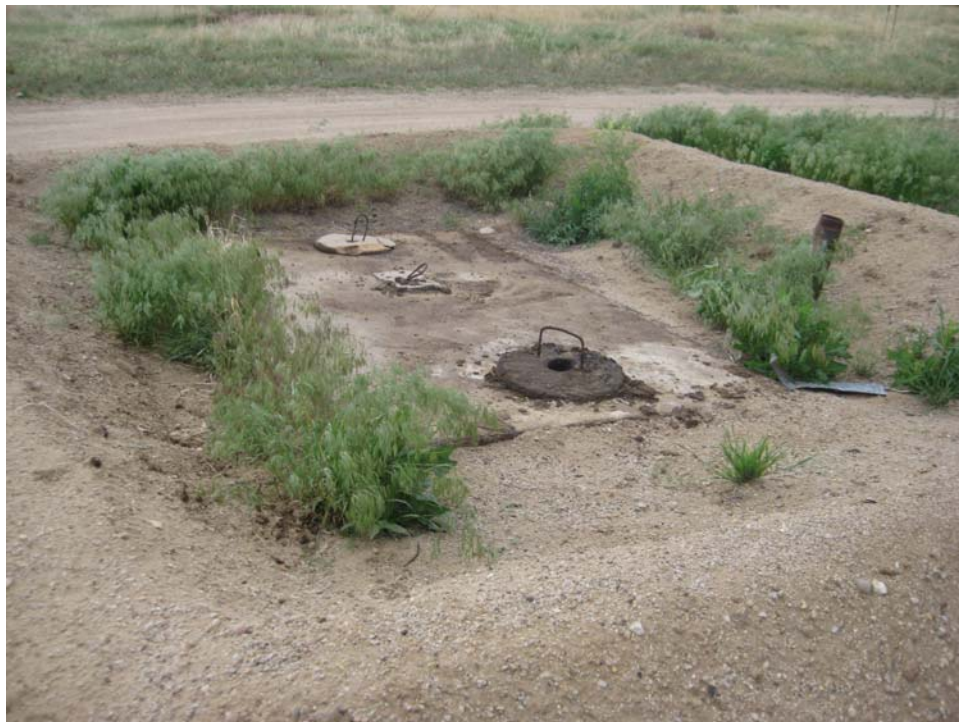
Photo 2. Buried concrete vault

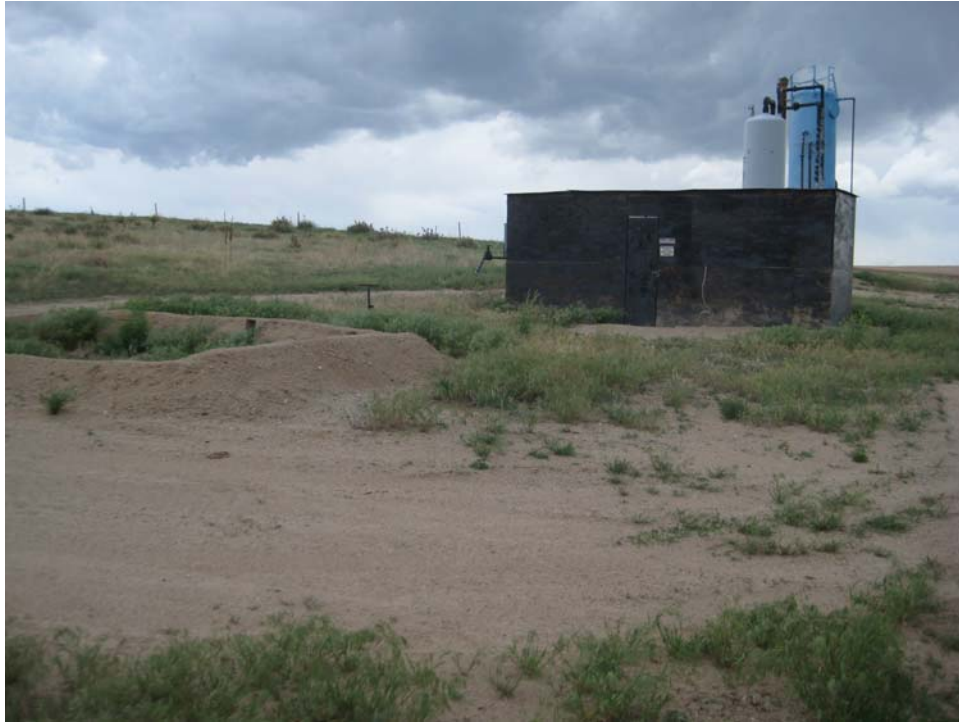
Photo 3. Buried concrete vault and two separators to the west
