Inspection Photos
Location Name: AC #14-16V
Location ID: 307892

Colorado Oil and Gas Conservation Commission
37.07846, -104.95774, 2485.5m
Apr 11, 2019 11:21:50

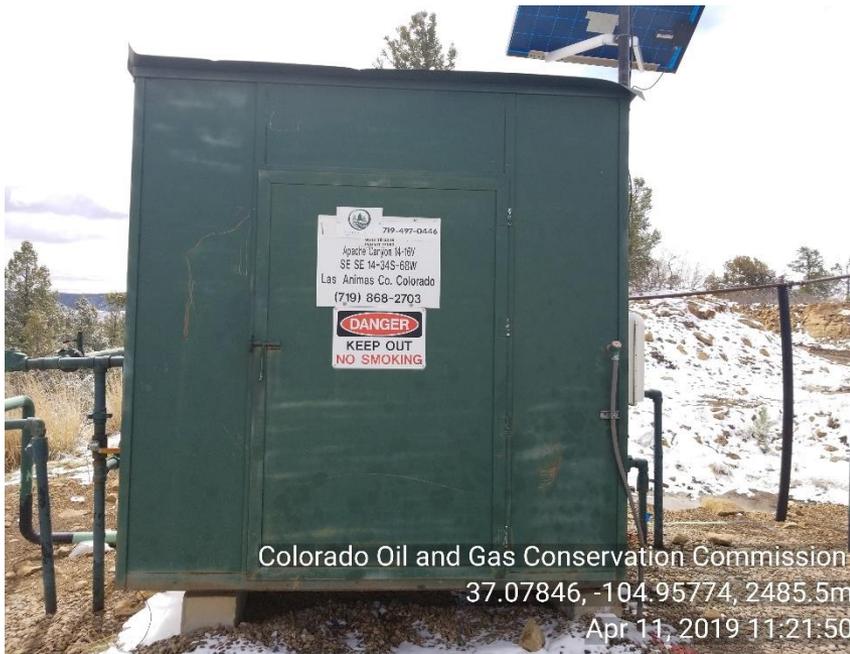
Photo 1 Sep/meter house.

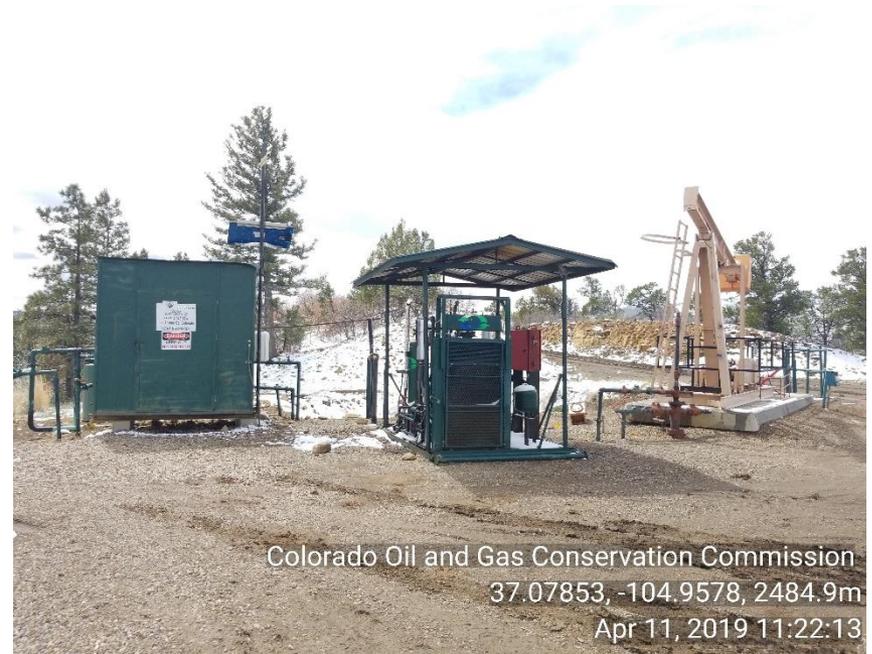
Photo 2 loc pic. Rods appear to have been removed from well. Pump jack not being used.

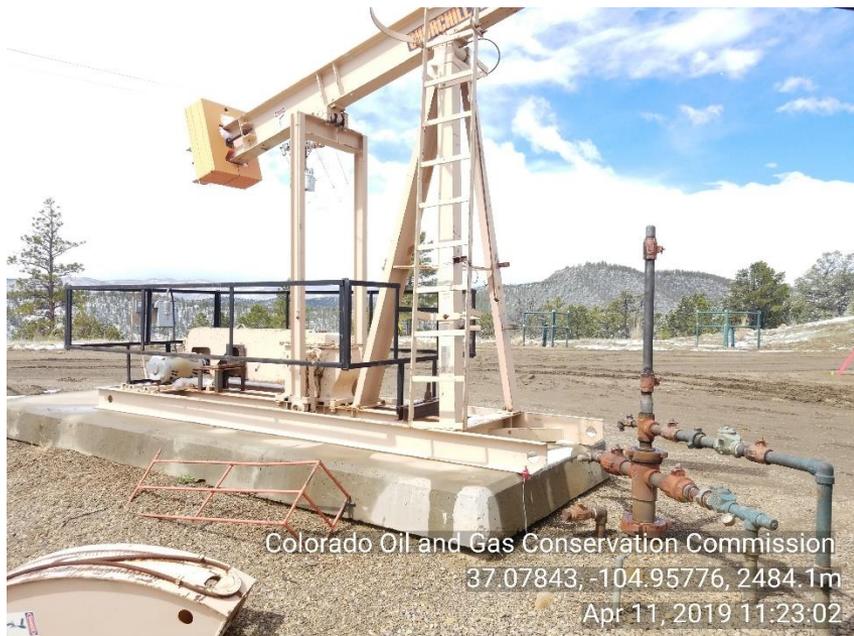
Photo 3 Unused equipment; PU, Cement base, horses head and guard.

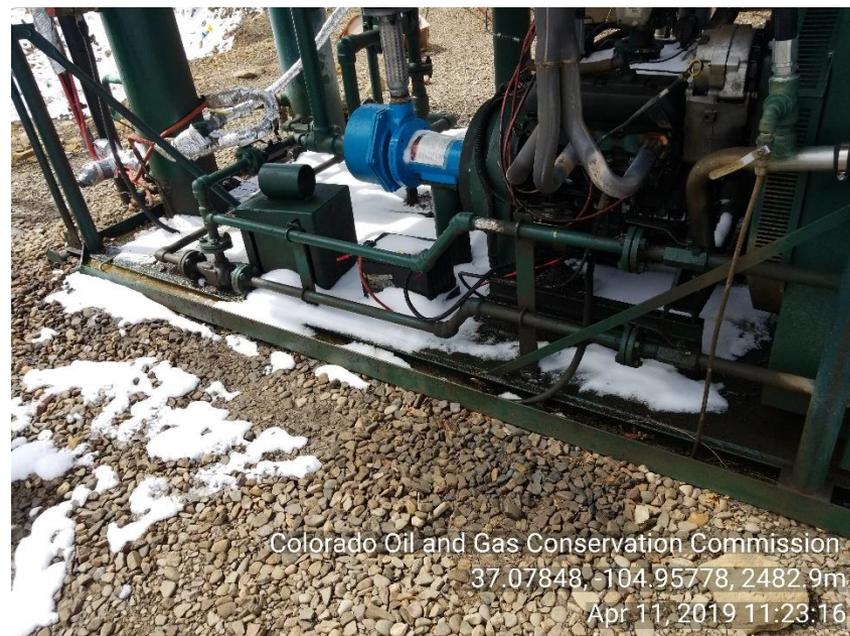
Photo 4 Stained soil around Liquid ring skid.

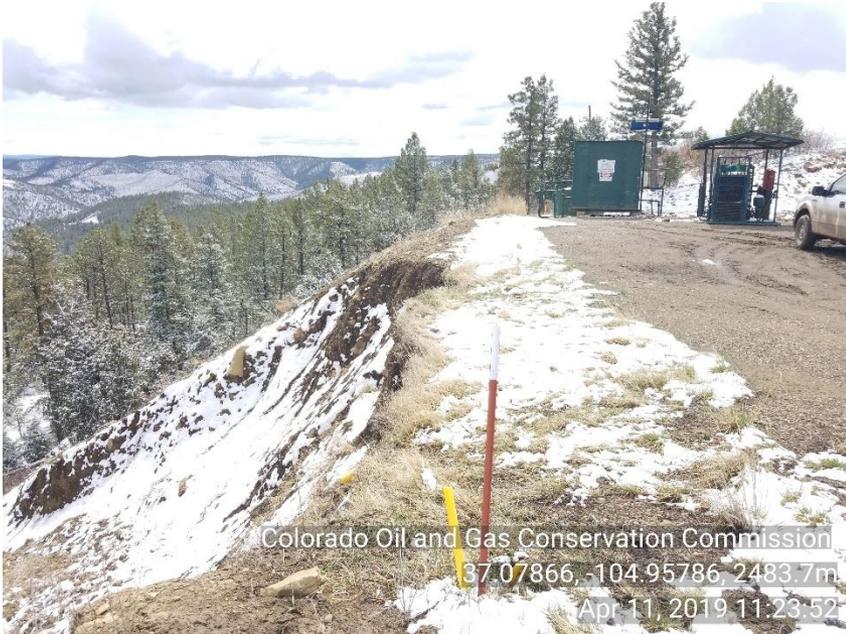
Photo 5 North east corner fill side of location appears to have broken away from location and slid down hill side.

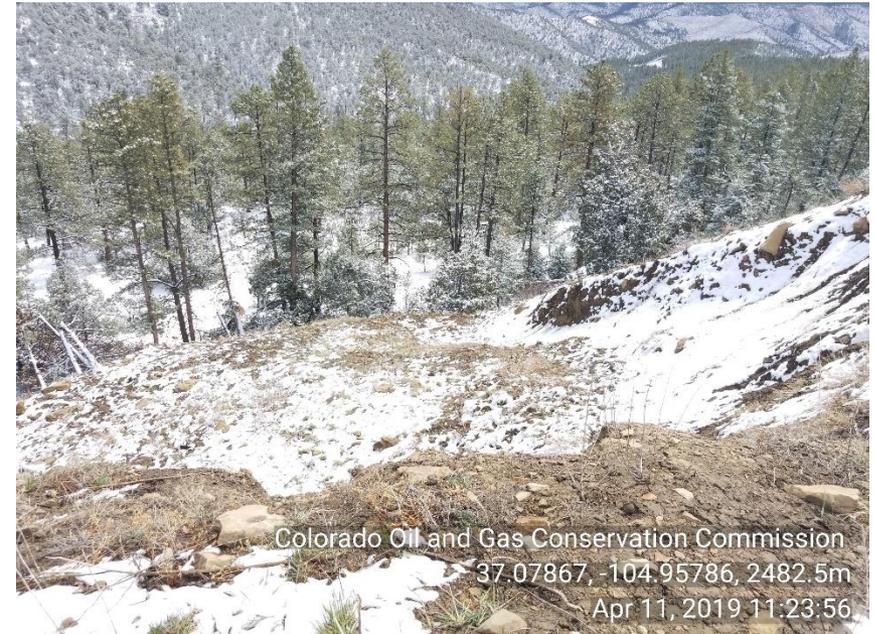
Photo 6 North east corner fill side of location appears to have broken away from location and slid down hill side

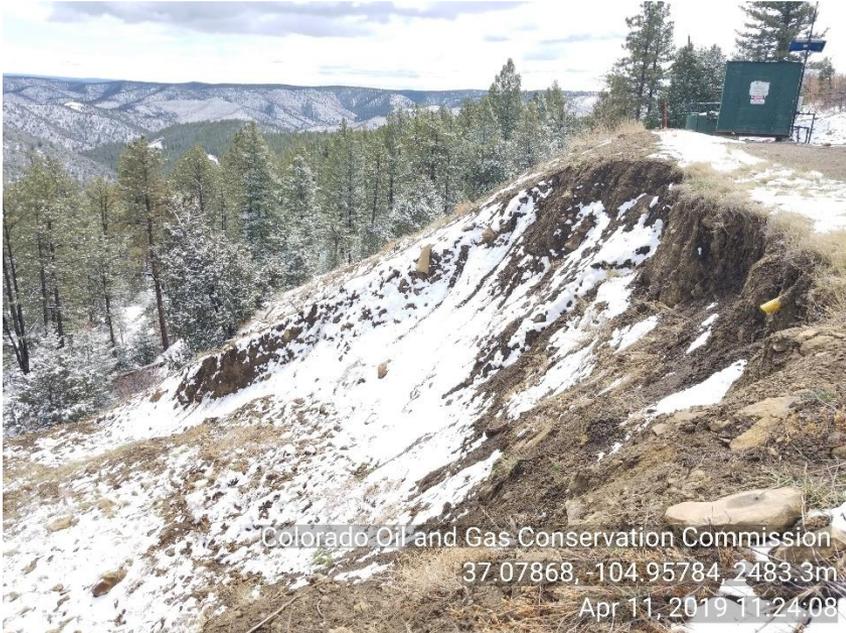
Photo 7 North east corner fill side of location appears to have broken away from location and slid down hill side.

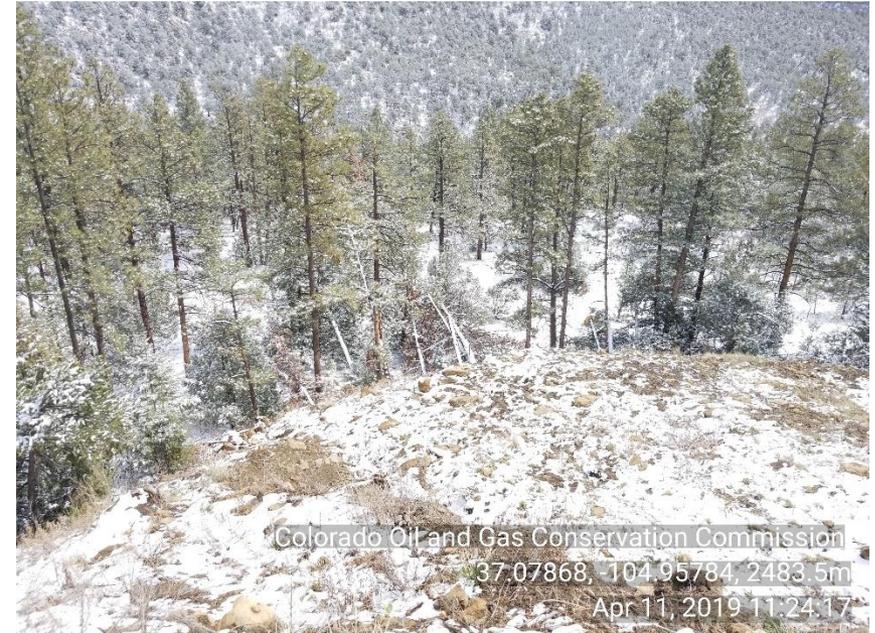
Photo 8 North east corner fill side of location appears to have broken away from location and slid down hill side and knocked down trees.

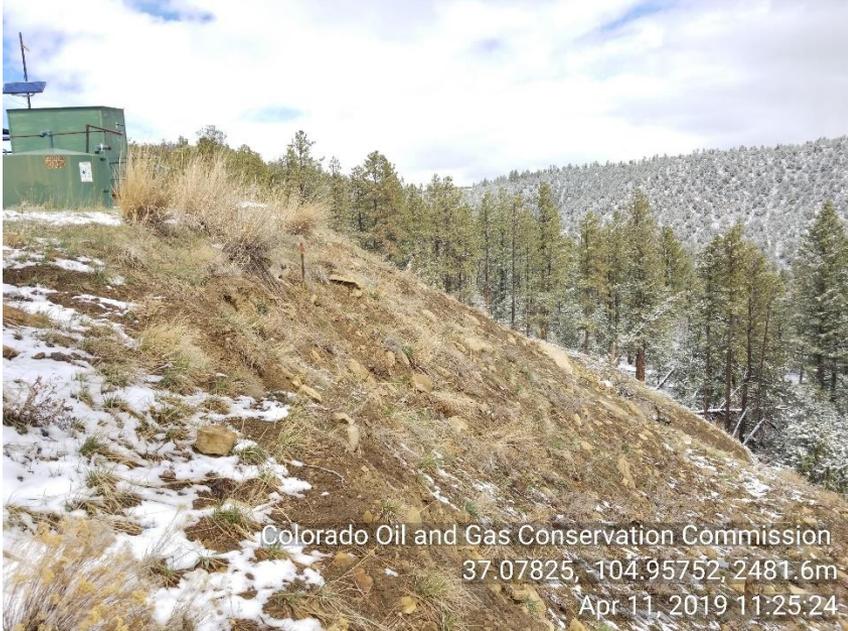
Photo 9 South east corner fill side of location appears to have broken away from location and slid down hill side.

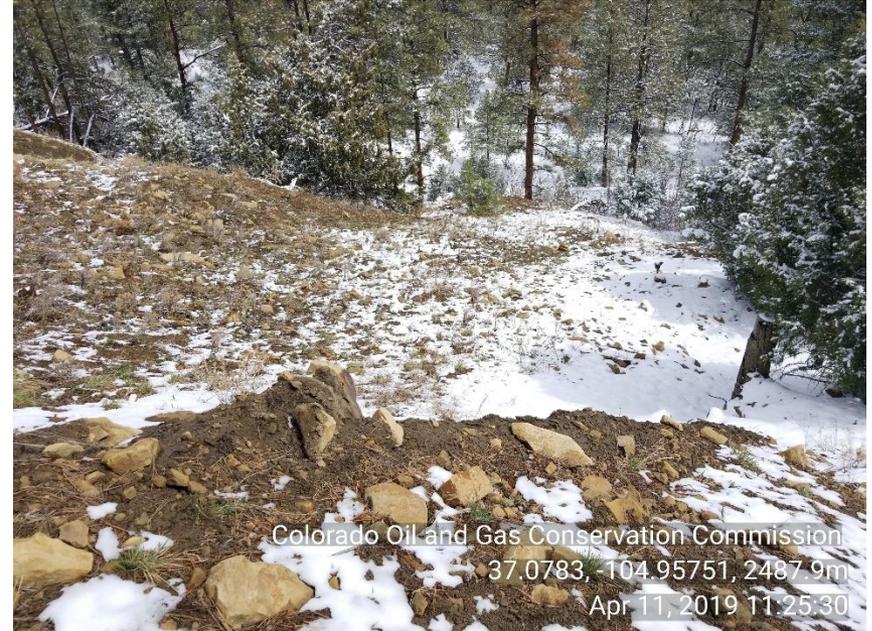
Photo 10 South east corner fill side of location appears to have broken away from location and slid down hill side.

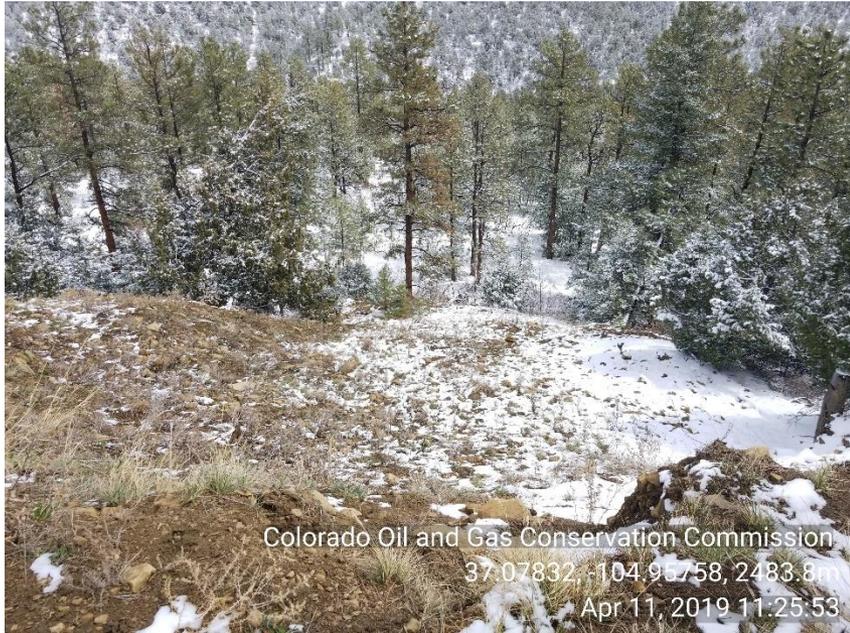
Photo 11 South east corner fill side of location appears to have broken away from location and slid down hill side.
