Inspection Photos
Location Name: AC# 24-02V
Location ID: 307884

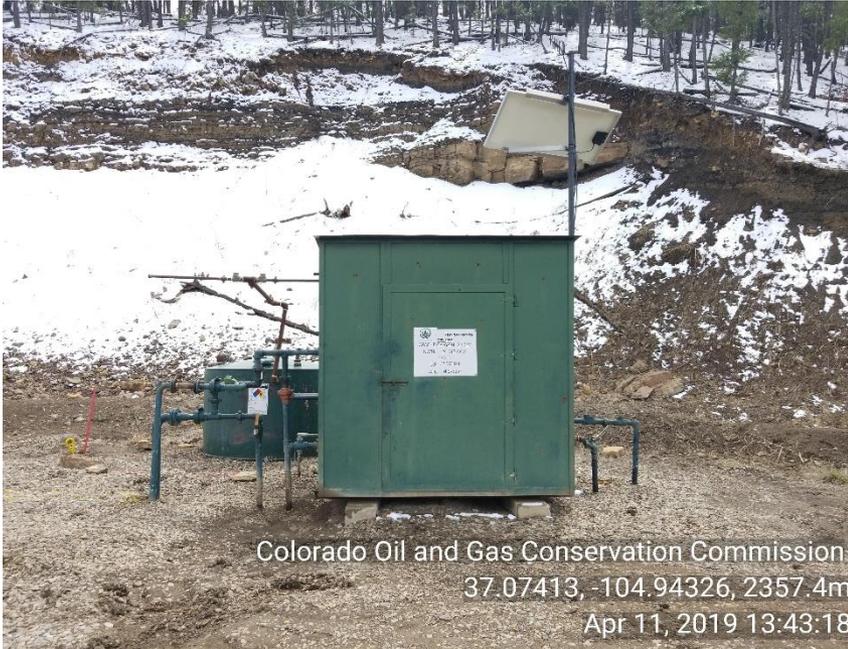
Photo 1 Sep/meter house

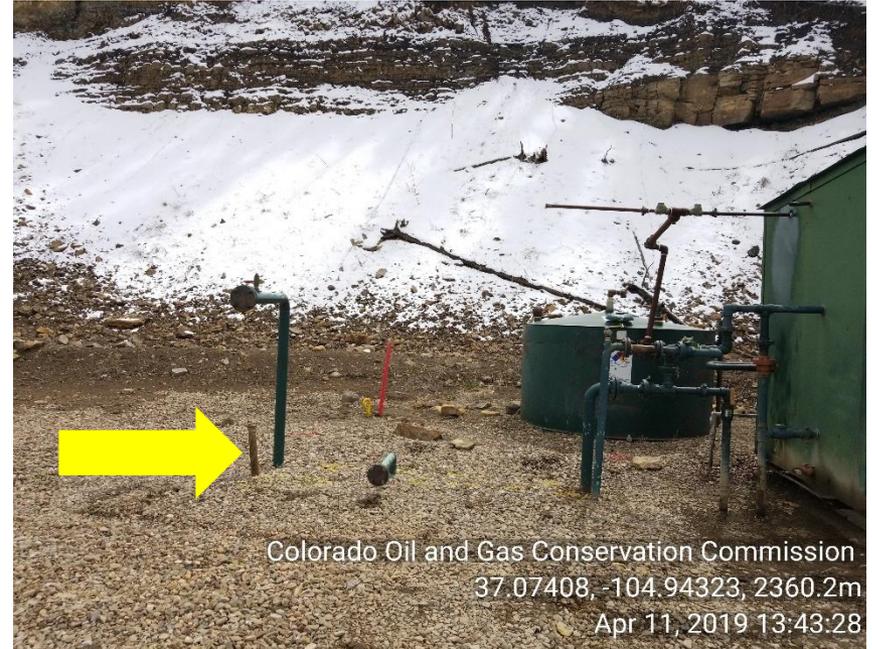
Photo 2 Unused, unmarked not LOTO risers

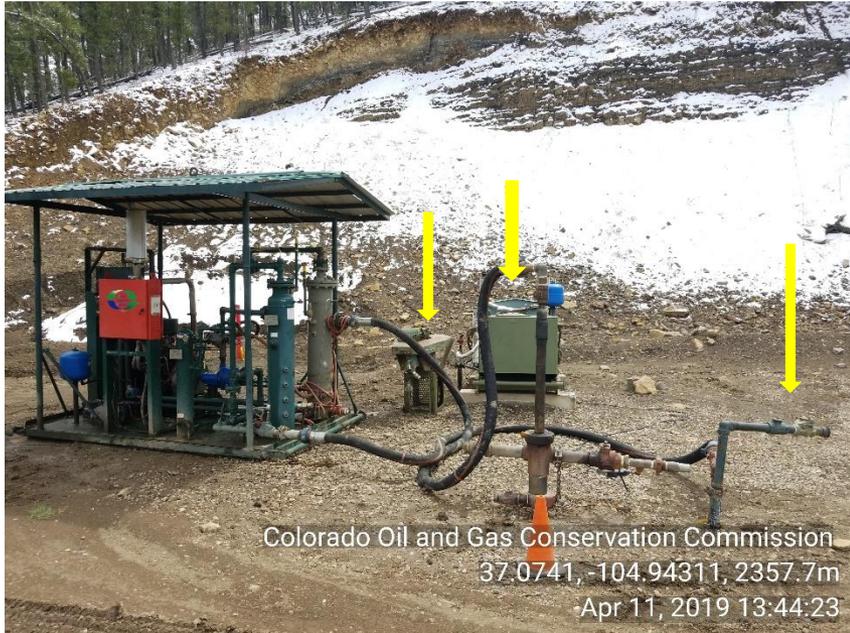
Photo 3 Liquid ring skid. Unused equipment (HYD skid, PC Drive). Unused, unmarked and not LOTO riser.

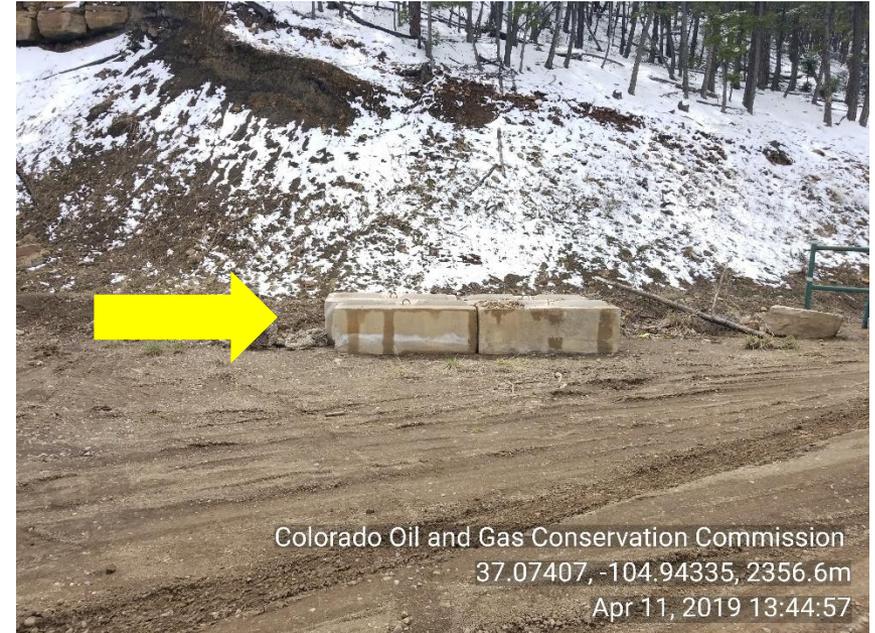
Photo 4 Unused equipment (cement blocks)

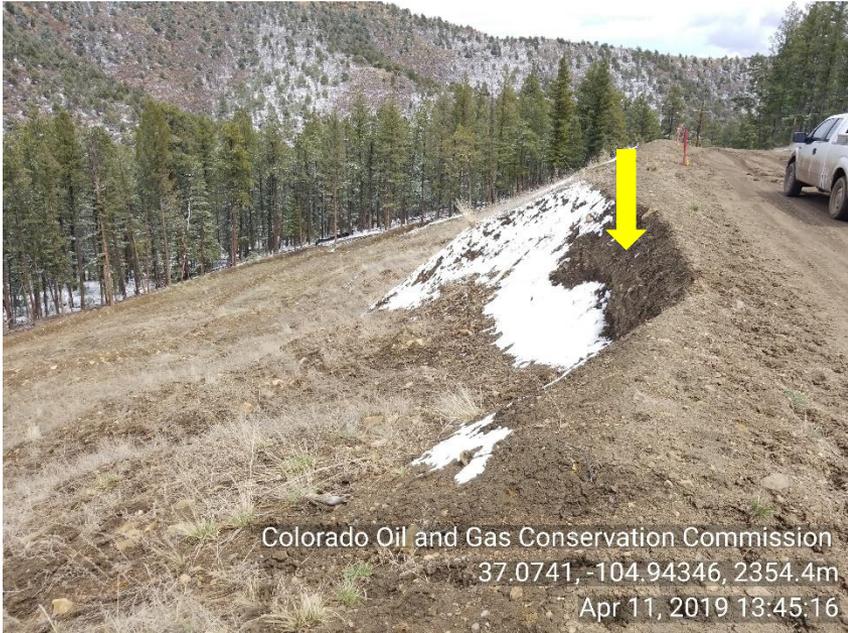
Photo 5 Storm water; location is eroding down hill side.

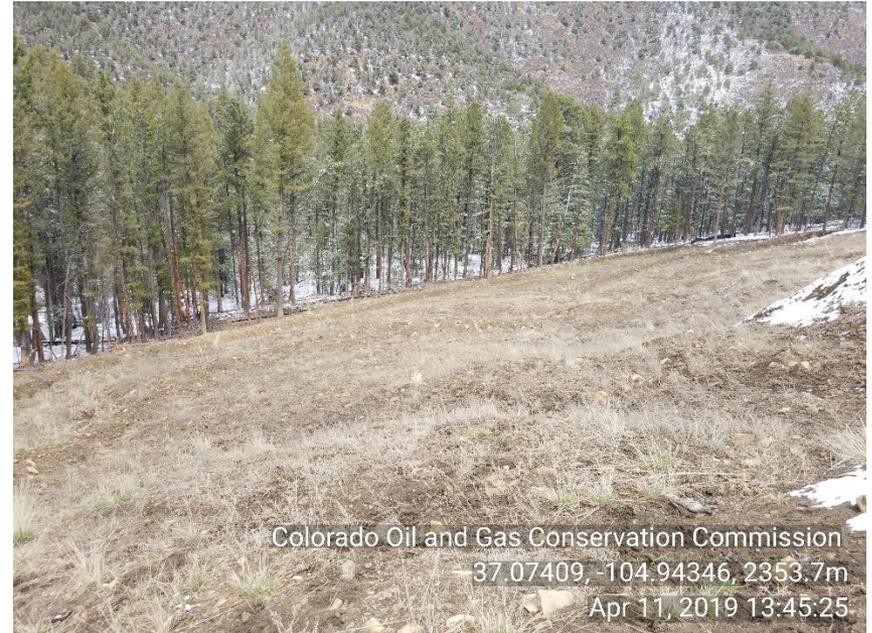
Photo 6 Berms around outer edge of fill side of location.

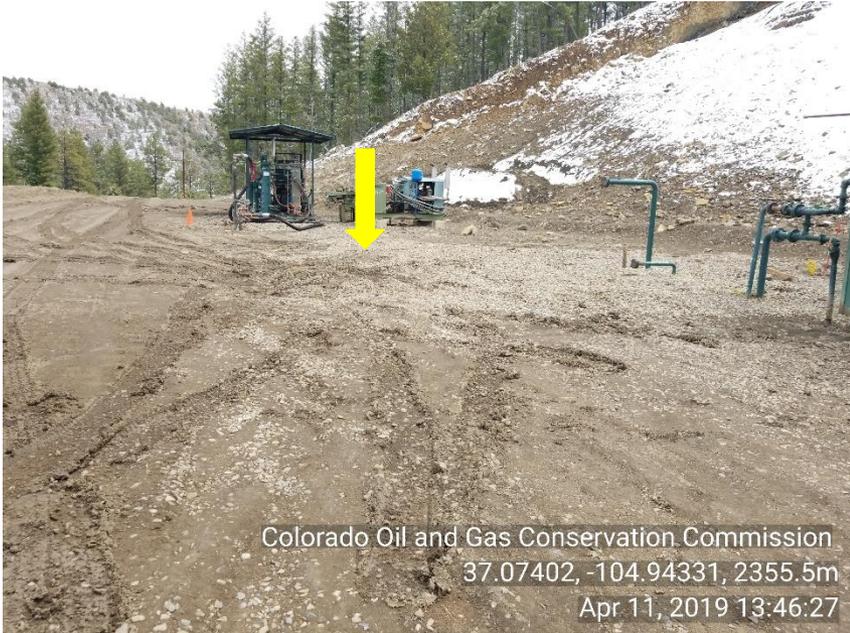
Photo 7 Storm water; Appears ditch line is settling deep ruts
