Inspection Photos
Location Name: GE# 17-14
Location ID: 308441

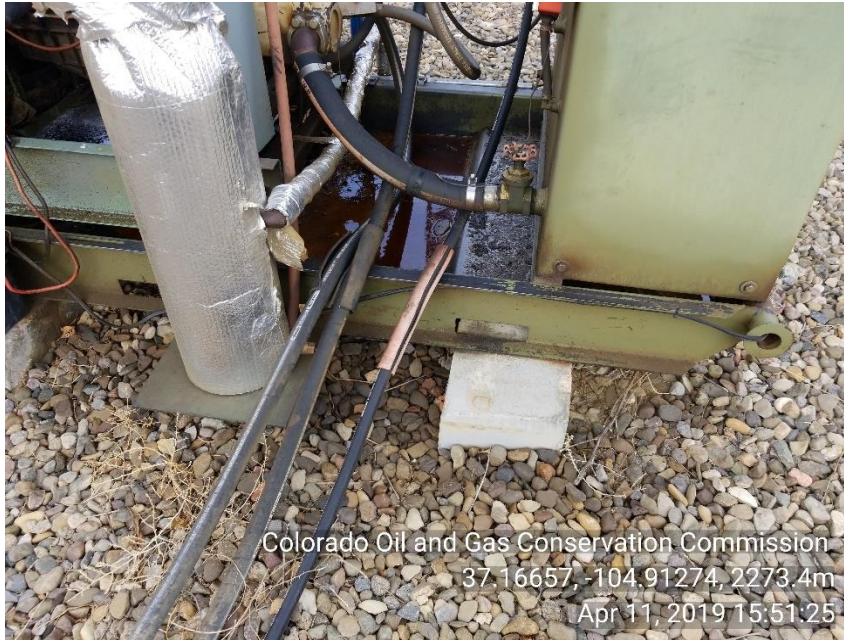
Photo 3 stained soil around HYD motor skid

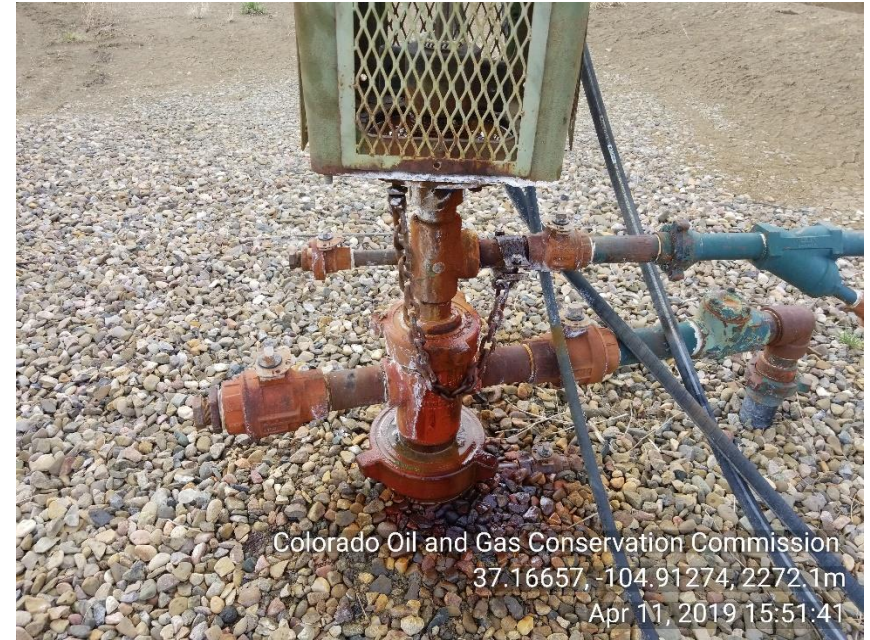
Photo 4 Mechanical issue packing leaking. Stained soil around WH
