Inspection Photos
Location Name: HR#29-14 and HR#29-14V
Location ID: 333804

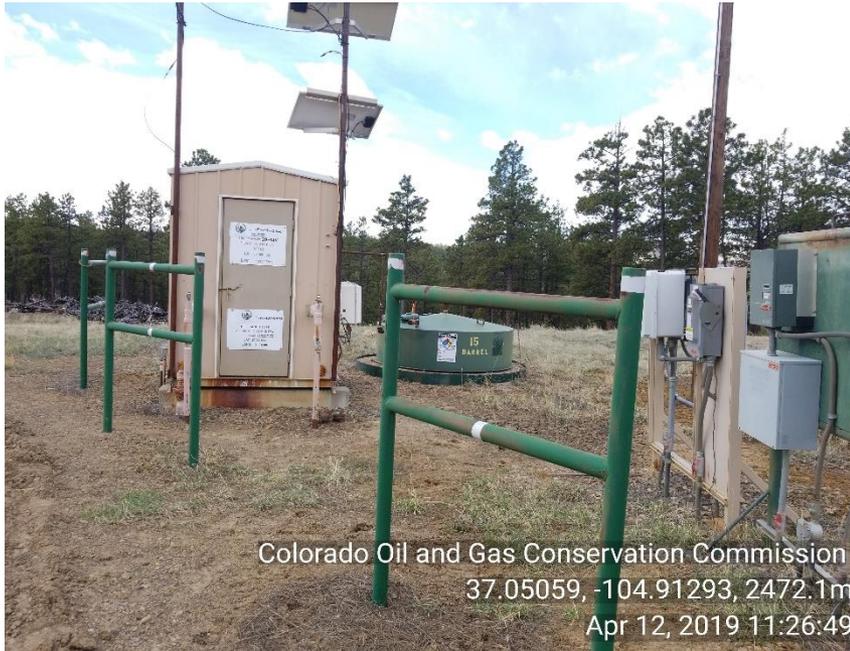
Photo 1 Duel Sep/meter house for HR#29-14 and HR#29-14V,15bbl produced water tank and electric panel.

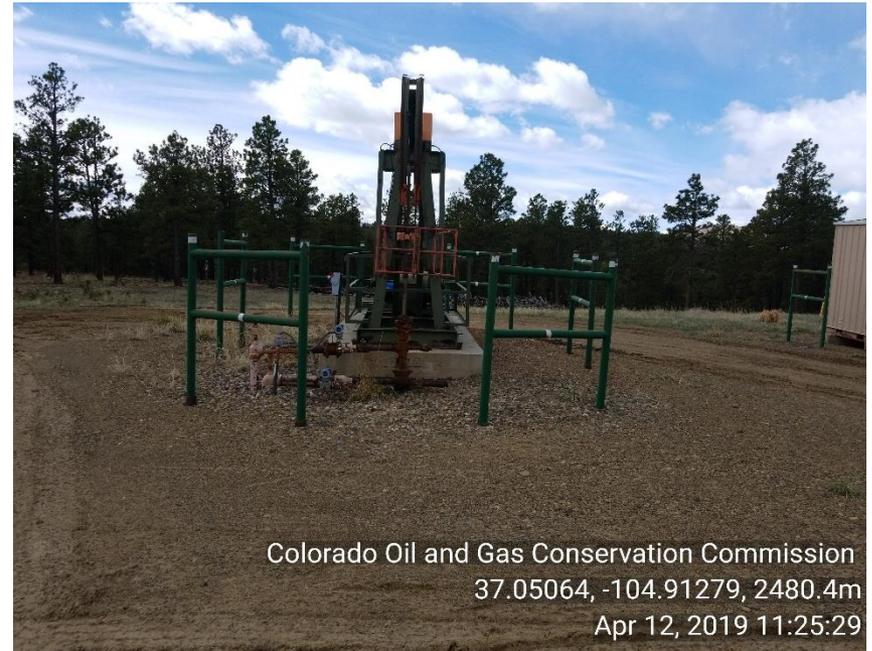
Photo 2 HR#29-14 PU

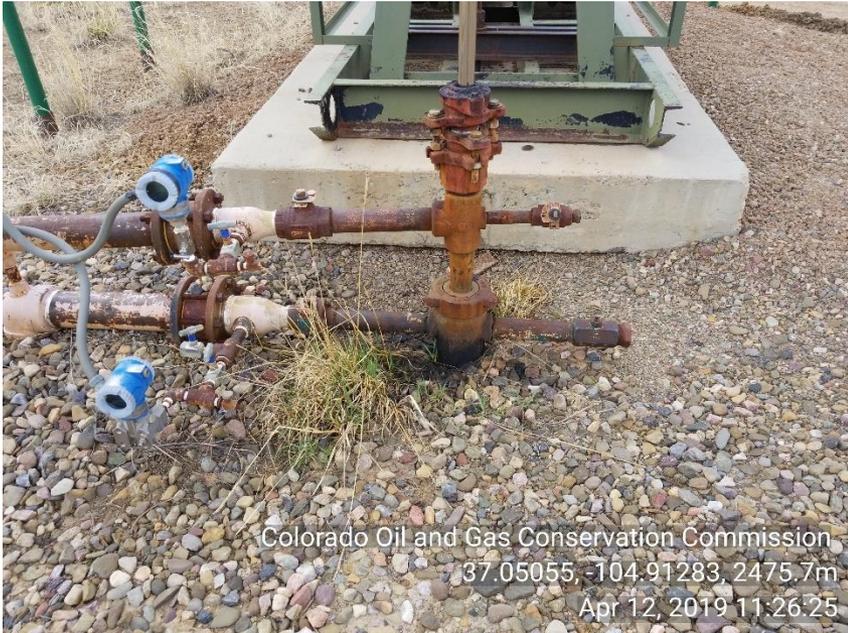
Photo 3 Stained soil around HR#29-14 WH.

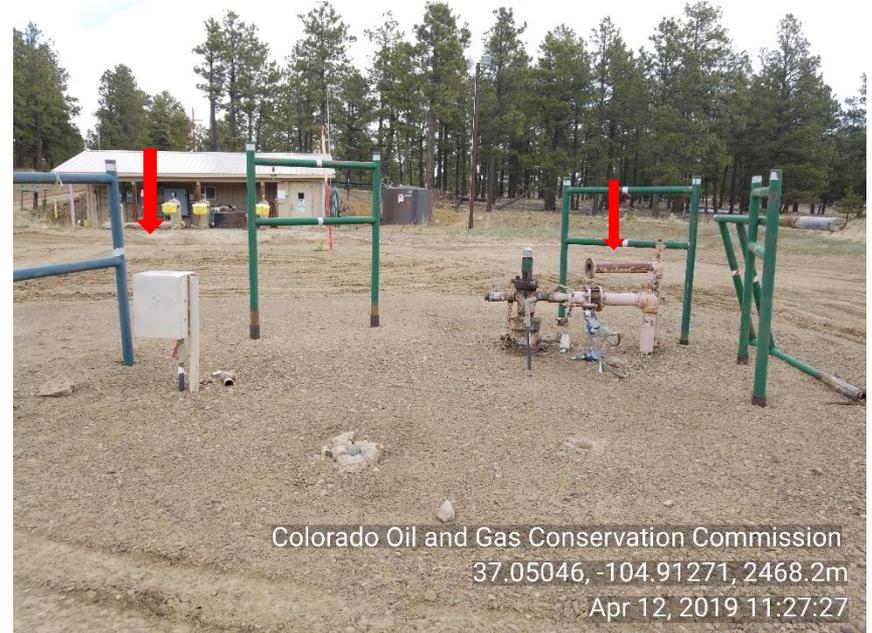
Photo 4 HR#29-14V WH. Unused, unmarked and not LOTO risers.

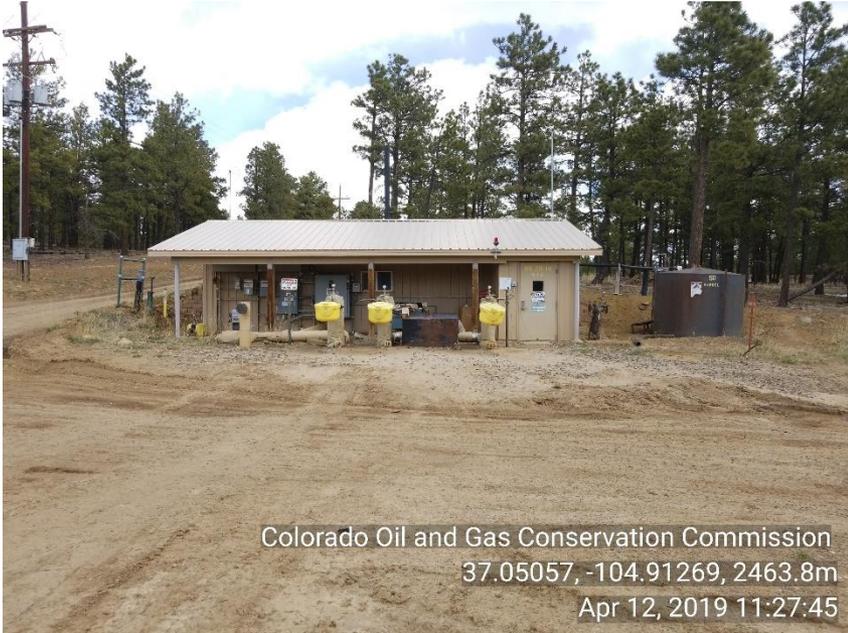
Photo 5 HR#29-14 Transfer station

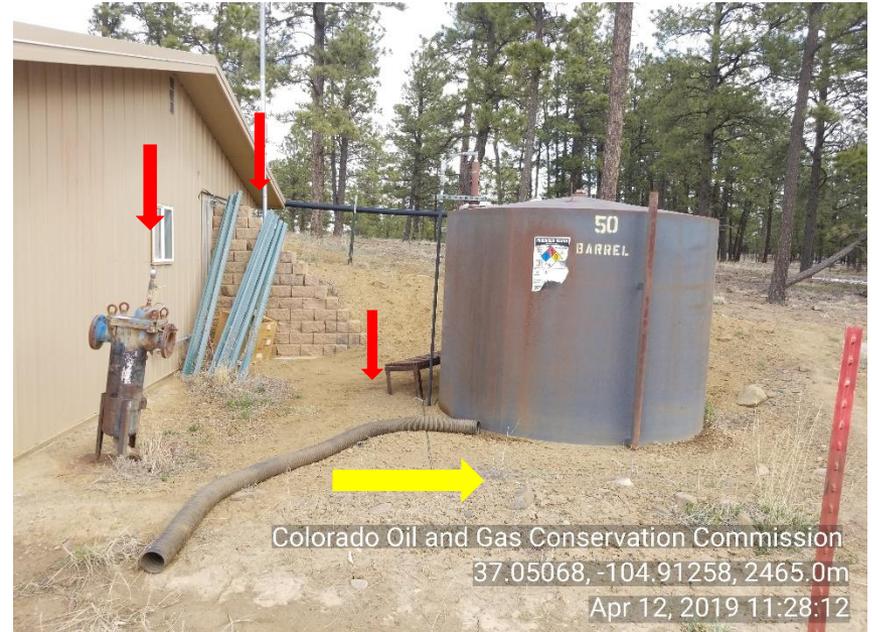
**Photo 6 Unused equipment Filter pot, hose and metal.
Inadequate berm around tank.**

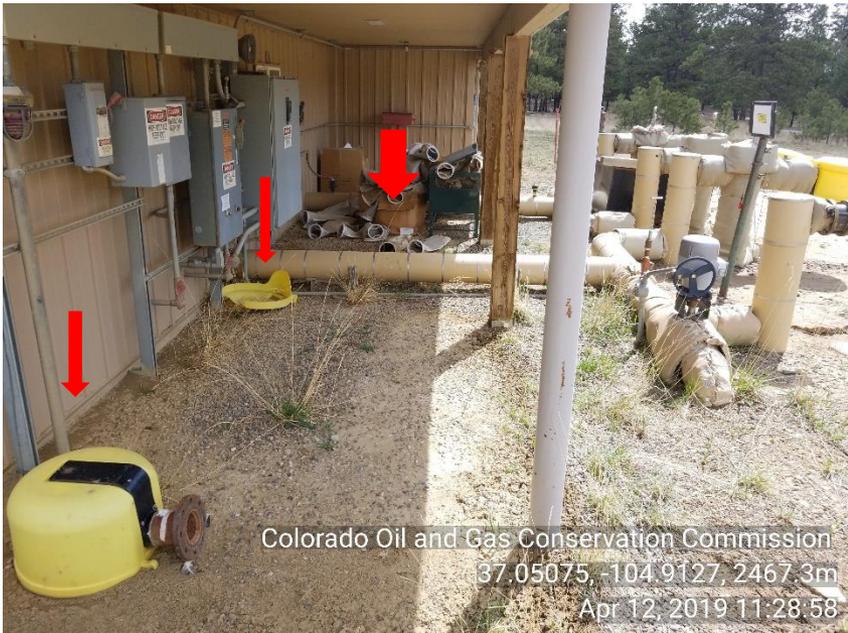
Photo 7 House Keeping What appears to be used filter pot filters laying on ground and unused unloading spill container.

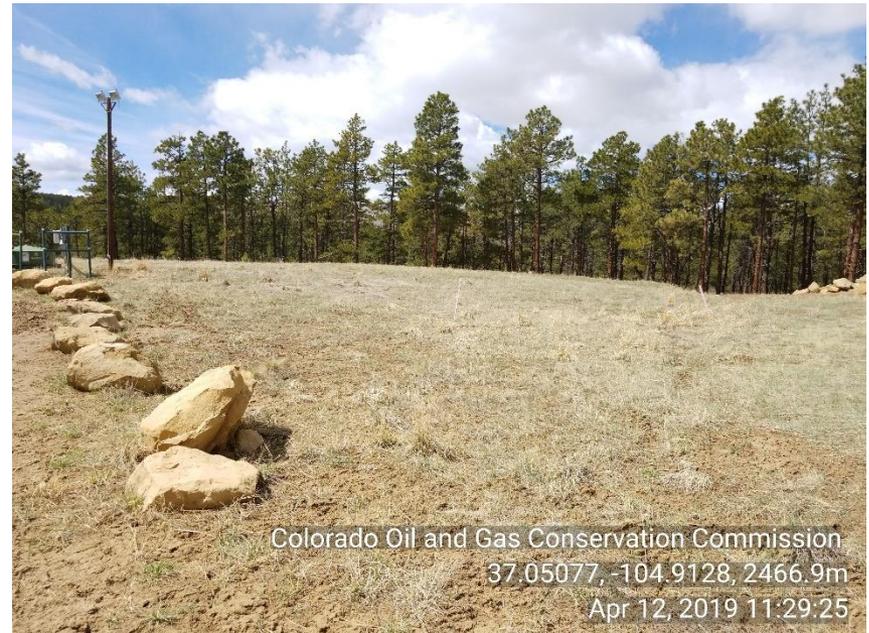
Photo 8 Reclaimed production pit.
