Location Name: APACHE CANYON 26-16V

API #: 05-071-07558

Insp. Doc. # 695100497

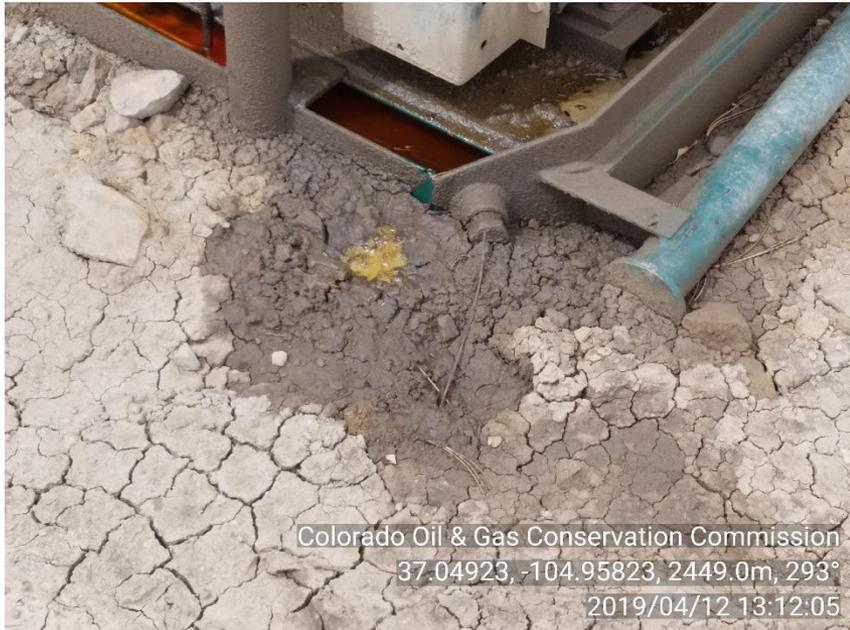
**PHOTO 3: THERE IS APP. 2' AREA OF IMPACTED SOIL ON SOUTHEAST CORNER OF COMPRESSOR SKID NEAR SKID DRAIN PLUG.**

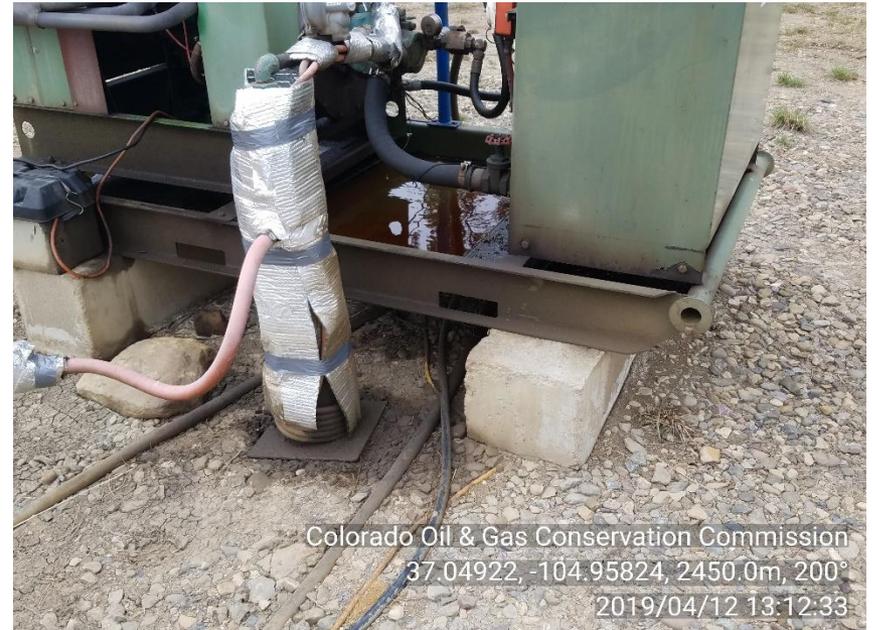
**PHOTO 4: THERE IS APP. 2' AREA ON IMPACTED SOIL AROUND BASE OF FUEL GAS SEPARATOR ON PRIME MOVER ENGINE SKID. ENGINE SKID HAS APP. 1' STANDING OIL IN SKID CONTAINMENT.**

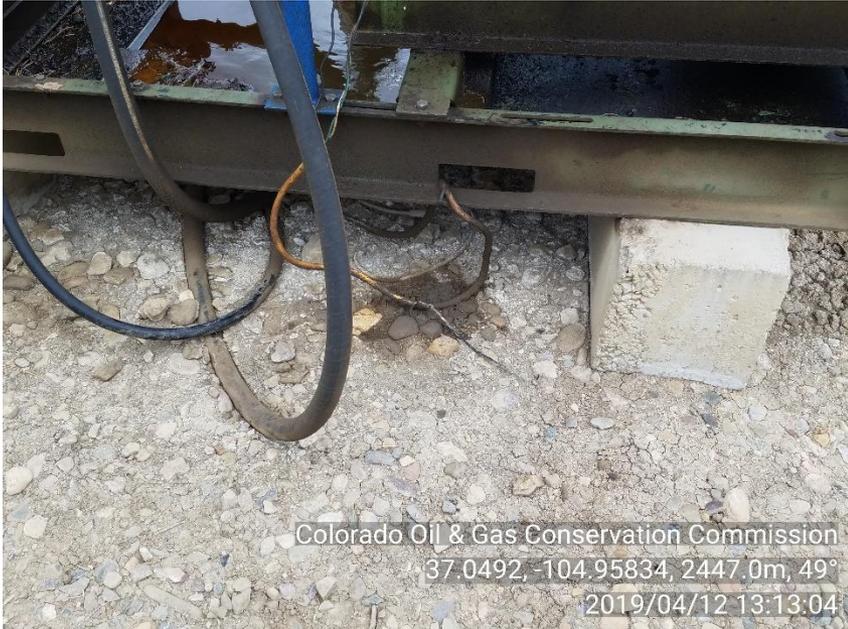
**PHOTO 5: APP. A 8" ROUND AREA OF IMPACTED SOIL ON WEST END OF PRIME MOVER ENGINE SKID.**
