# Inspection Photos

Operator: D90 ENERGY LLC # 10706

Location ID: 451812

Inspection Doc. Number: 682504729

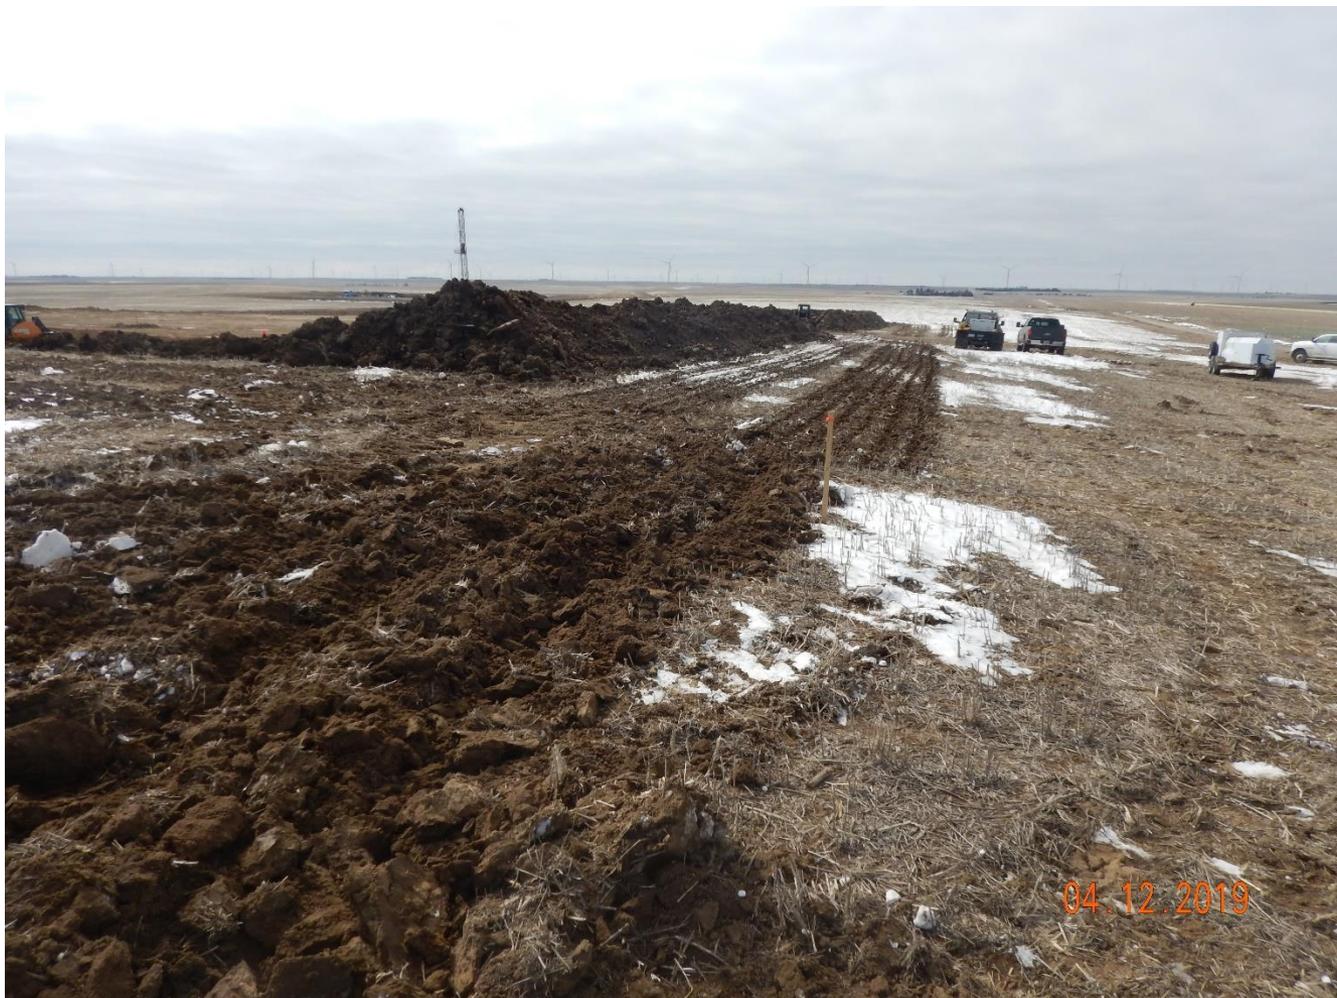
**Photo 1:** Photo taken from the northwest corner of the disturbance area, facing south. Photo shows construction in process. Photo also shows operator has installed two (2) separate rows of surface roughening along perimeter of the location.

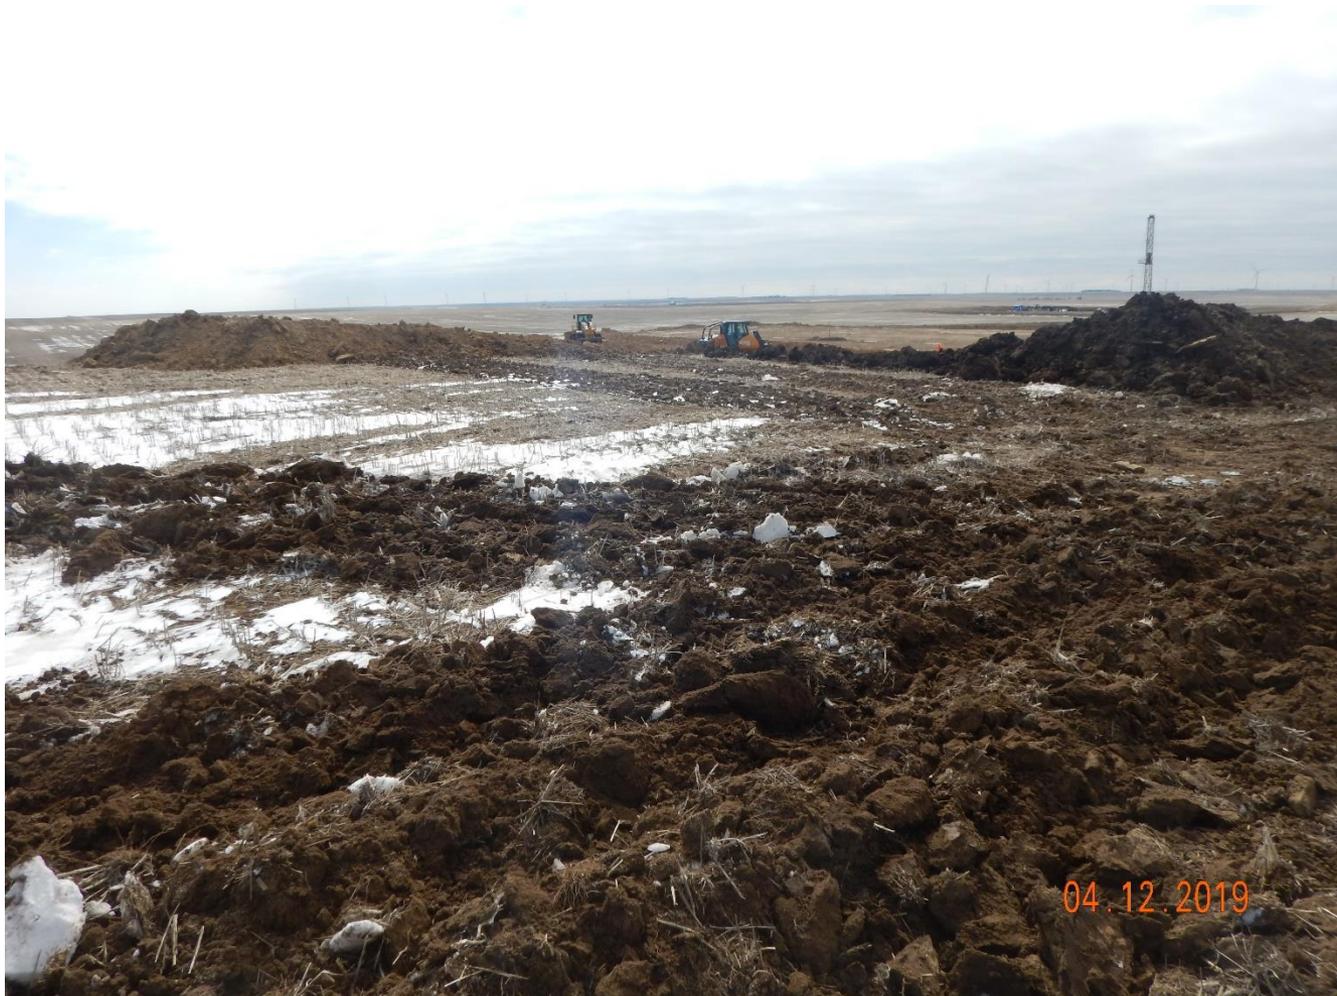
**Photo 2:** Photo taken from the northwest corner of the disturbance area, facing southeast. Photo shows construction in process. Photo also shows operator has installed two (2) separate rows of surface roughening along perimeter of the location.

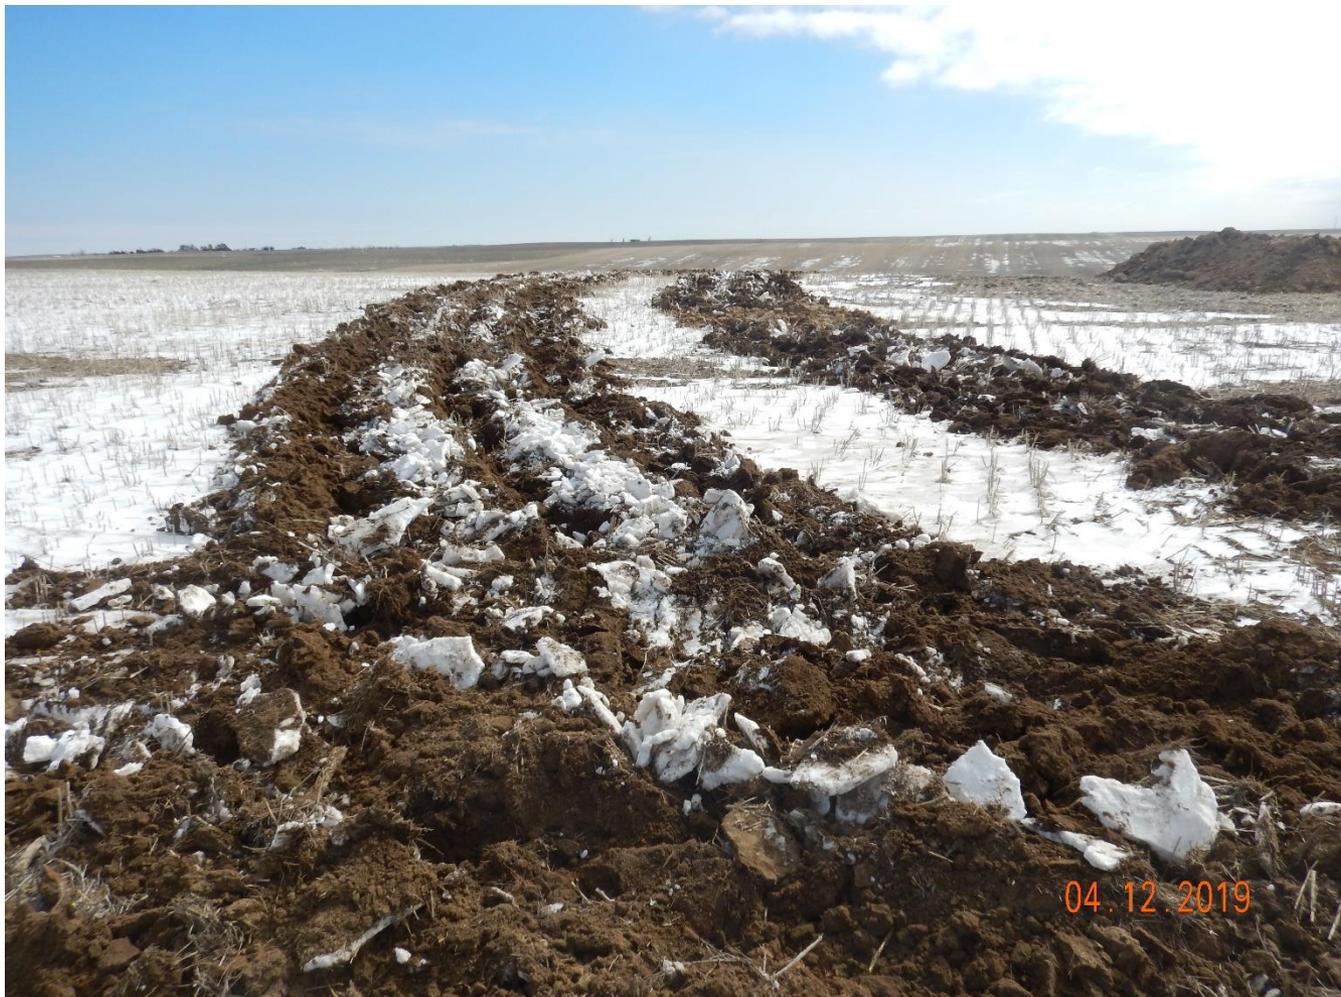
**Photo 3:** Photo taken from the northwest corner of the disturbance area, facing south. Photo shows construction in process. Photo also shows operator has installed two (2) separate rows of surface roughening along perimeter of the location.

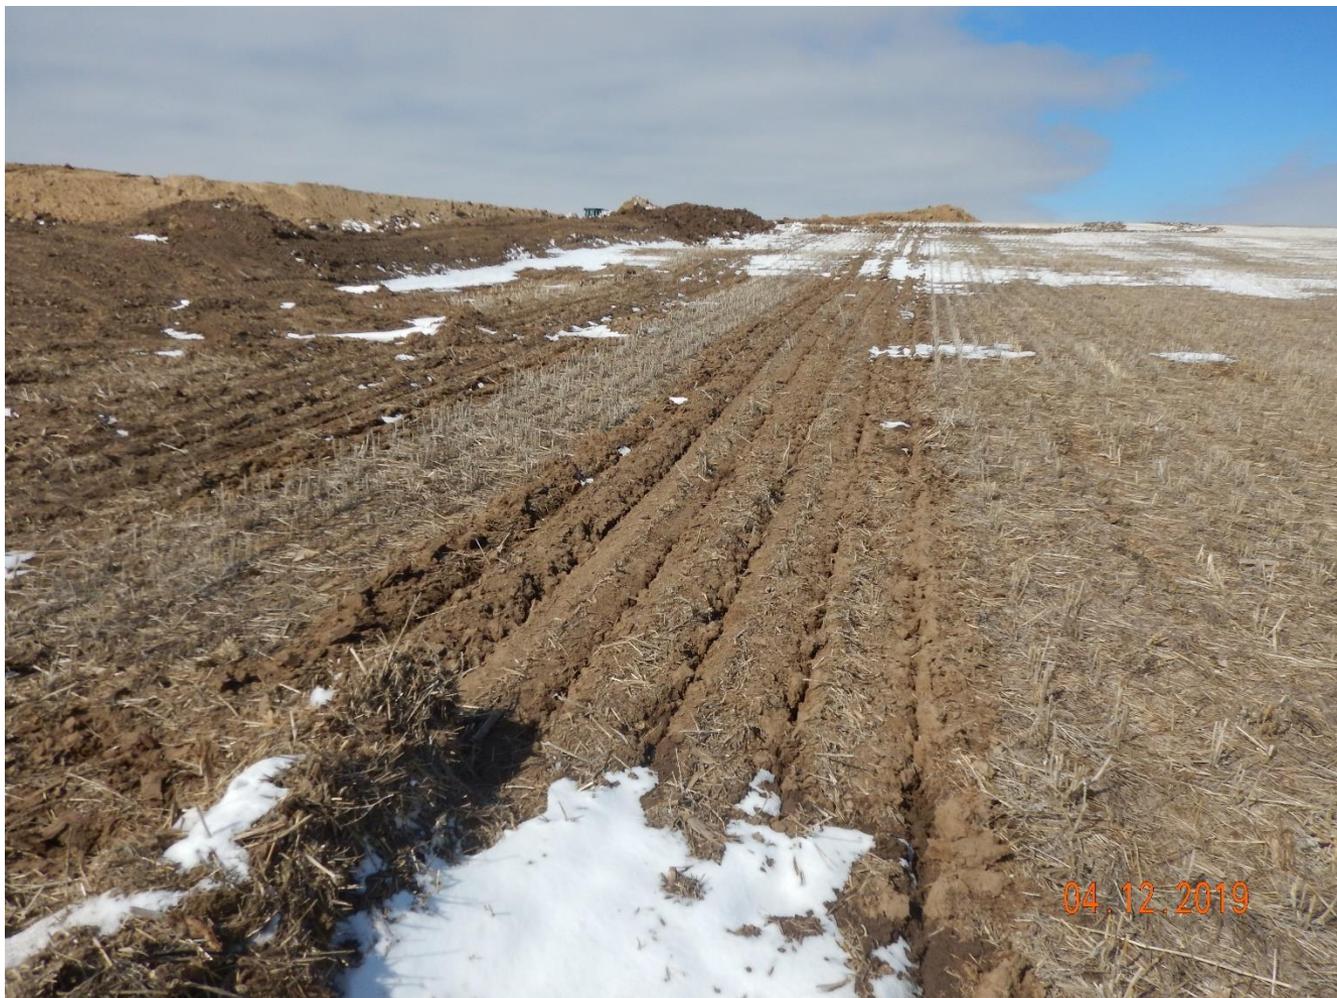
**Photo 4:** Photos taken from the northwest corner of the disturbance area, facing south. Photo shows area of the location where surface roughening has been installed with the slope, rather than along the contour of the slopes. This is not good engineering practices.

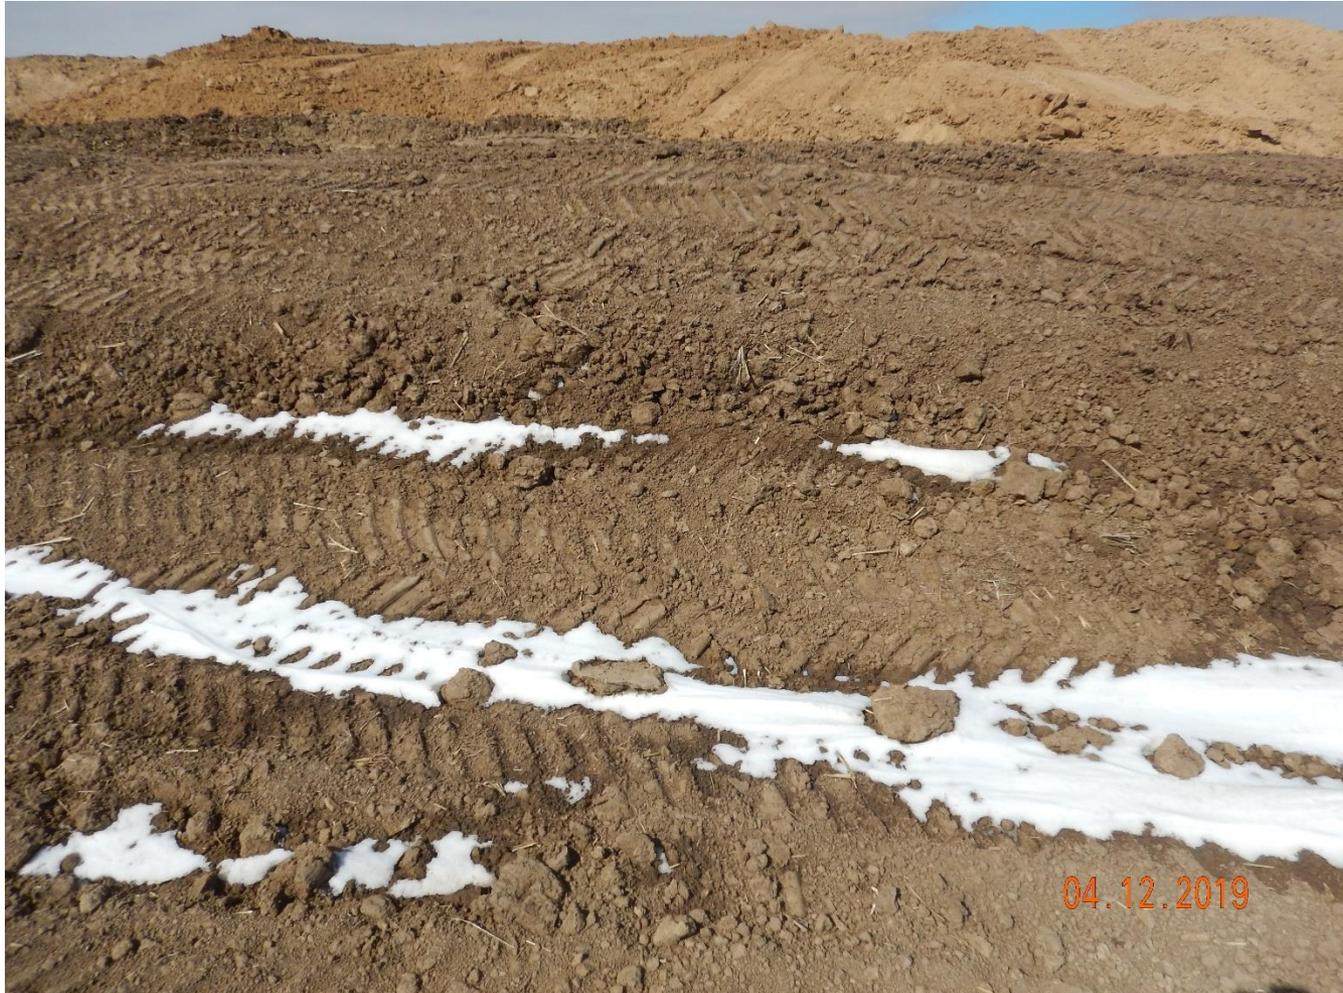
**Photo 5:** Photos taken from the topsoil berm on the east end of the location. Photo shows tracking has not been installed perpendicular to the slope. This is not good engineering practices. Additionally, due to evident vehicle use on berm, compaction concerns are becoming evident.
