**Inspection Photos**  
**Operator: Enervest Operating**  
**Location/API #: 067-05192**  
**Date: 4-9-2019**

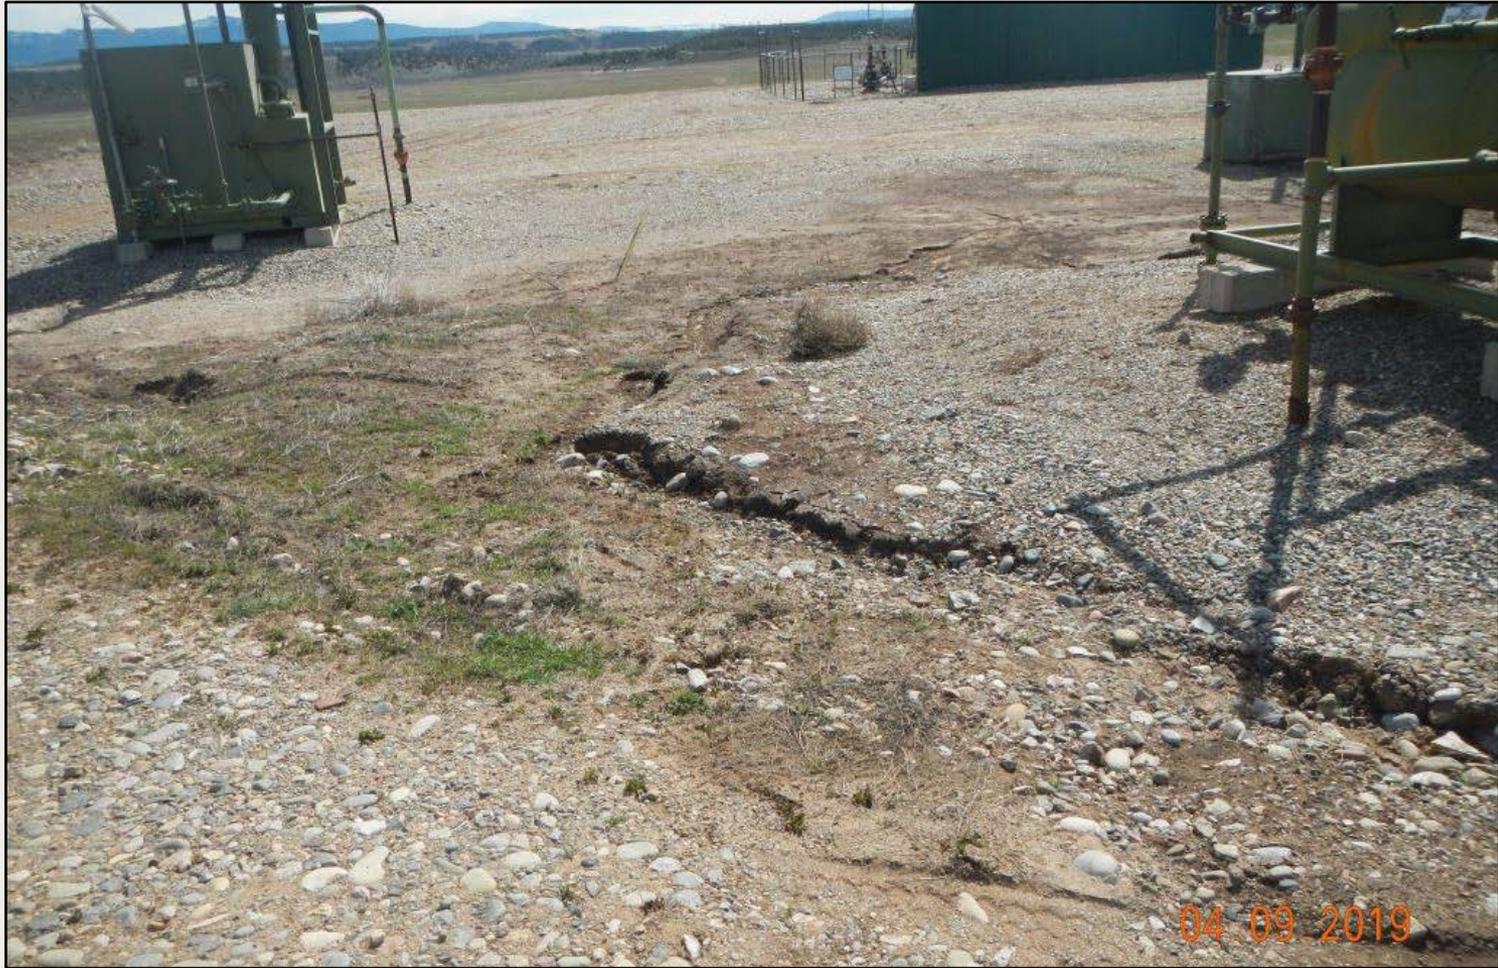
Photo 1. View of an erosional channel forming around project facilities within the western project area.

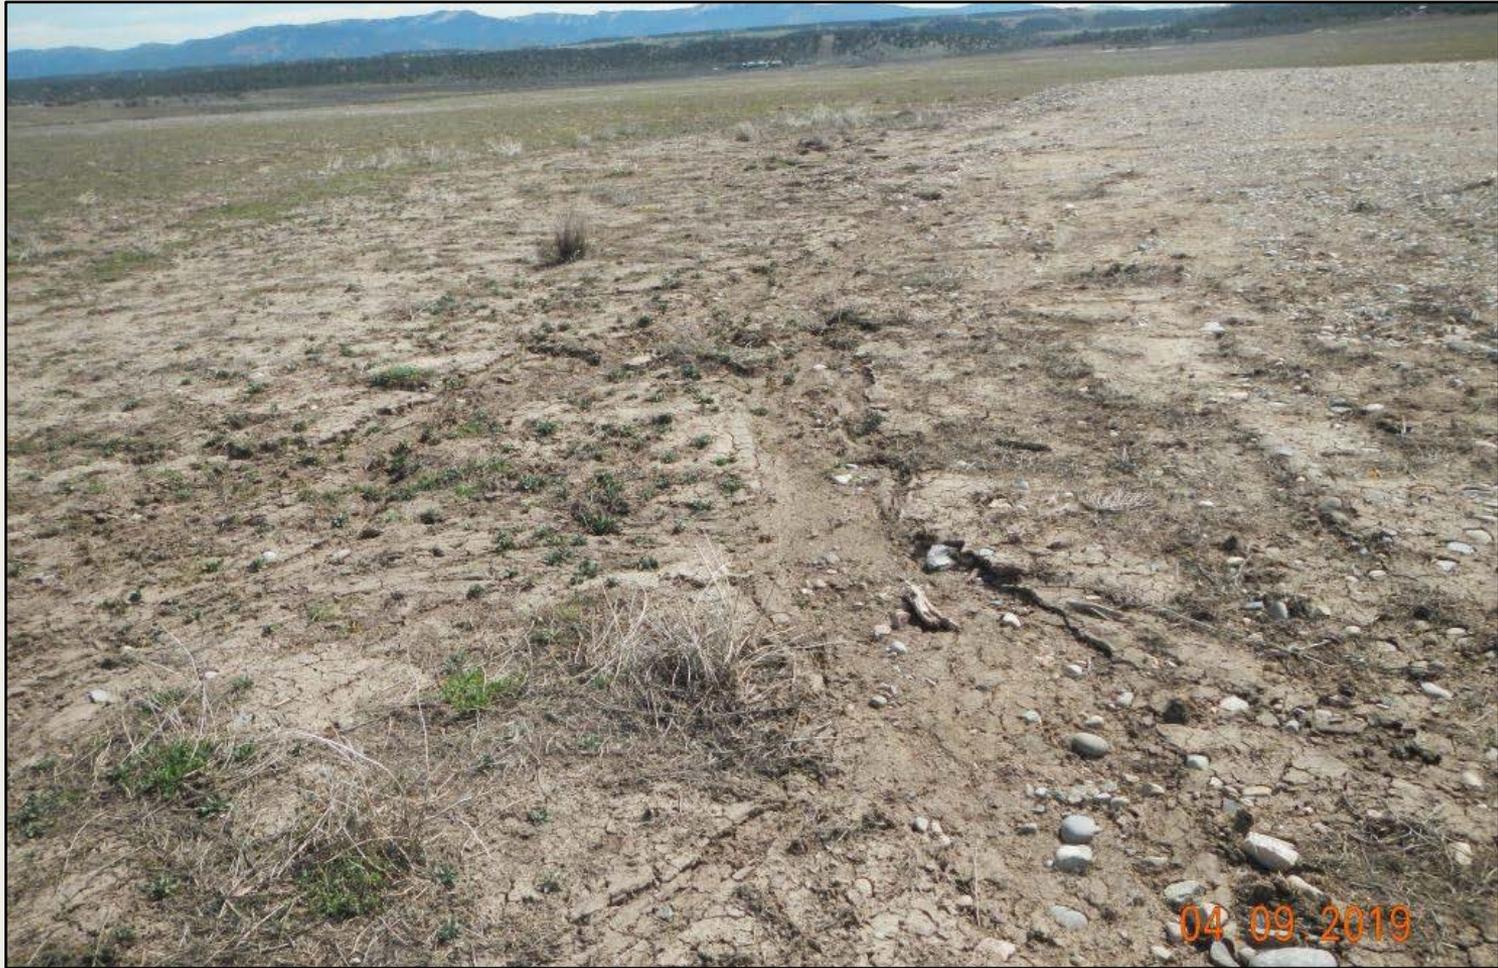
Photo 2. View of erosional channeling and sediment deposition along the northern edge of the working area.

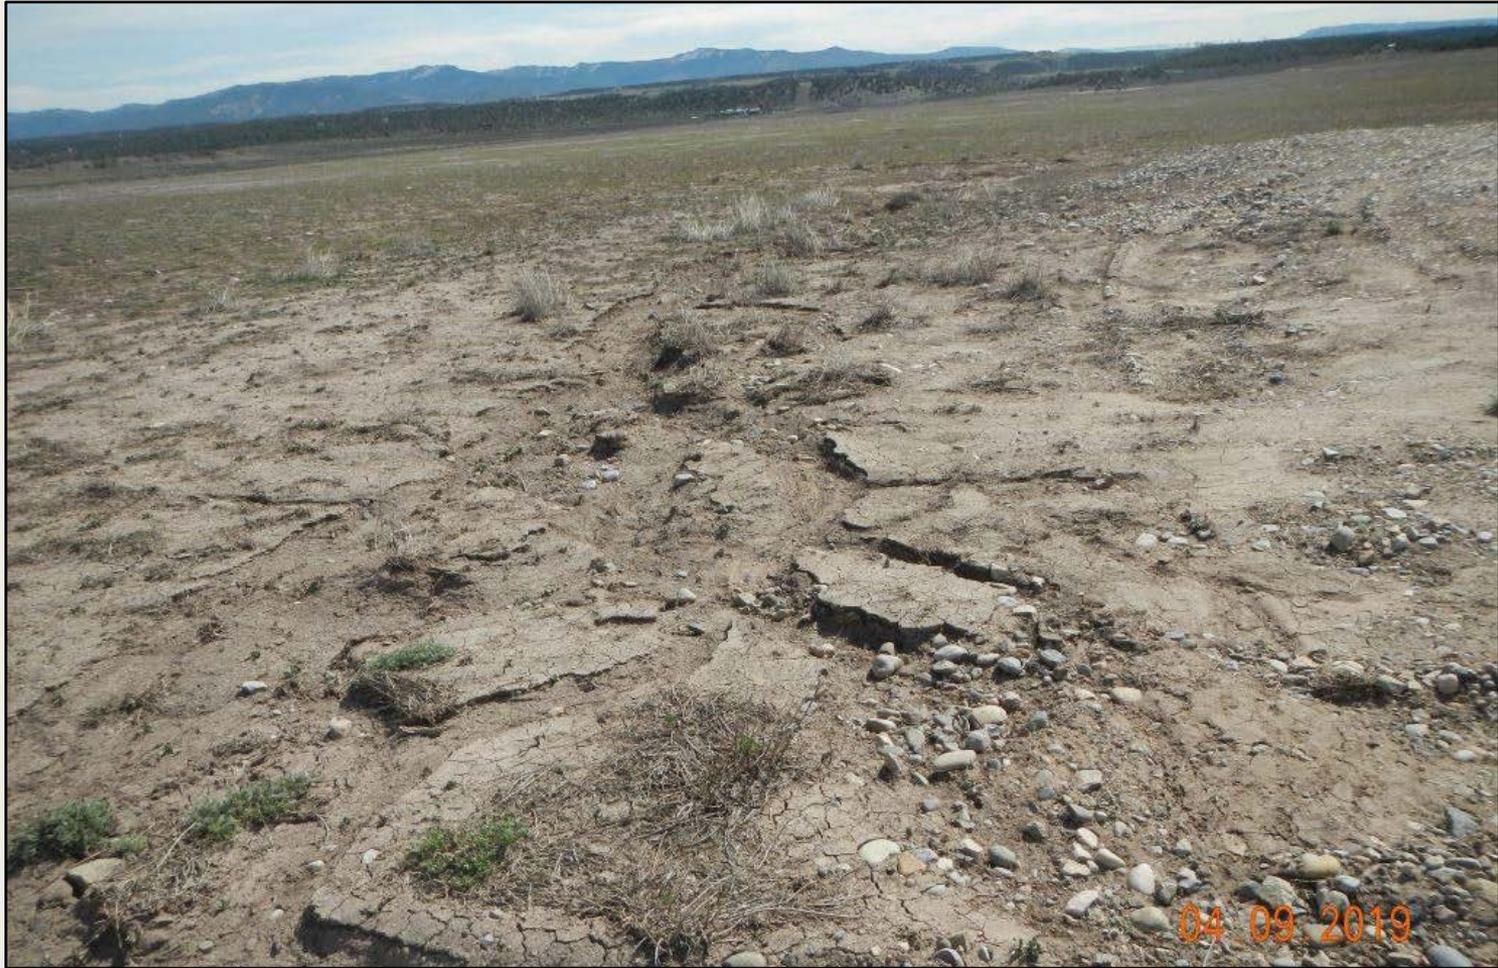
Photo 3. View of erosional channeling within the northeastern project area.

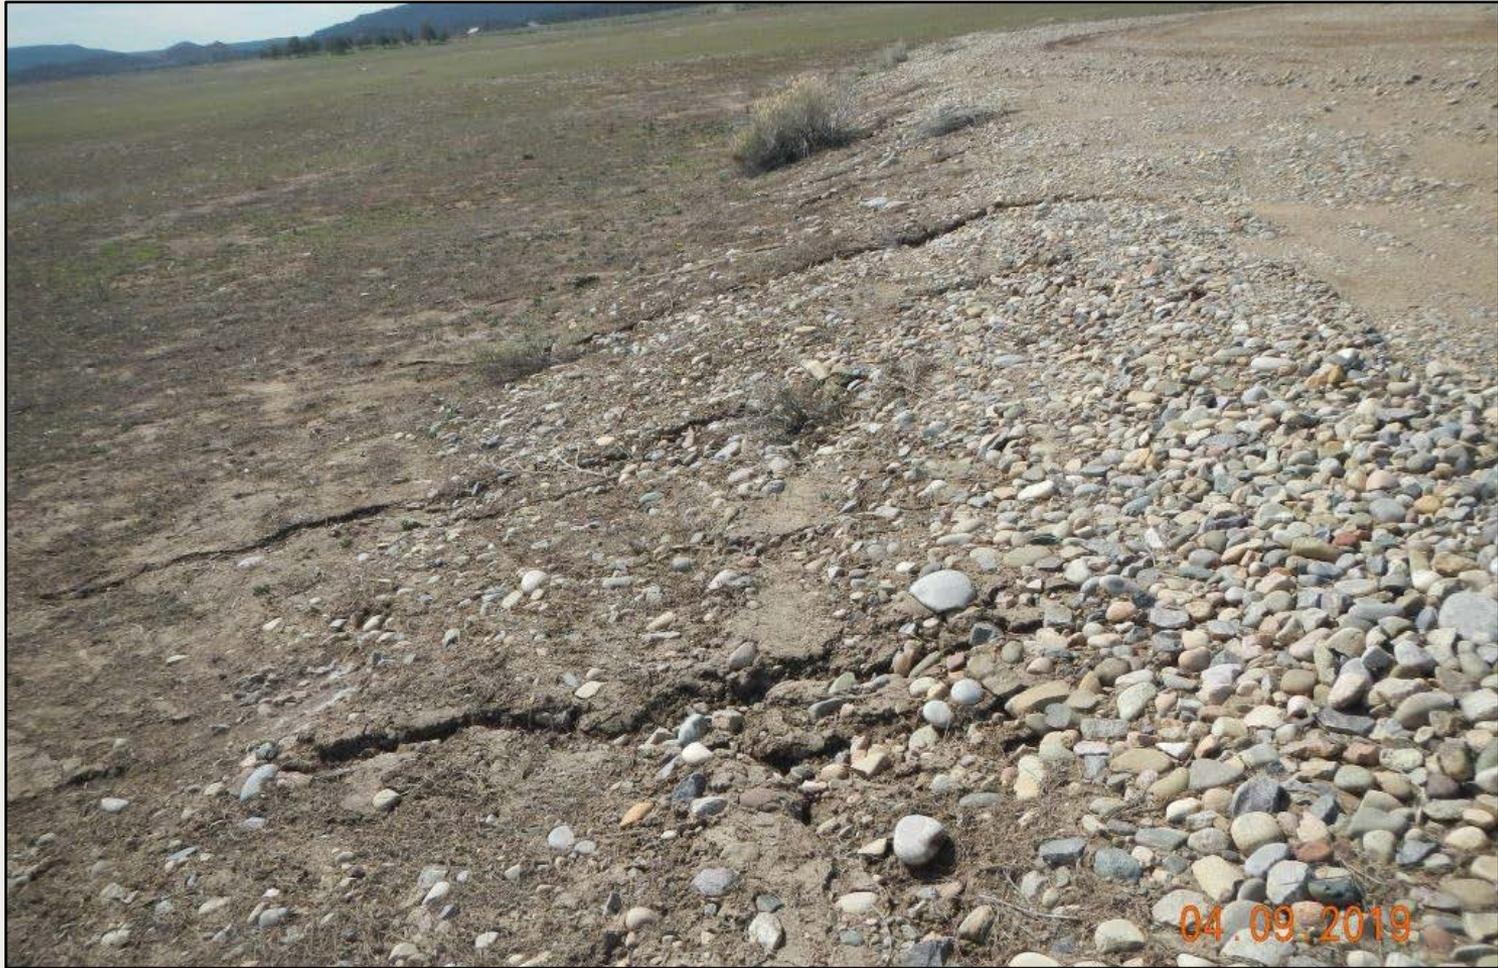
Photo 4. View of erosional rilling within the eastern project area.

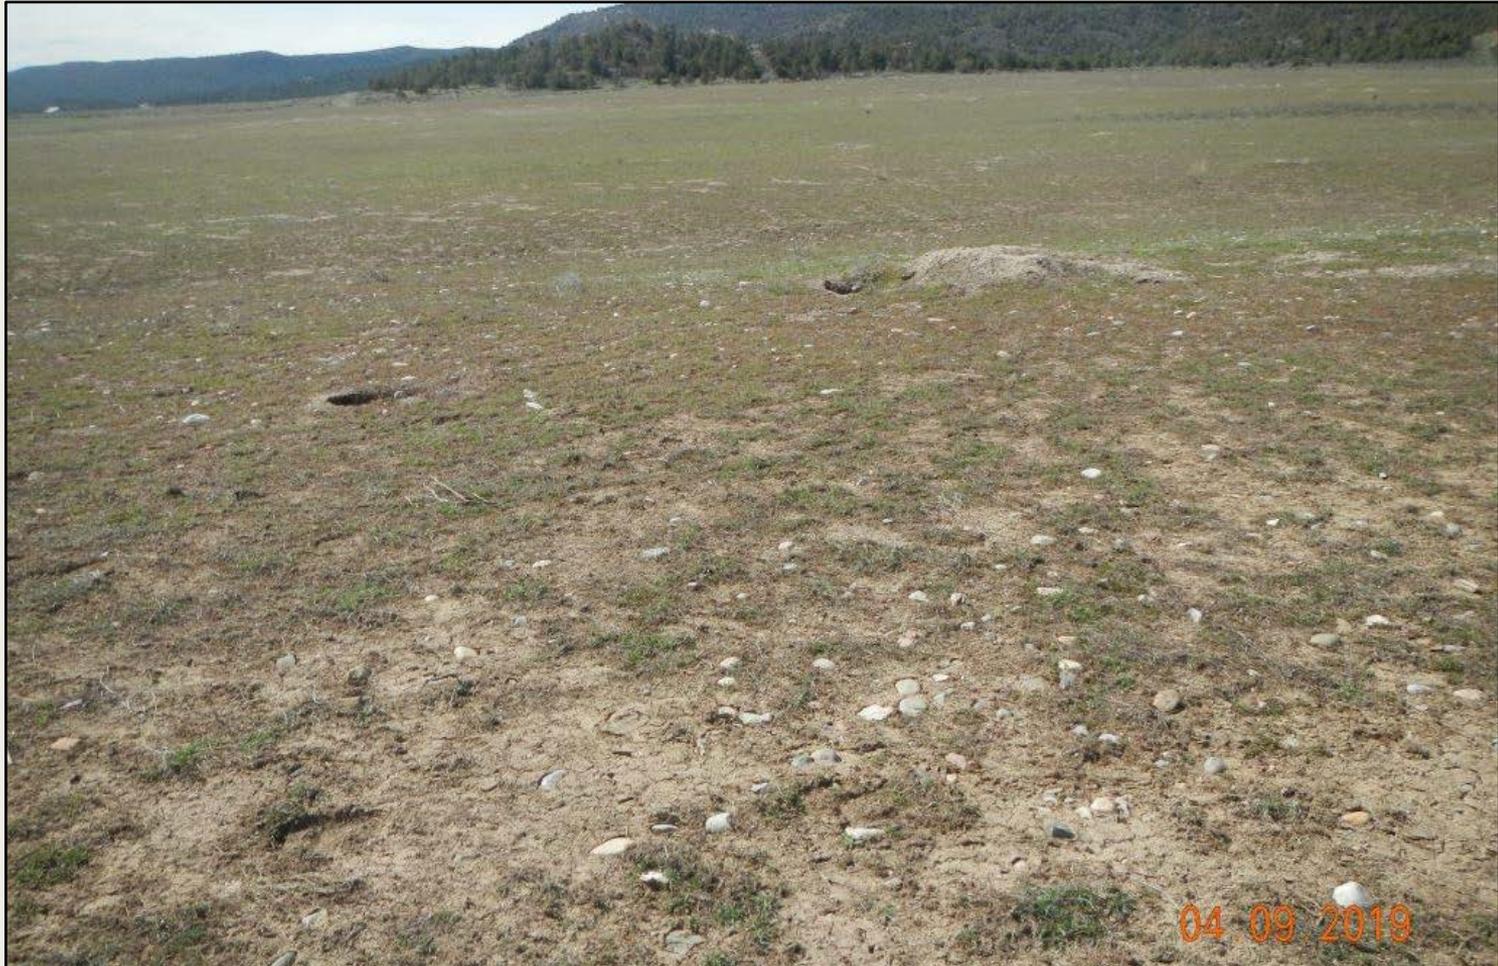
Photo 5. View of condition of reference area at this time.
