Inspection Photos
Operator: BP America
Location/API #: 067-06295
Date: 4-9-2019

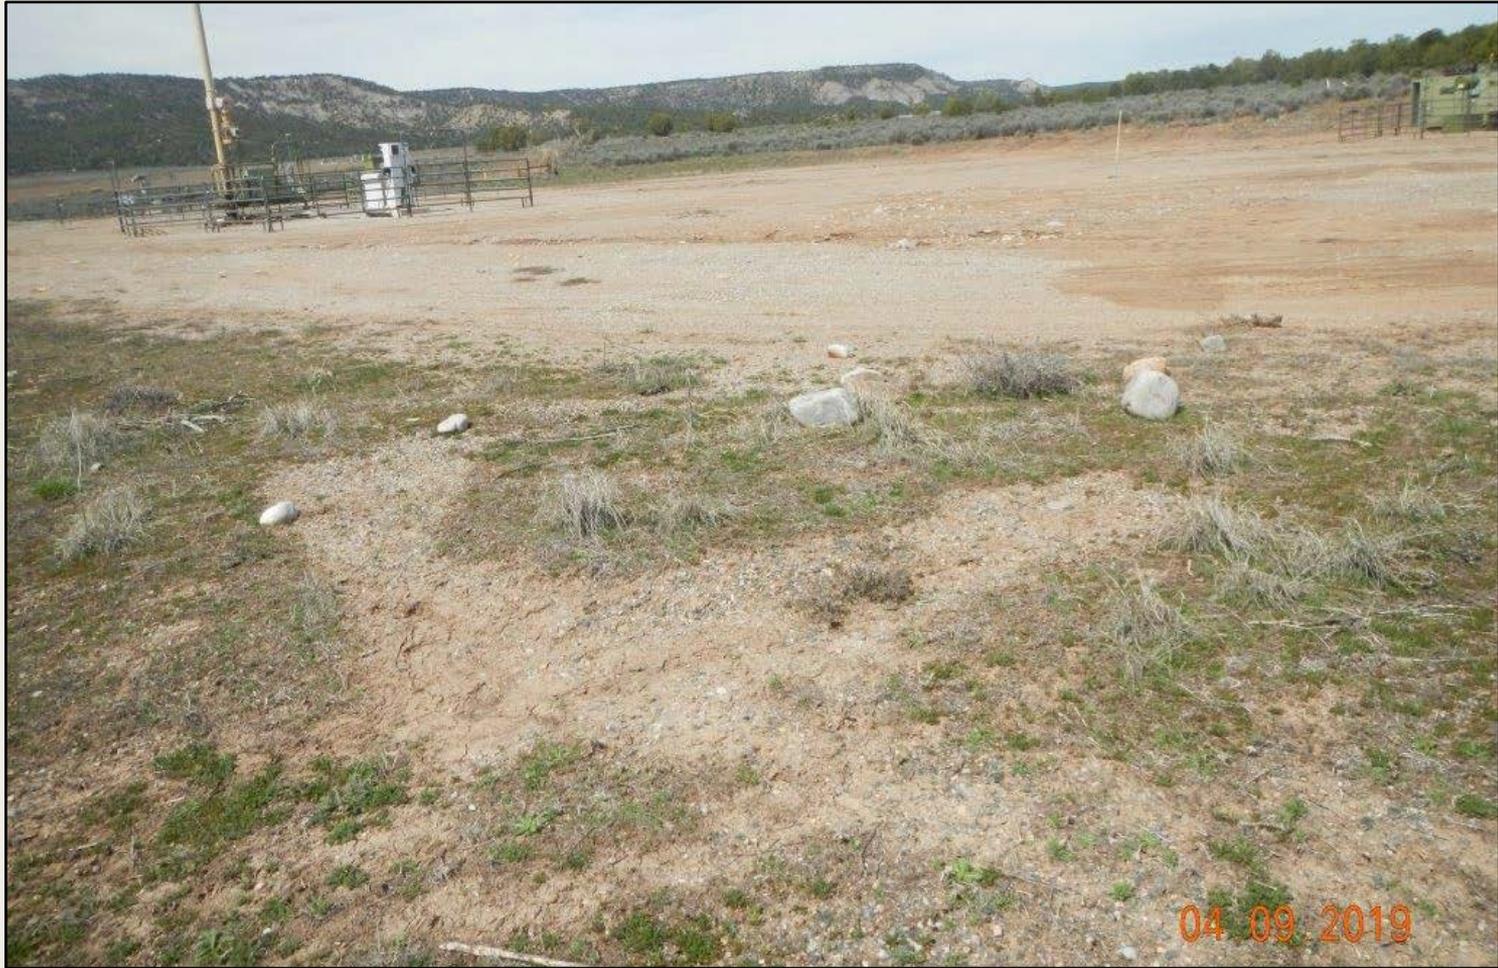
Photo 1. View of the project area from the southeastern corner facing center.

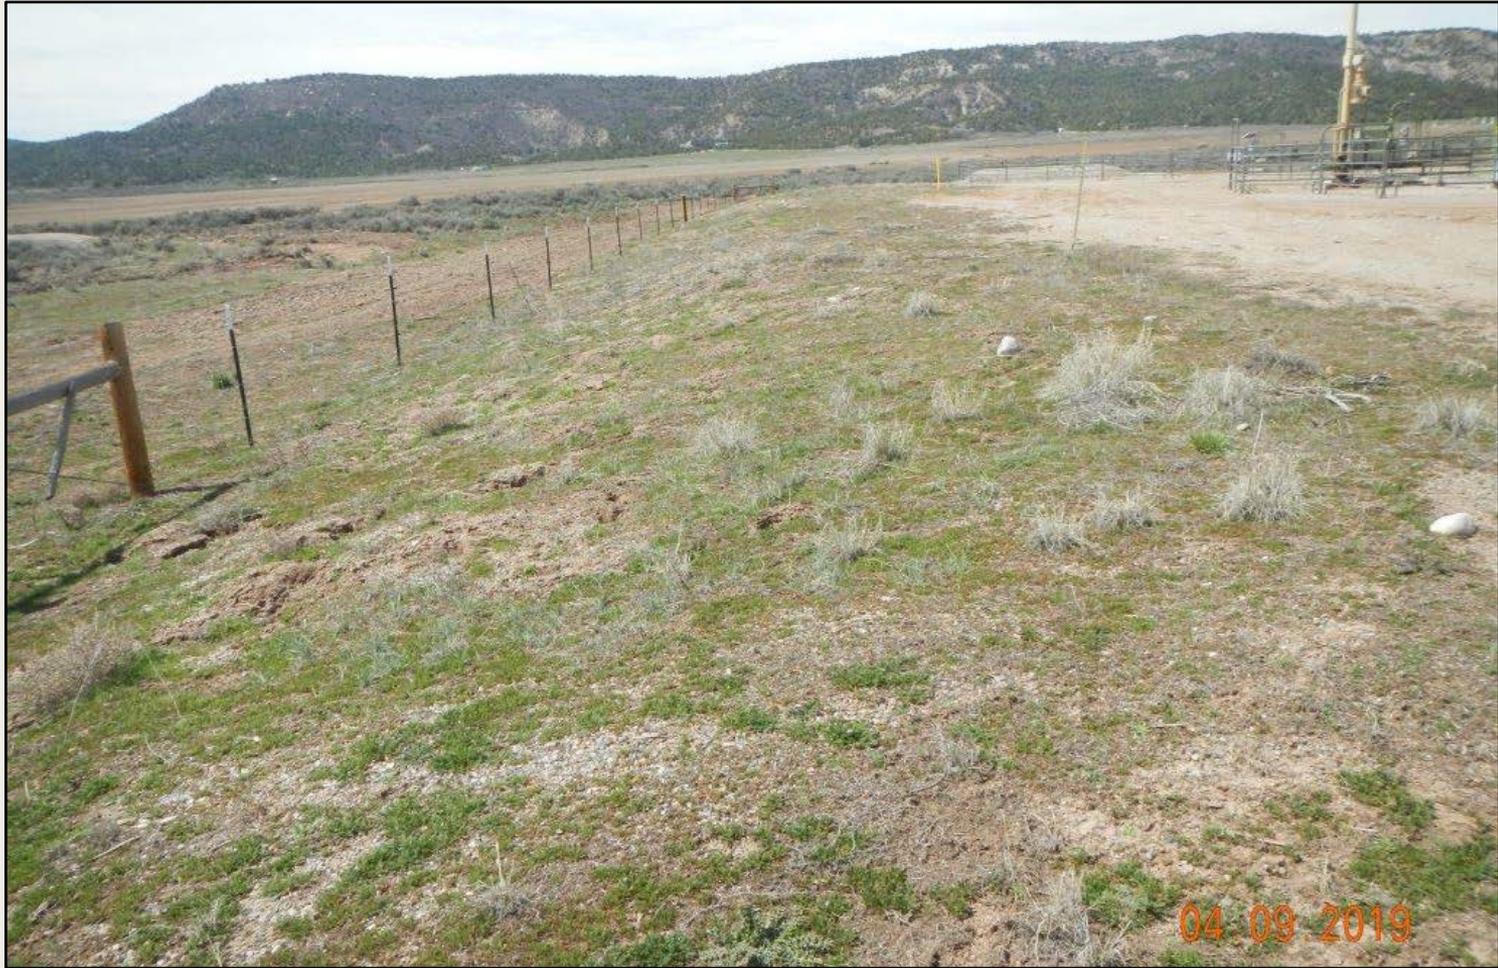
Photo 2. View of the southern project area from the southeastern corner facing westward.

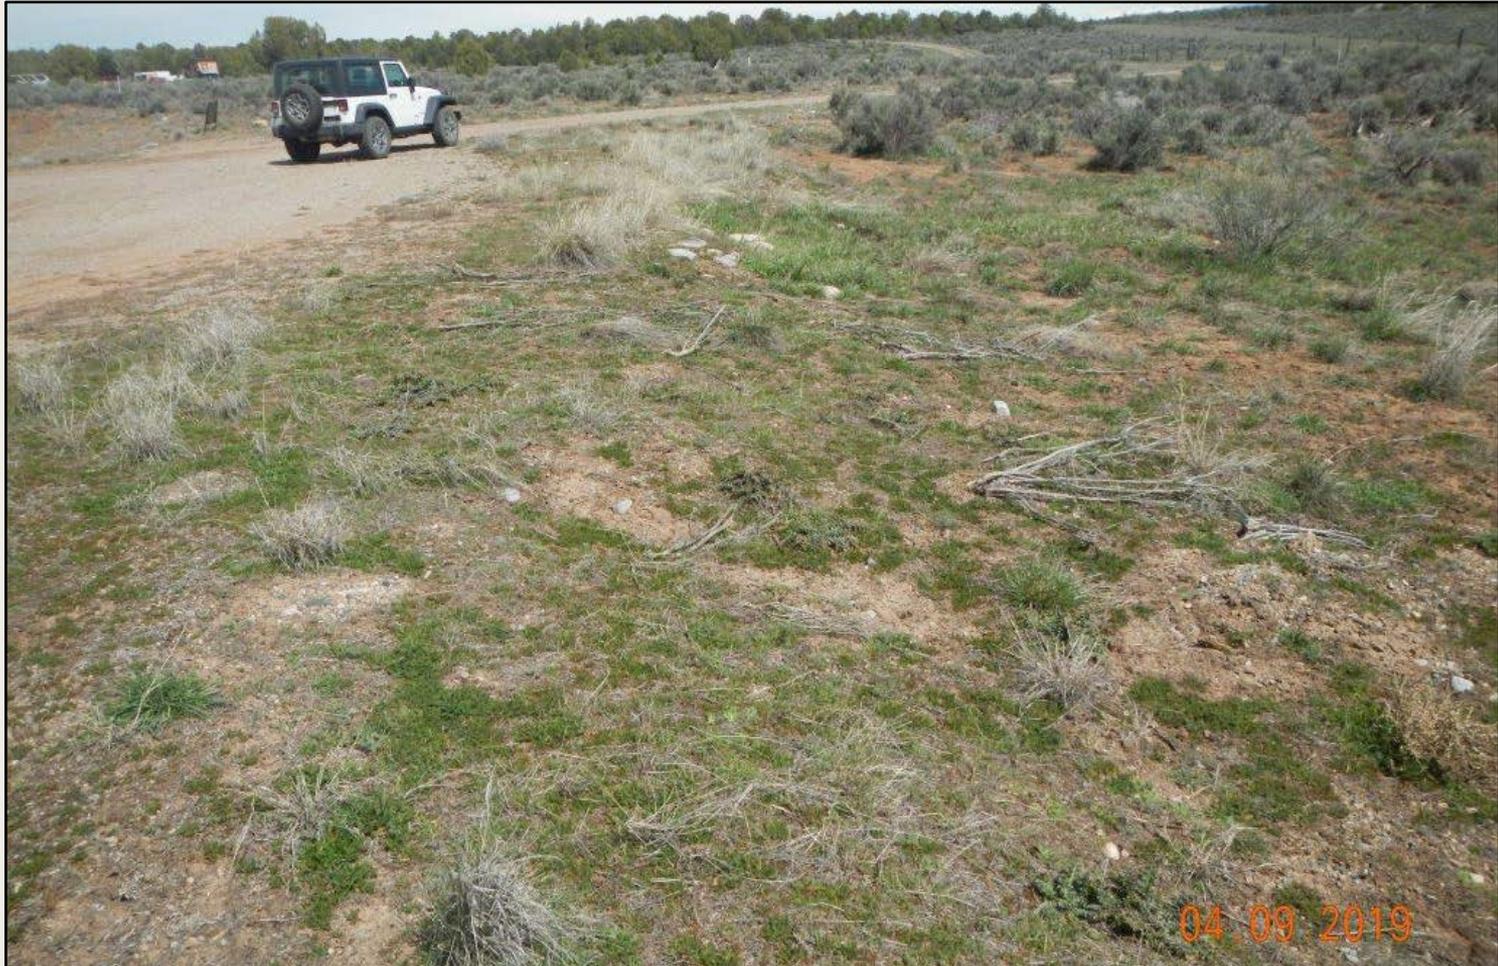
Photo 3. View of the eastern project area from the southeastern corner facing northward.

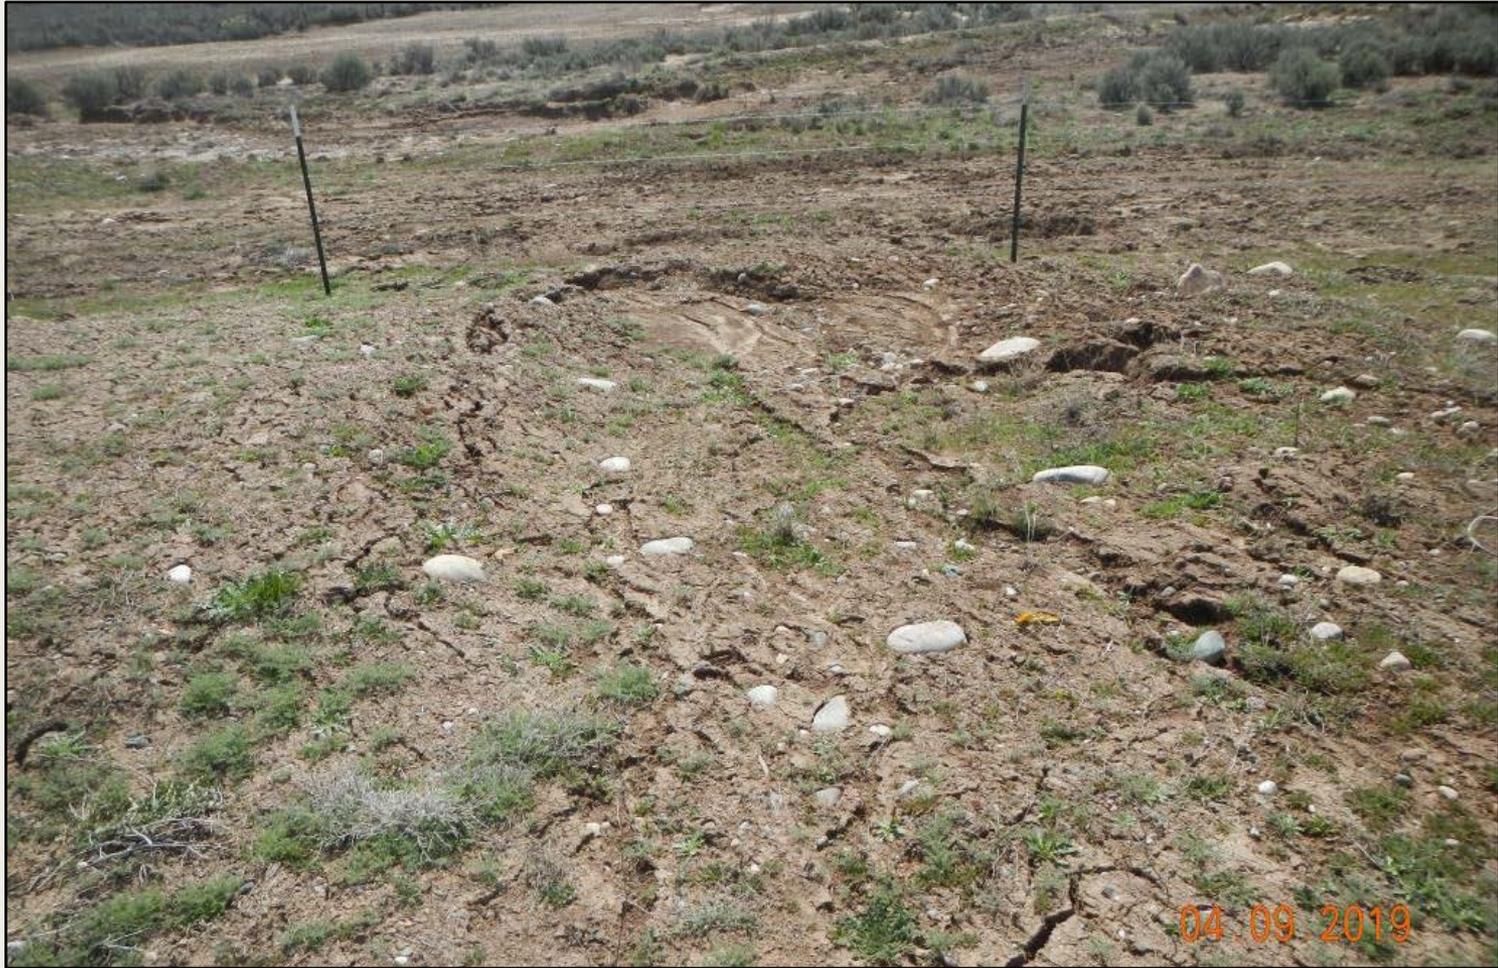
Photo 4. View of erosional channeling and sediment discharge within the southern project area.

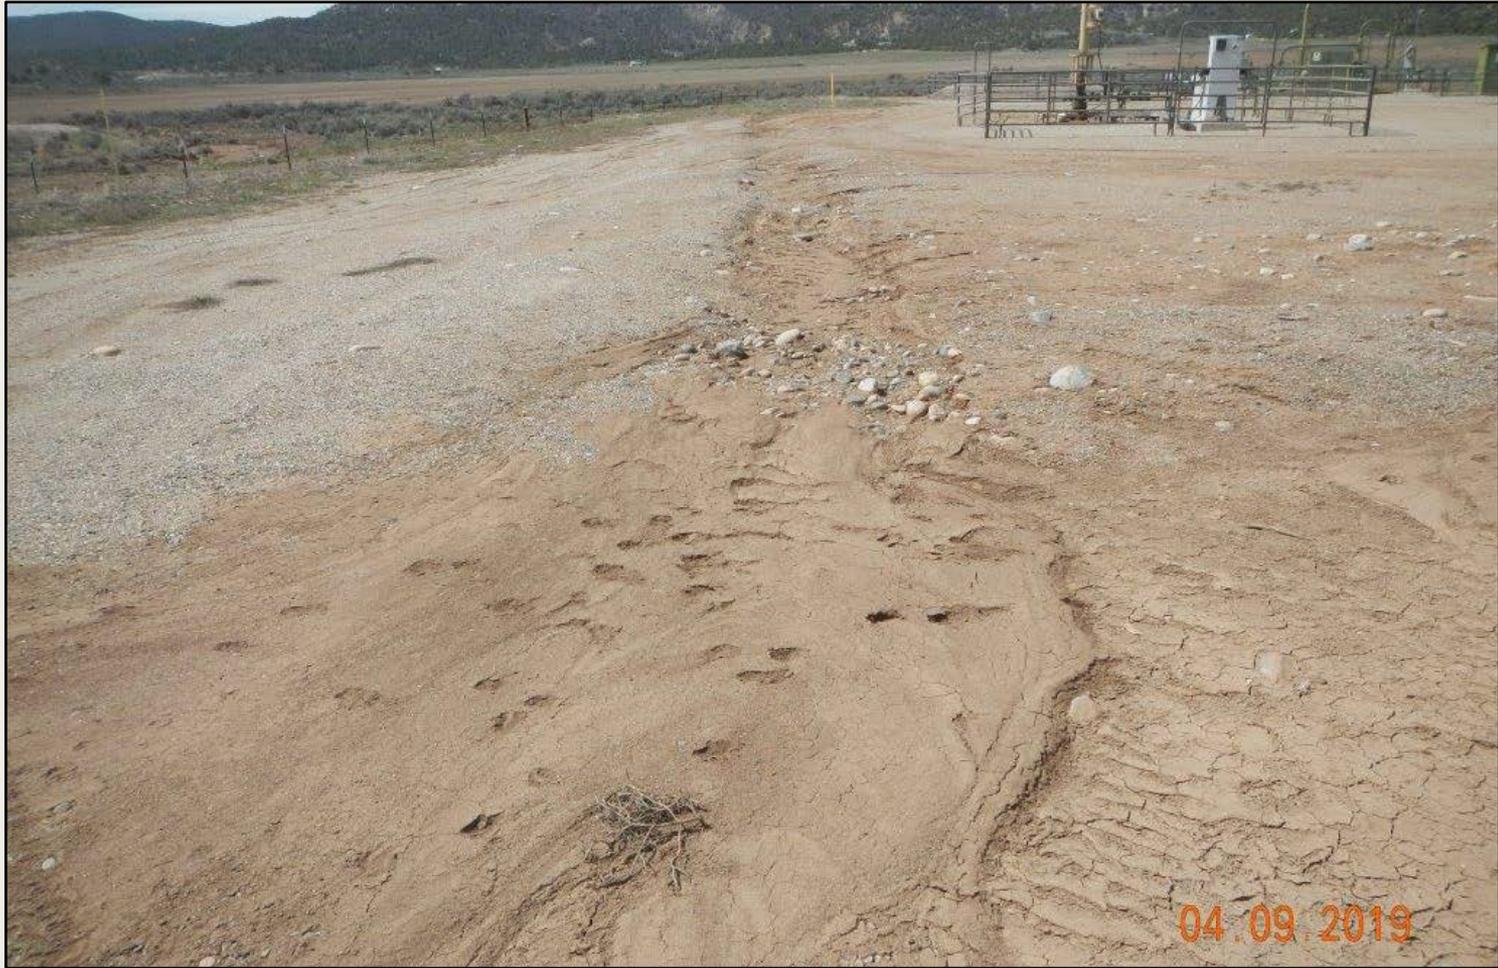
Photo 5. View of erosional channeling and sediment deposition within the southeastern portion of the working area.

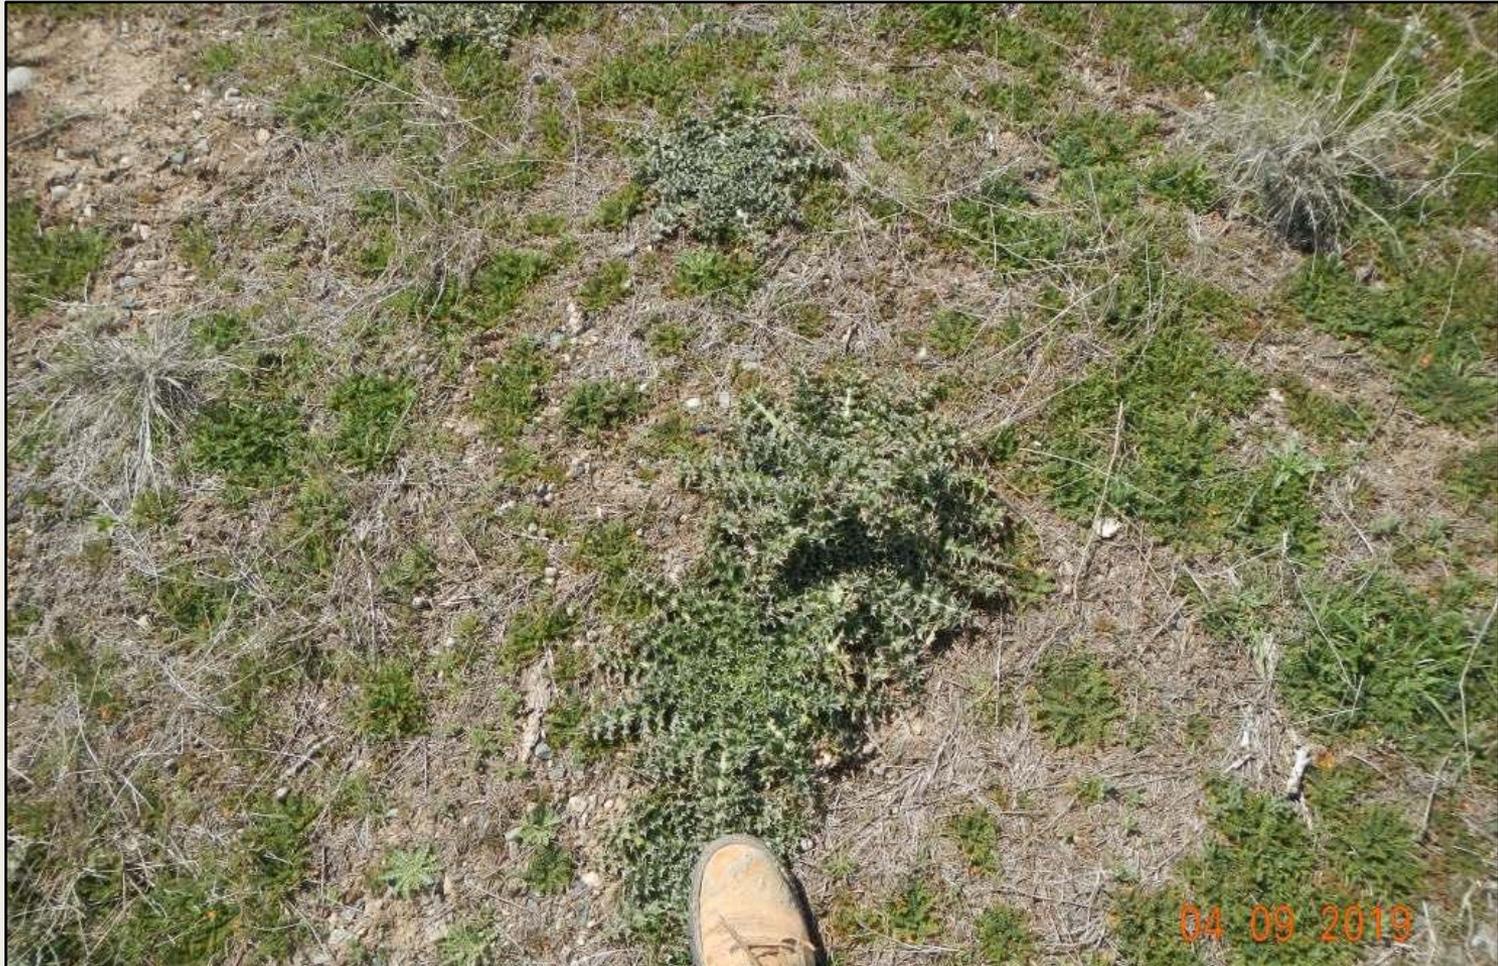
Photo 6. View of musk thistles (*Carduus nutans*) within the interim reclamation area. Approximately 200 individuals observed.
