Inspection Photos

Location Name: Motu East Location ID 439459

Inspection Date: 4/15/2019

COLORADO
Oil & Gas Conservation
Commission
Department of Natural Resources

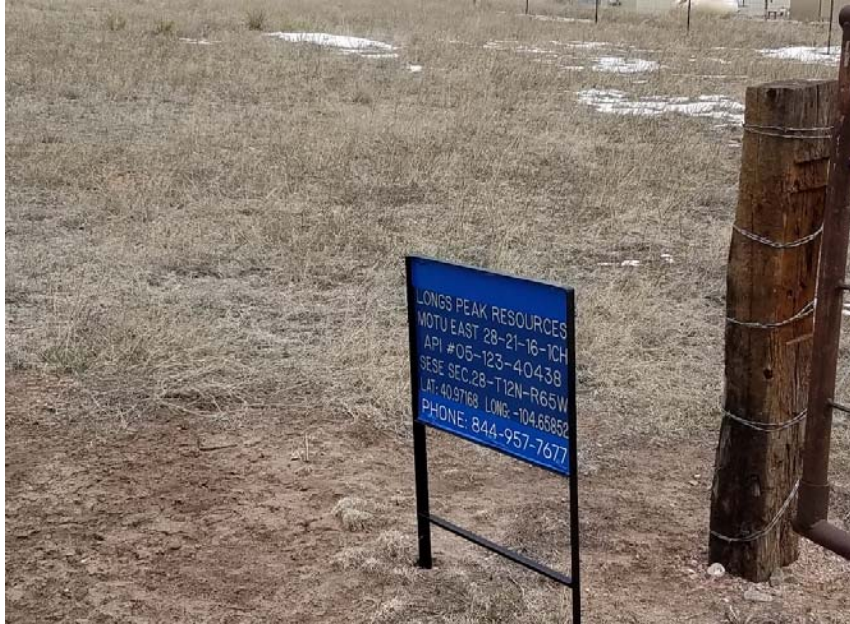
Photo 1 – Location sign at entrance

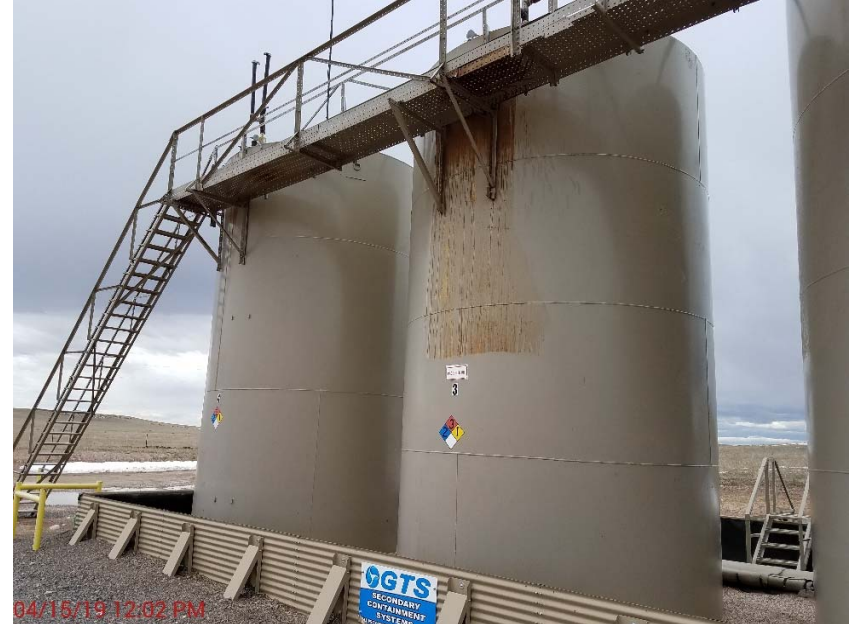
Photo 2 – Thief hatch with previous release and no capacity on crude oil tanks

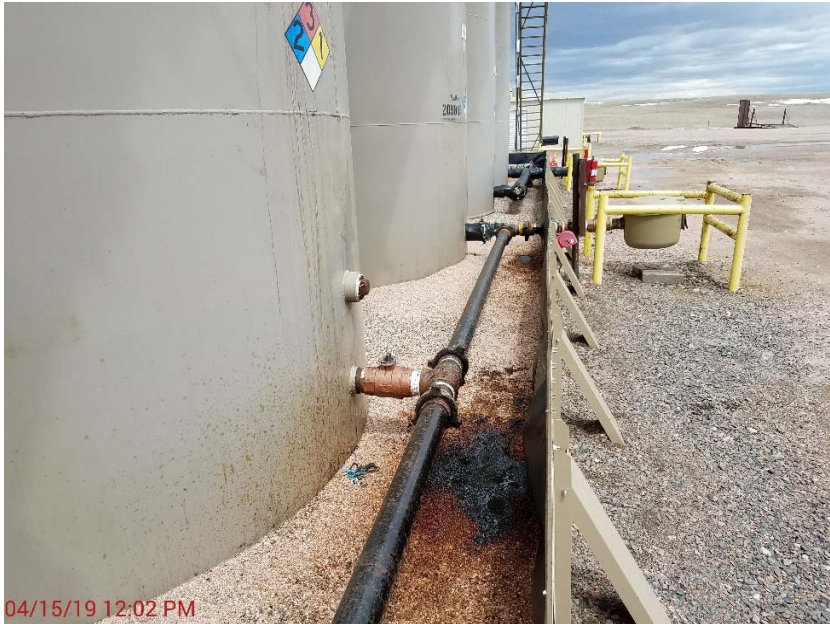
Photo 3– Leaking crude oil load out line.

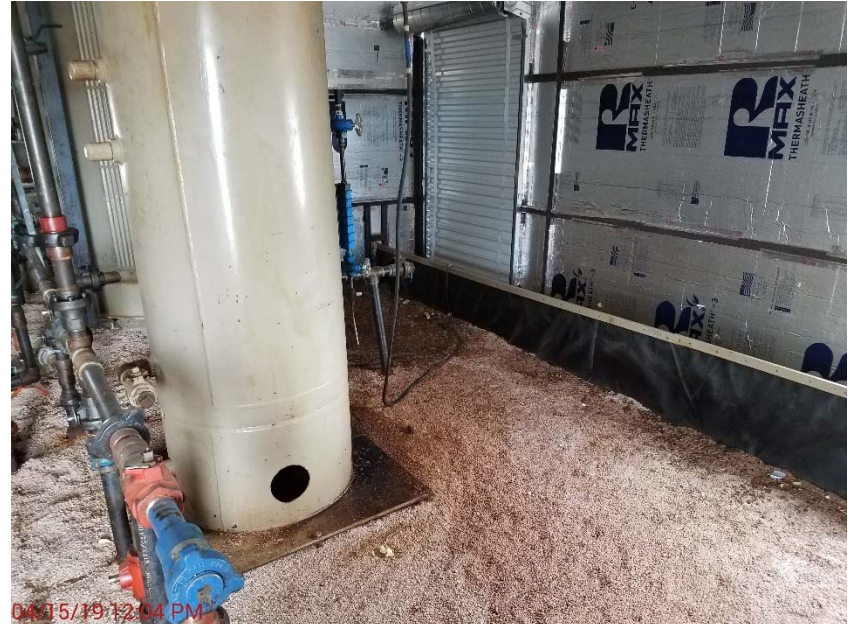
Photo 4 – Leaks inside treater building

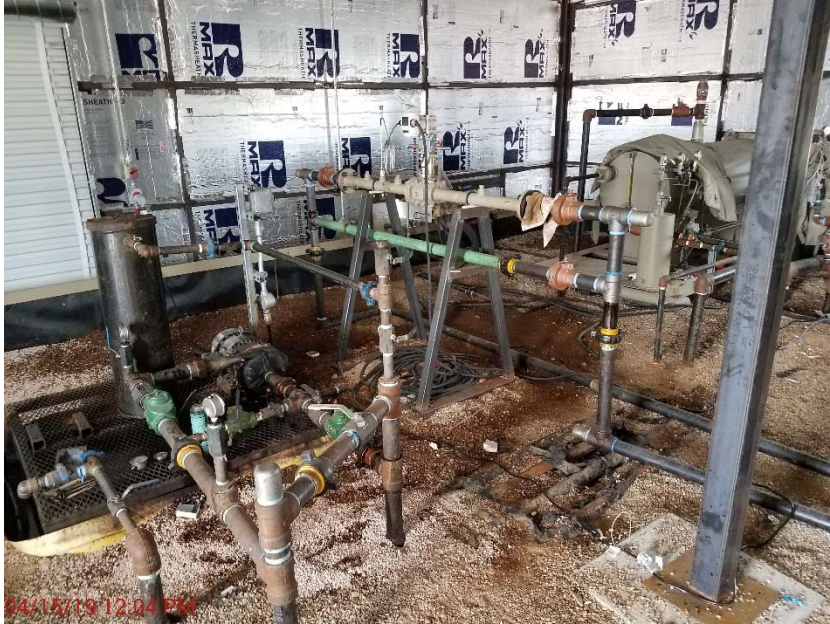
Photo 5 – Leaks within treater building

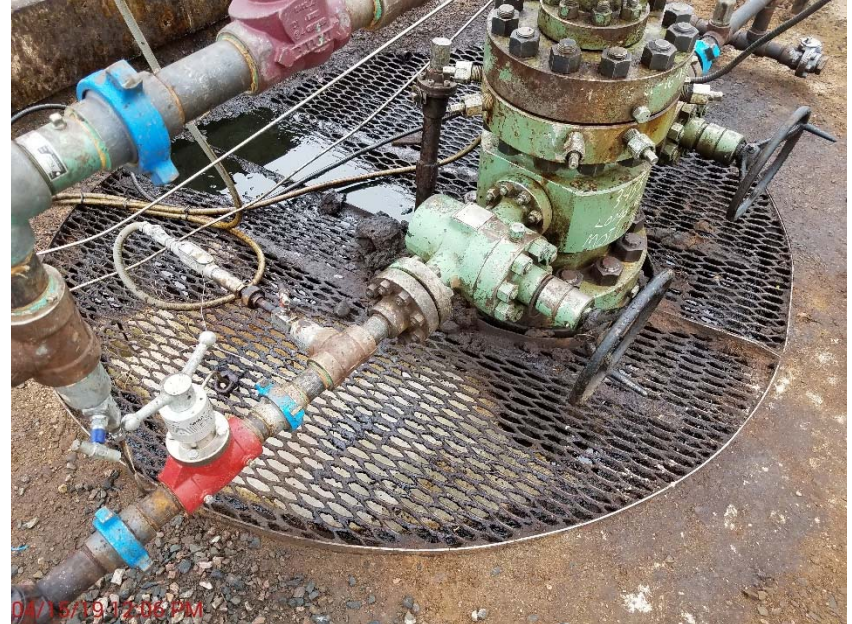
Photo 6 – Leaks around wellhead with cellar full of water and hydrocarbons

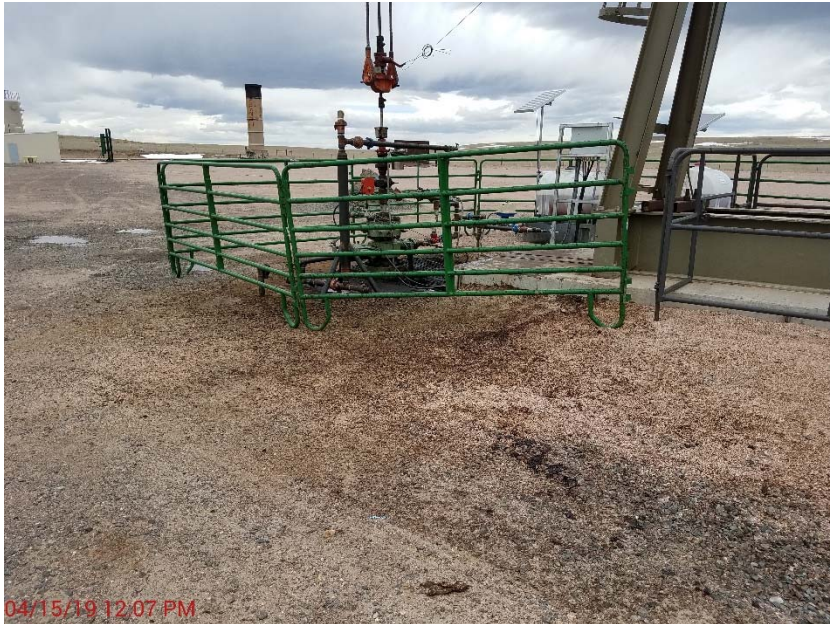
Photo 7 – Stained soil at wellhead and pumpjack

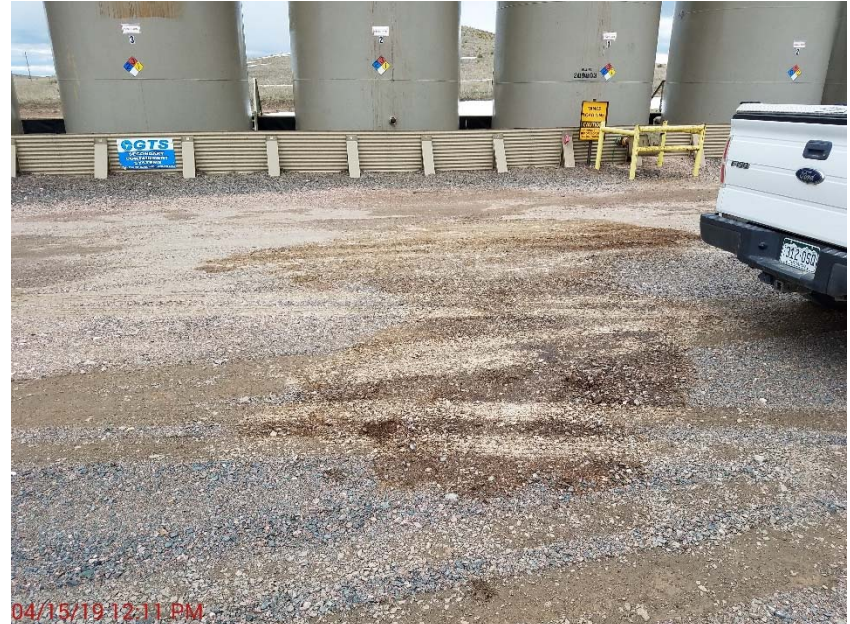
Photo 8 – Stained soil outside containment at crude oil loadout.

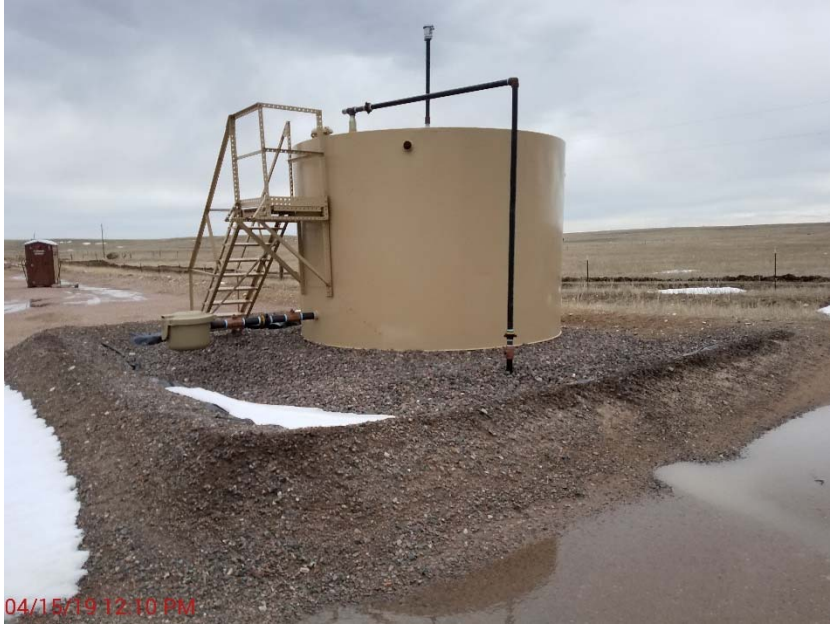
Photo 9 – Unlabeled AST – lacks NFPA, capacity and contents

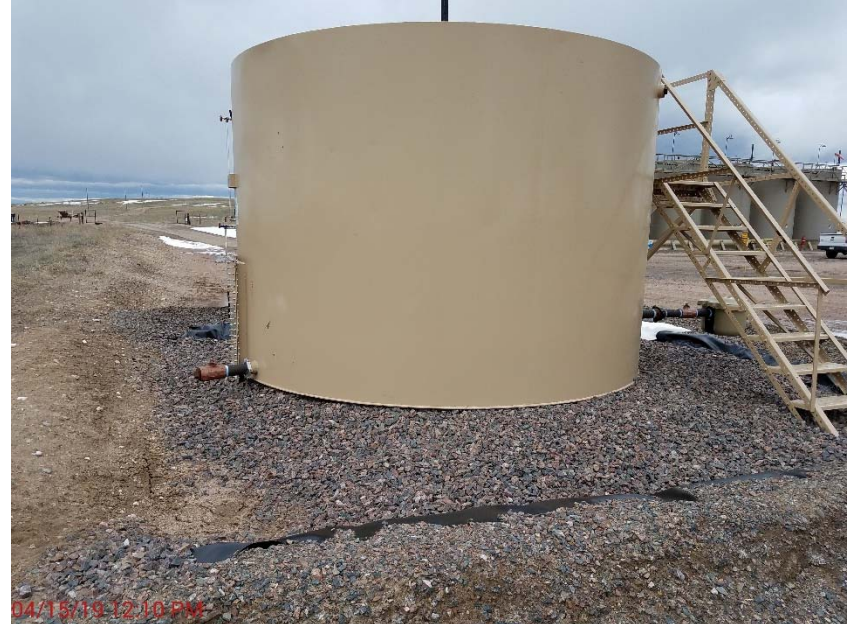
Photo 10 – Unlabeled AST, secondary containment not adequate for tank.

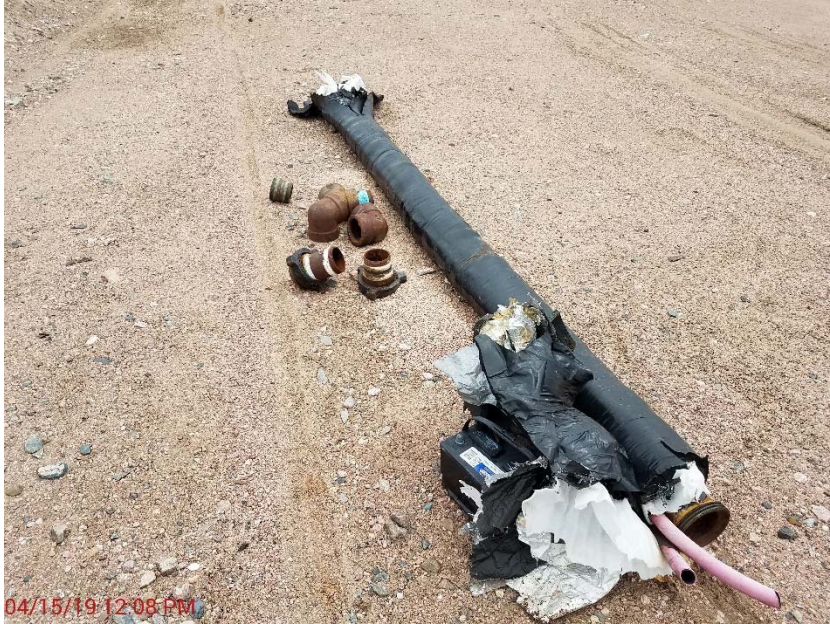
Photo 11 – Unused equipment on location

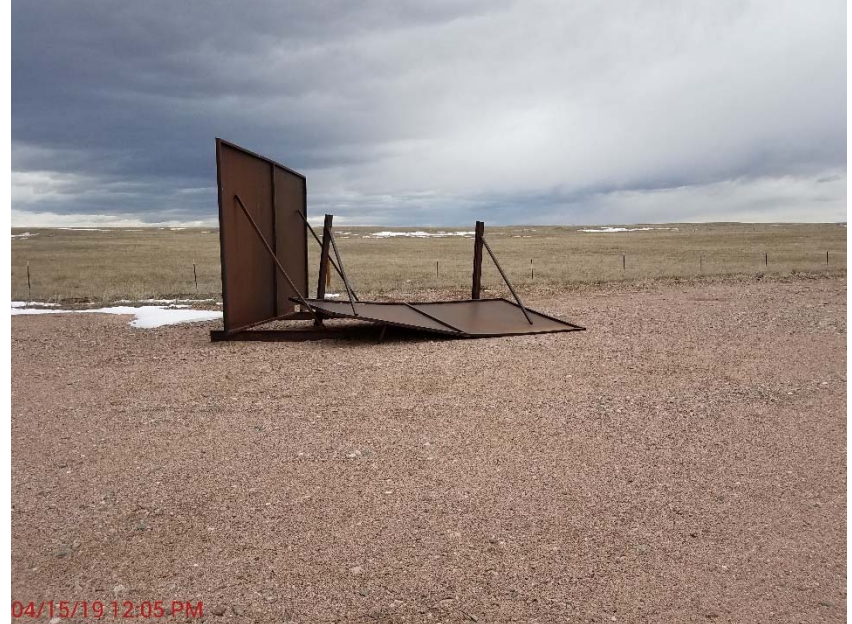
Photo 12 – Unused equipment on location
