Inspection Photos
Operator: BP America
Location/API #: 067-06340
Date: 4-9-2019

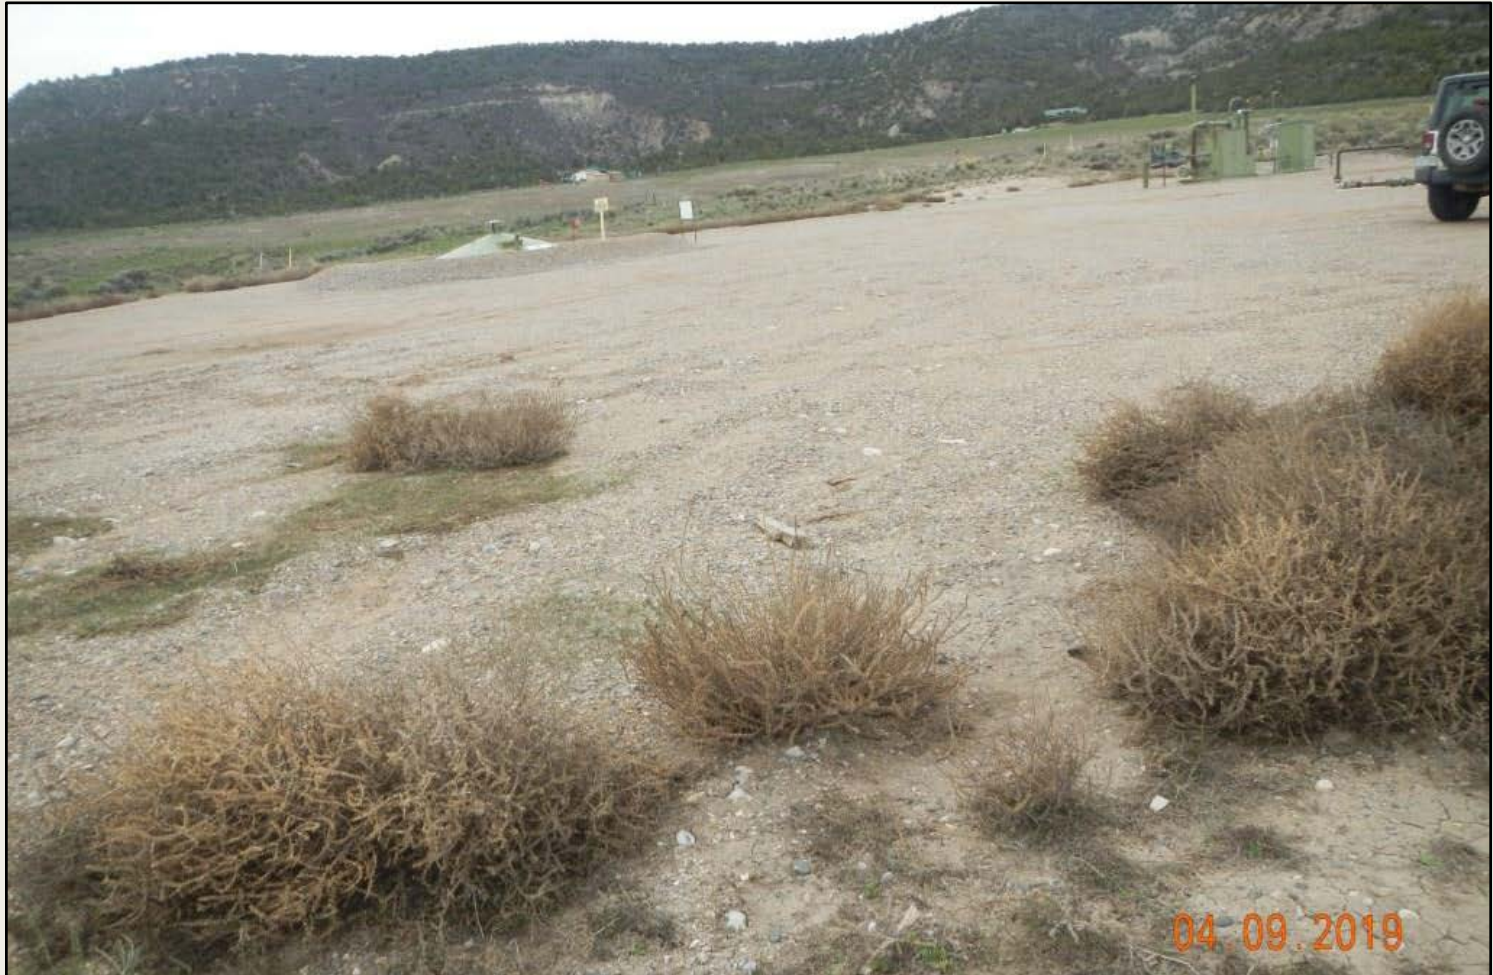
Photo 1. View of the project area from the northeastern corner facing center.

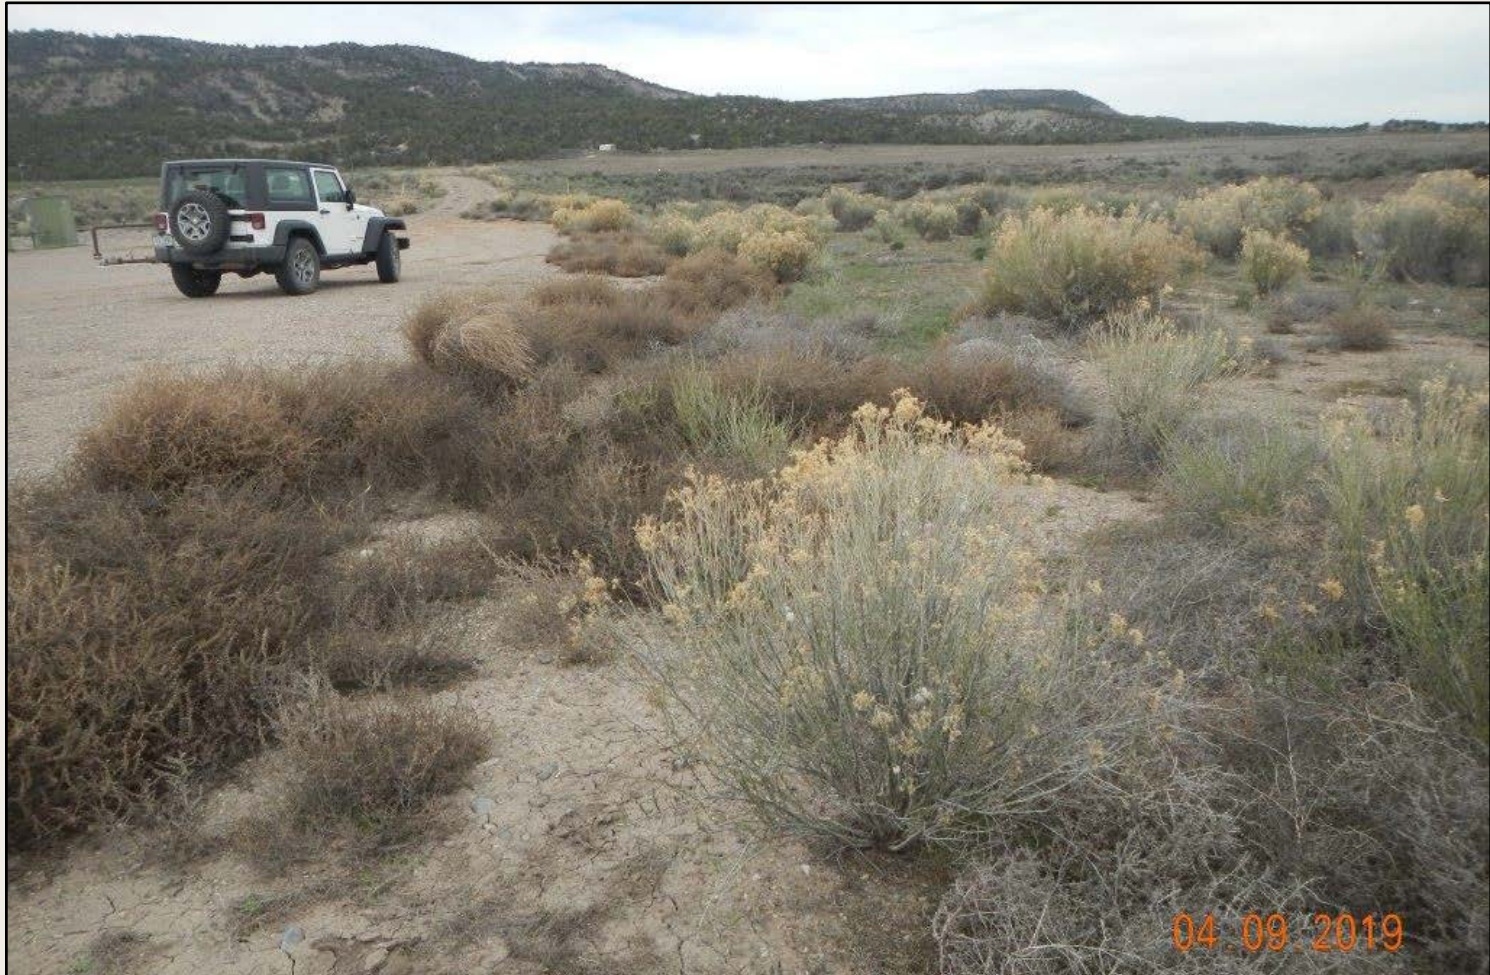
Photo 2. View of the northern project area from the northeastern corner facing westward.

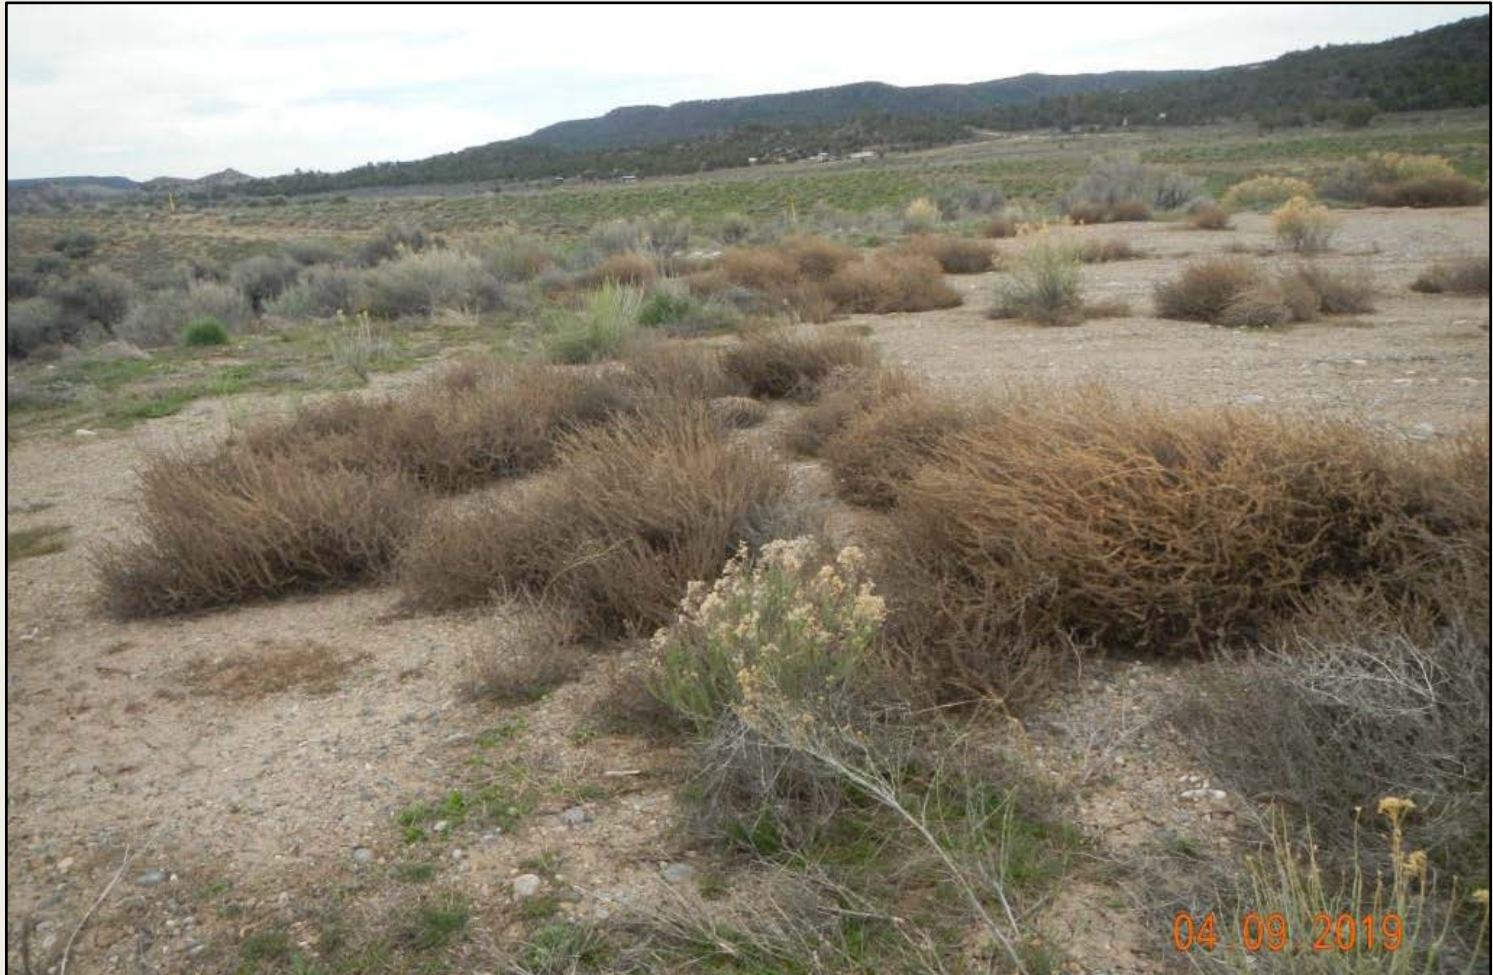
Photo 3. View of the eastern project area from the northeastern corner facing southward. Russian thistle debris needs to be removed.

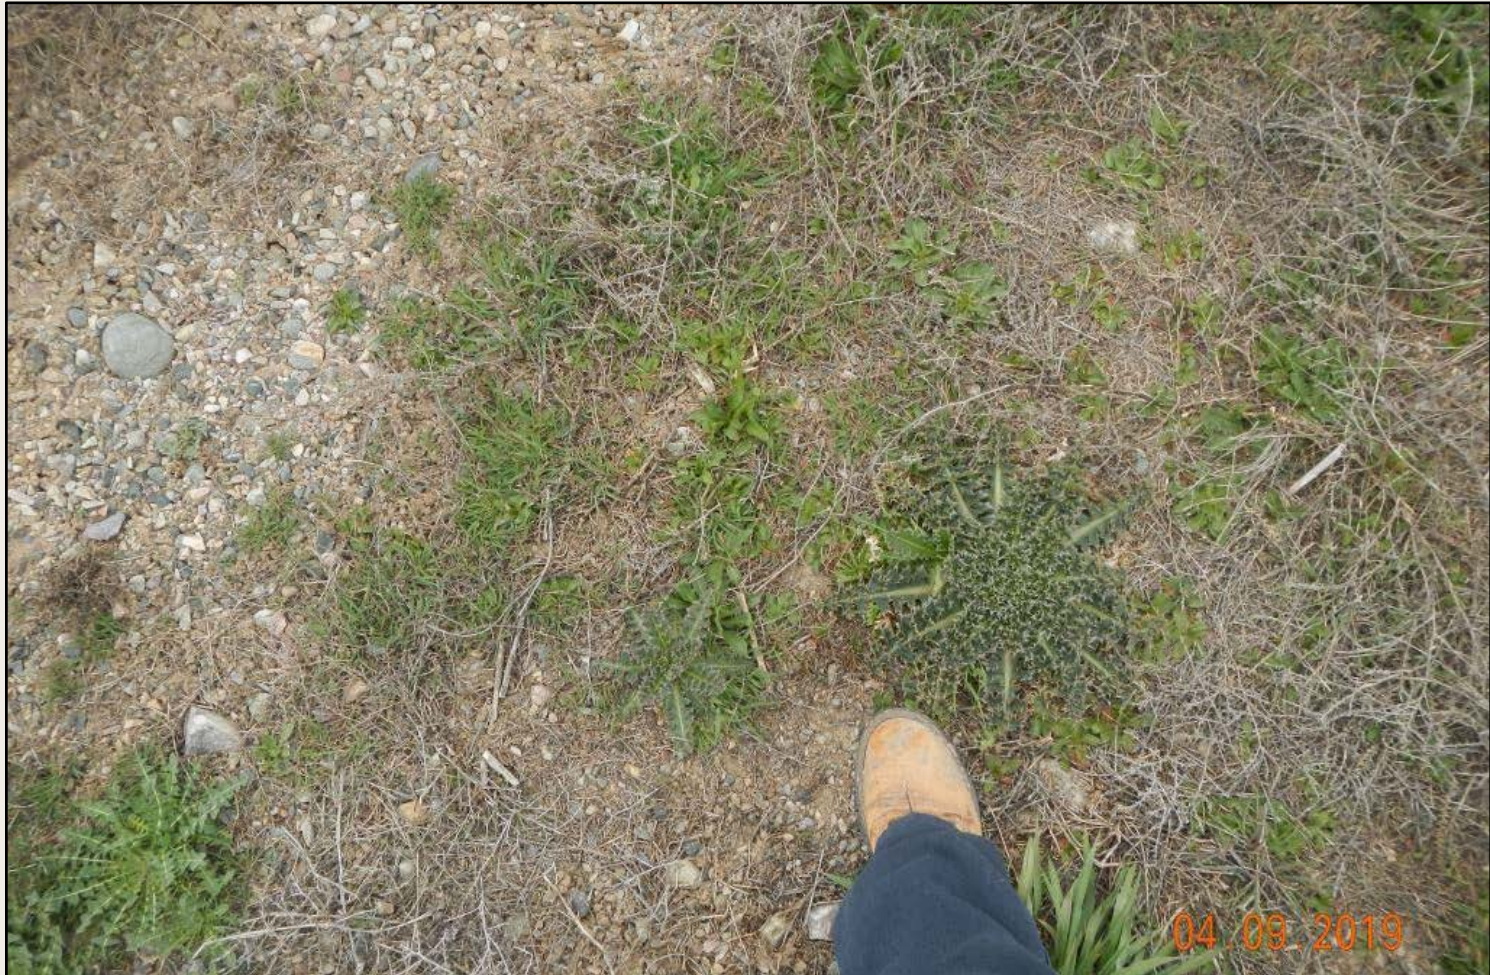
Photo 4. View of musk thistles (*Carduus nutans*) within the interim reclamation area. Approximately 150 individuals present.

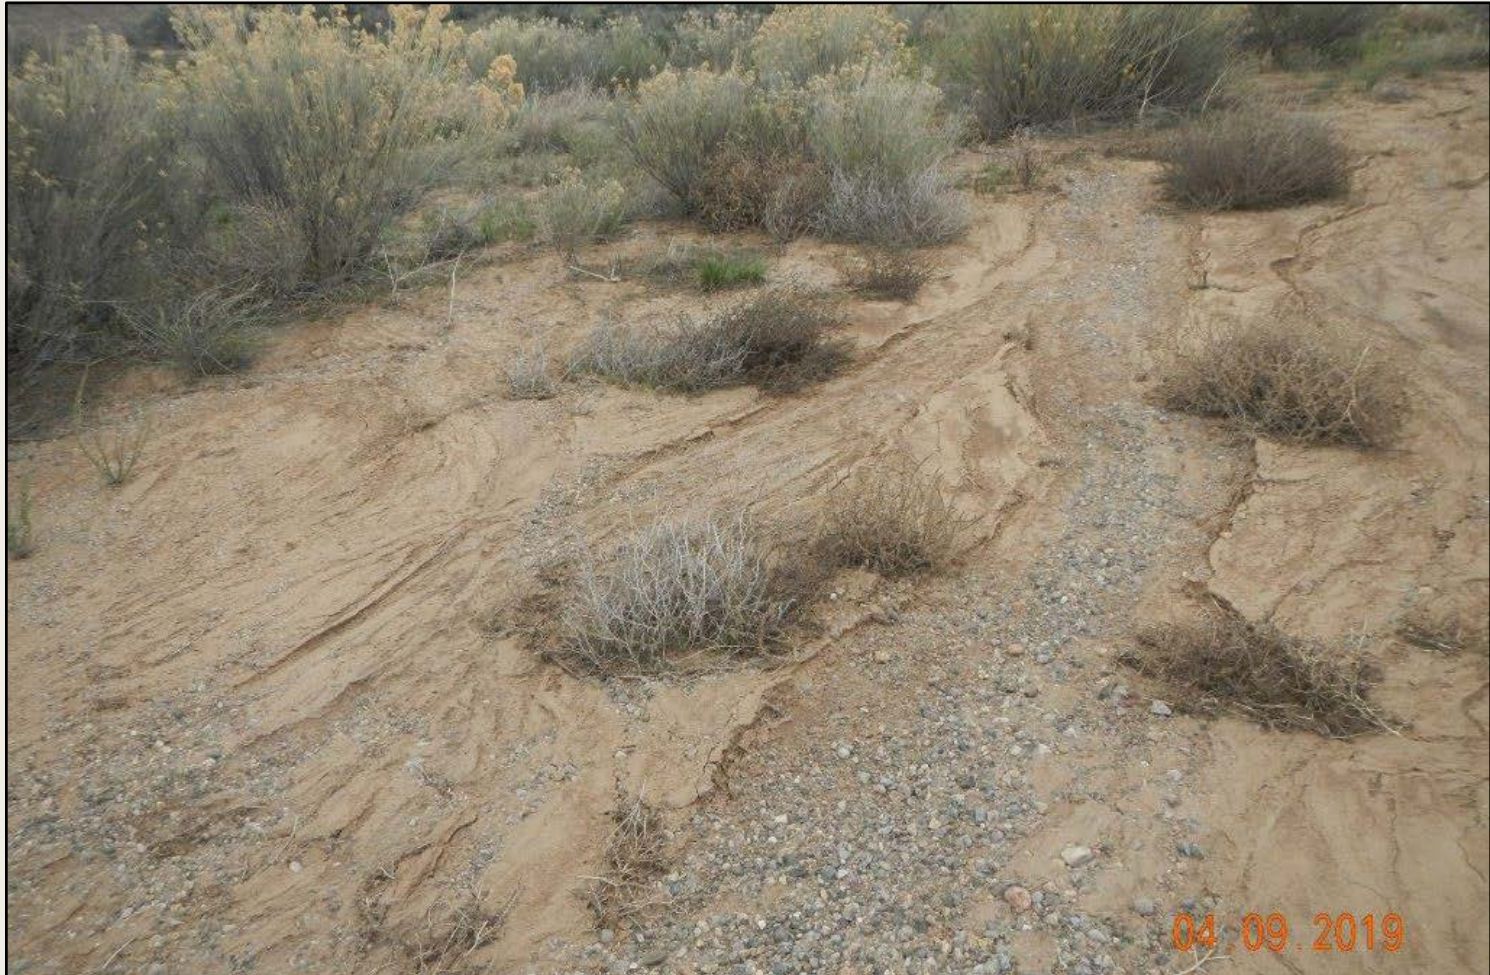
Photo 5. View of erosion within the northwestern portion of the project area, where stormwater flows from the access road appear to erode the road surface and carry sediment and debris downslope toward the northern drainage.

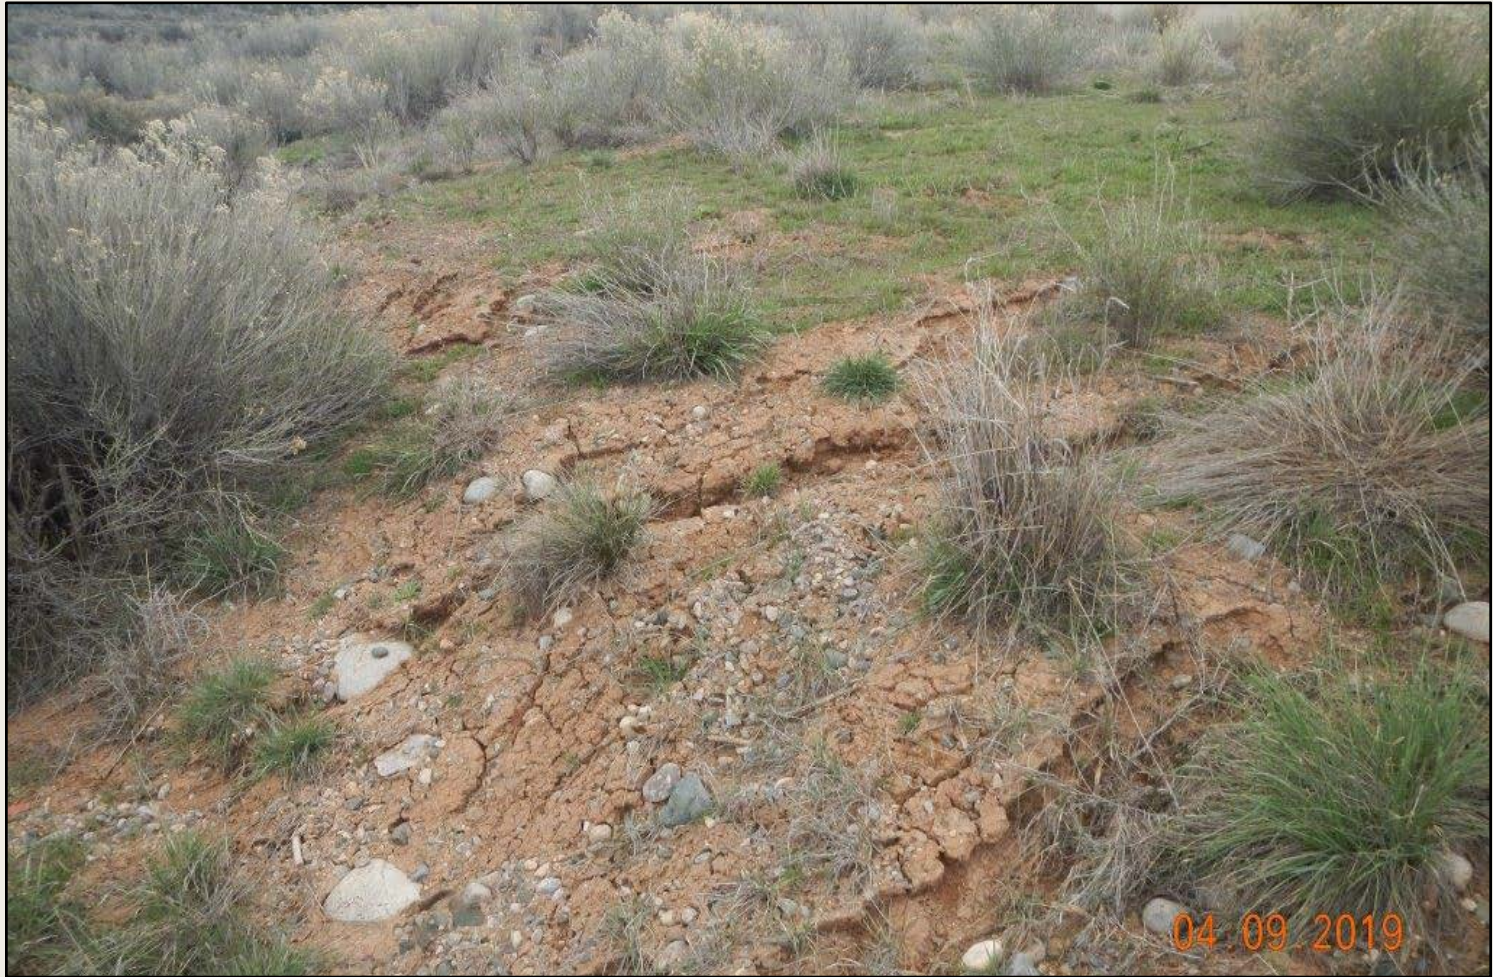
Photo 6. View of erosion down-slope from photo 5, at the edge of the project area, adjacent to a drainage.
