Inspection Photos
Operator: BP America
Location/API #: 067-05226
Date: 4-9-2019

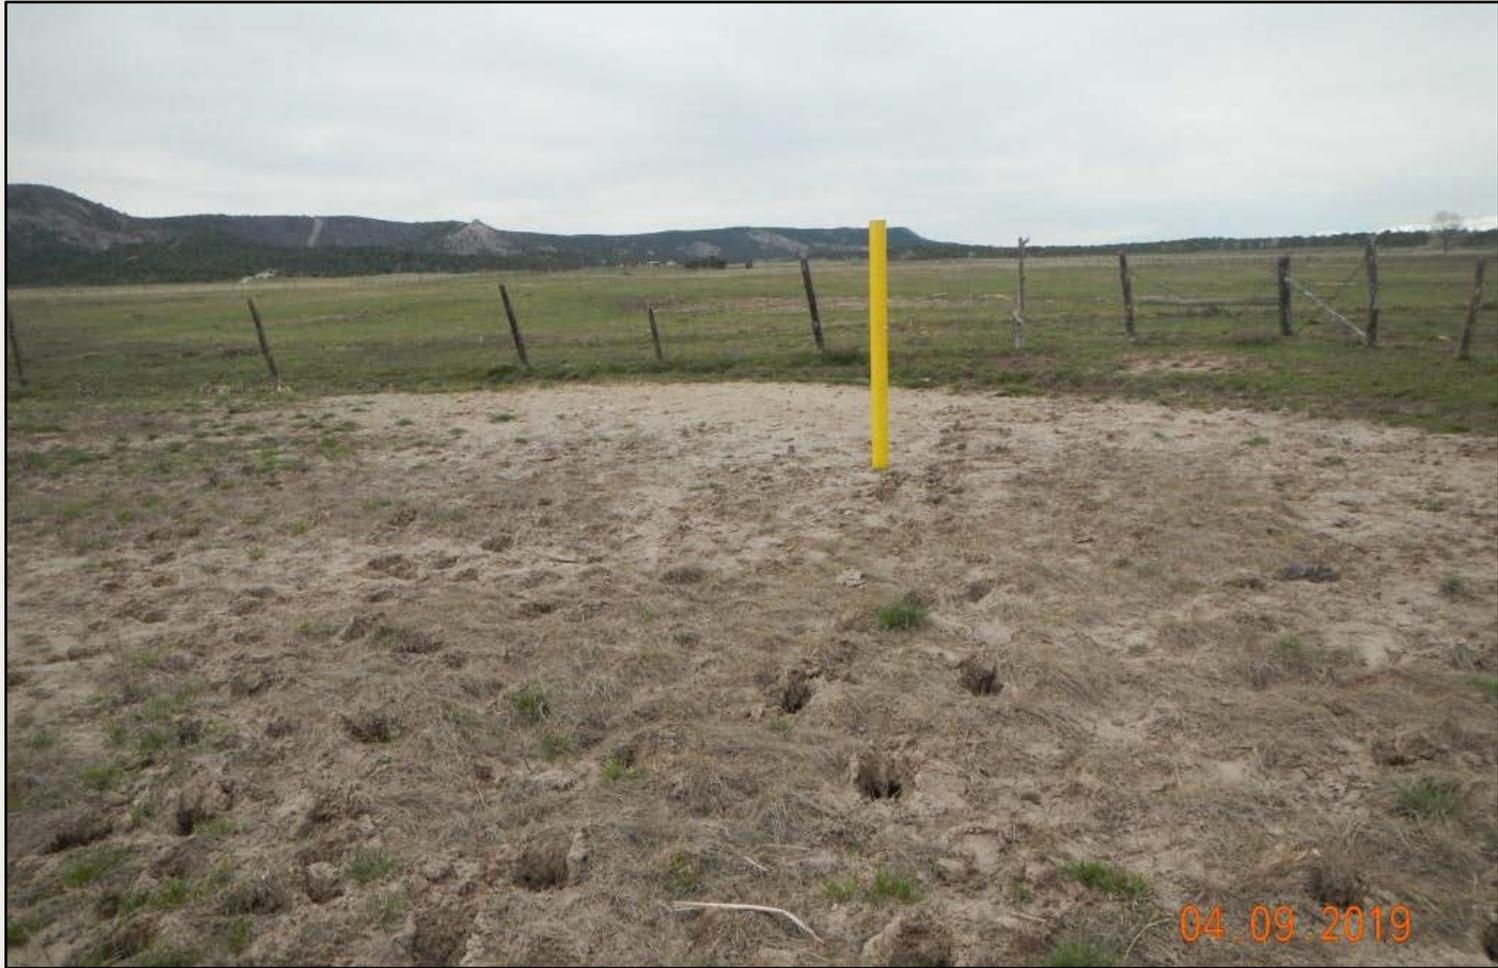
Photo 1. View of the wellhead marker facing southward. Revegetation is sparse around wellhead. Gravel observed.

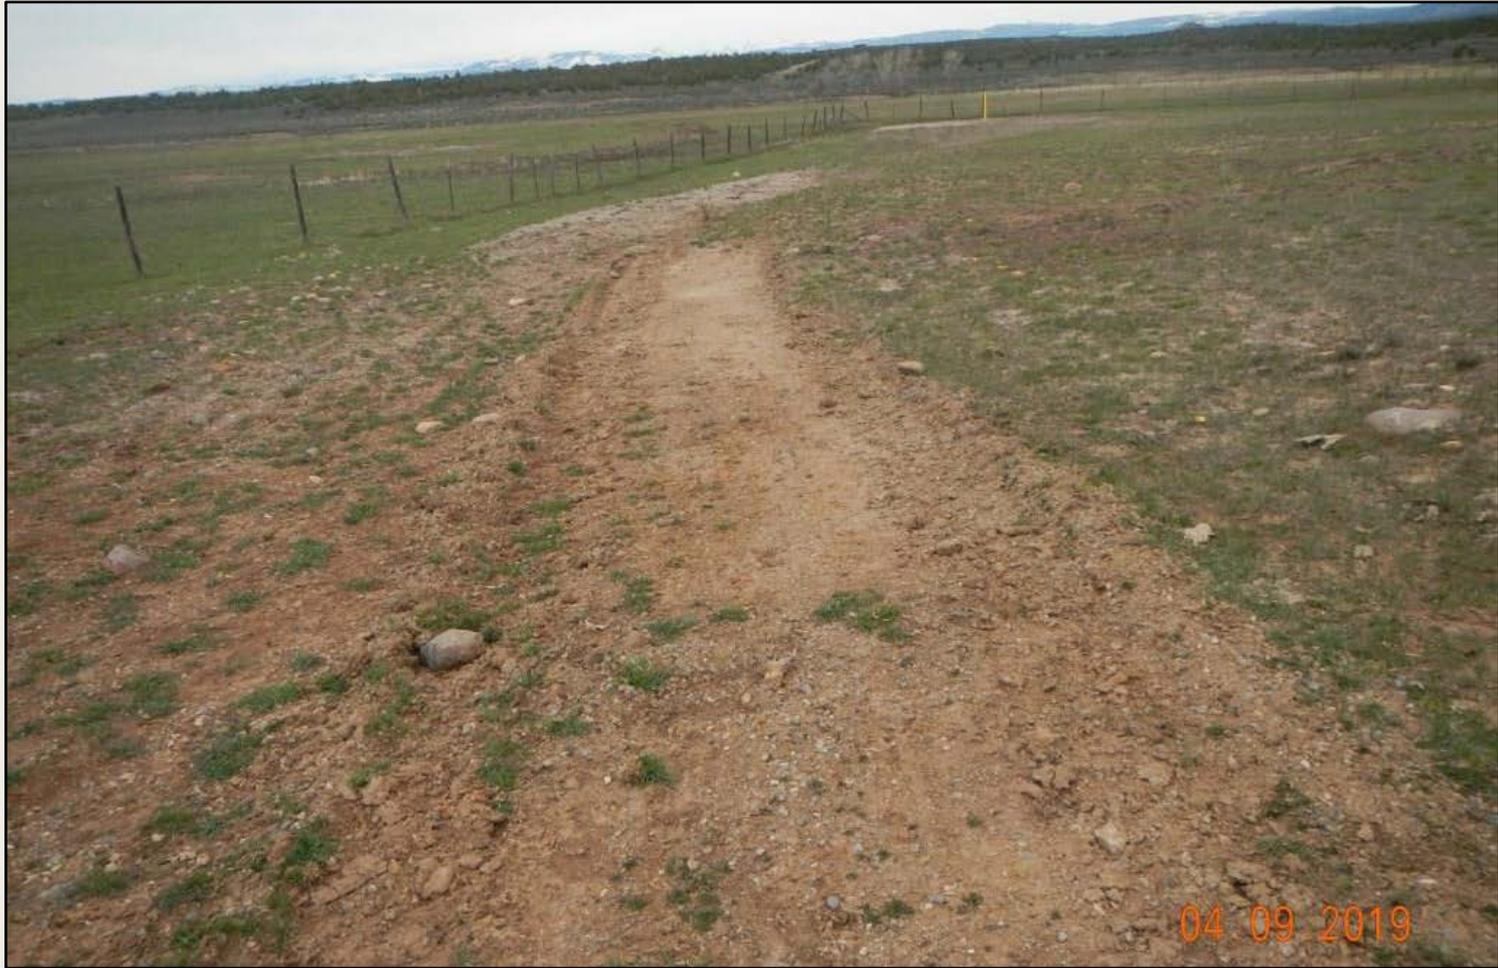
Photo 2. View of former access road still in place, facing southward.

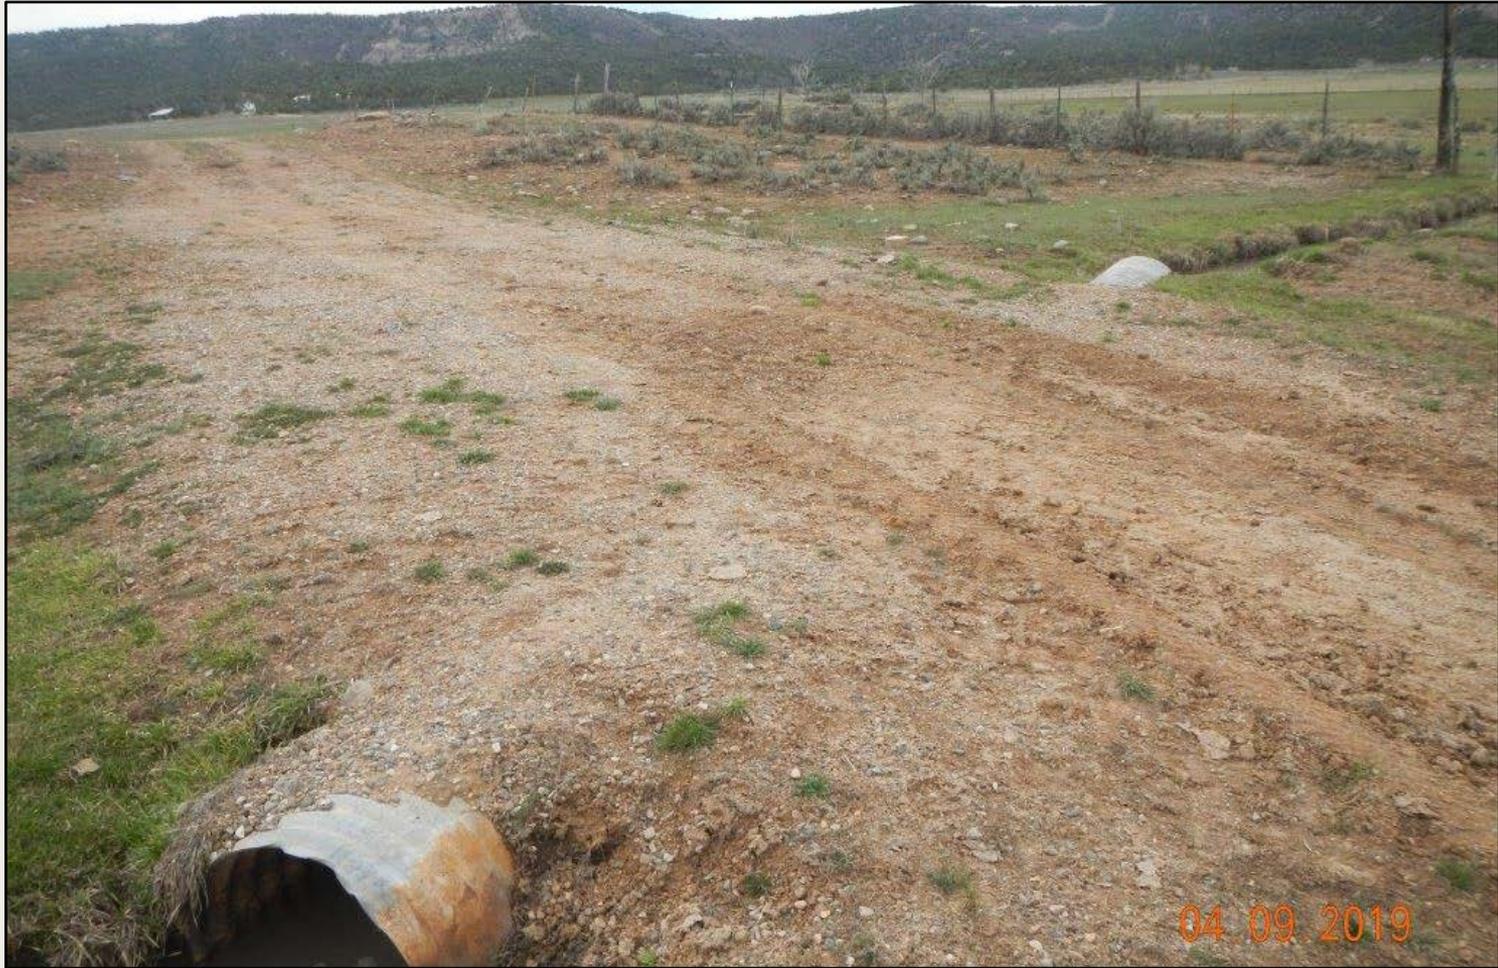
Photo 3. View of culvert and access road still in place, facing southwestward.

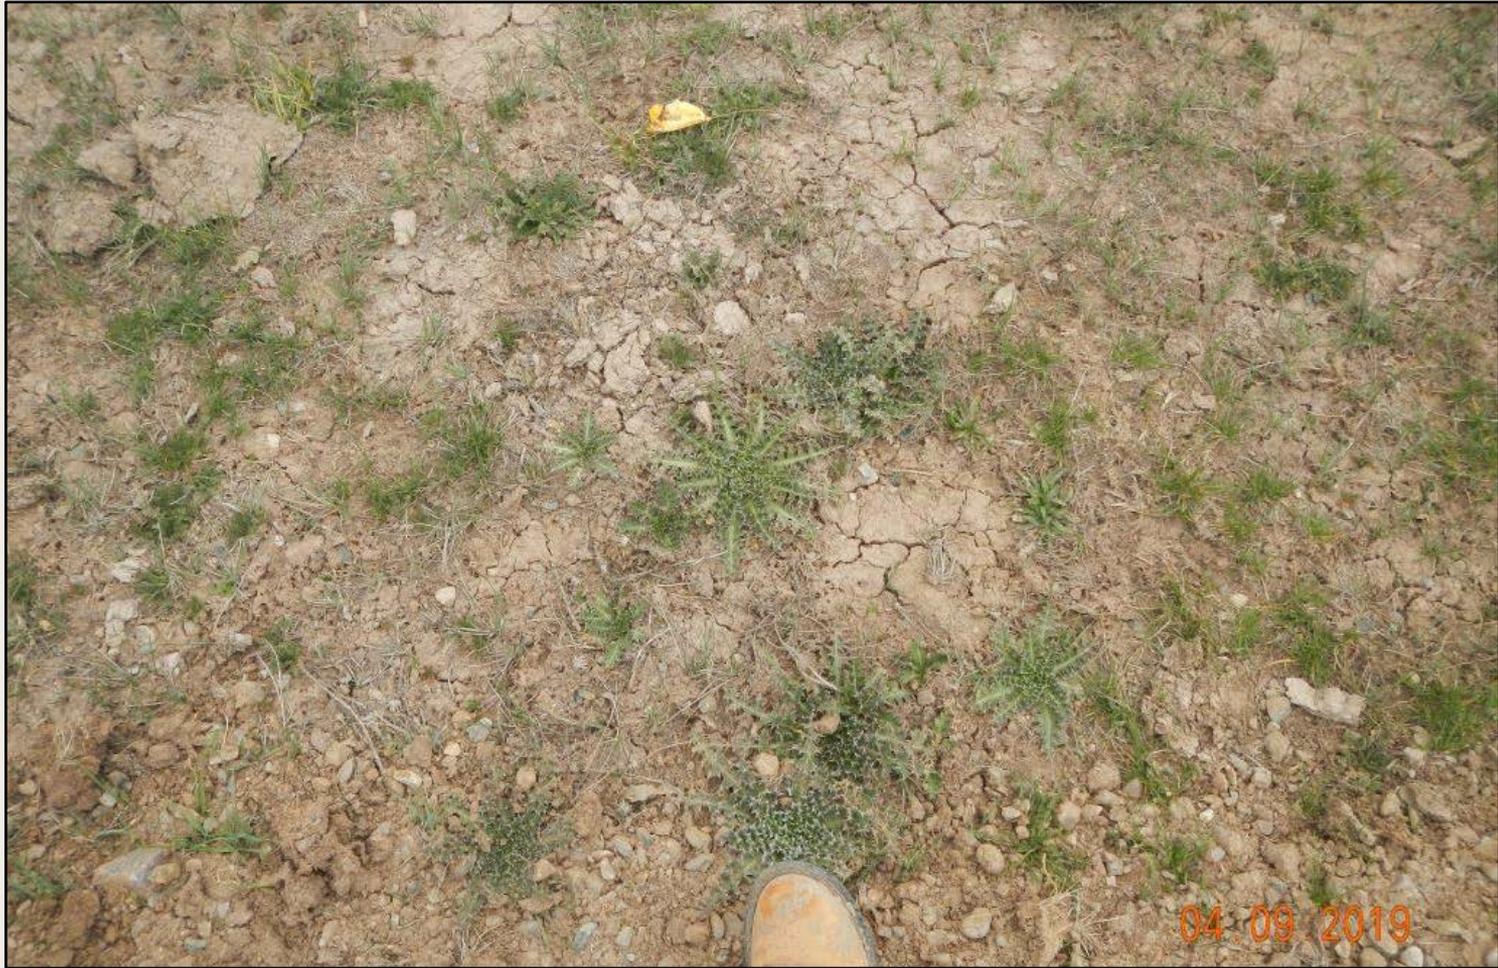
Photo 4. View of musk thistles (*Carduus nutans*) within the interim reclamation area. Approximately 50 individuals present.

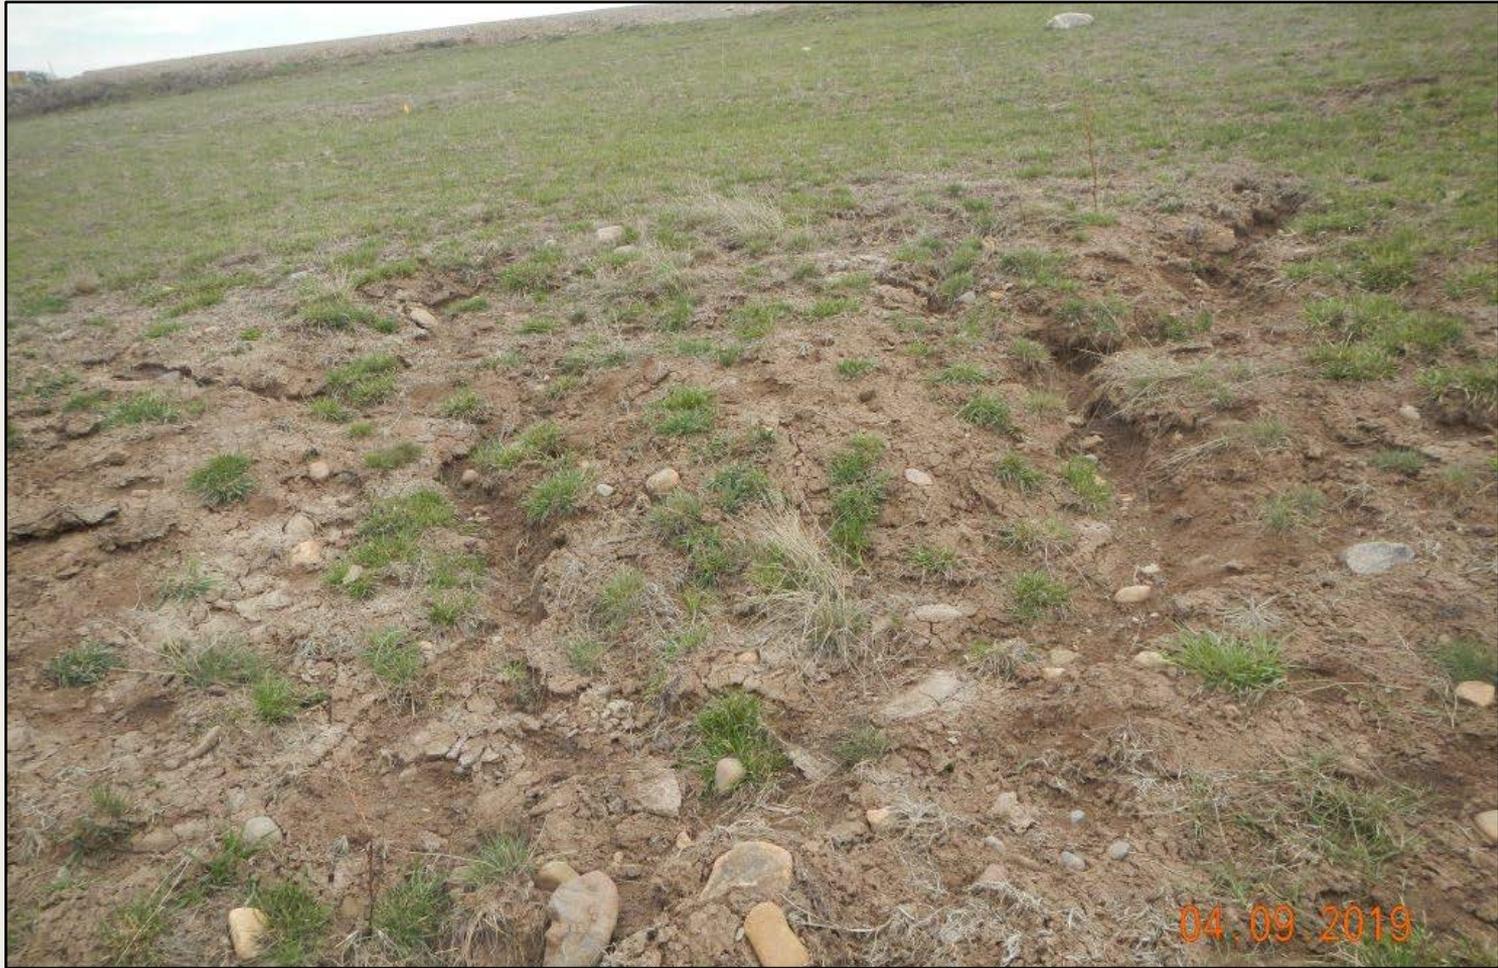
Photo 5. View of erosional rilling within the southern project area.

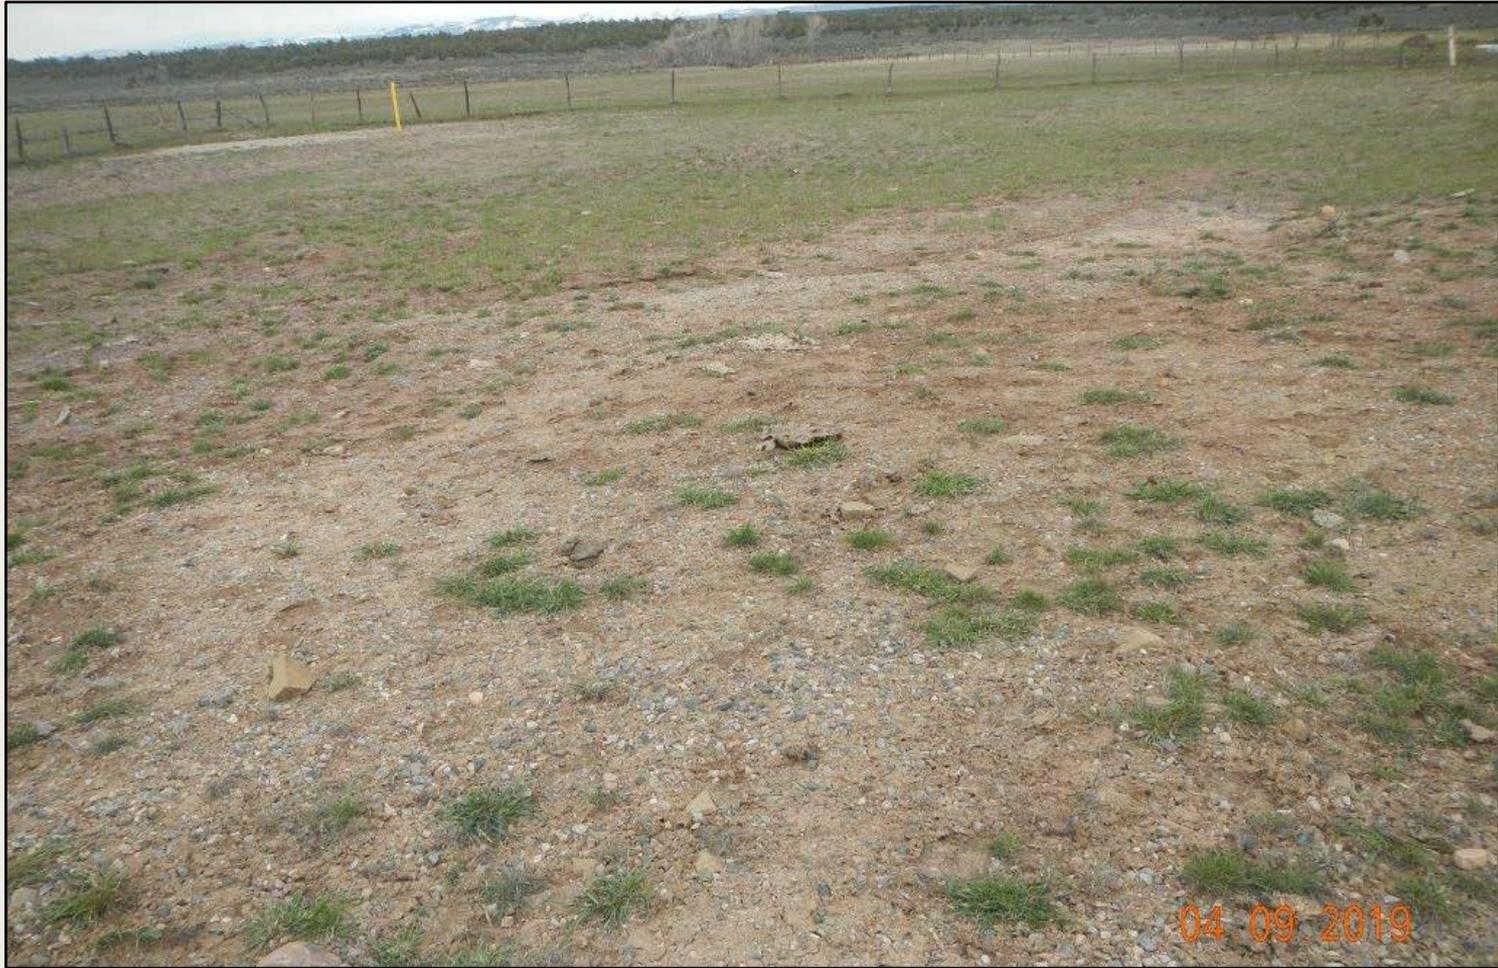
Photo 6. View of area with poor revegetation and gravel present within the southern project area.
