Inspection Photos

API: 05-071-08419

Operator: TIMBER CREEK OPERATING LLC

Inspection Date: 4/16/2019

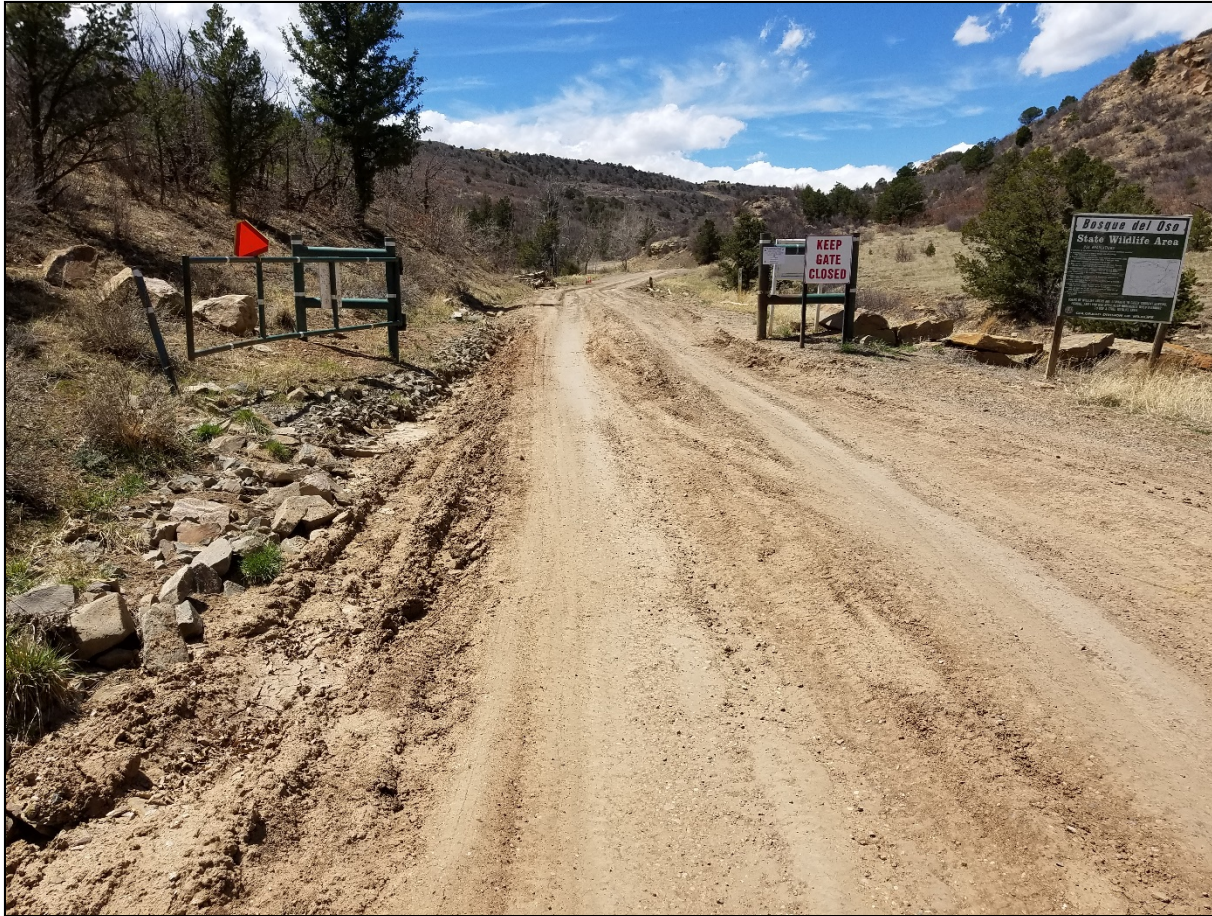
Photo 1. Facing northwest along the main road at the gate of Cherry canyon. Stormwater appears to have flowed down the road from a plugged culvert. There is vehicle rutting and erosion in this area.

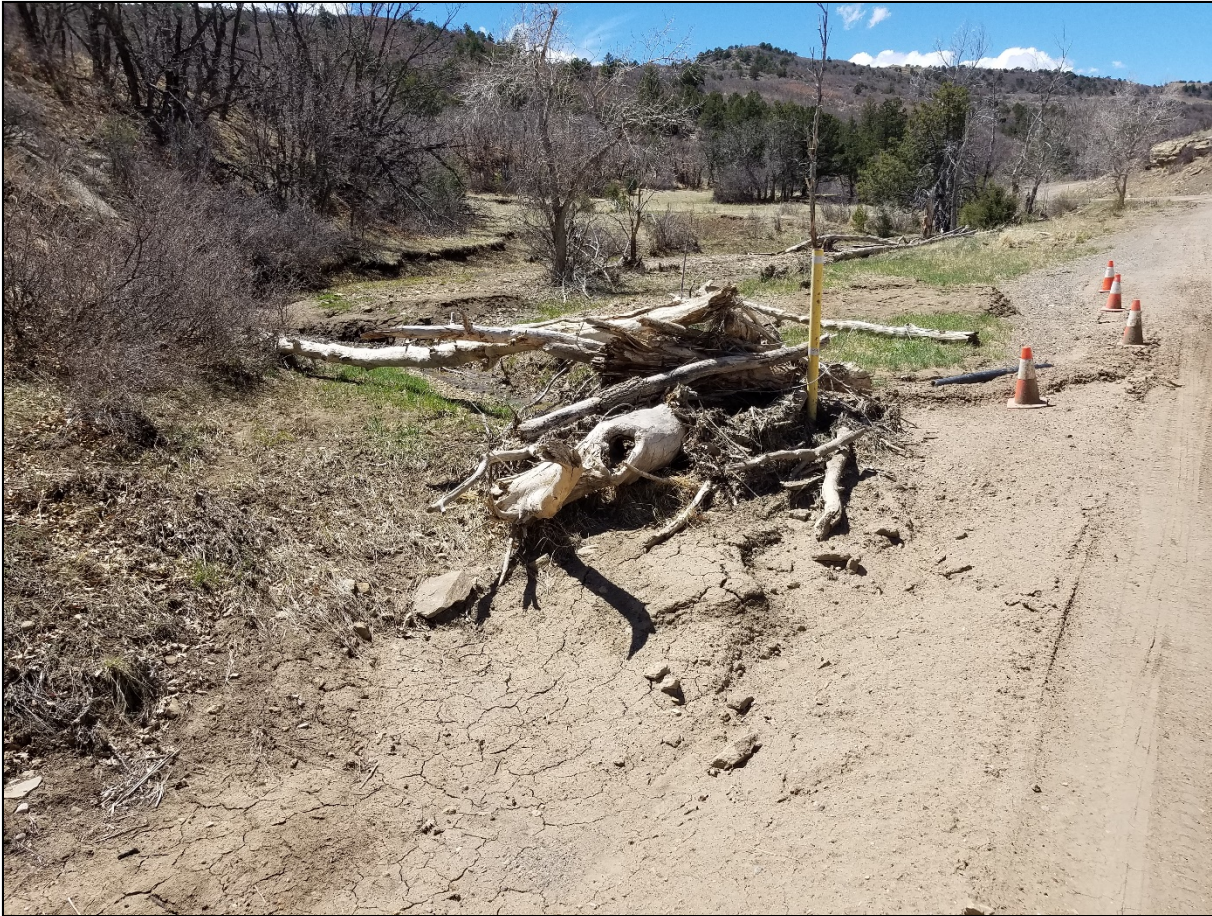
Photo 2. The culvert has been plugged up at the stream crossing causing stormwater to flow down the road.

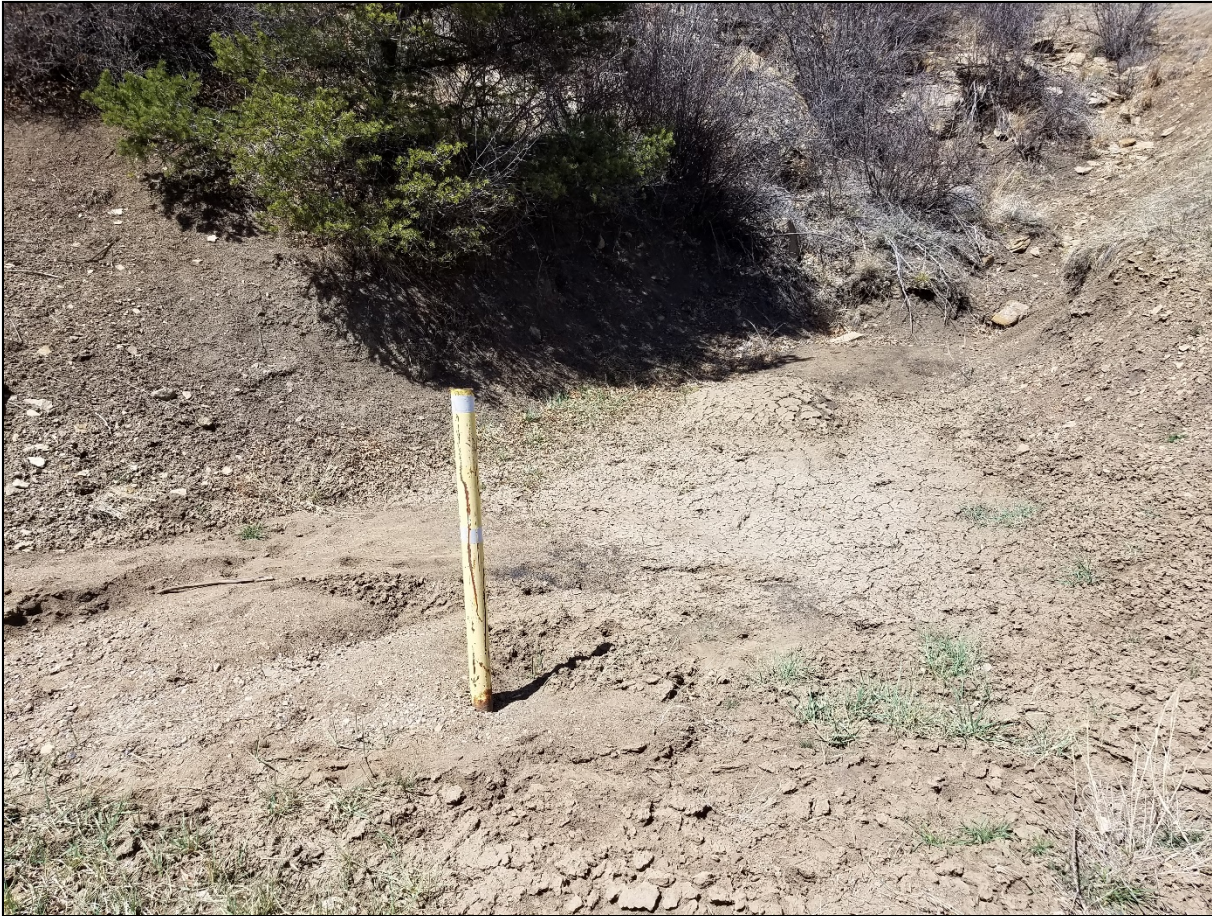
Photo 3. Another culvert up the main road is filled in with sediment.

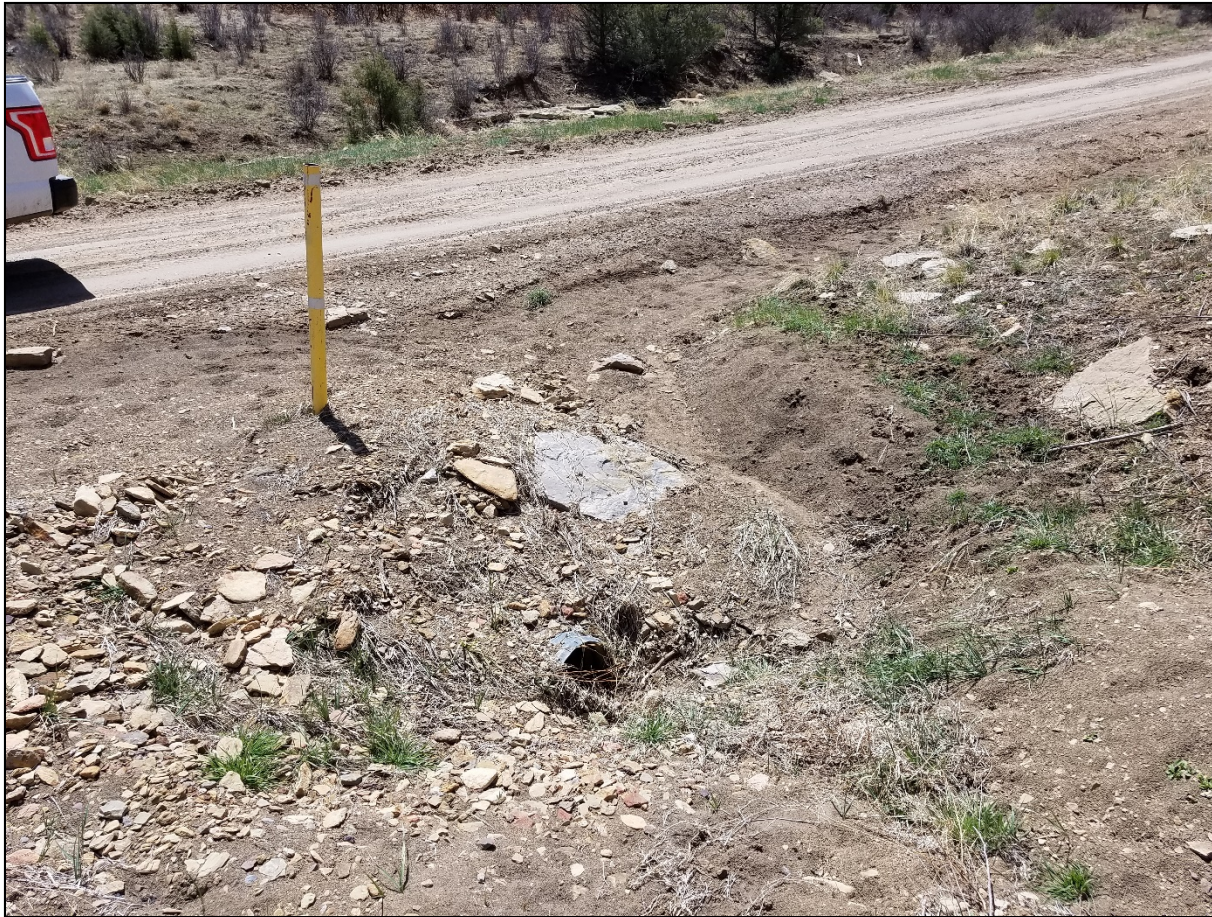
Photo 4. Further up the road is another culvert that is halfway full of sediment.

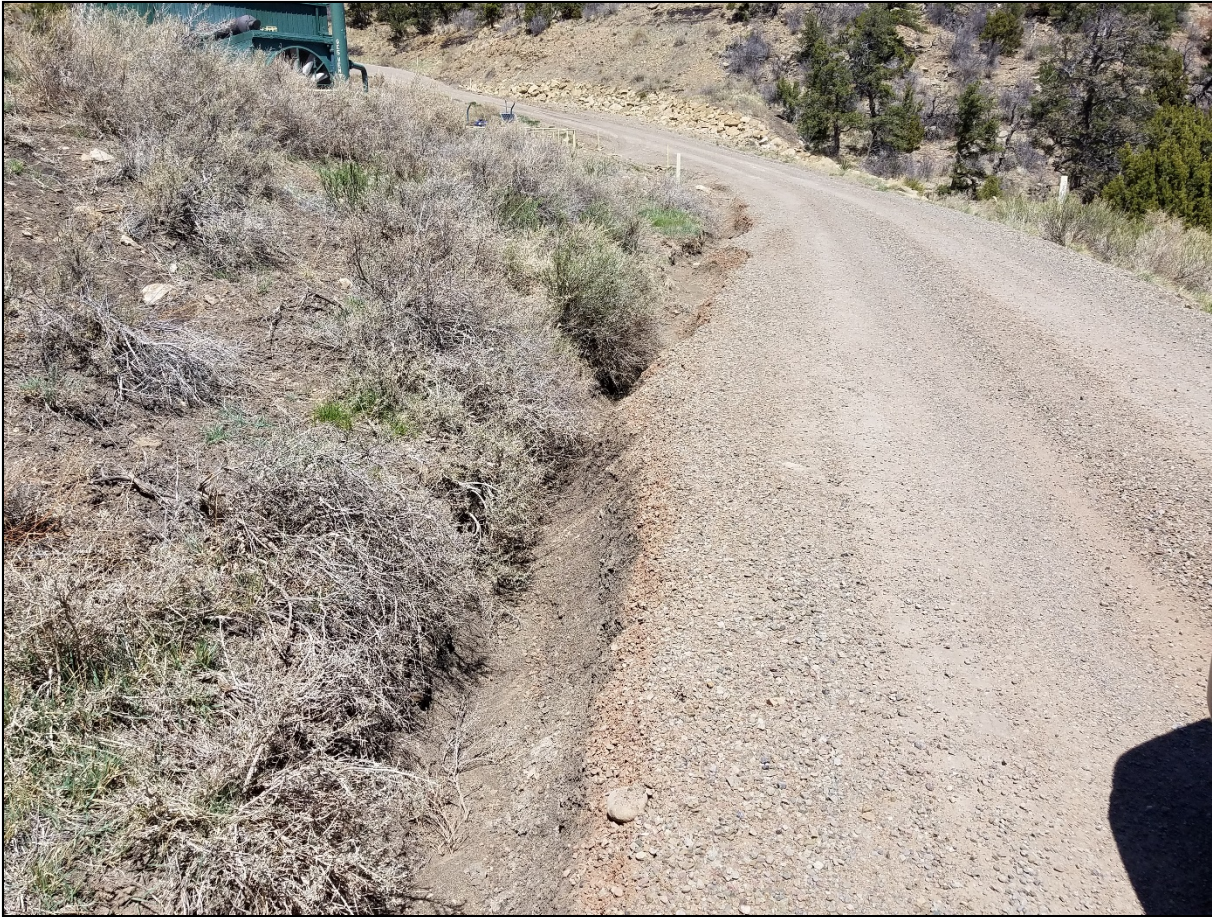
Photo 5. Erosion has deepened the side of the access road near the location. BMP's are needed to prevent further erosion.

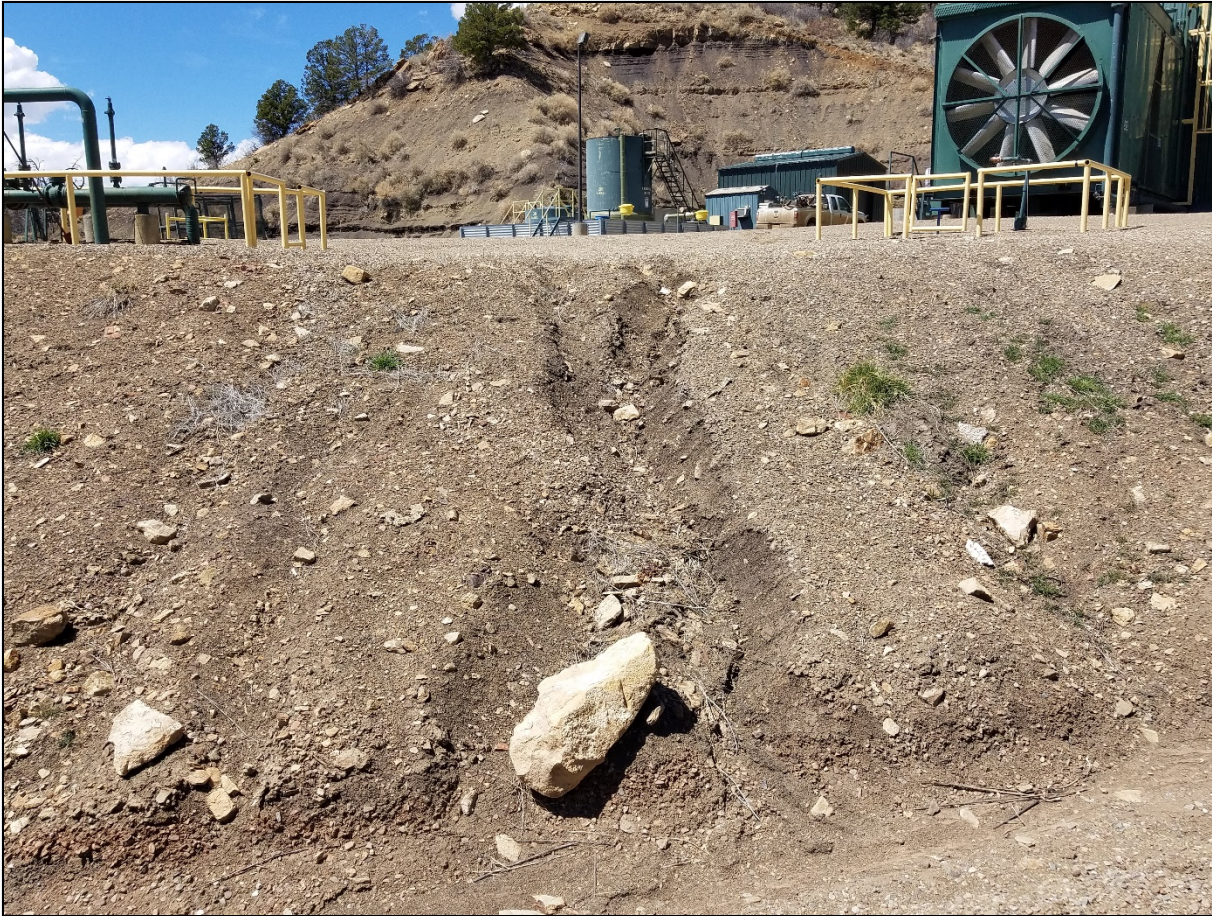
Photo 6. There are erosion issues off the east side of the pad.

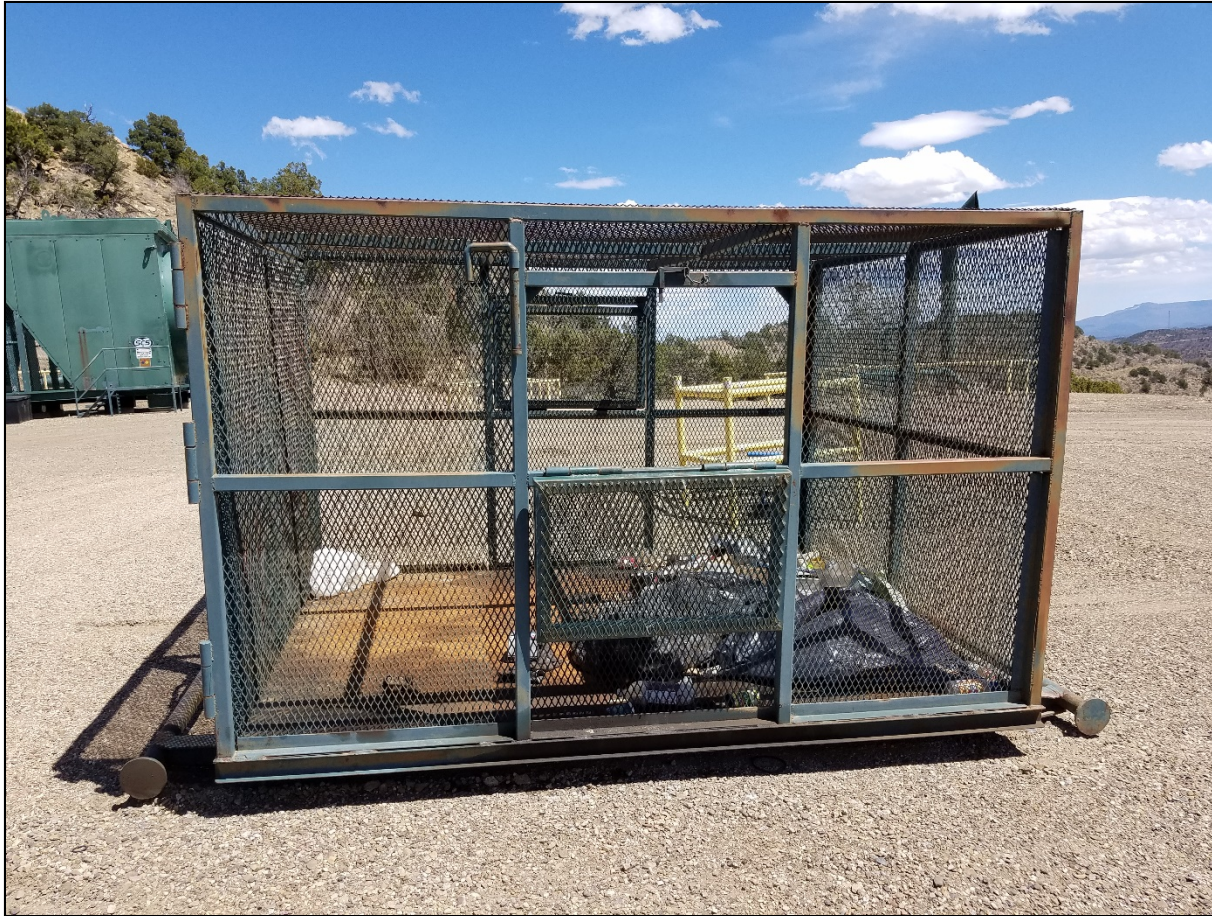
Photo 7. The door on the trash container is open. It was noticed that there was some trash that blew out.

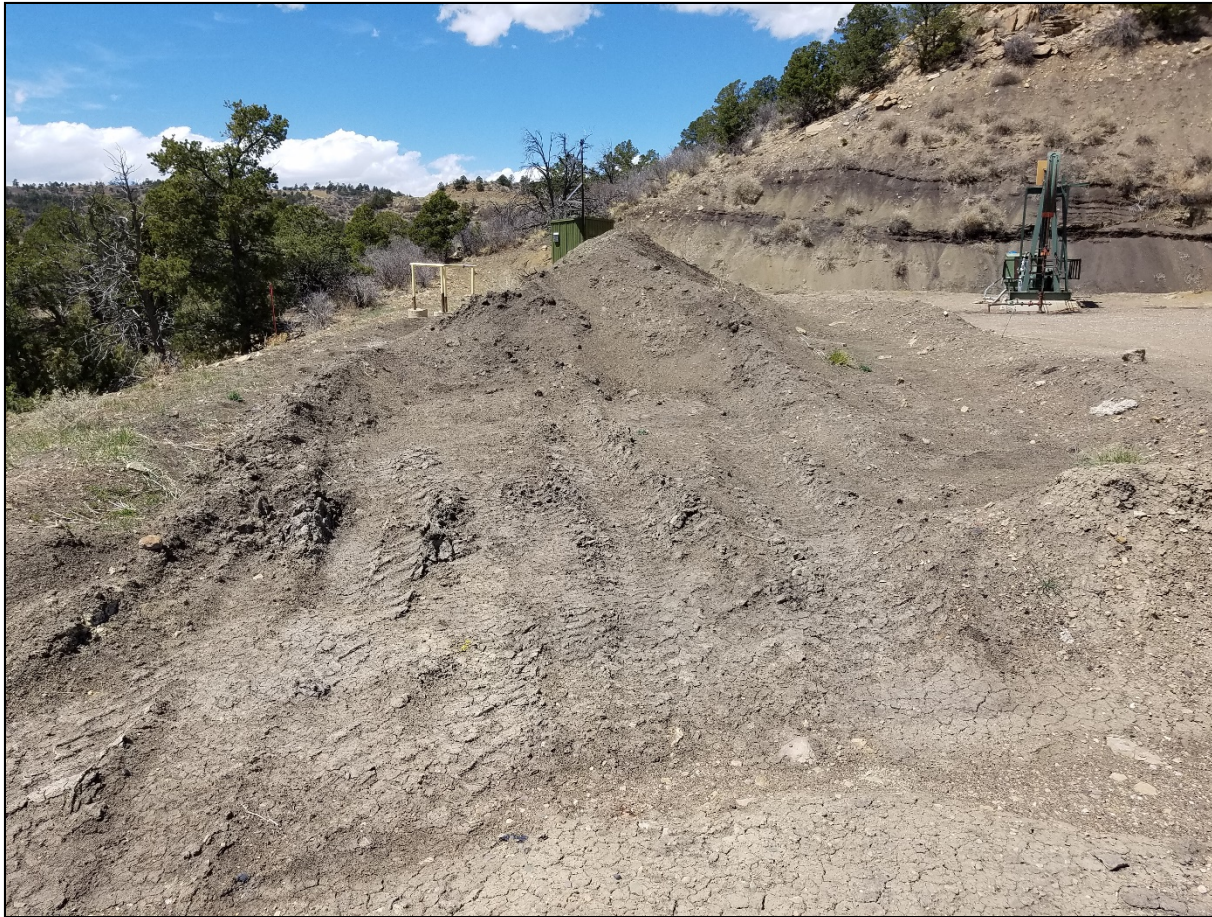
Photo 8. The berm around the soil pile has been removed.

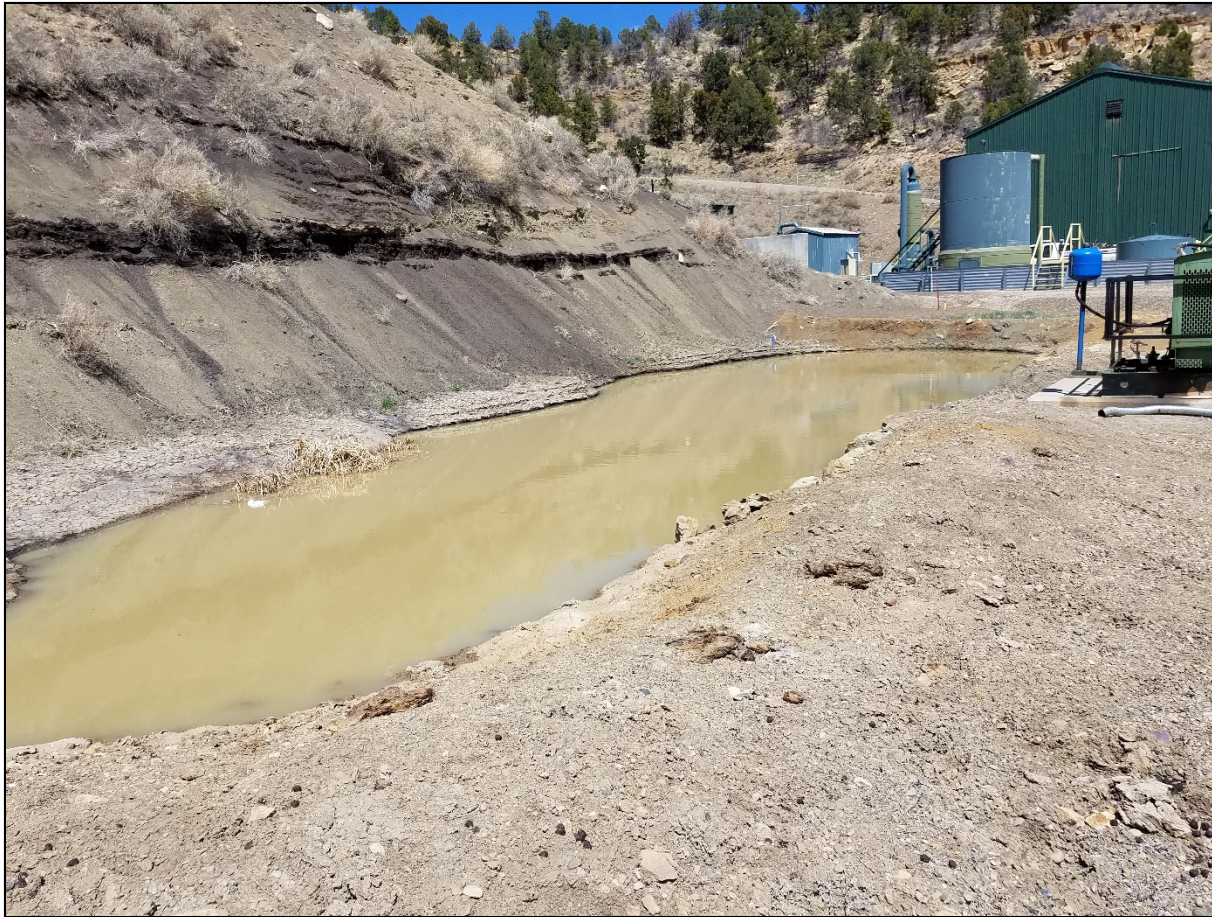
Photo 9. Pit at the location has 2ft. Freeboard and marker.

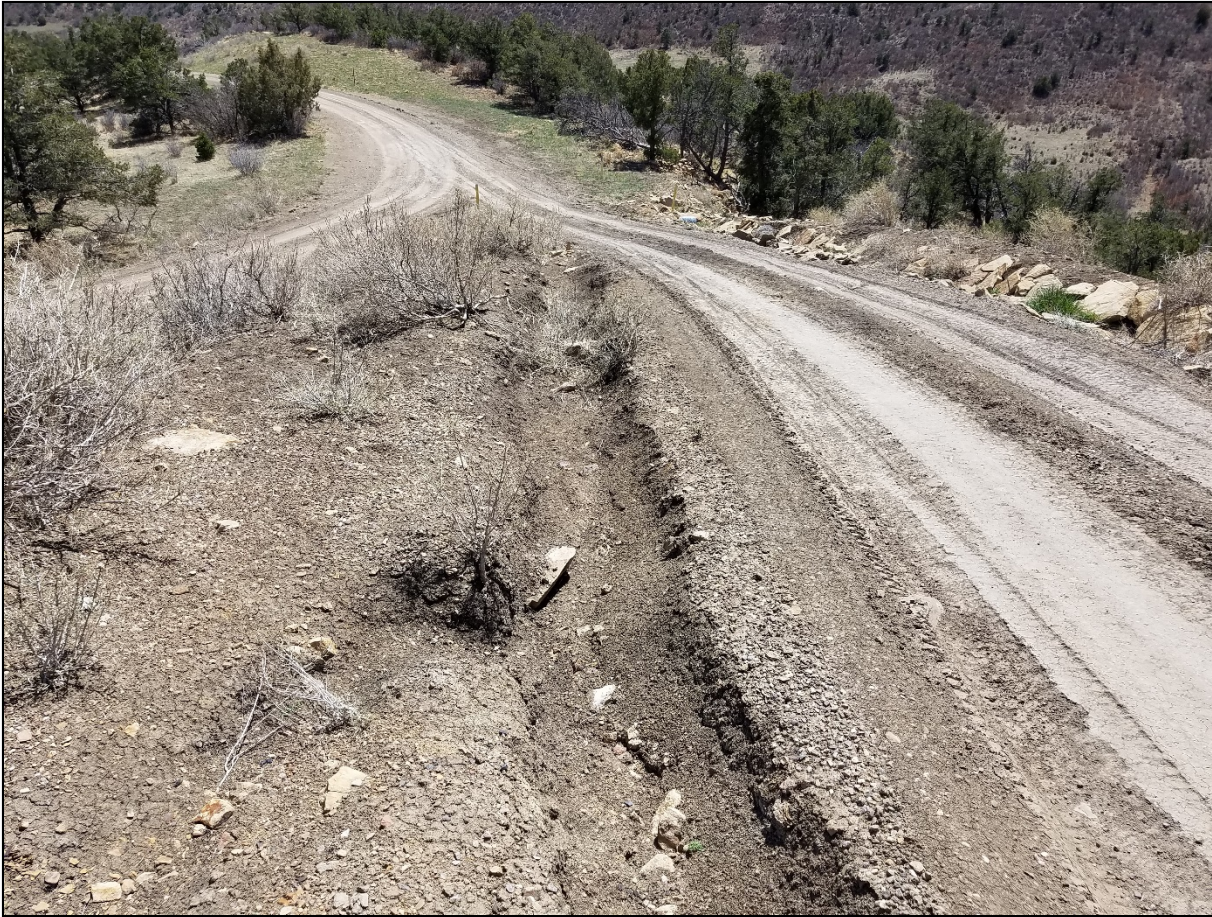
Photo 10. South access road has signs of erosion. BMP's are needed to prevent further erosion.

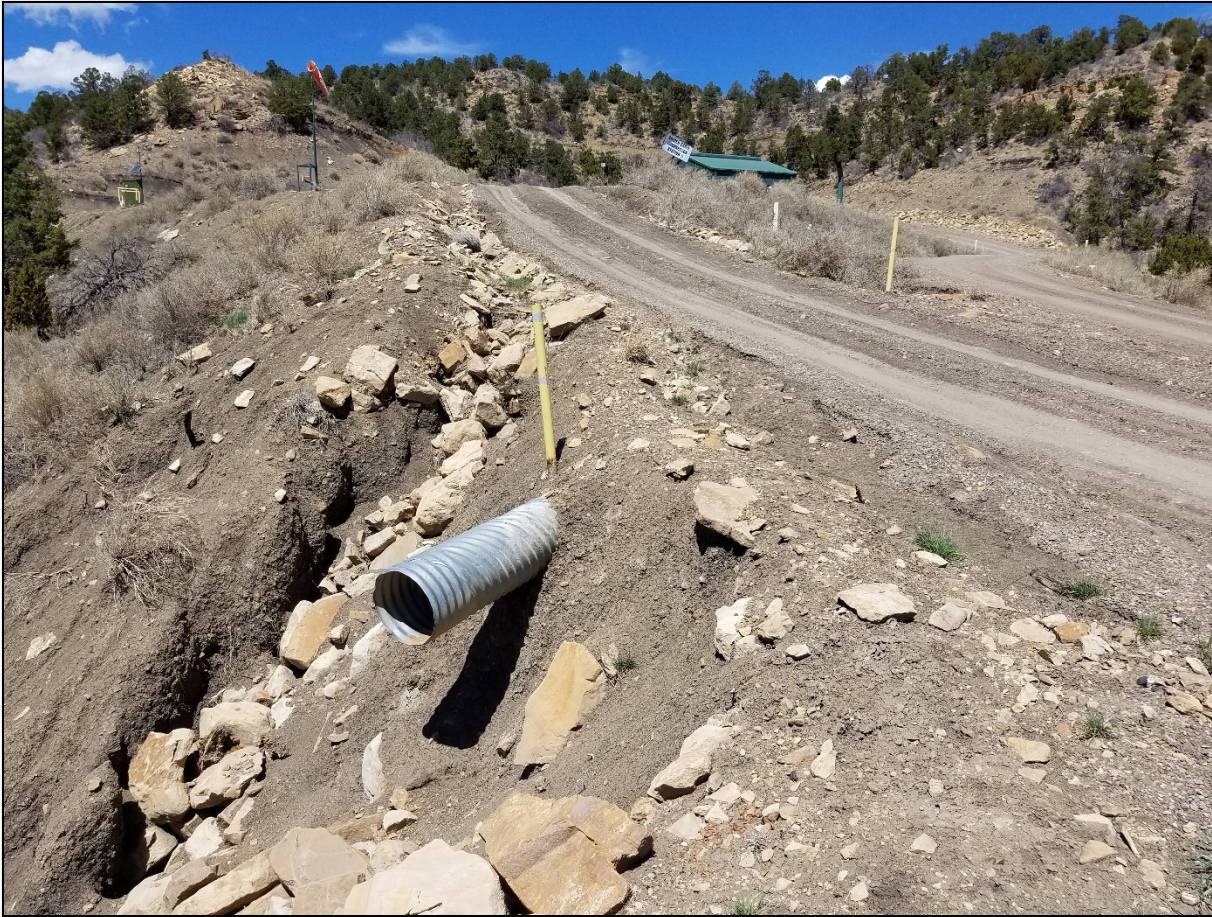
Photo 11. The culvert at the access road has had erosion issues. More rip/rap may be needed in this area.
