Inspection Photos
Location Name: CRYSTAL 13-4
API #: 05-071-06360
Insp. Doc. # 695100528

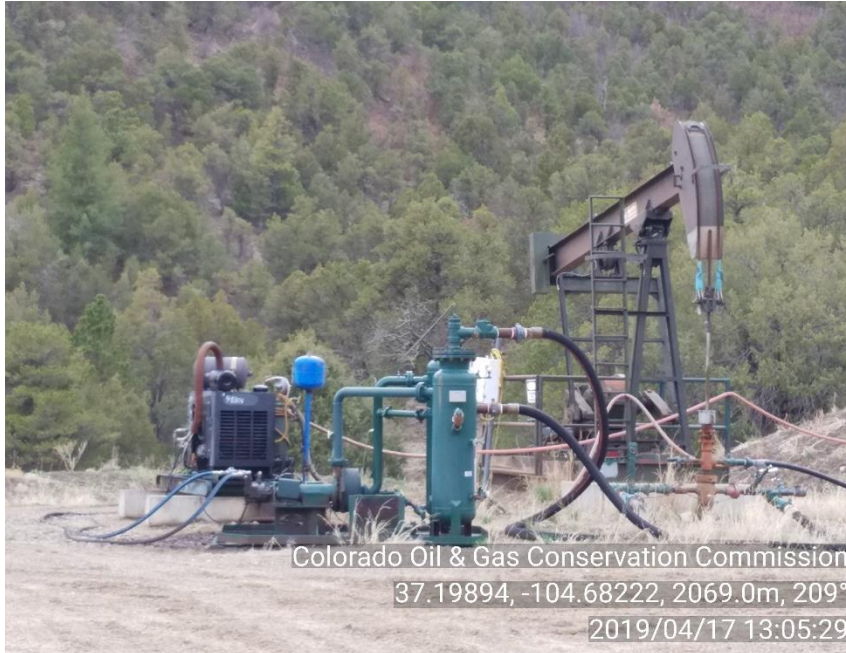
PHOTO 1: LOCATION

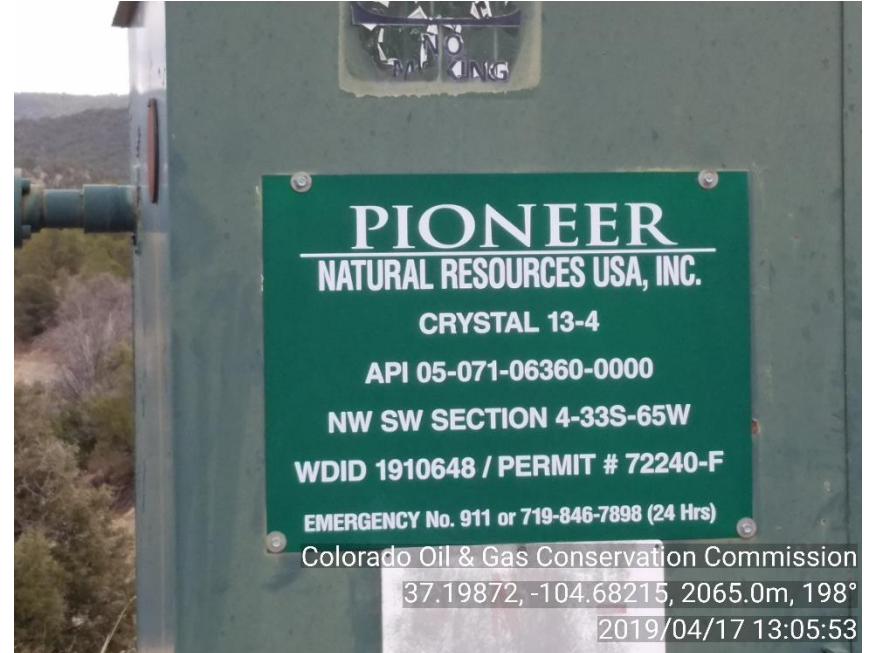
PHOTO 2: METER HOUSE/WELL SIGN

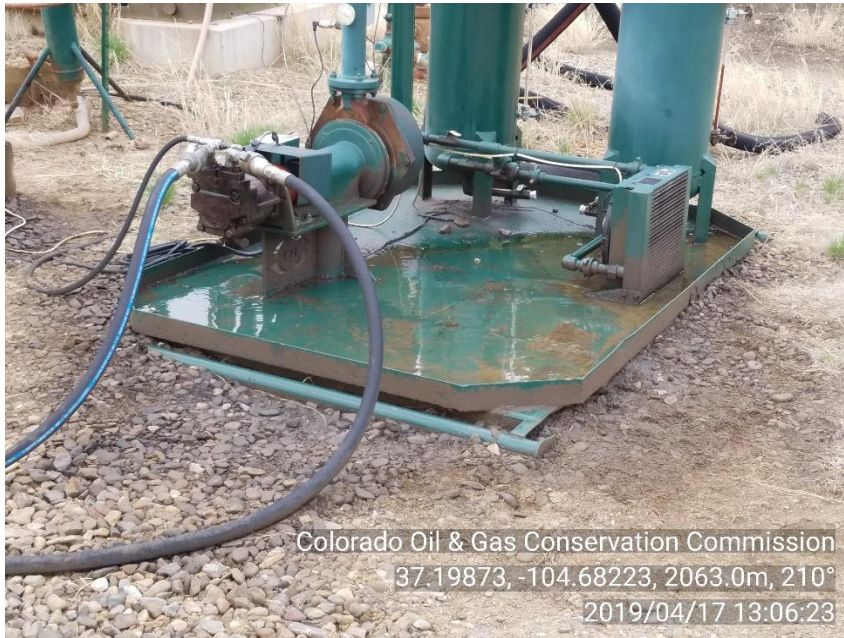
PHOTO 3: IMPACTED SOIL ALL AROUND COMPRESSOR SKID

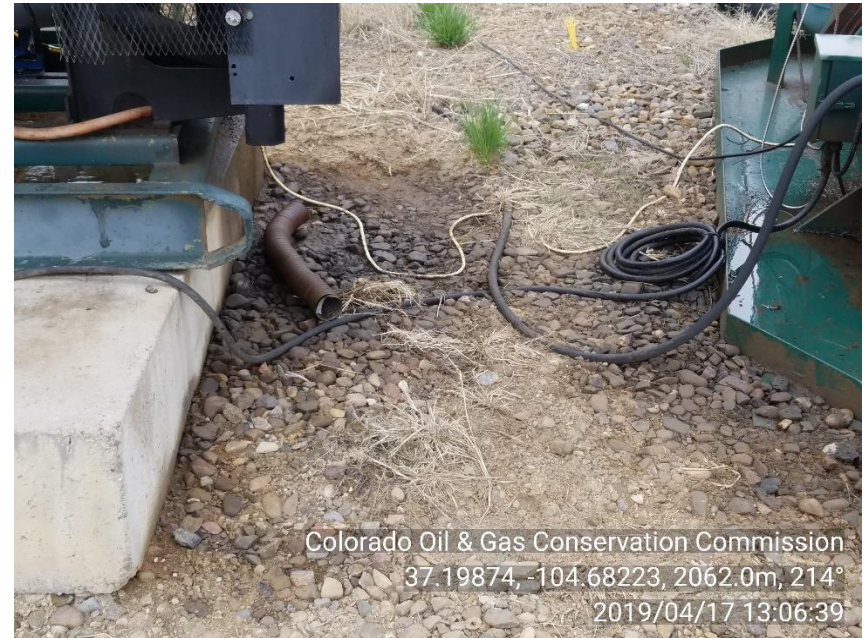
PHOTO 4: IMPACTED SOIL ON WEST SIDE OF COMPRESSOR PRIME MOVER SKID.

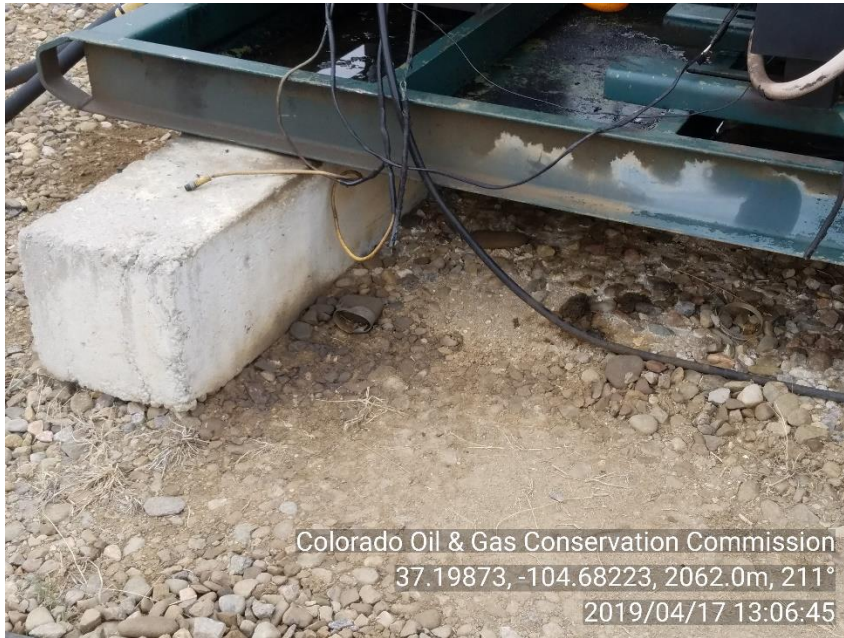
PHOTO 5: IMPACTED SOIL ON NORTH SIDE OF COMPRESSOR PRIME MOVER SKID.

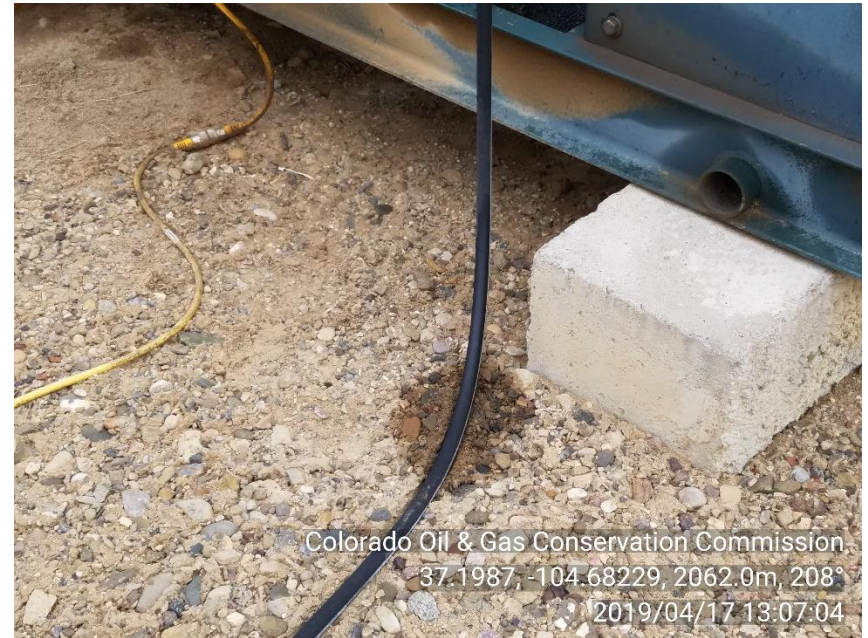
PHOTO 6: IMPACTED SOIL ON SOUTH SIDE OF COMPRESSOR PRIME MOVER SKID.

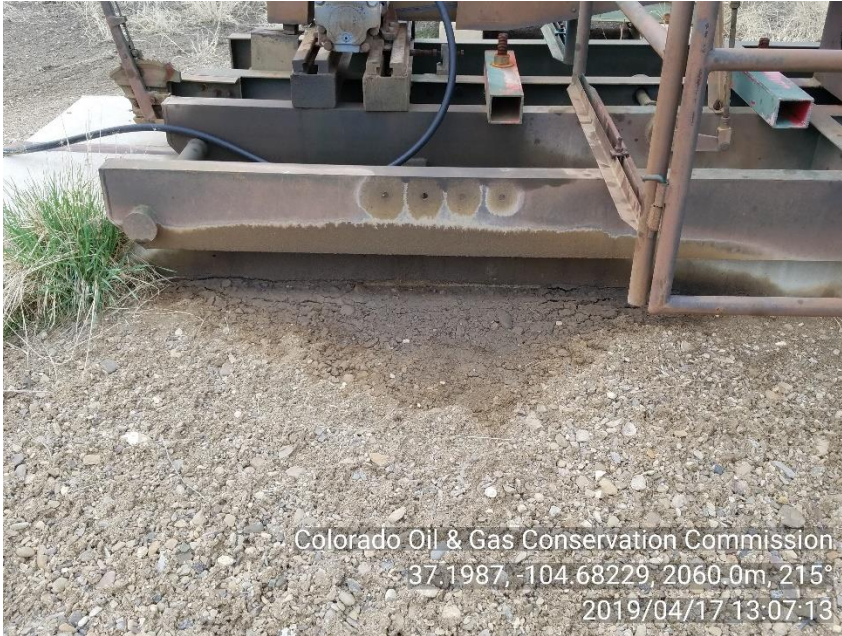
PHOTO 7: IMPACTED SOIL ON NORTH SIDE OF PUMPJACK HYDRAULIC MOTOR.

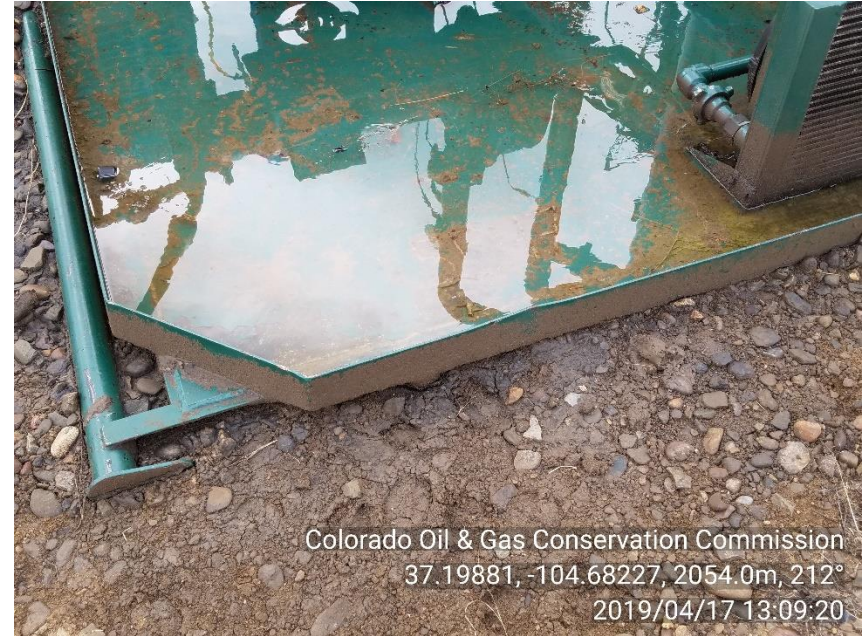
PHOTO 8: APP. 2" OF STANDING WATER WITH OIL CONTAMINATION IN COMPRESSOR SKID IS WITHIN APP. 2" FROM RUNNING OVER
