Inspection Photos  
Operator: BP America  
Location/API #: 067-05202  
Date: 4-9-2019

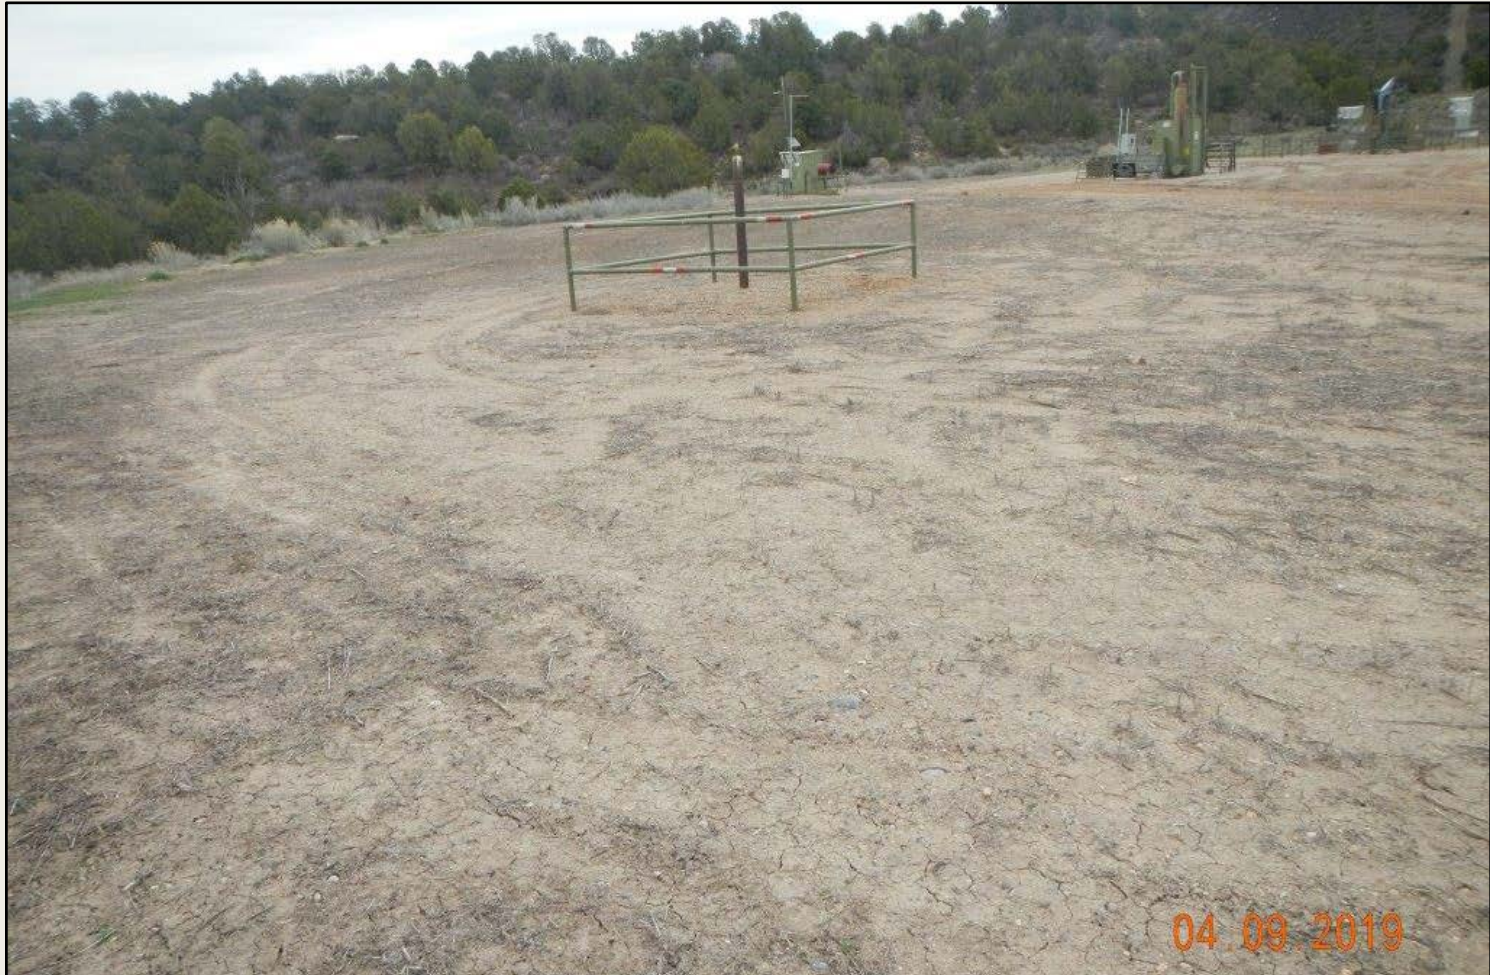
Photo 1. View of the project area from the northeastern corner facing center. Area around the plugged well does not appear necessary for production operations related to the producing well, and needs to be reclaimed.

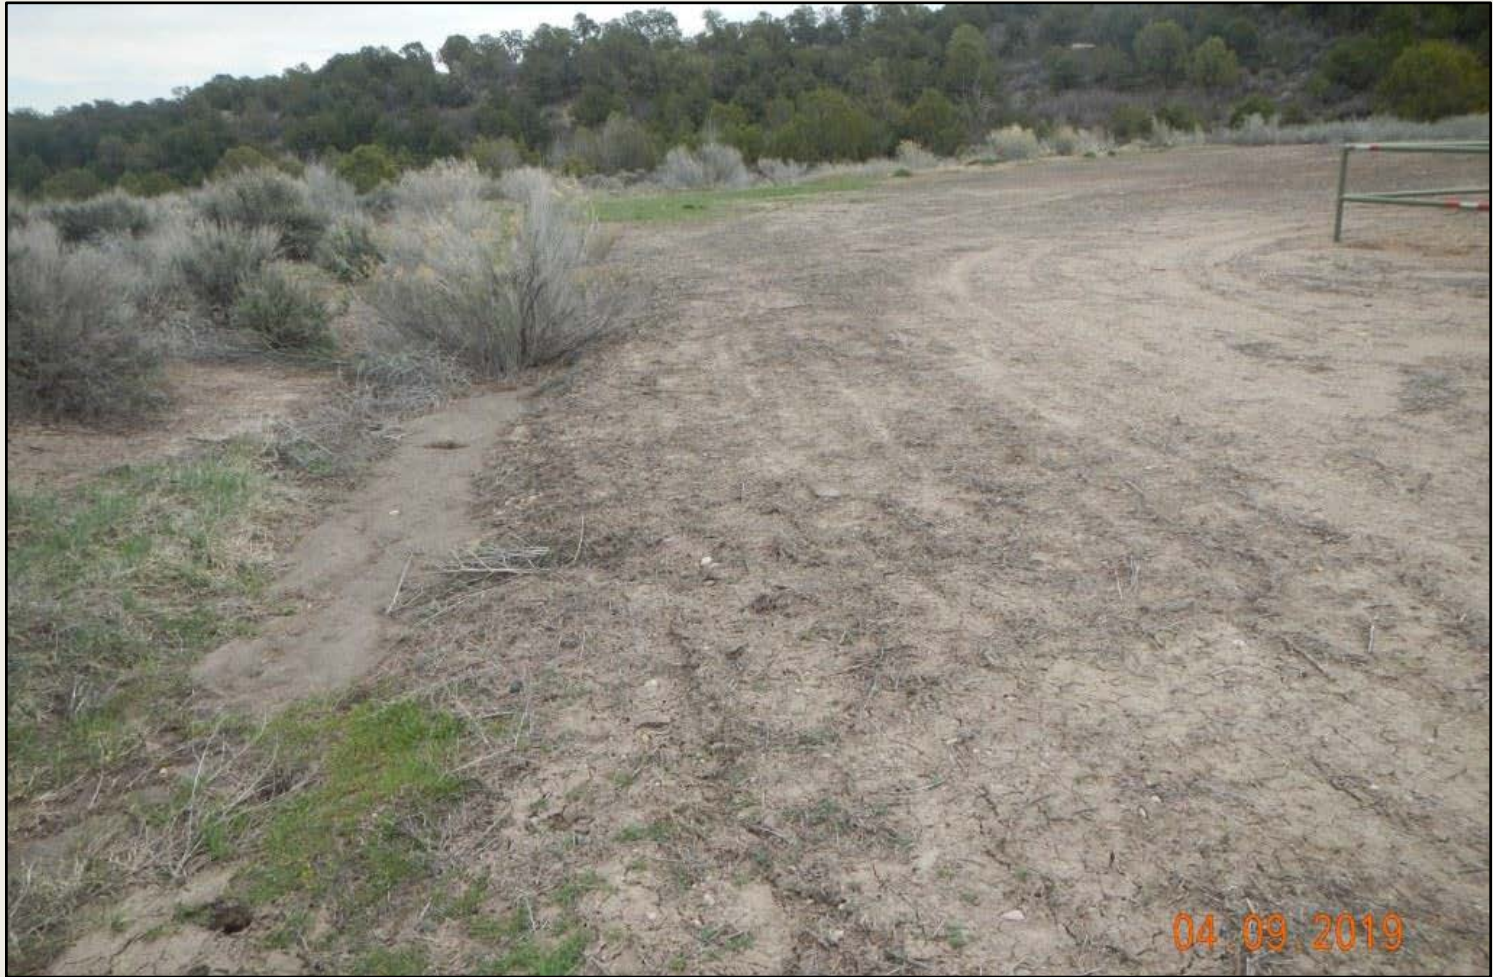
Photo 2. View of the eastern project area from the northeastern corner facing southward.

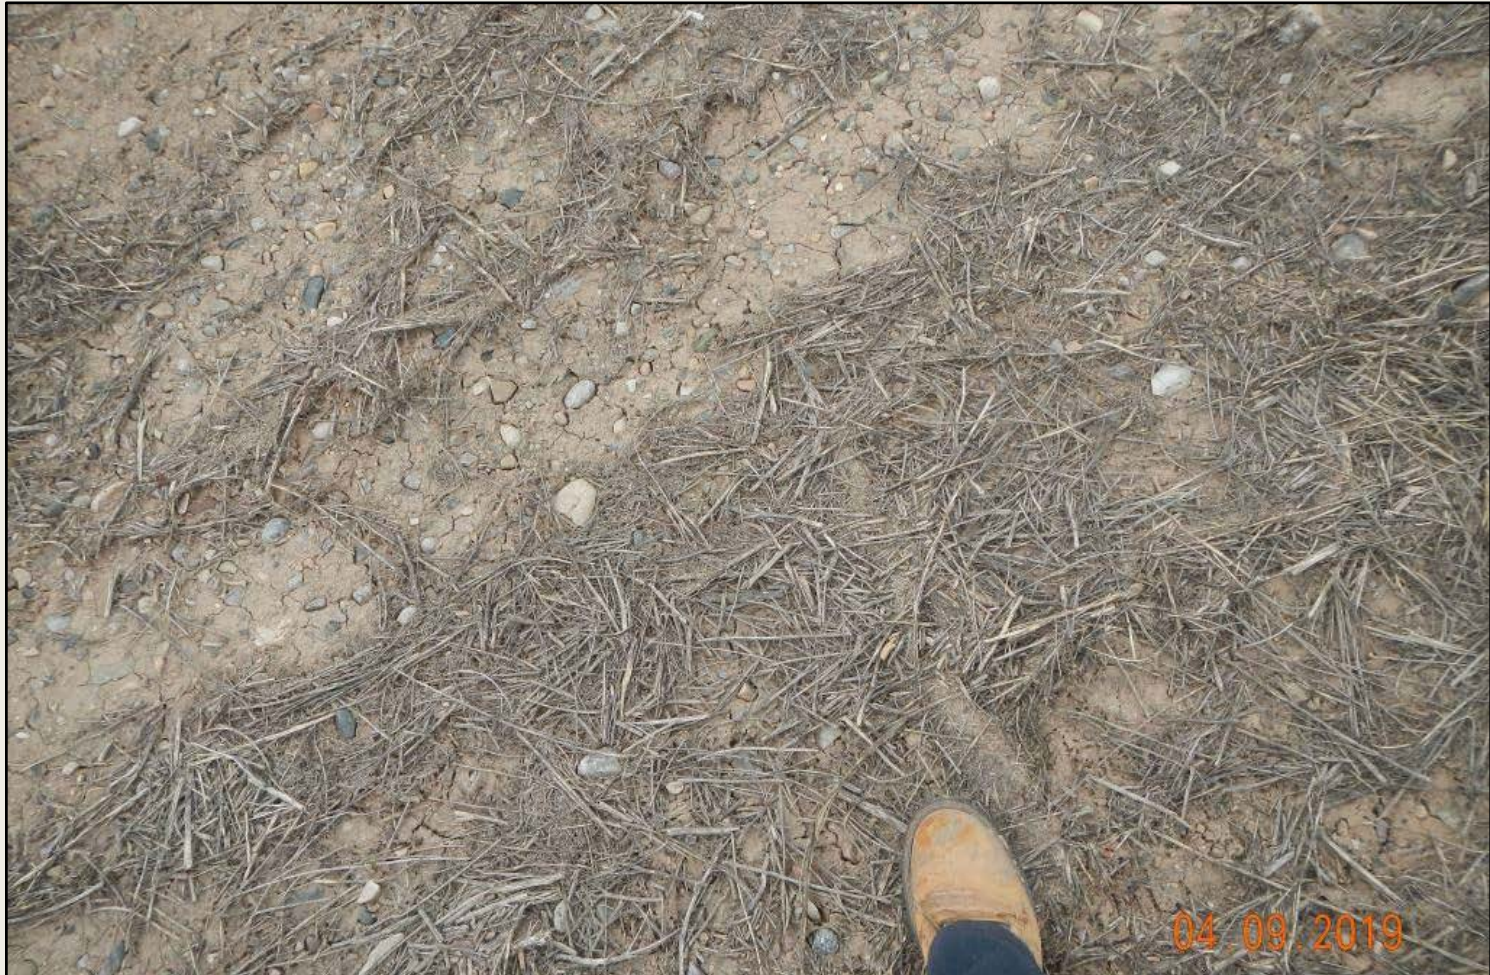
Photo 3. View of what appears to be mowed annual vegetation around plugged well.

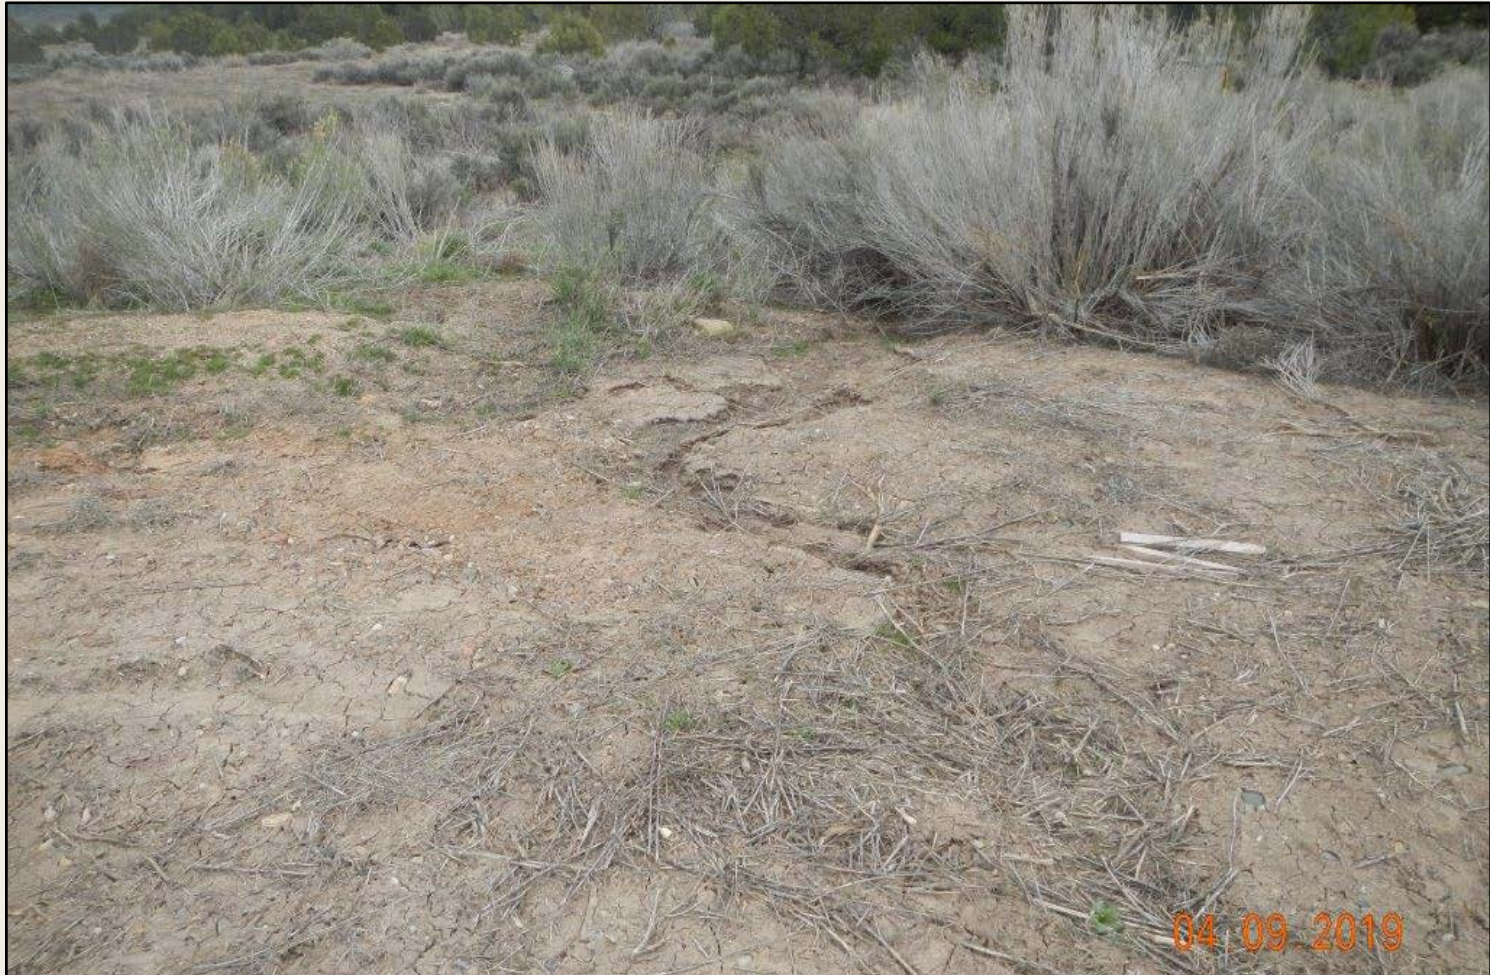
Photo 4. View of erosional channel within the eastern project area.

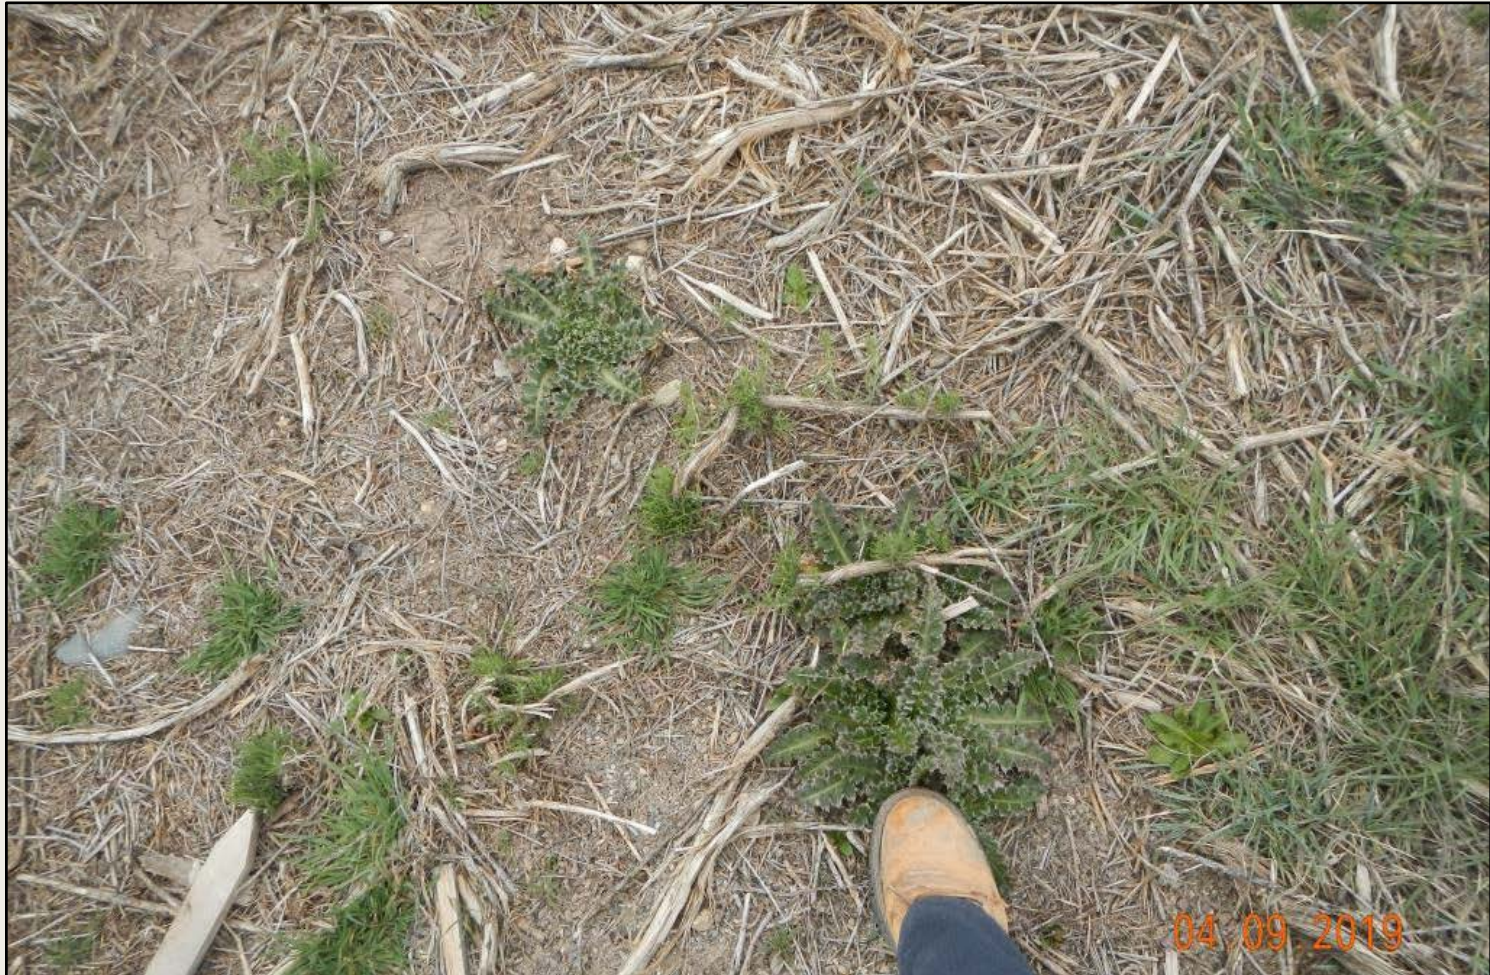
Photo 5. View of musk thistle (*Carduus nutans*) rosettes within the eastern project area.
