Inspection Photos

Operator: D90 ENERGY LLC - 10706

Location ID: 435480

Inspection Doc. Number: 682504787

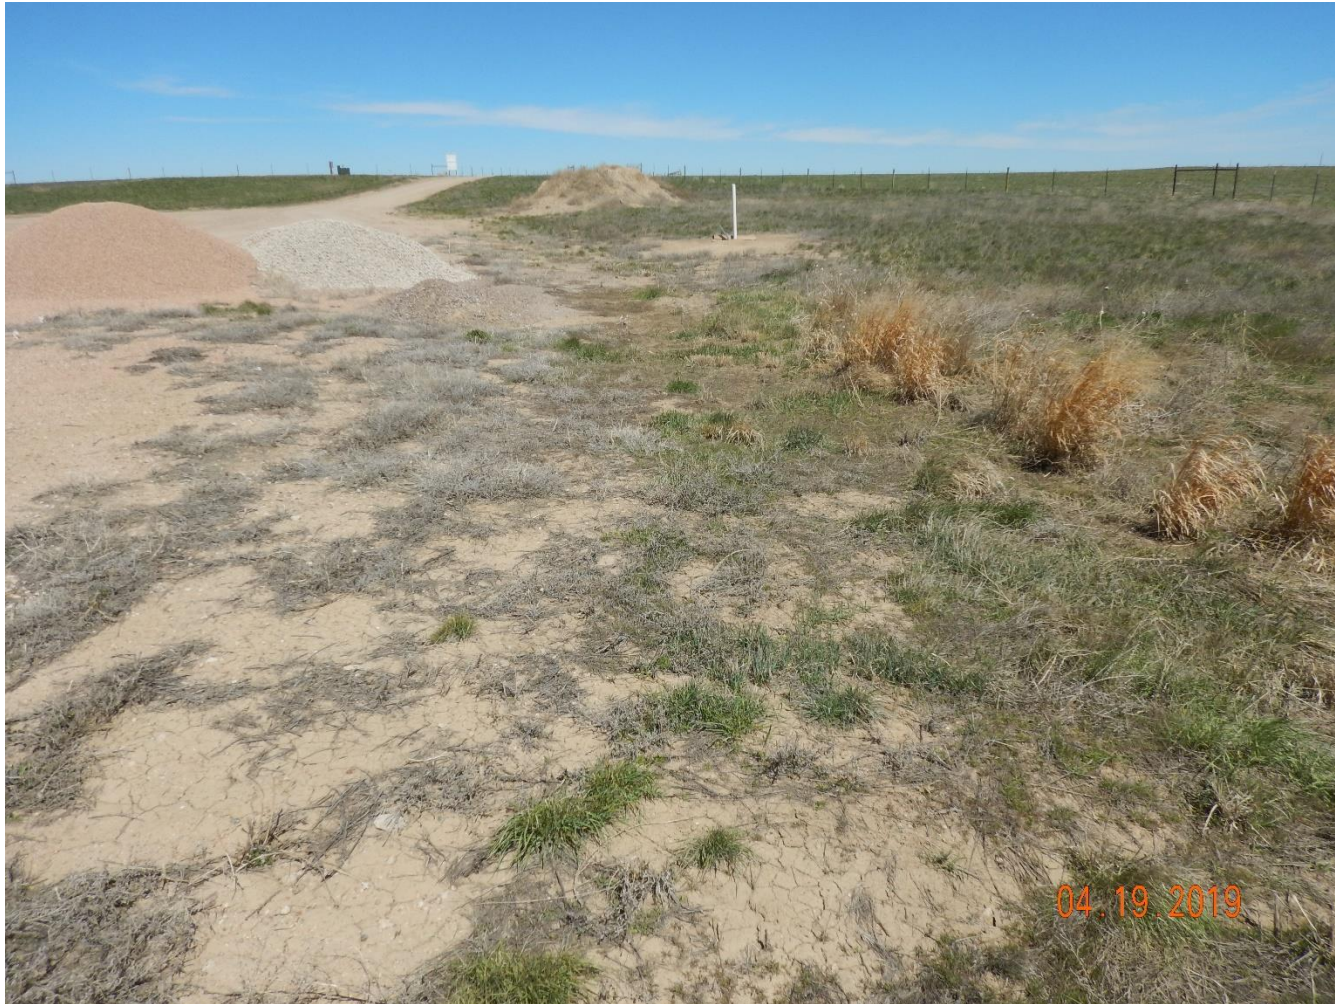
Photo 2: Photo taken from the southeast end of the location, facing north. Photo shows interim and production areas.

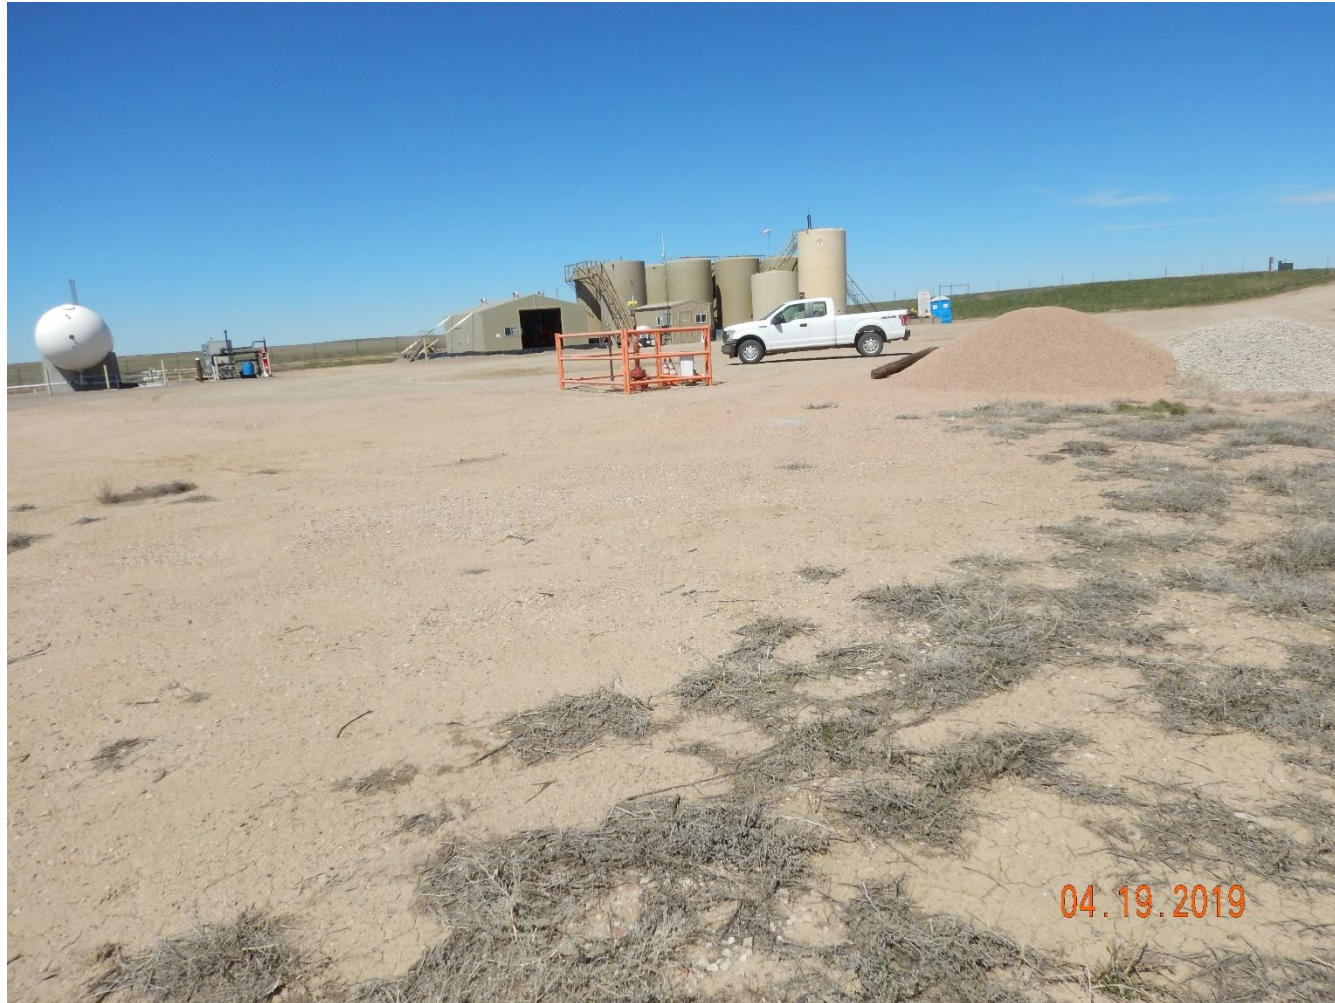
Photo 3: Photo taken from the southeast end of the location, facing northwest. Photo shows interim and production areas.

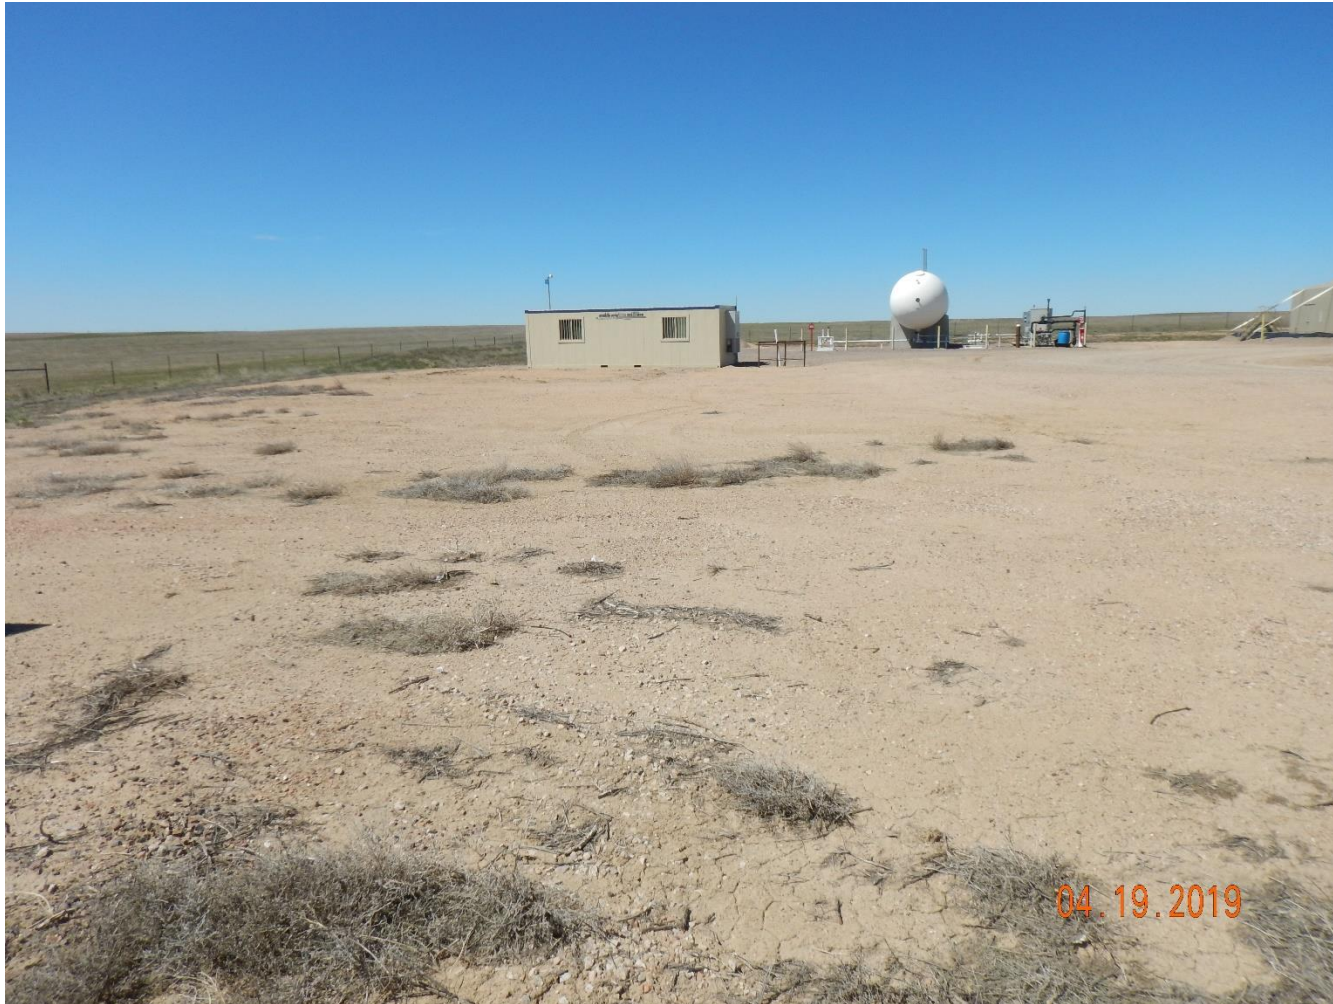
Photo 4: Photo taken from the southeast end of the location, facing west. Photo shows interim and production areas.

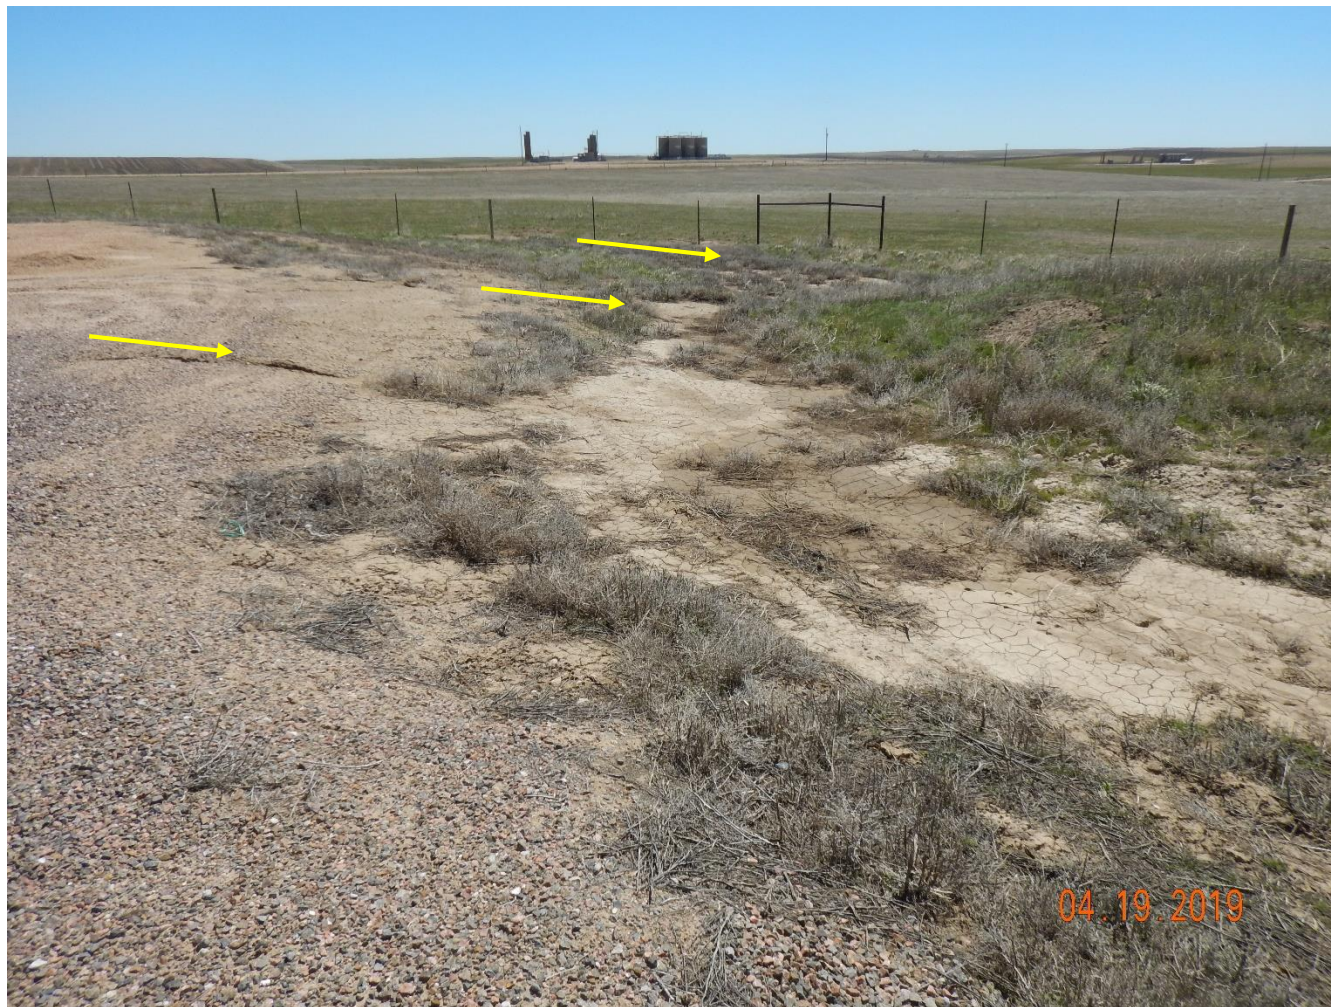
Photo 5 Photo taken from the south end of the location. Photo shows insufficient stormwater BMPs to allow for sediment laden free stormwater discharge from the location. Photo shows erosion degradation and stormwater runoff transporting sediment beyond location onto adjacent lands.

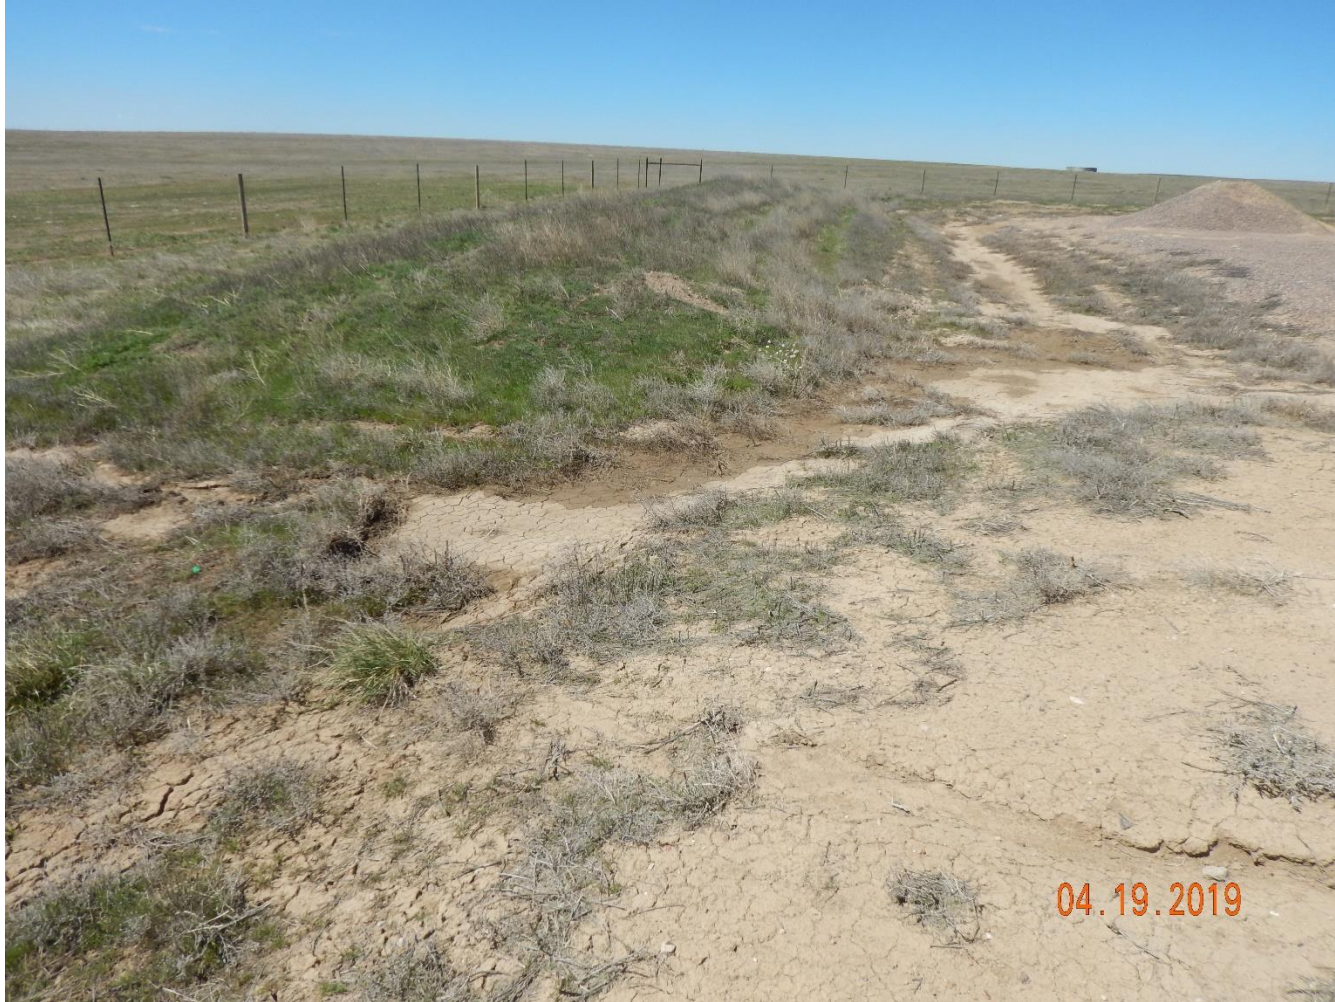
Photo 6: Photo taken from the south end of the location. Photo shows insufficient stormwater BMPs at the ditch to allow for sediment laden free stormwater discharge from the location.

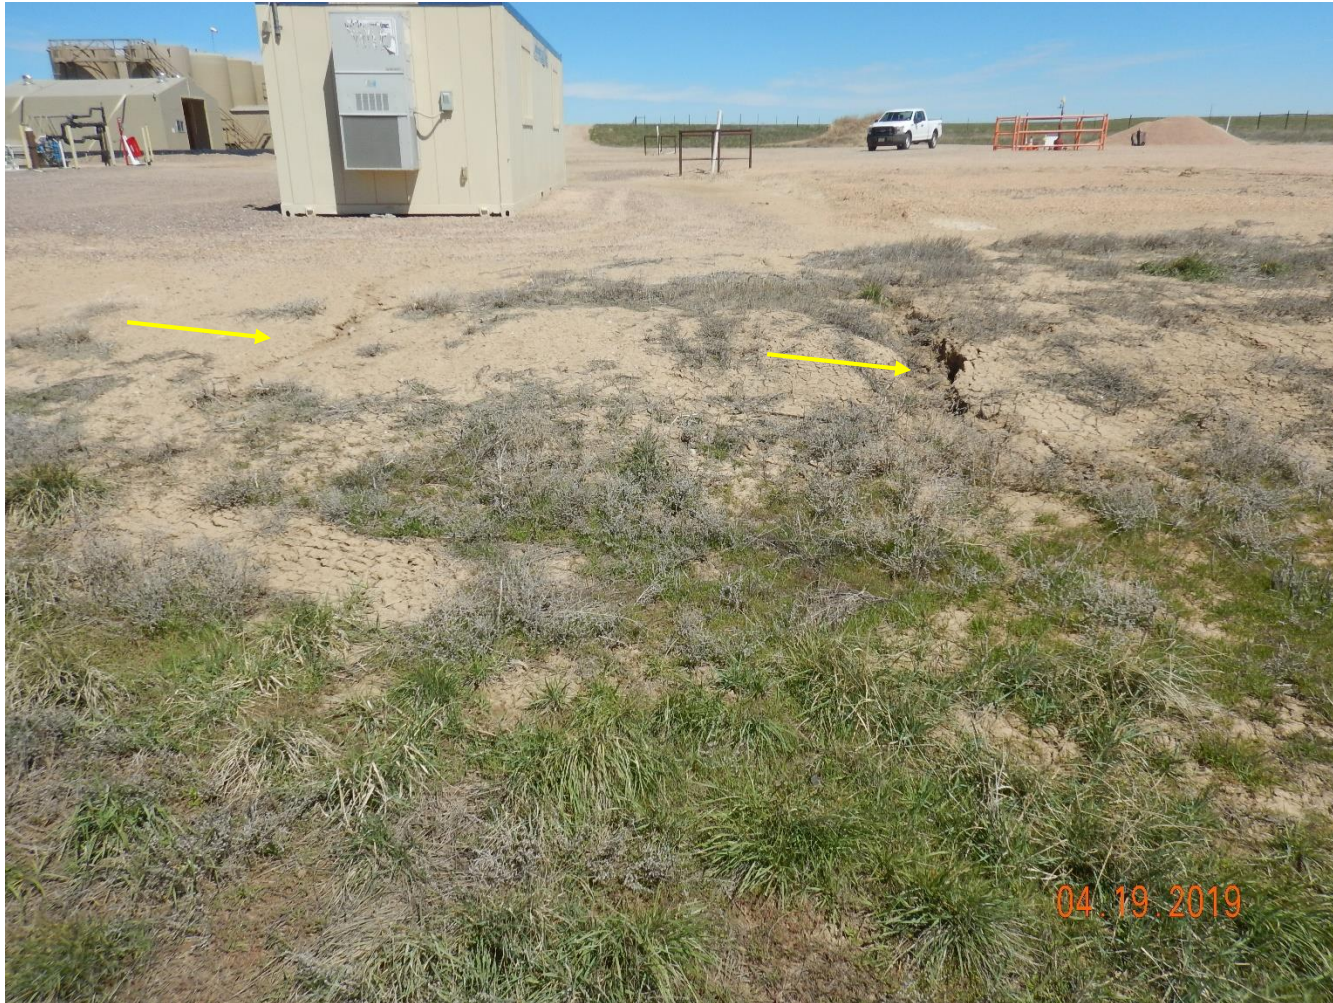
Photo 7: Photo shows stormwater erosion degradation on location/interim areas.

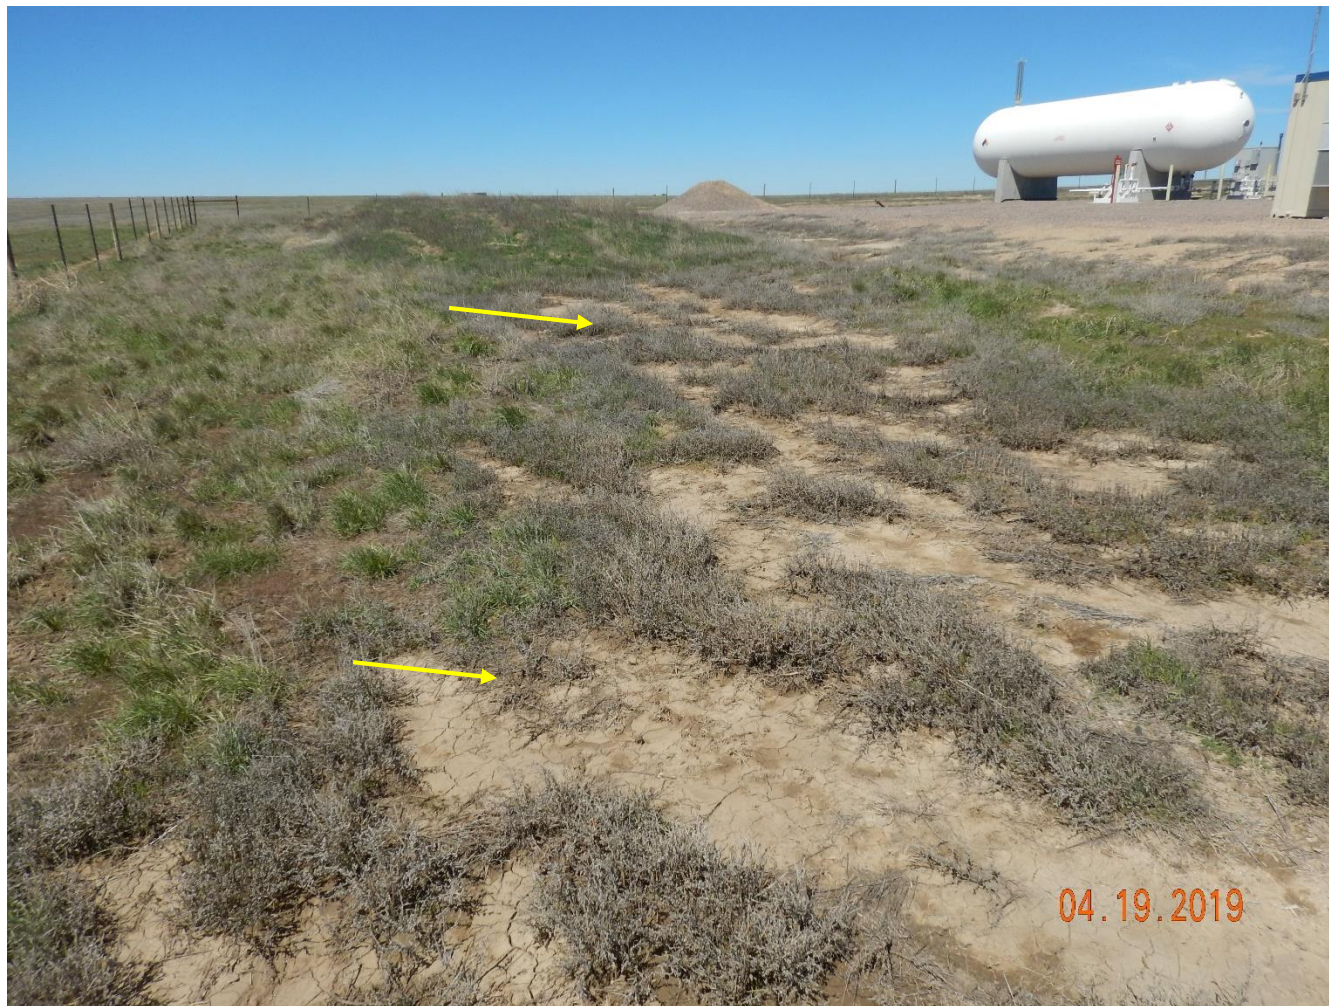
Photo 8: Photo taken from the southeast end of the location, facing west. Photo shows insufficient stormwater BMPs at the ditch to allow for sediment laden free stormwater discharge from the location. Photo also shows sediment deposition on the interim area.

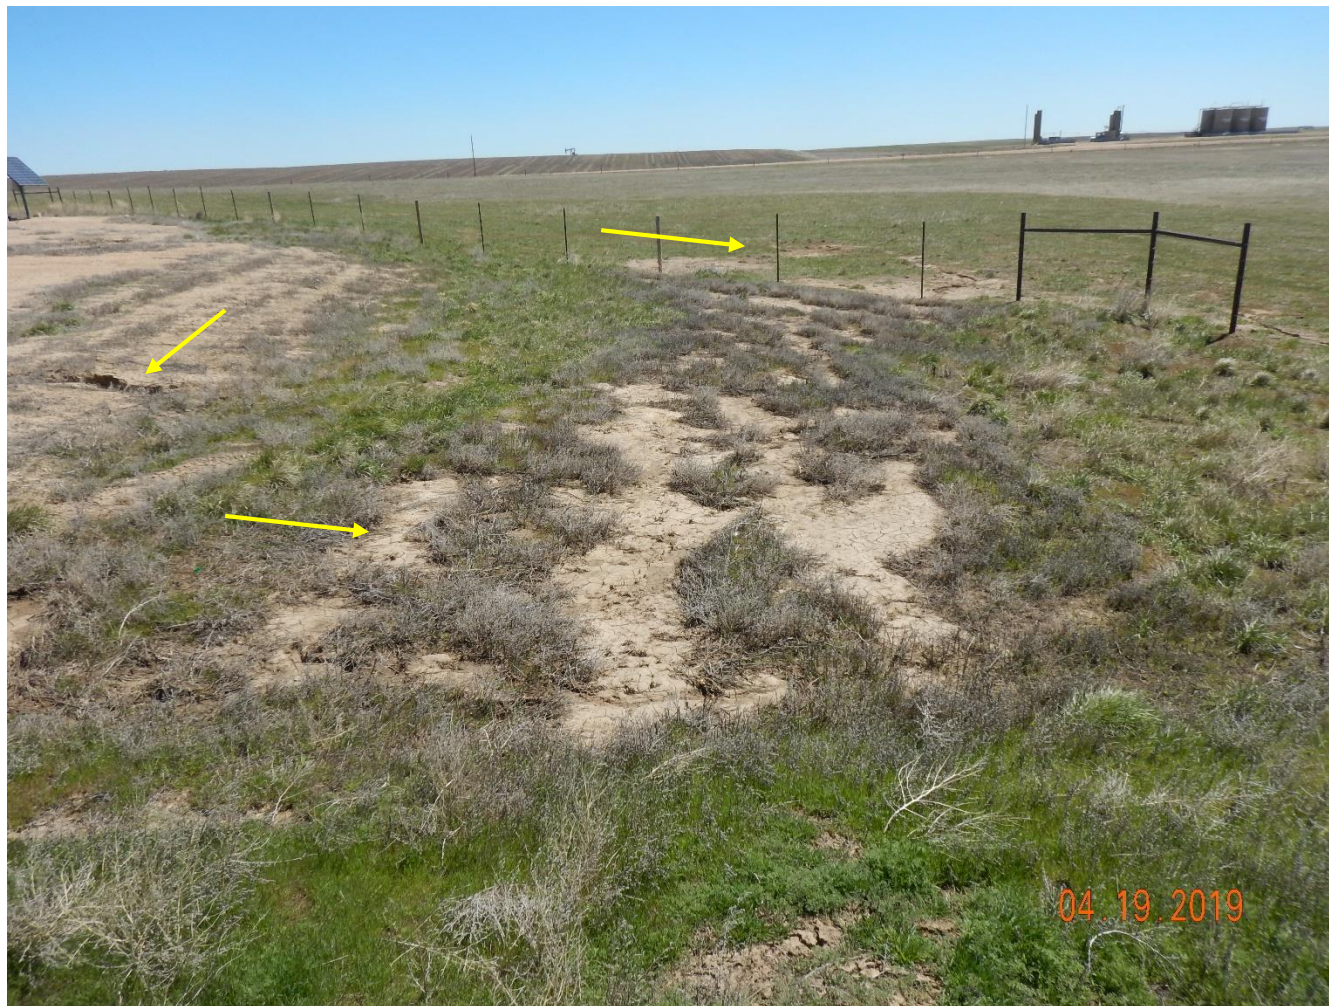
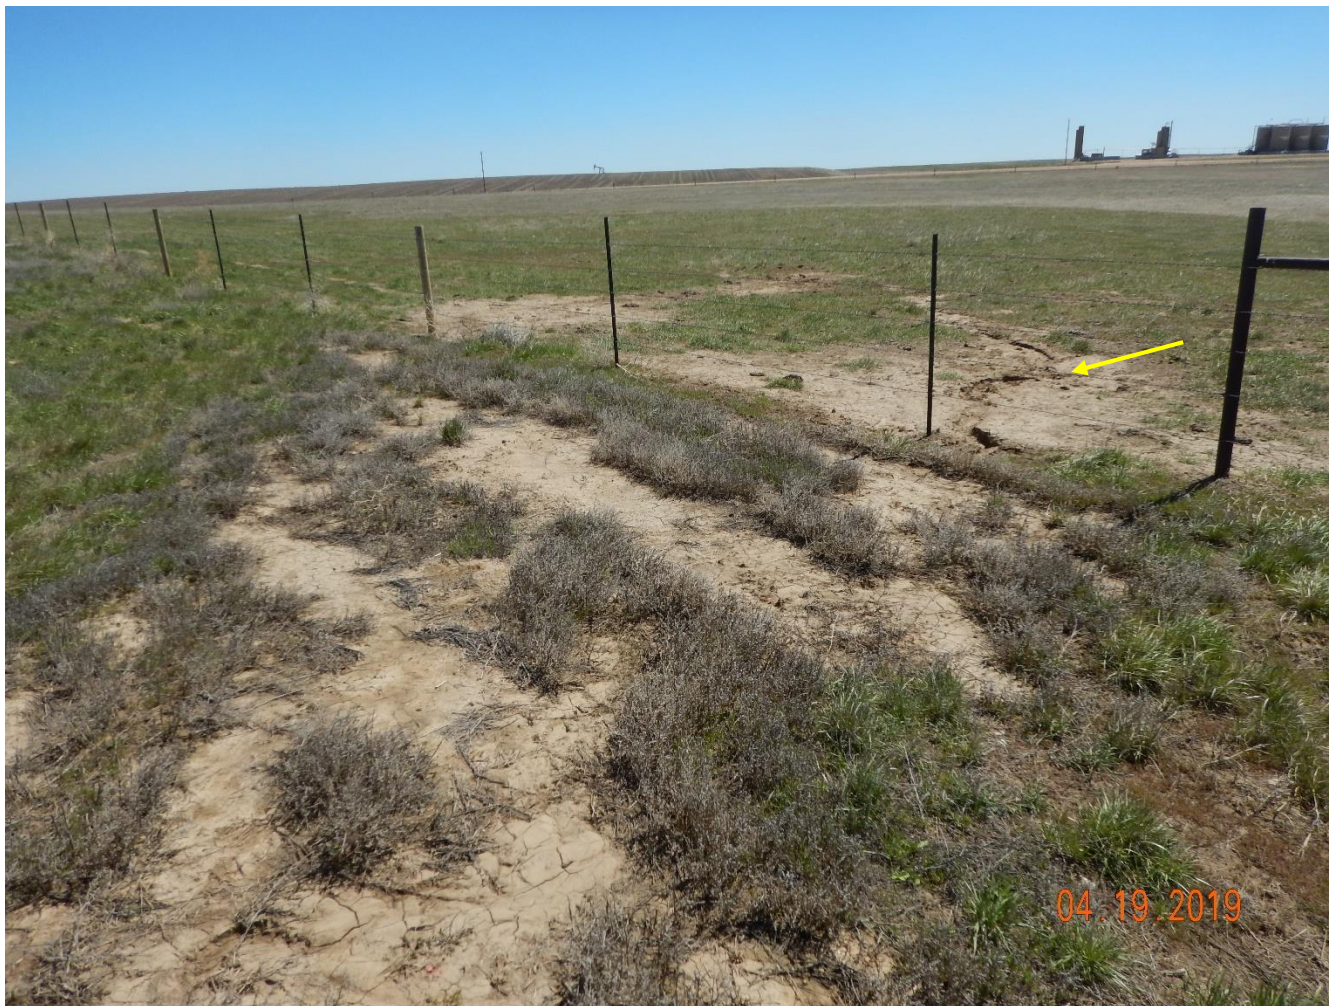
Photo 9: Photo taken from the southeast end of the location, facing east. Photo shows insufficient stormwater BMPs to allow for sediment laden free stormwater discharge from the location. Photo also shows erosion degradation, and sediment deposition on the interim area and areas off location.

Photo 10: See comments under photo 9.

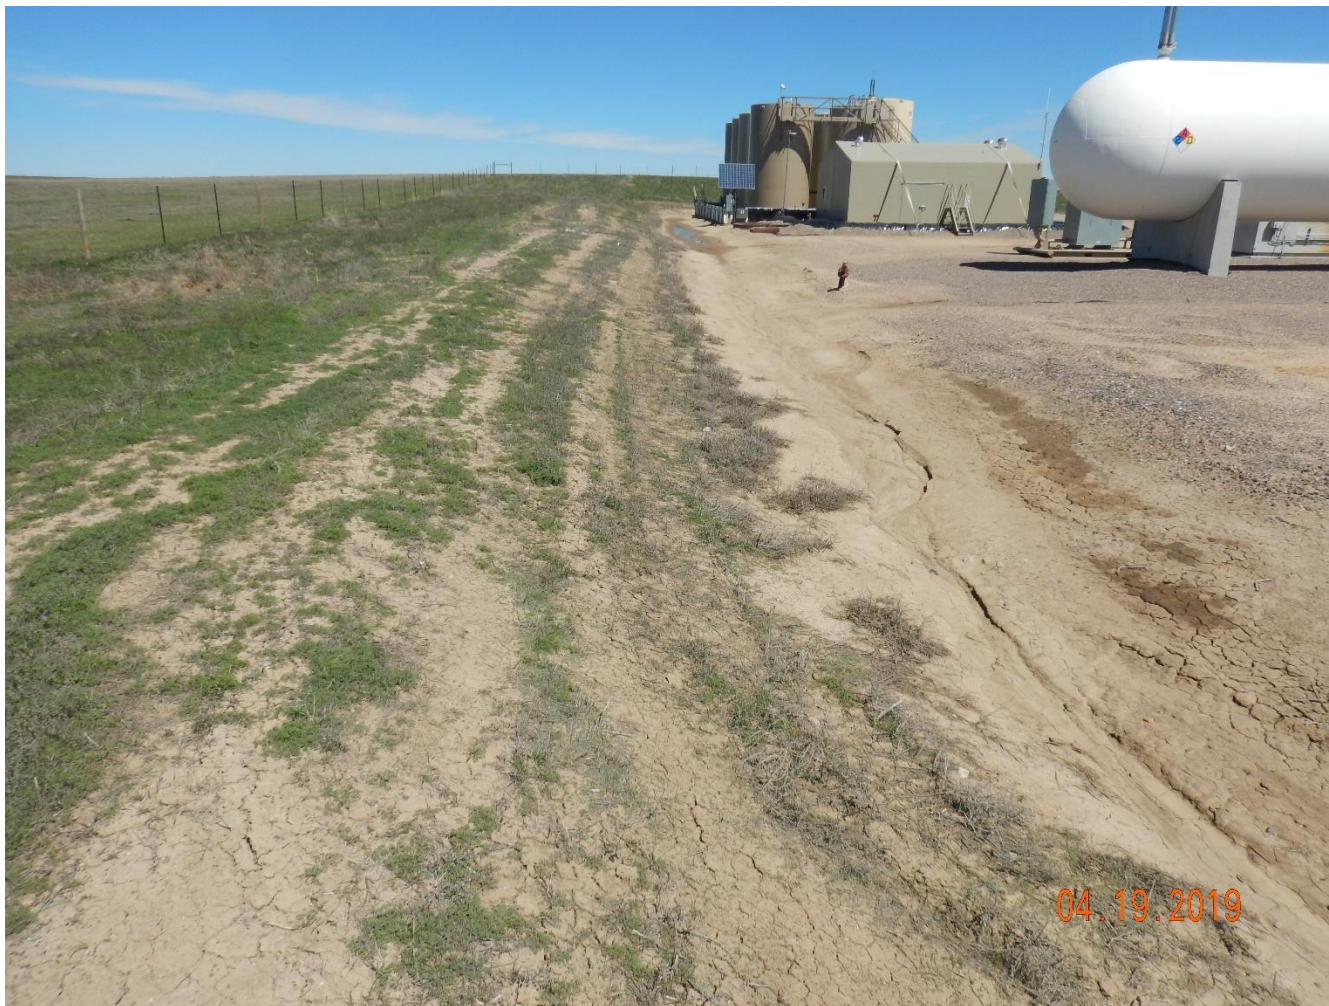
Photo 11: Photo taken from the southwest end of the location, facing north. Photo shows interim and production areas. Photo also shows perimeter stormwater ditch.

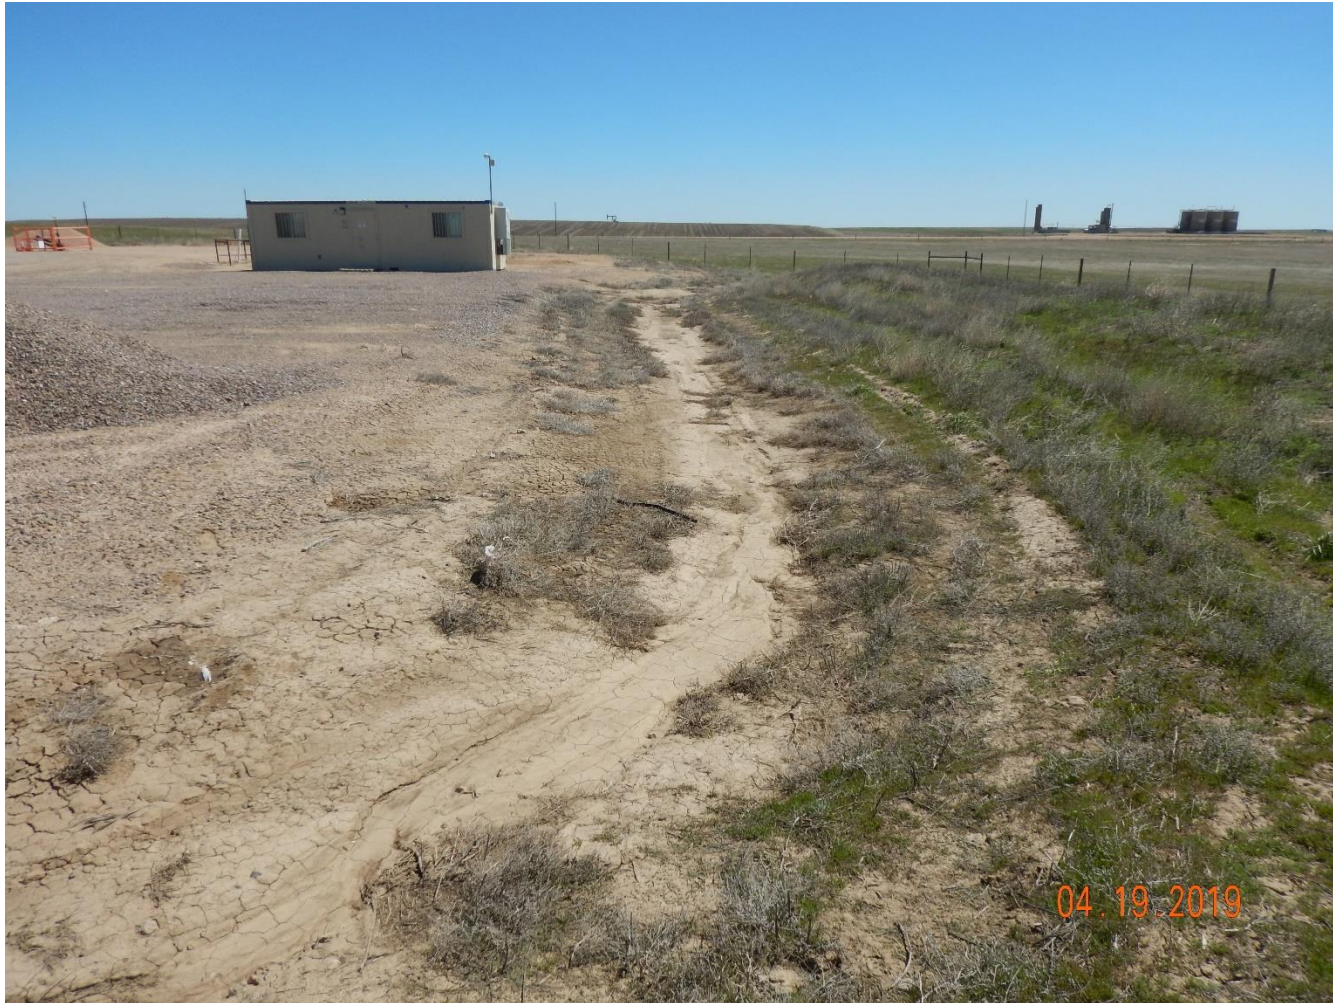
Photo 12: Photo taken from the southwest end of the location, facing east. Photo shows interim and production areas. Photo also shows perimeter stormwater ditch.

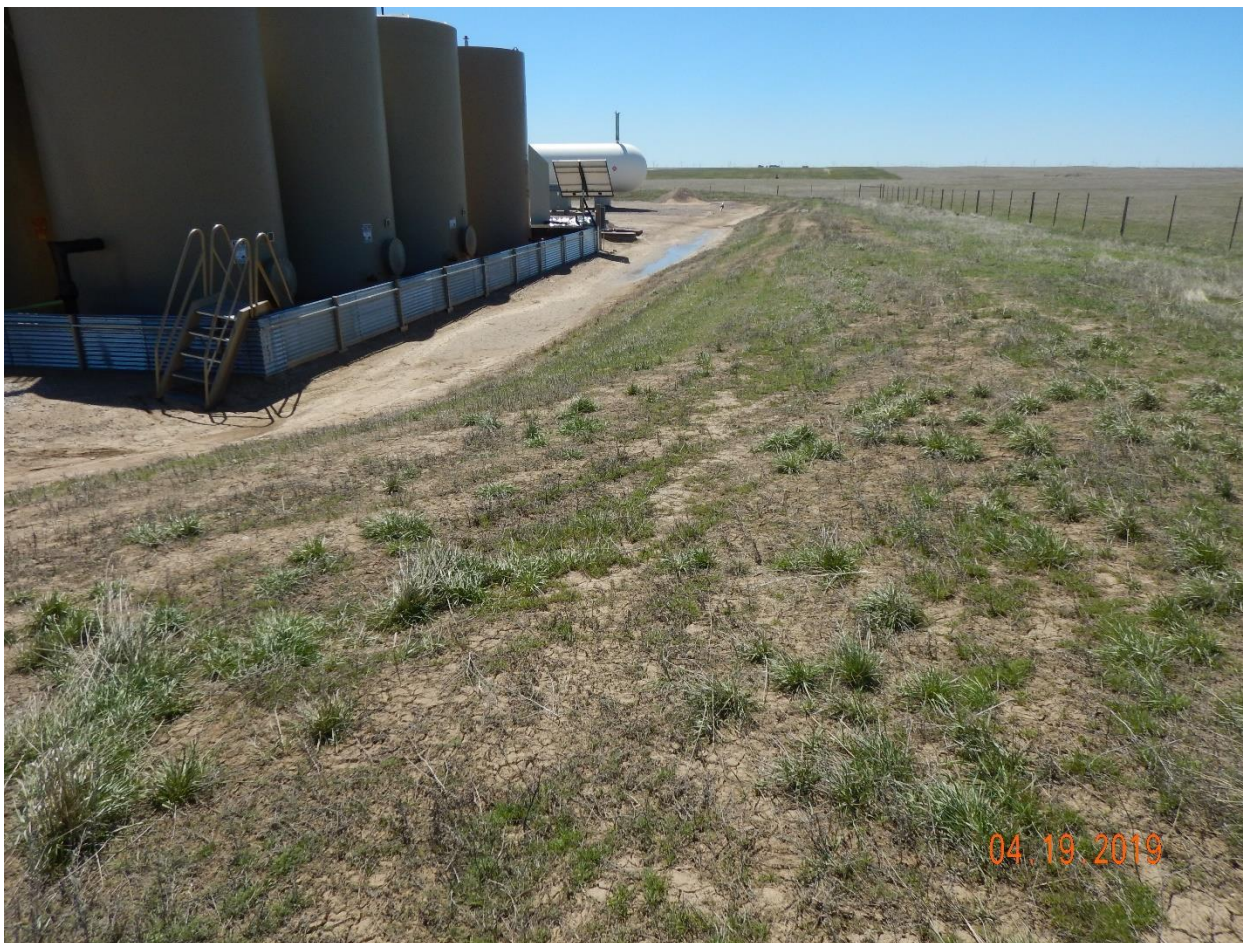
Photo 13: Photo taken from the northwest end of the location, facing south. Photo shows interim and production areas. Photo also shows perimeter stormwater ditch.

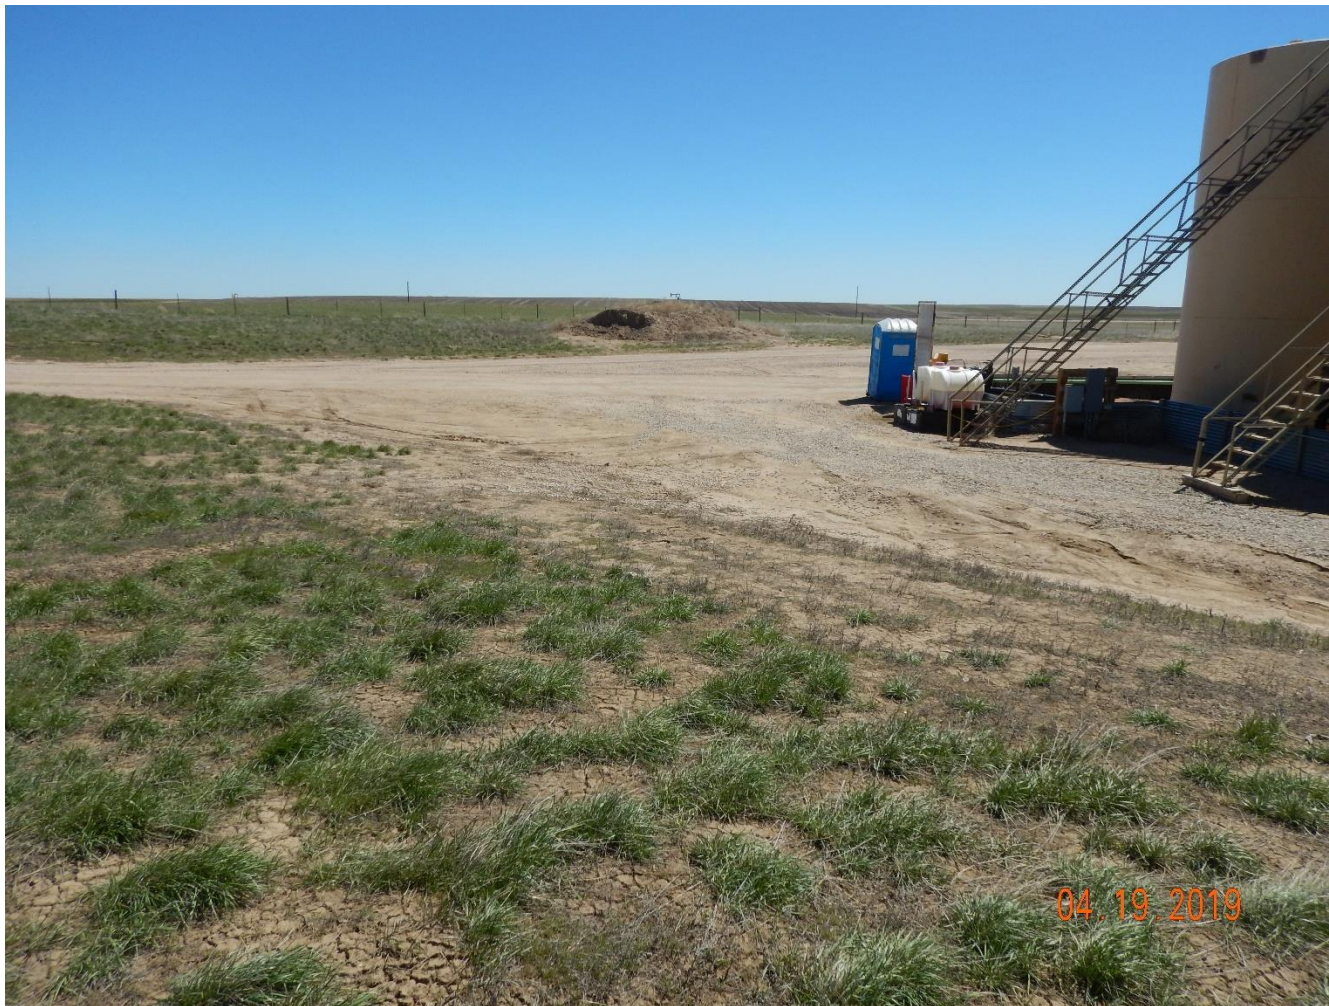
Photo 14: Photo taken from the northwest end of the location, facing east. Photo shows interim and production areas. Photo also shows perimeter stormwater ditch.

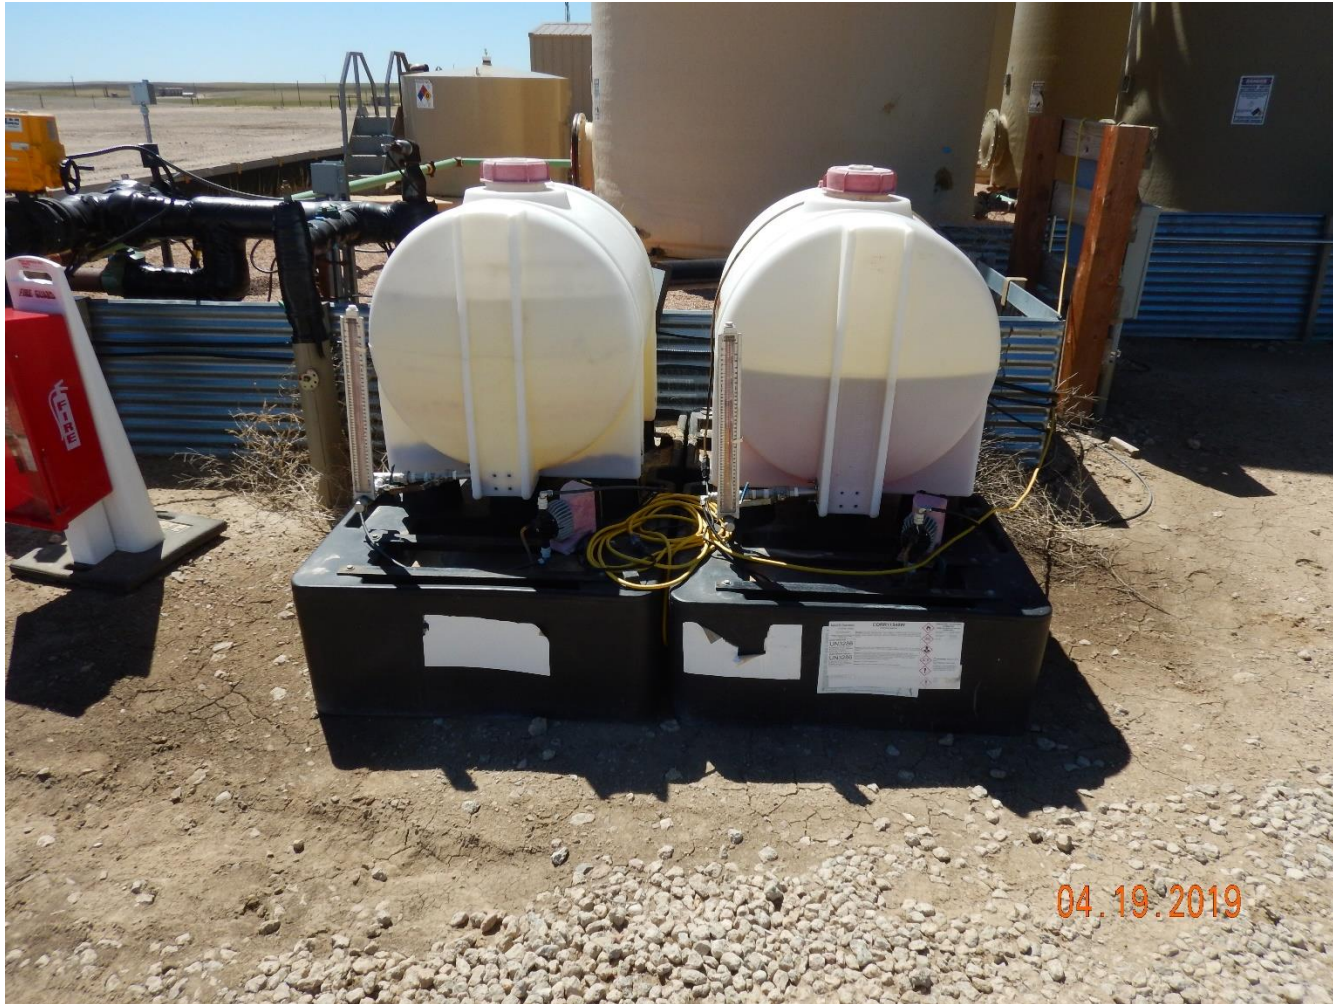
Photo 15: Photo shows secondary containment BMPs in proper functioning condition.

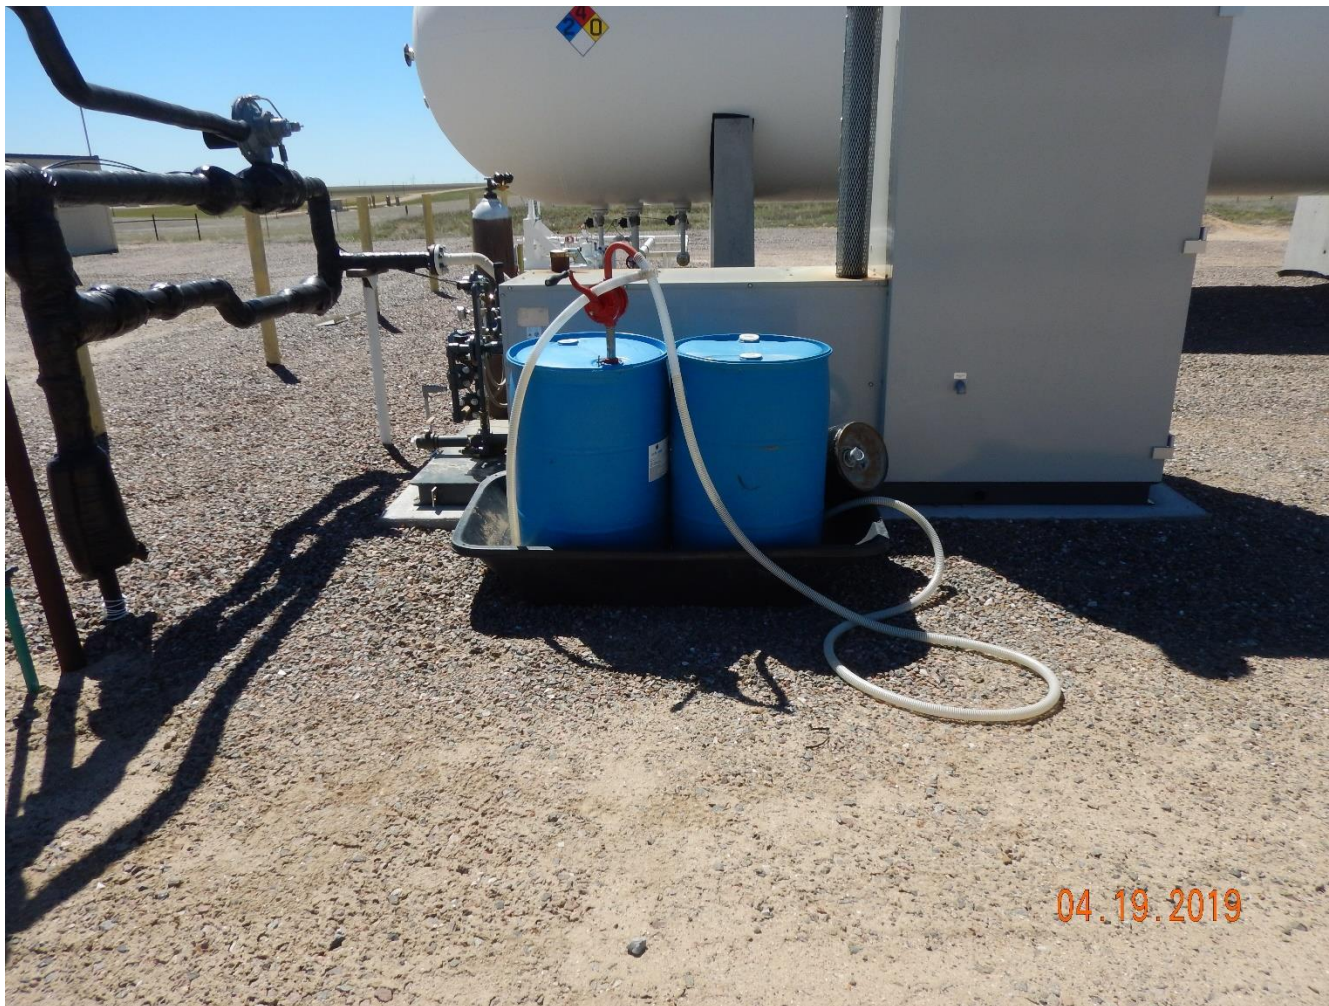
Photo 16: Photo shows barrels have been properly stored within secondary containment.

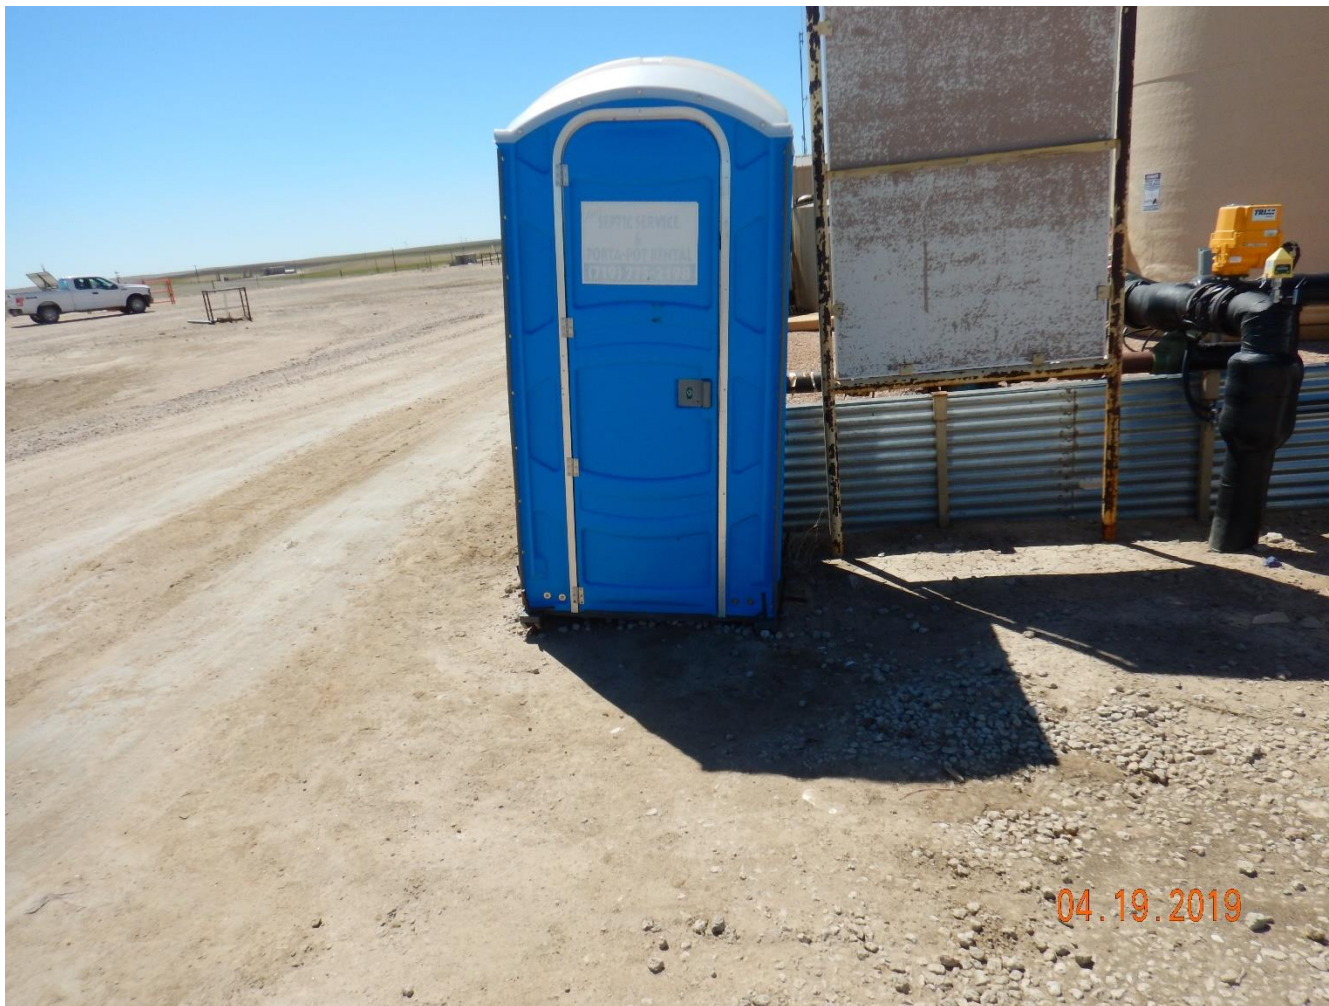
Photo 17: Photo shows porta-john has been properly secured.
