Inspection Photos

Operator: D90 ENERGY LLC - 10706

Location ID: 435480

Inspection Doc. Number: 682504787

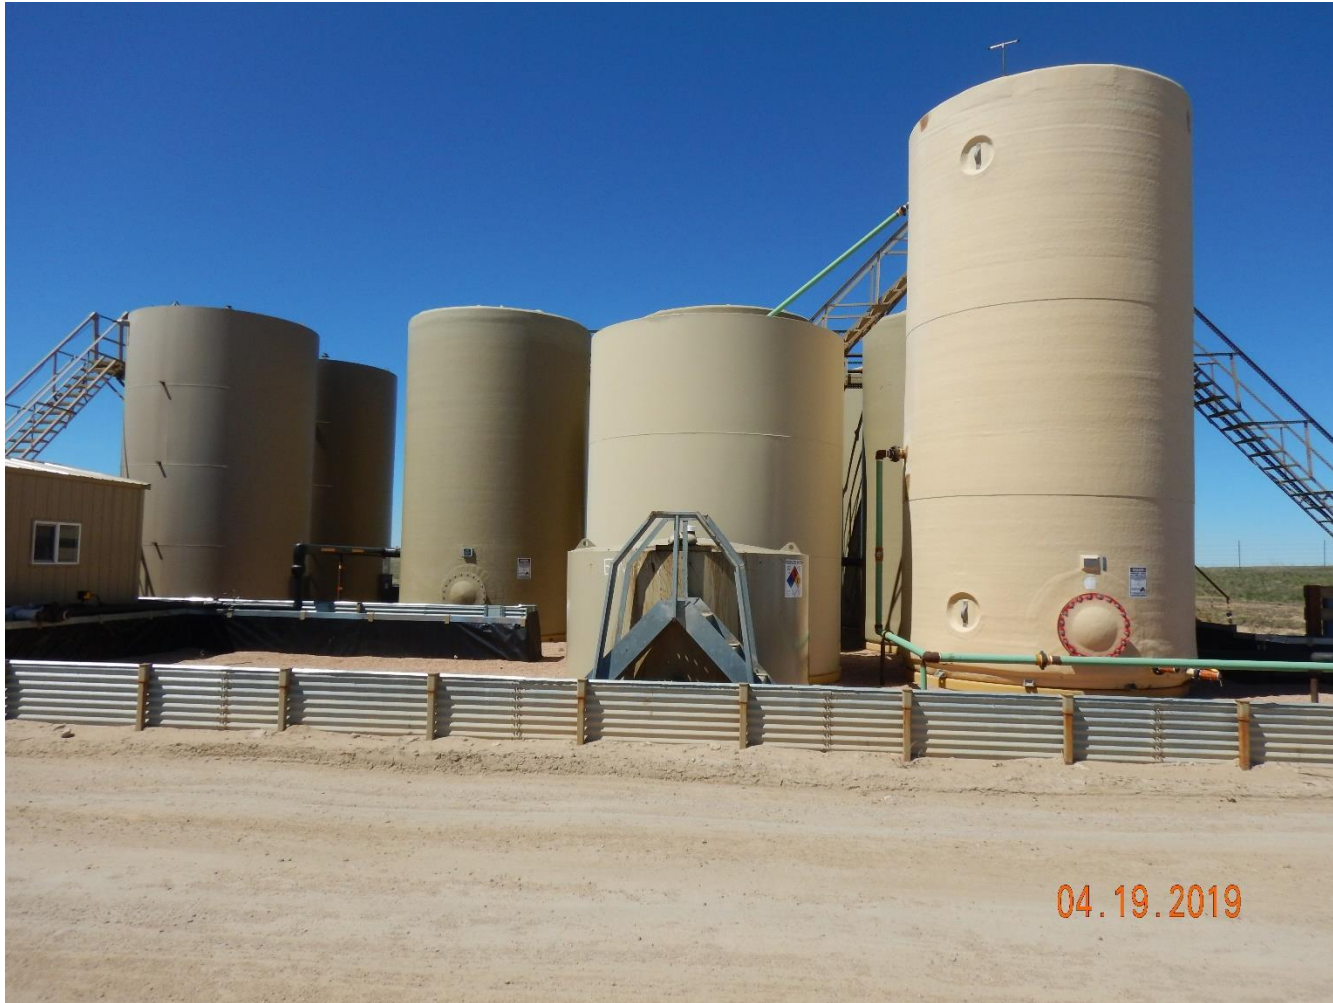
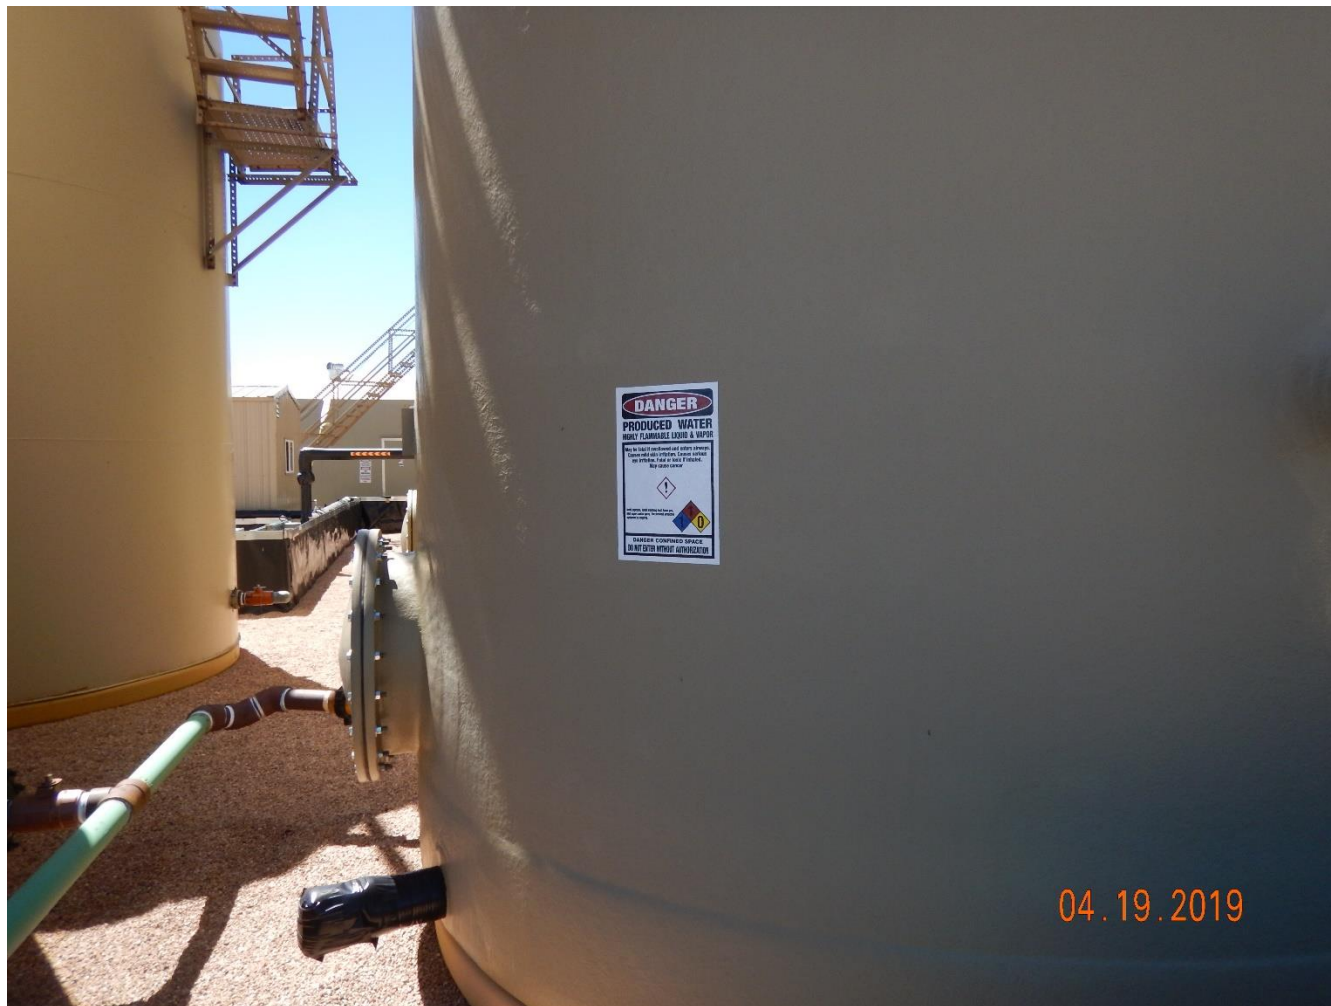
Photo 18: Photo taken from the location, facing west. Photo shows the ten (10) tanks at the battery. Tanks appears have tank contents and NFPA labelling, however, tanks appear to be missing capacity labeling in accordance with 210.d

Photo 19: See comments under photo 18.

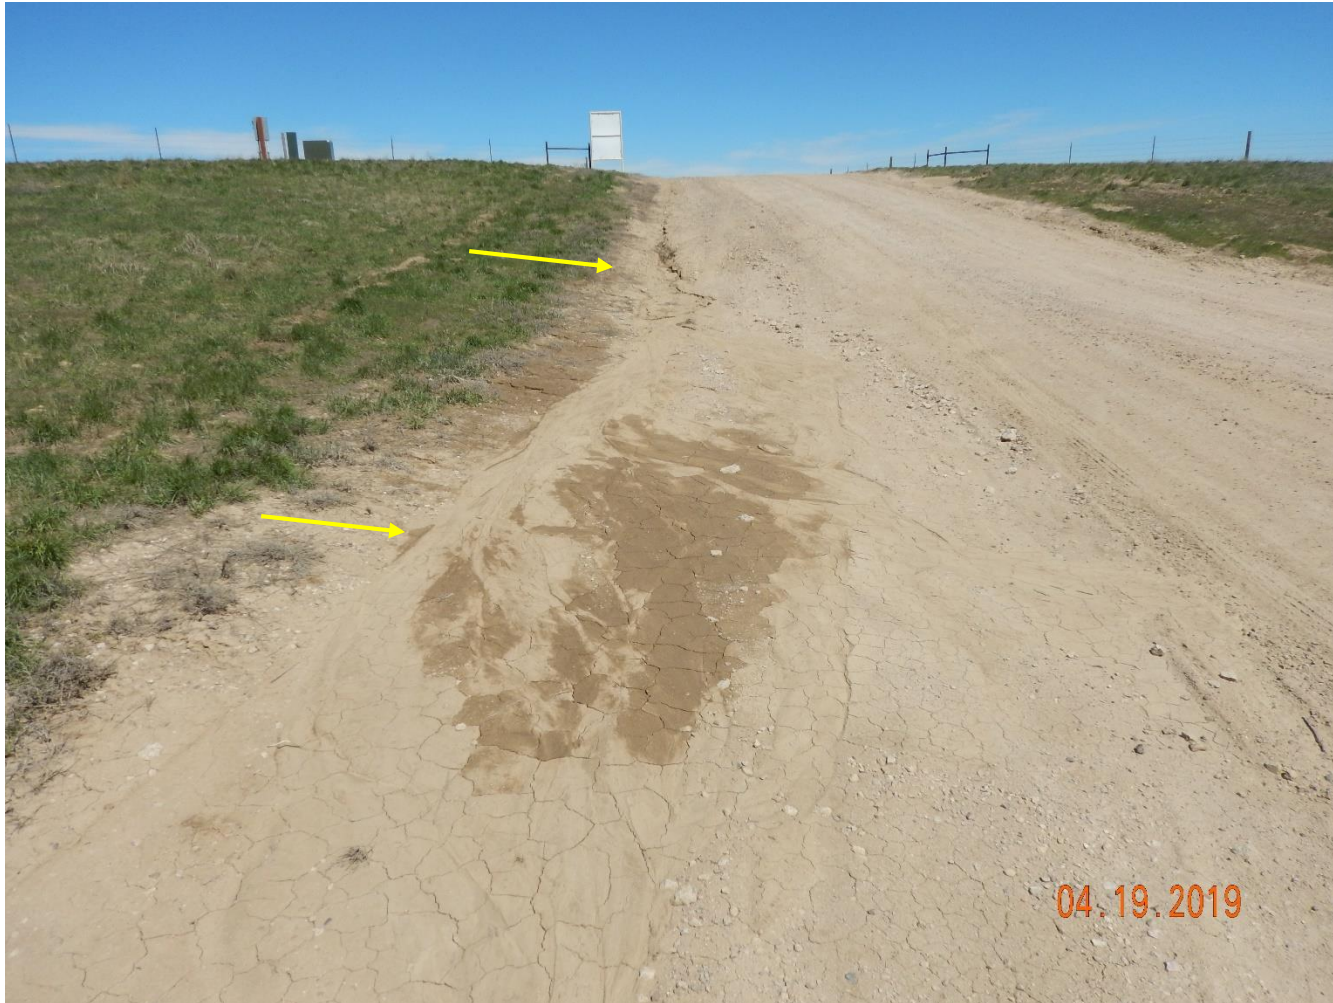
Photo 20: Photo taken from the location, facing north. Photo shows erosion degradation on access road.
