## Inspection Photos

Location Name: Harrison Cr Wtr Trtment Fac Impound

Location ID: 425510 & Facility ID: #441238

Inspection Date: April 09, 2019

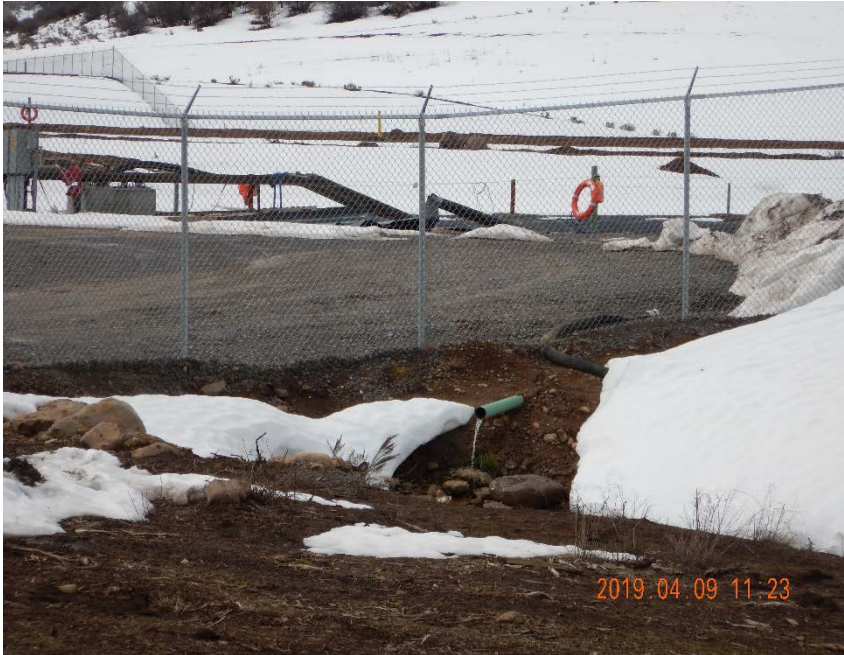
**Photo #1 – View of discharge point for ‘Pond 4’ dewatering system (located at NE side of pit complex). COGCC has suggested previously that operator install a sign to identify discharge to stormwater ditch. No sign had been installed prior to inspection date.**

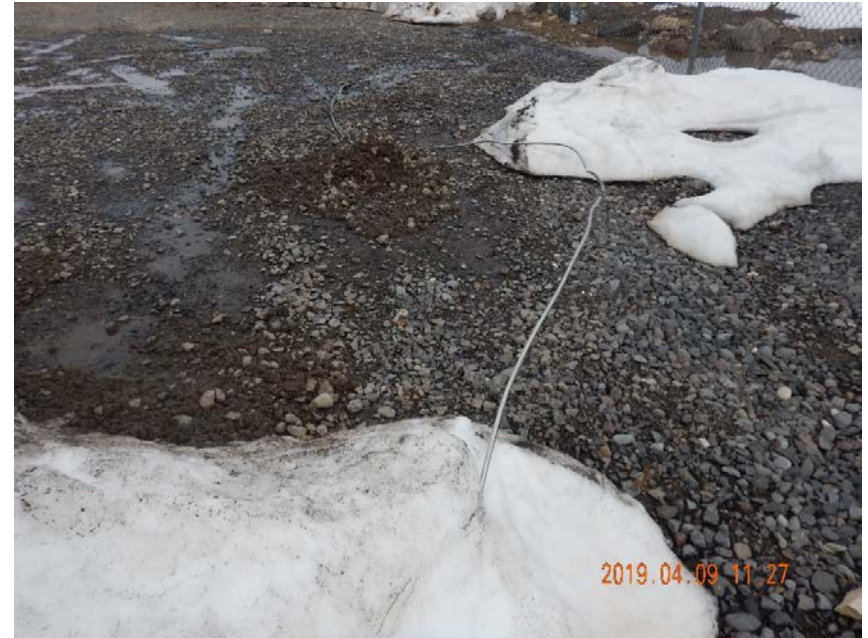
**Photo #2 – Unidentified ¼” stainless line located east of ‘Pond 2’ lacks any protection from truck traffic.**

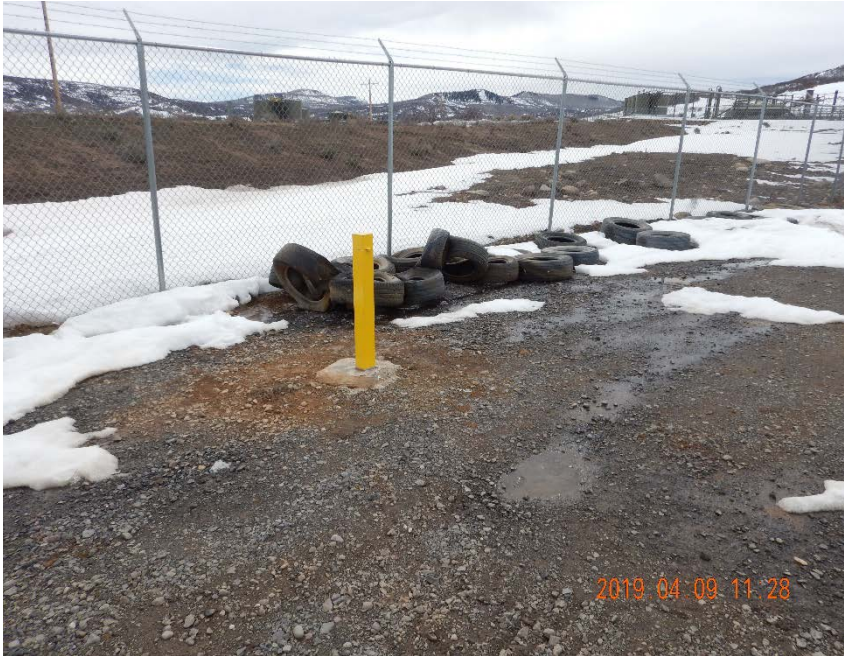
**Photo #3 – Junk tires located east of ‘Pond 2,’ near monitoring well.**

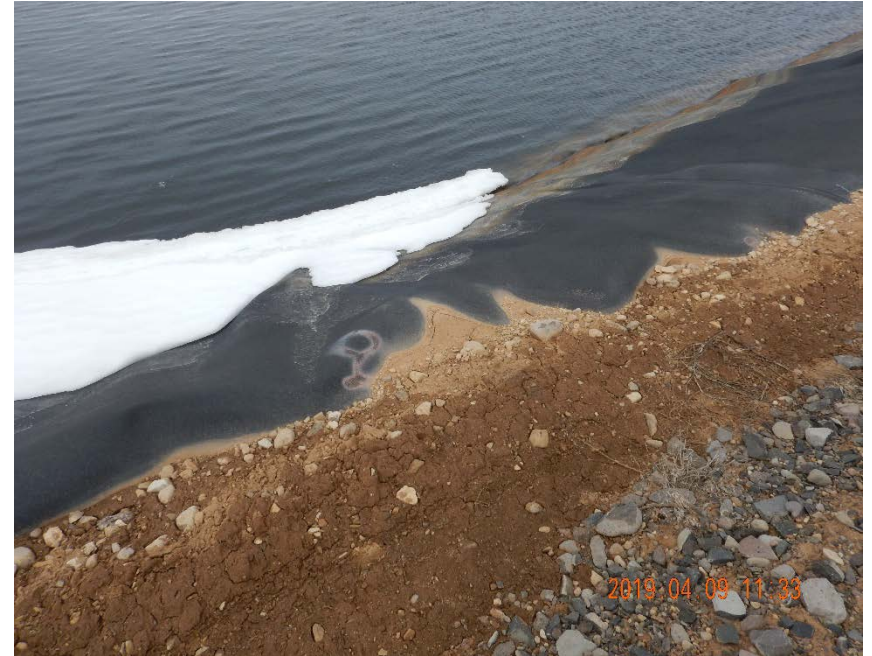
**Photo #4 – Sediment transport and gravel/road base encroachment onto pit liner at SE corner of ‘Pond 2.’**

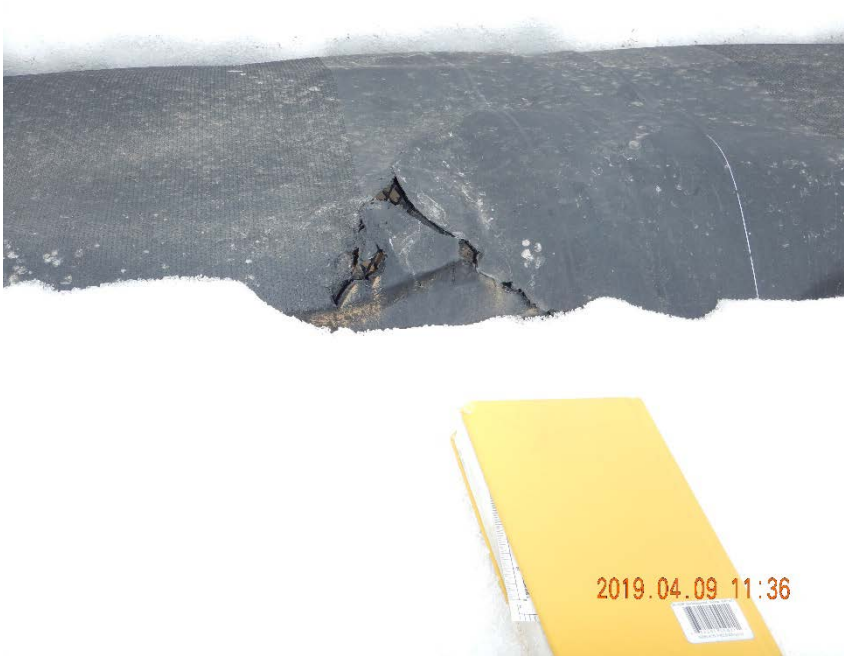
**Photo #5 – Hole in pit liner (on south side of ‘Pond 2,’ near anchor trench) measuring approximately 5” x 5”.**

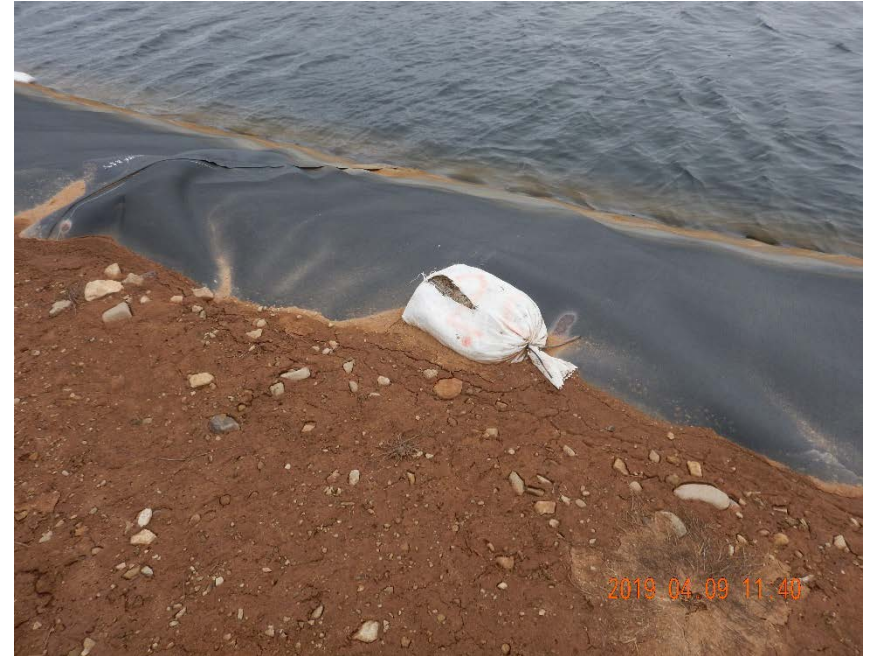
**Photo #6 – Damaged sand bag on top of liner (on west side of ‘Pond 2,’ near anchor trench).**

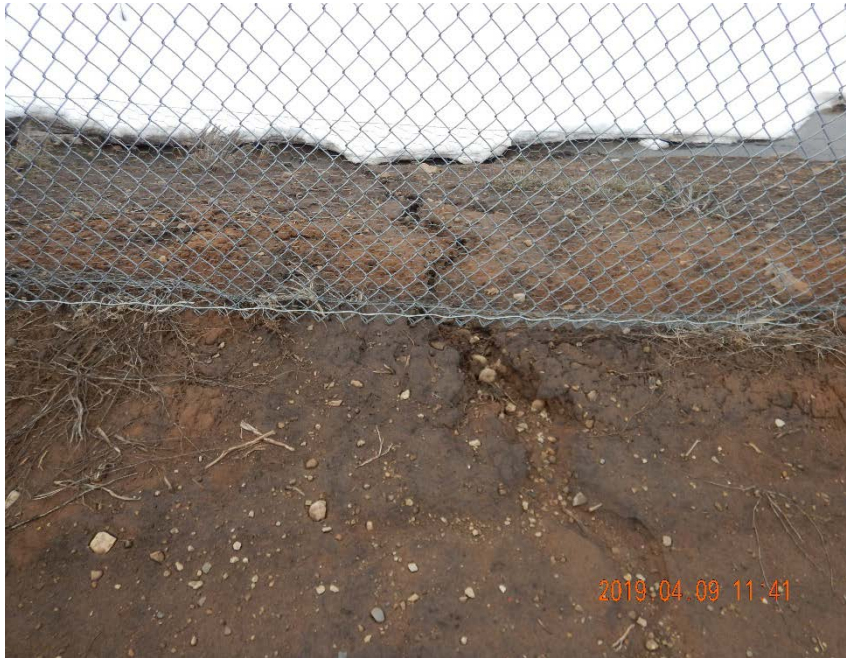
**Photo #7 – Erosion rill with on-site sediment transport observed along west fence line (1).**

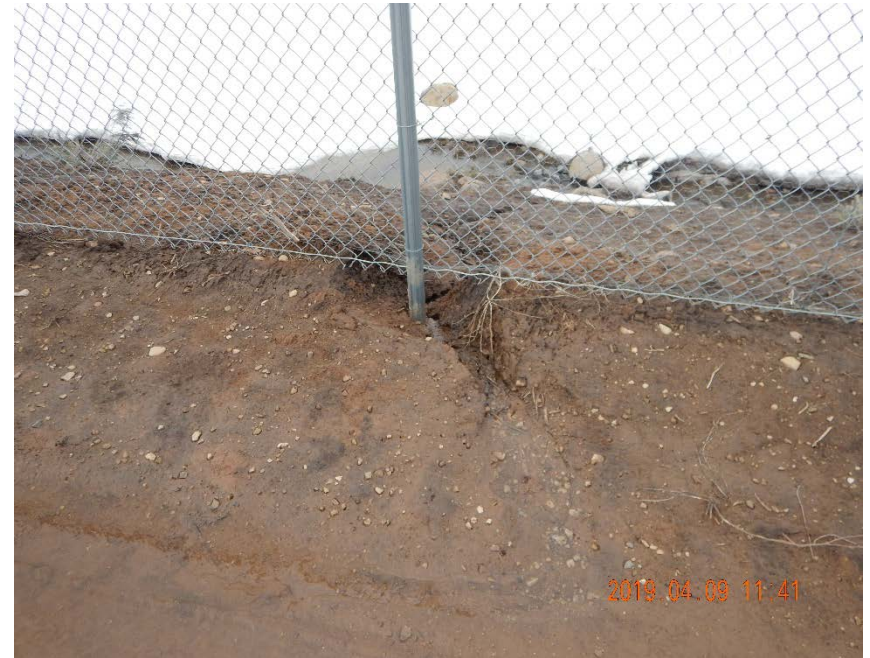
**Photo #8 - Erosion rill with on-site sediment transport observed along west fence line (2).**

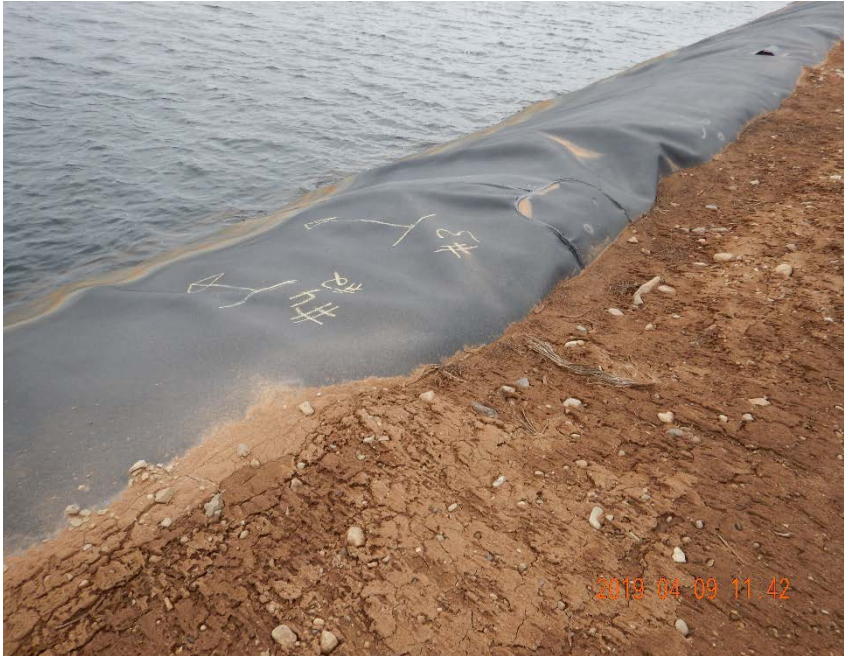
**Photo #9 – Sediment accumulation in low portion of the pit berm (northwest side of 'Pond 2').**

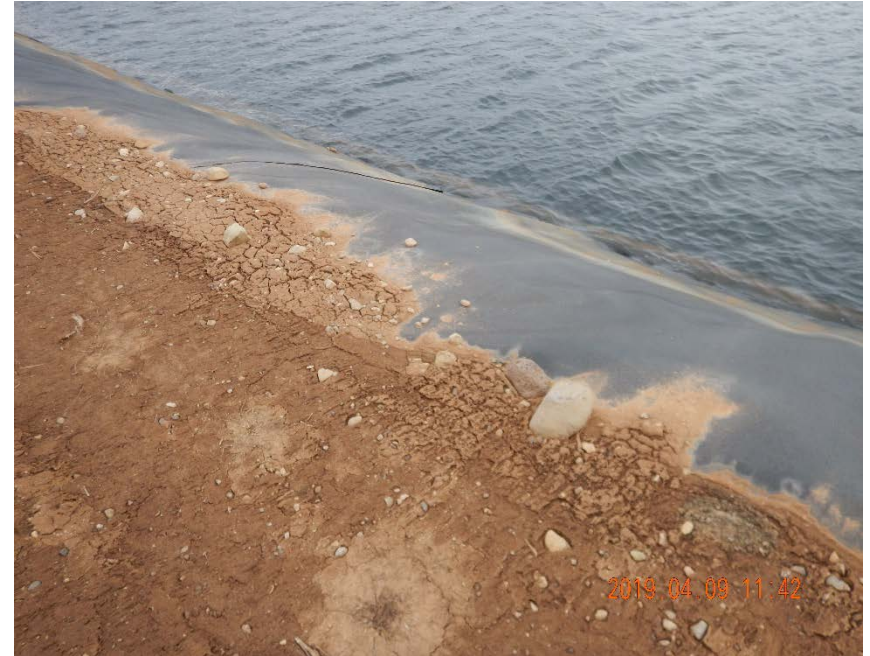
**Photo #10 – Transport of sediment and rocks onto liner (northwest side of 'Pond 2').**

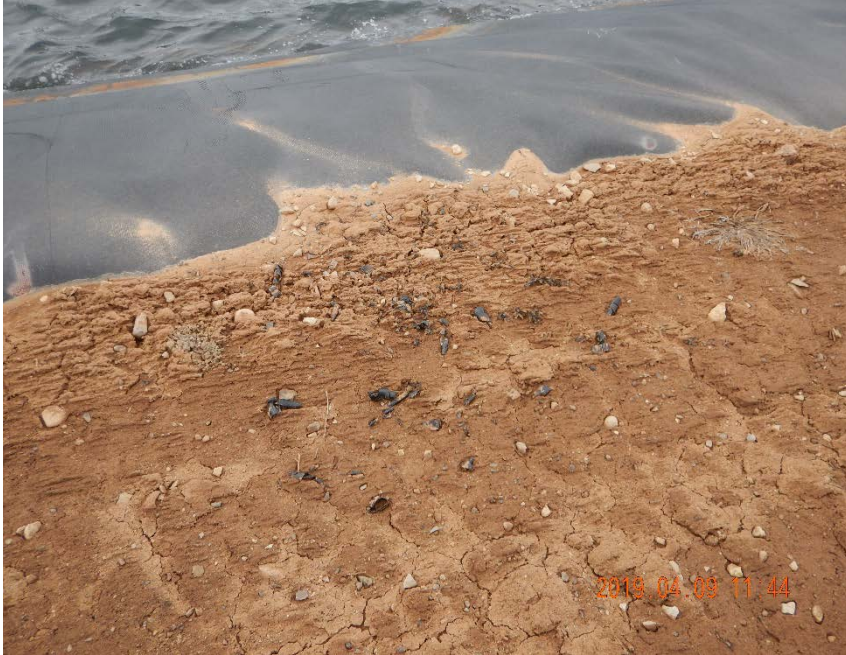
**Photo #11 – Plastic trash on north side of 'Pond 2.'**

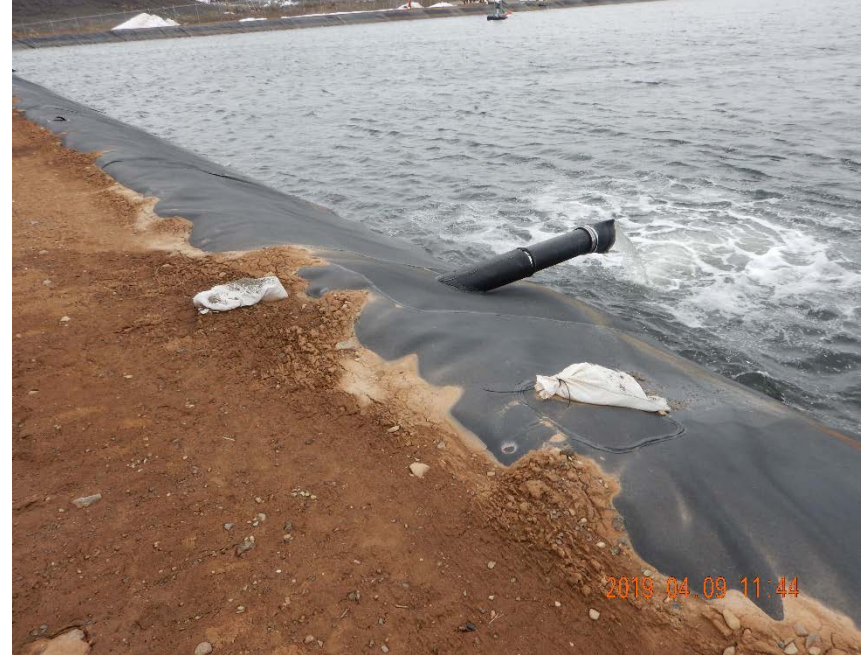
**Photo #12 – Damaged sandbags and sediment transport onto liner on north side of 'Pond 2.'**

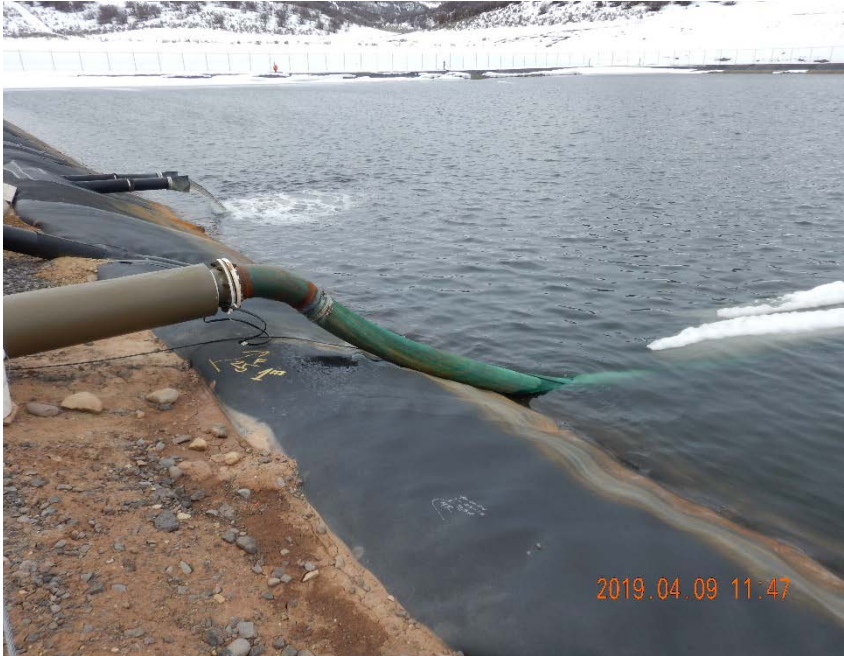
**Photo #13 – Hose leading to agitator resting directly on pit liner on east side of 'Pond 2.' Note steady drip observed from taped area of hose.**

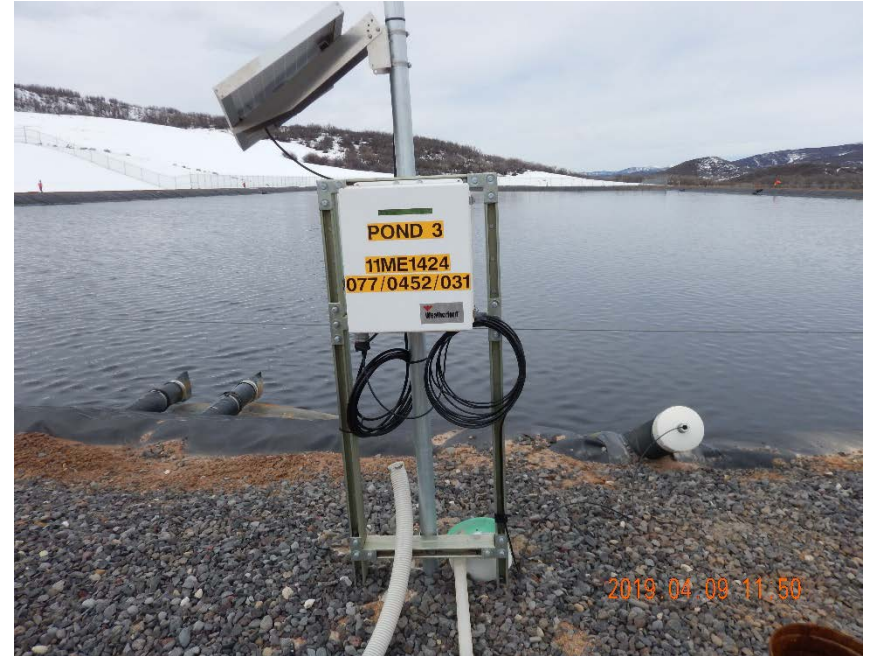
**Photo #14 – Leak detection system on east side of 'Pond 3.'**

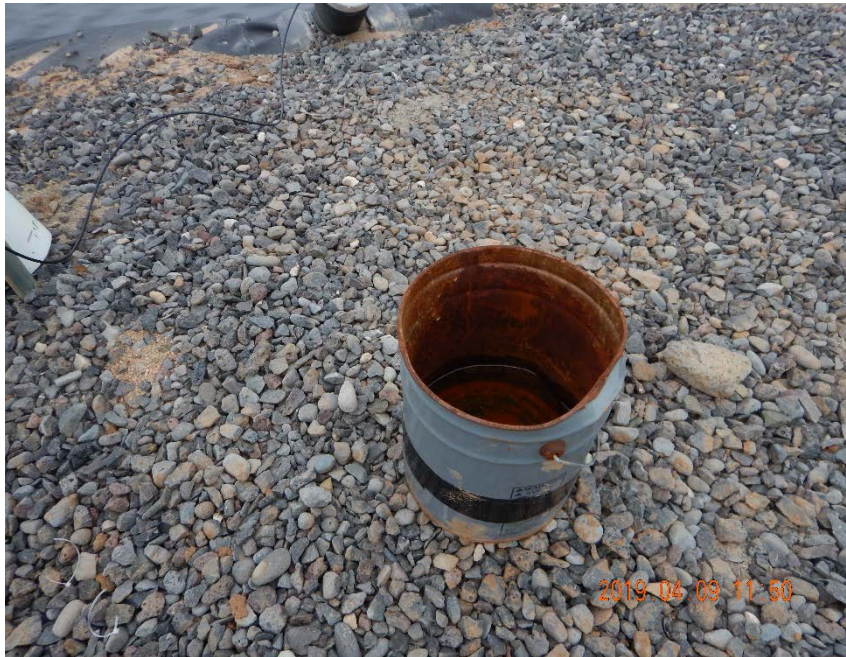
Photo #15 – Unused equipment east of 'Pond 3' (1).

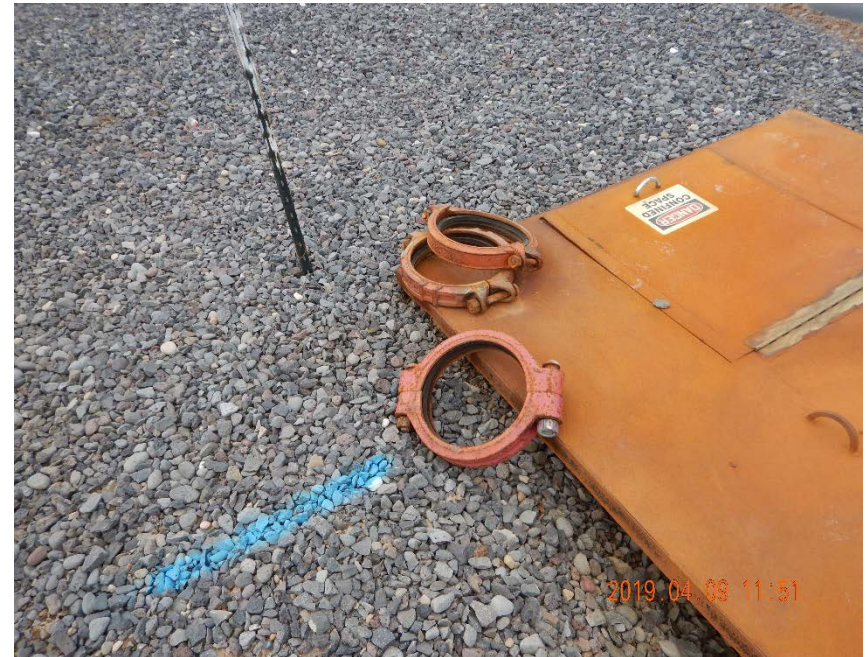
Photo #16 - Unused equipment east of 'Pond 3' (2).

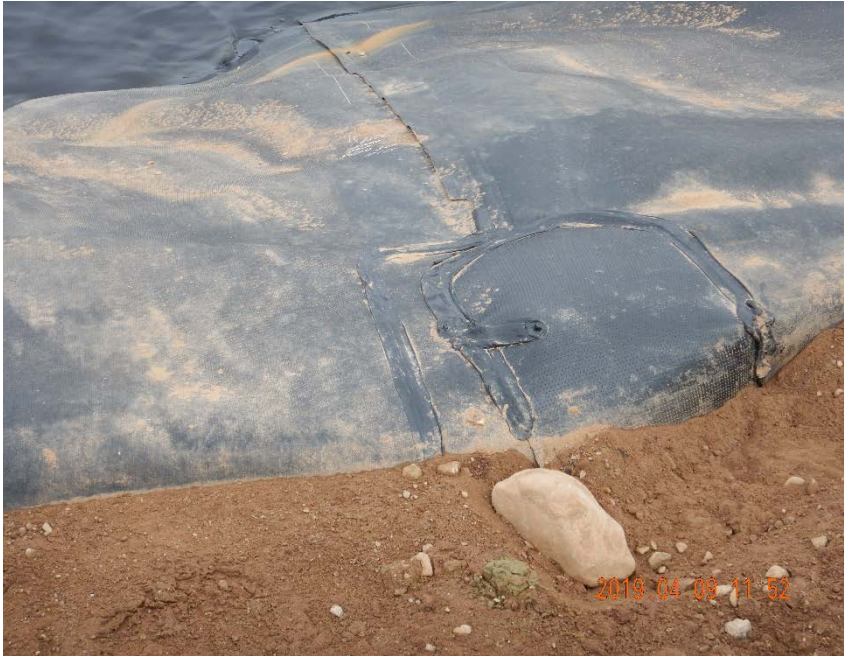
**Photo #17 – Hole in liner (SE corner of ‘Pond 3’) reported to operator under previous Field Inspection Report had been patched prior to inspection date.**

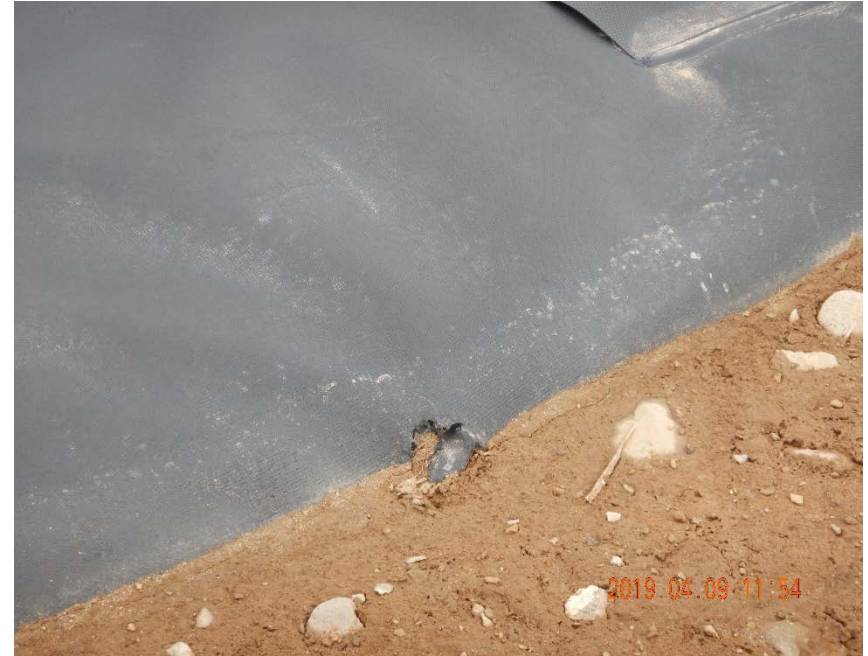
**Photo #18 – Hole in south side of liner (‘Pond 3,’ along anchor trench).**

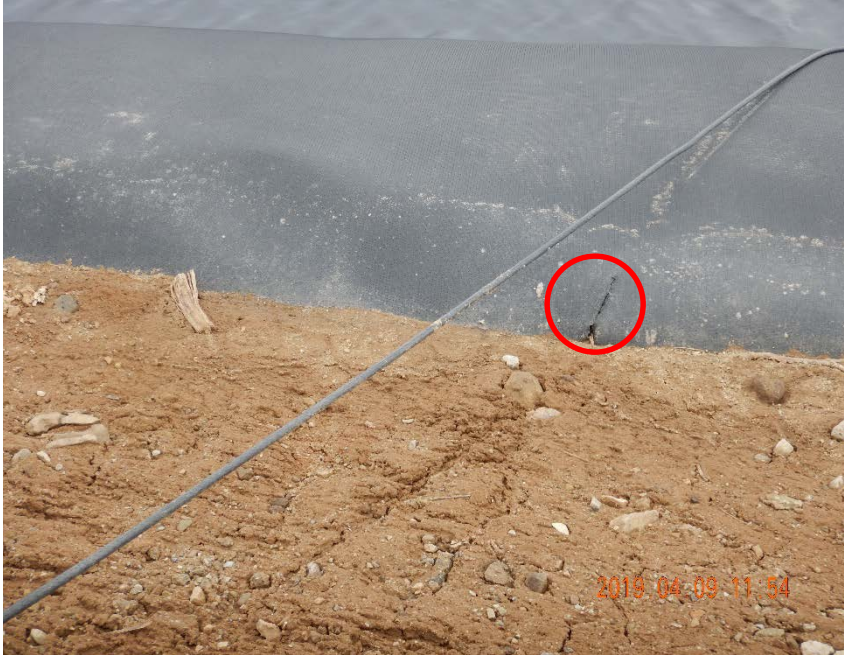
**Photo #19 – Steel cable on south side of 'Pond 3' has caused damage to pit liner (~4" tear, red circle).**

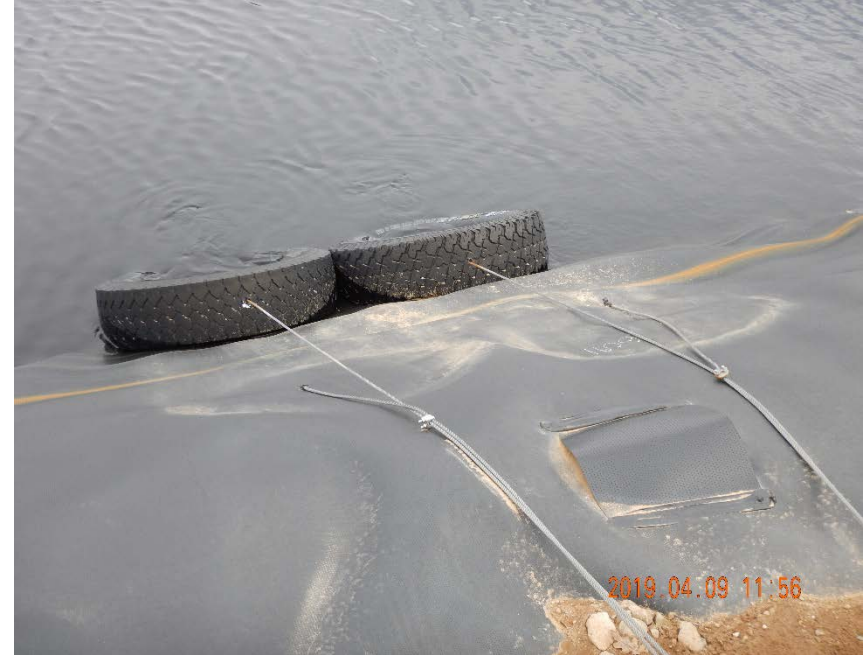
**Photo #20 – Egress ladder on south side of 'Pond 3' has steel cables with metal hardware in direct contact with pit liner (1).**

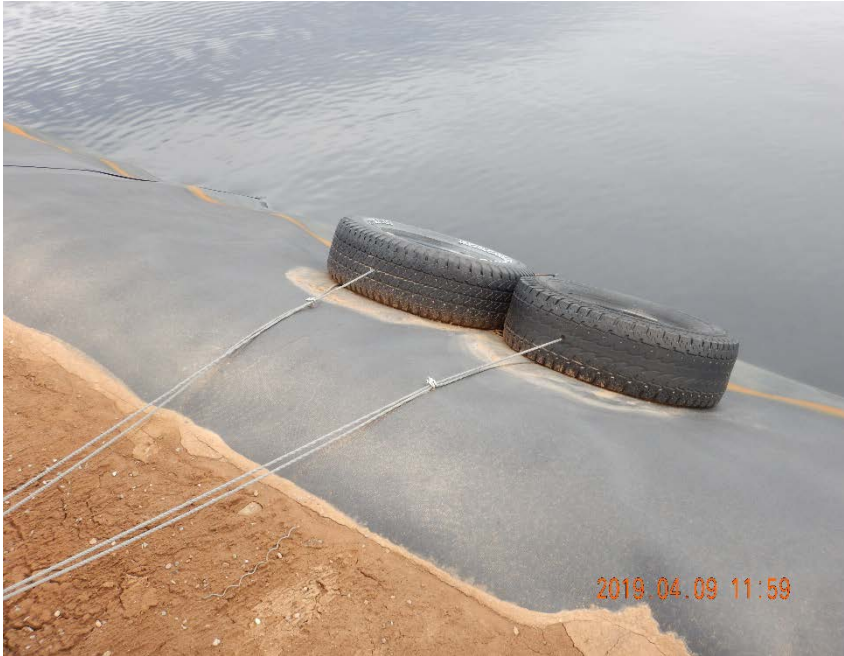
**Photo #21 - Egress ladder on west side of 'Pond 3' has steel cables with metal hardware in direct contact with pit liner (2).**

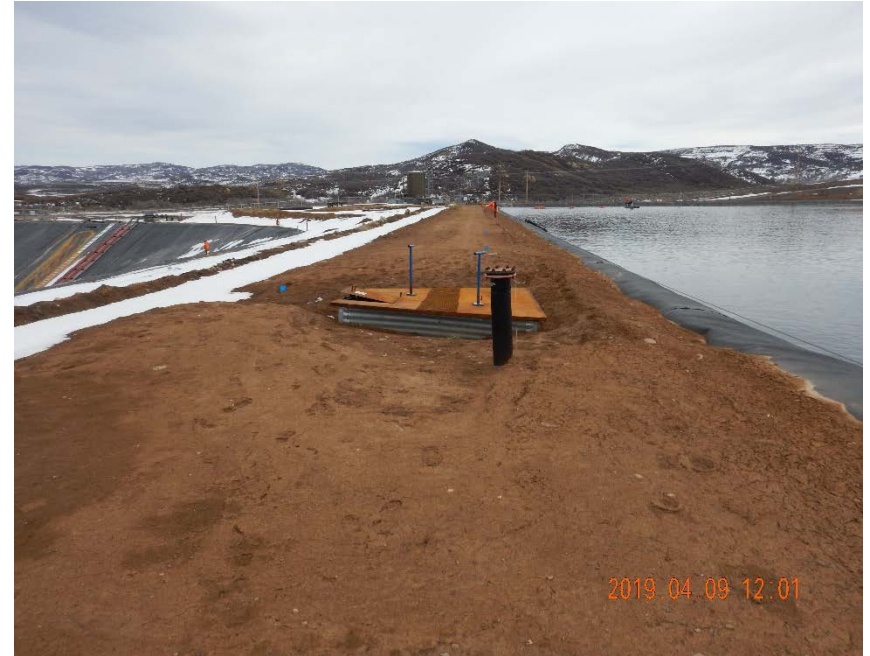
**Photo #22 – Evidence of erosion and subsidence observed at valve can with flowline riser located north of 'Pond 3.'**

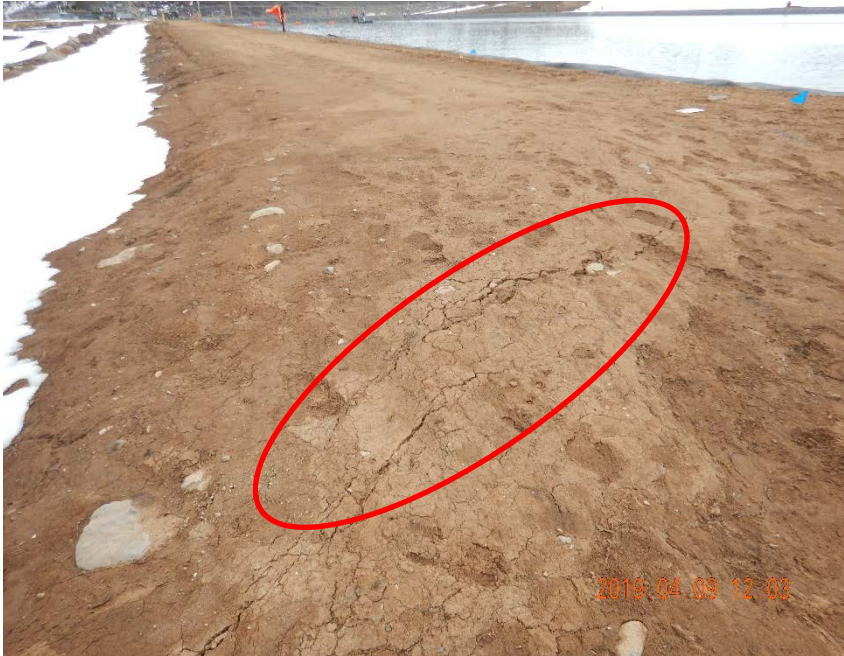
**Photo #23 – Evidence of subsidence observed at valve can with flowline riser located north of 'Pond 3' (red circle).**

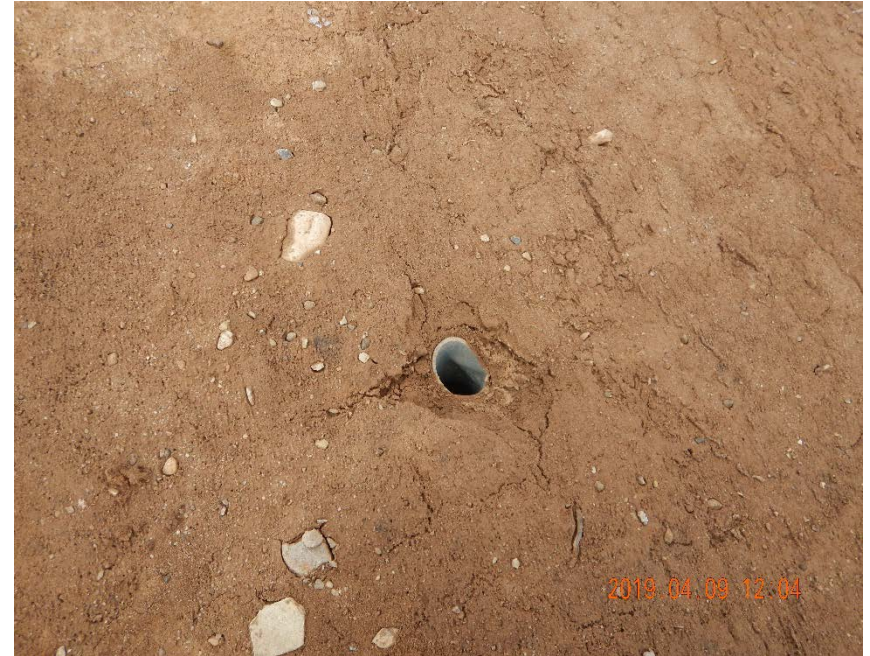
**Photo #24 – Unidentified riser located northeast of valve can, between 'Pond 3' and 'Pond 4.'**

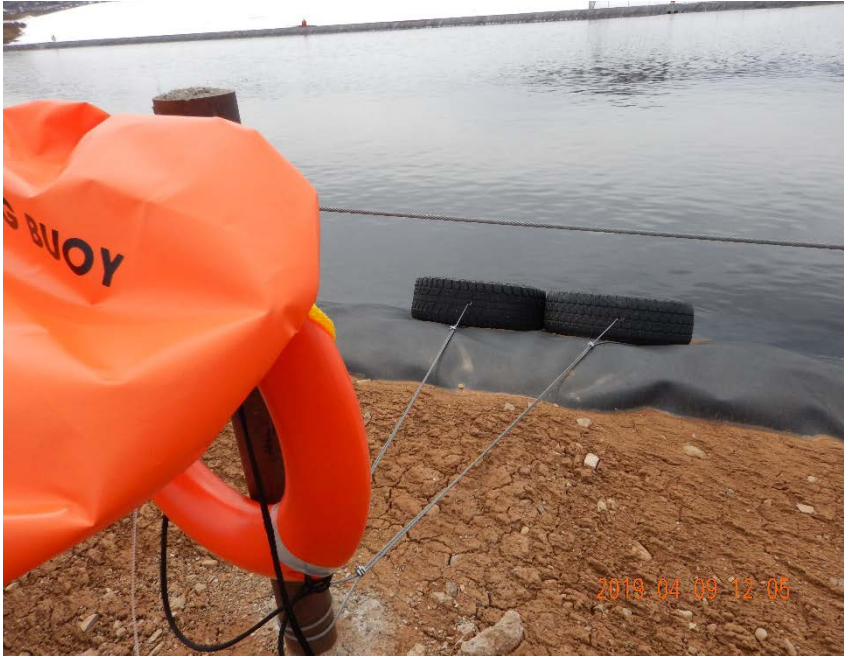
**Photo #25 - Egress ladder on north side of 'Pond 3' has steel cables with metal hardware in direct contact with pit liner (3).**

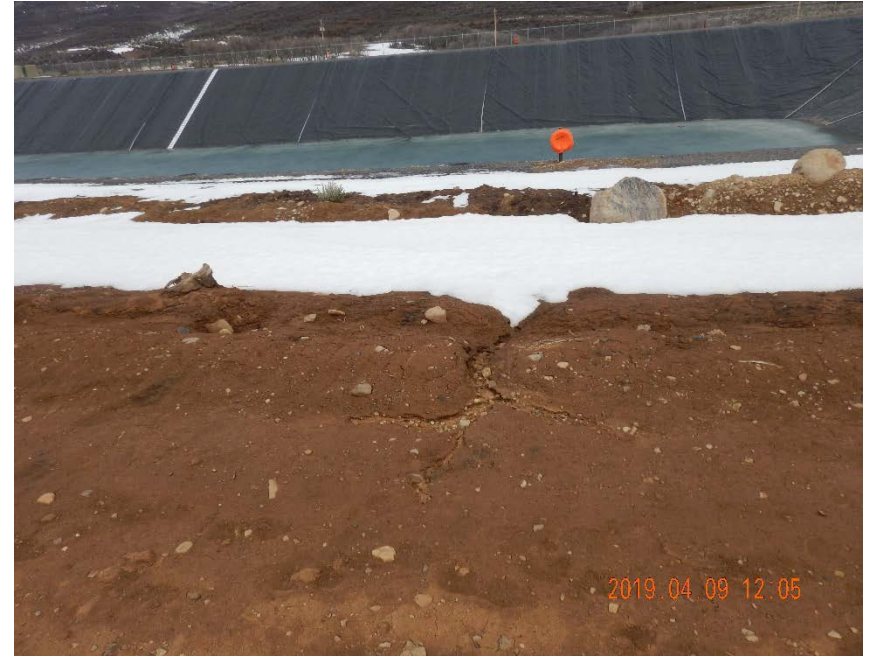
**Photo #26 – Erosion and sediment transport leading north from 'Pond 3,' toward 'Pond 4.'**

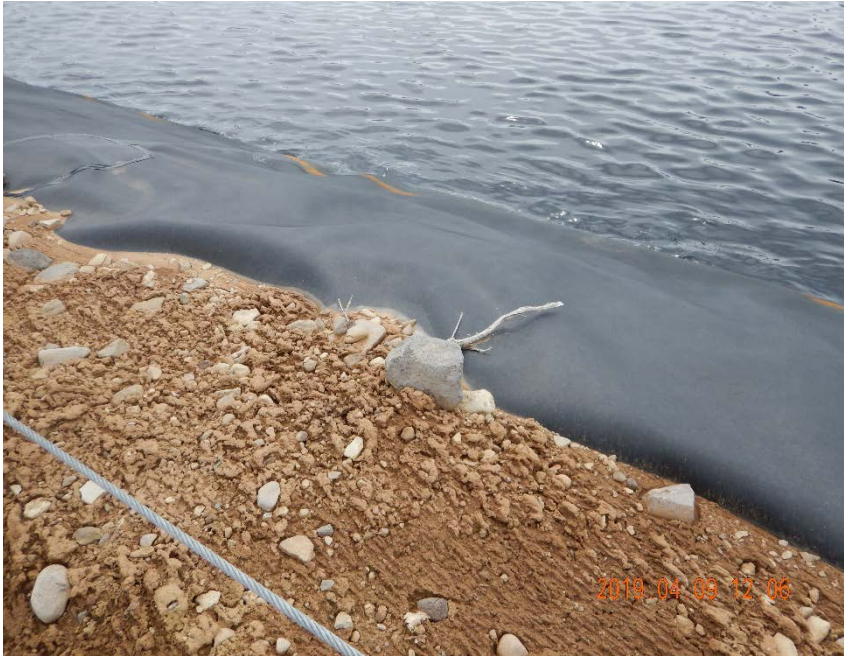
**Photo #27 – Foreign debris encroaching onto pit liner on north side of 'Pond 3.'**

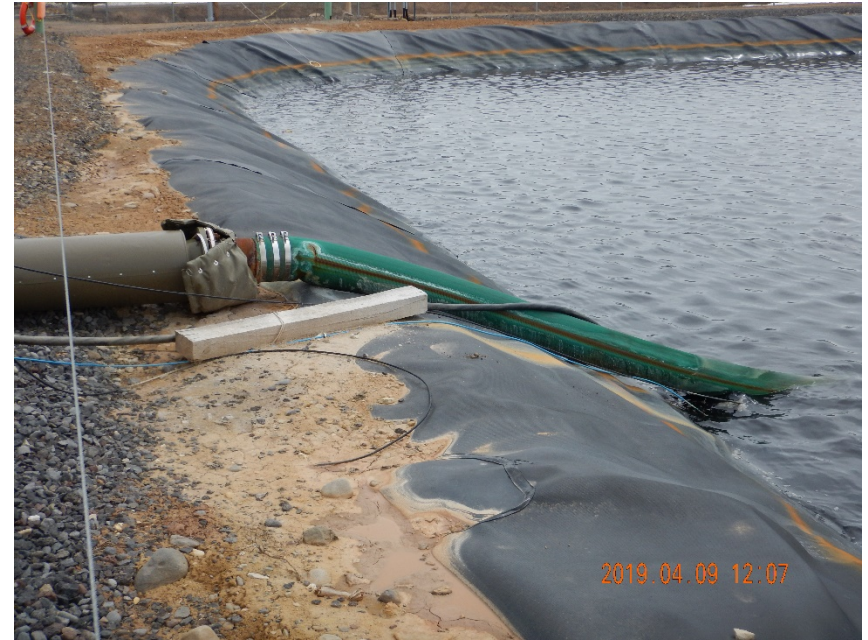
**Photo #28 - Hose leading to agitator resting directly on pit liner on north side of 'Pond 3.' Note wood debris and cable resting on top of liner.**

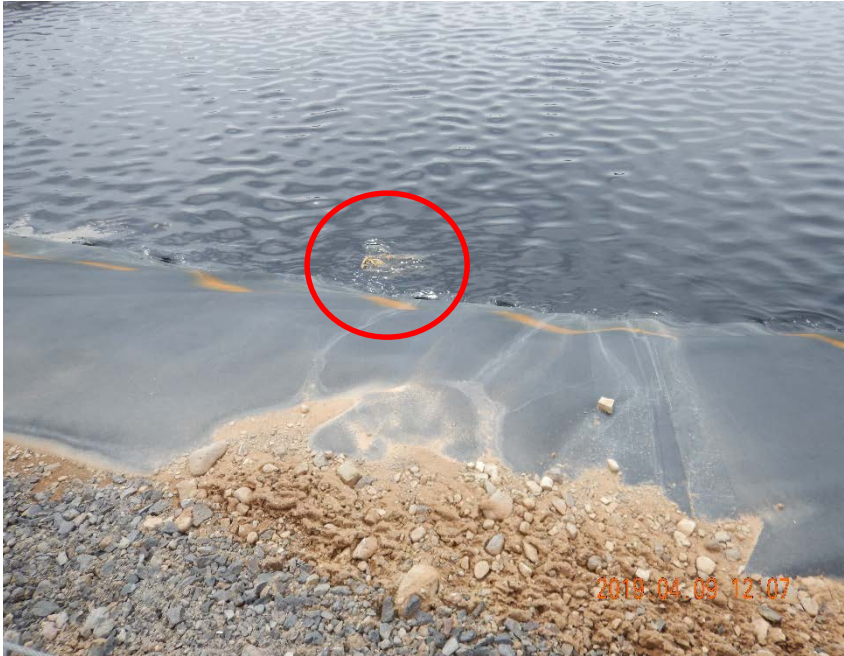
**Photo #29 – Evidence for transport of sediment and rocks into pit/onto pit liner observed in NE corner of 'Pond 3.'**  
**Note trash observed inside of pit (red circle).**

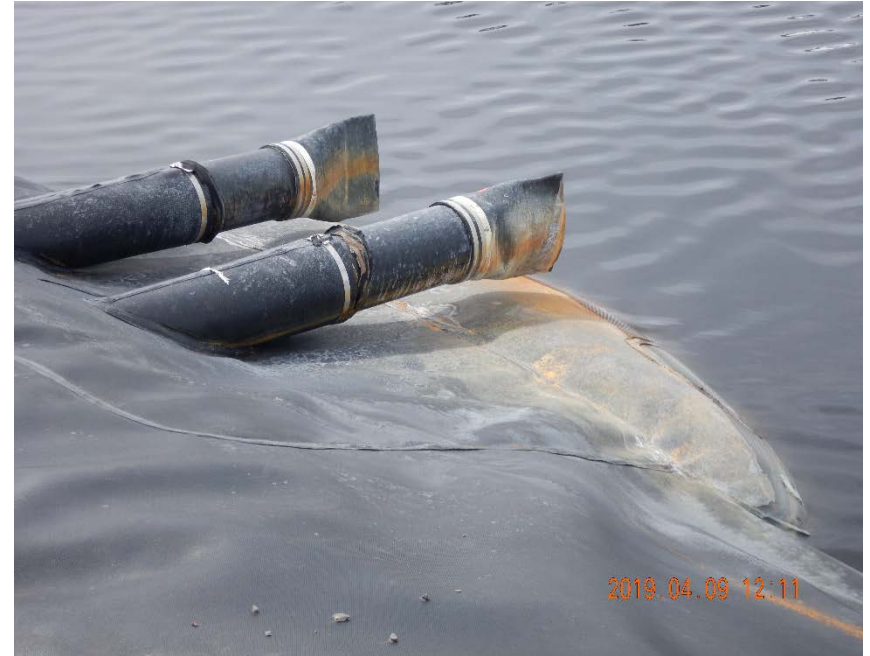
**Photo #30 – Pit liner beneath inlet on east side of 'Pond 3' appeared to be bulging/floating on inspection date.**

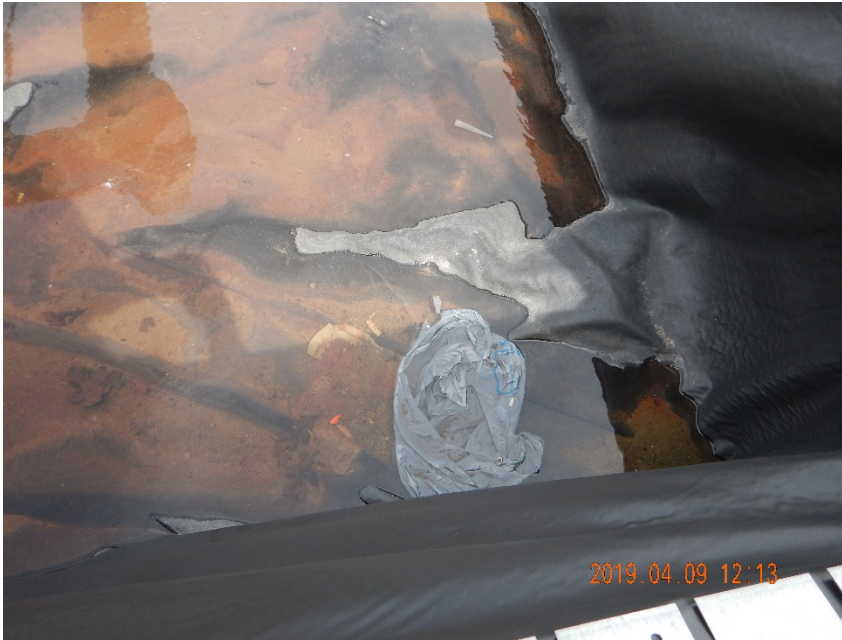
**Photo #31 – Assorted trash/debris inside of tank battery secondary containment area. Note fluids inside of tank battery did not exhibit hydrocarbon sheen or odor on inspection date.**

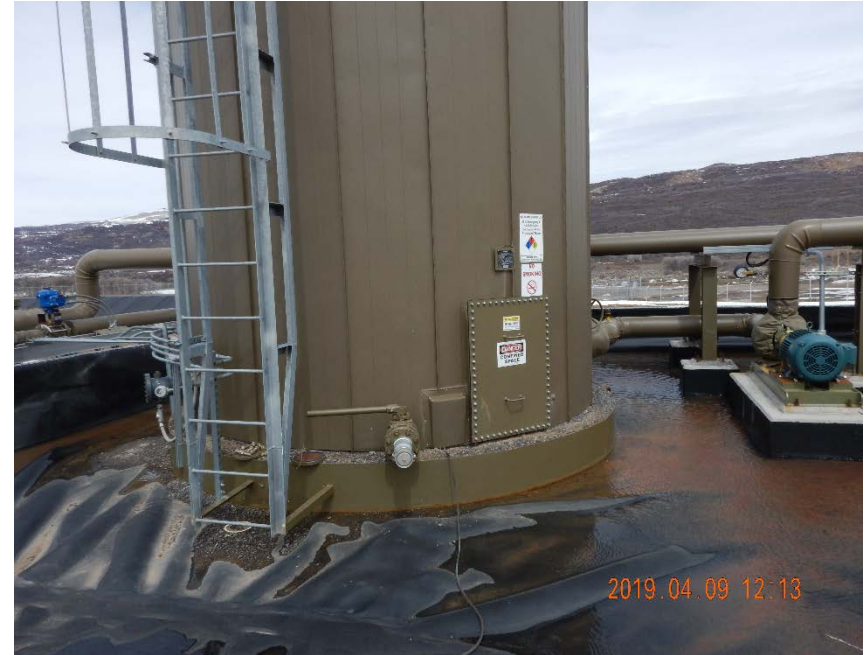
**Photo #32 – 400 bbl produced water AST has NFPA placard and volume label on SE side.**

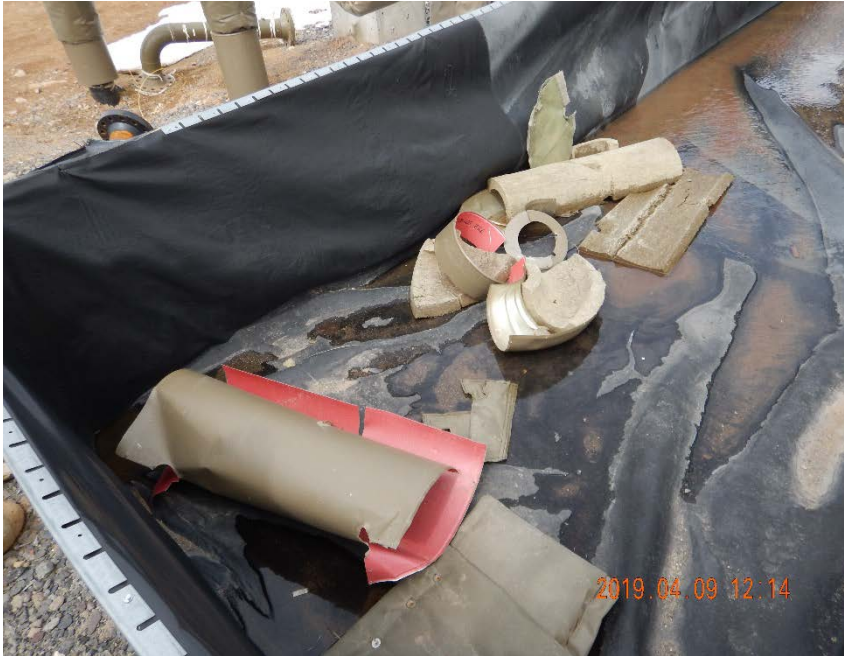
Photo #33 - Metal trash and debris observed in SW corner of tank battery containment area on inspection date.

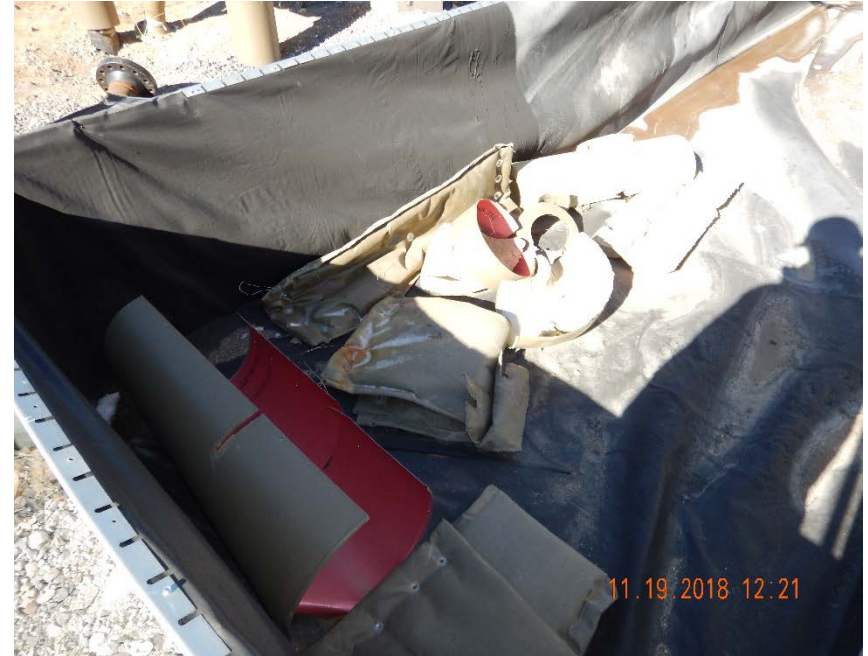
Photo #34 – Field photo dated **November 19, 2018** documents conditions of metal scrap from previous photo.

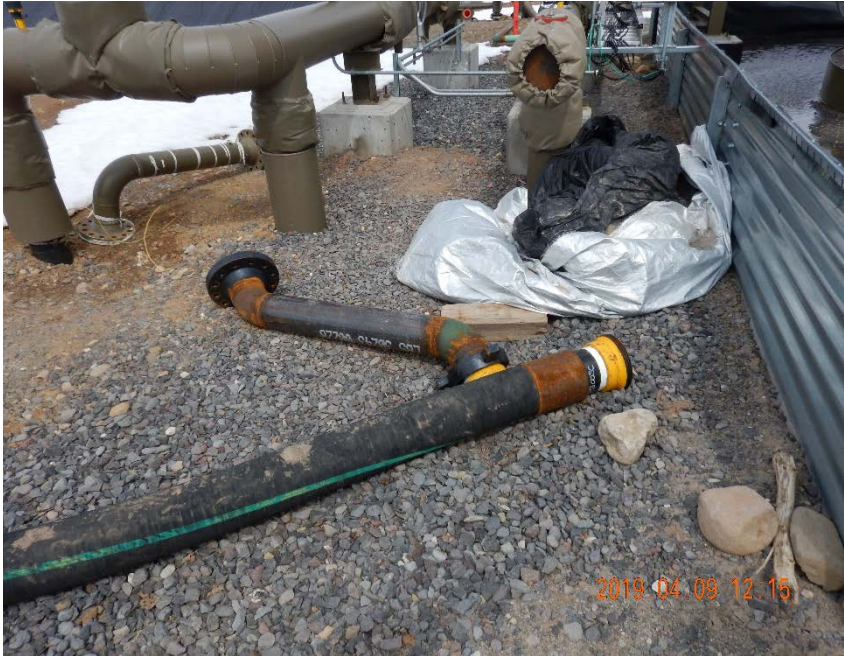
**Photo #35 – Unused pipe and tarp located outside of tank battery secondary containment (on west side).**

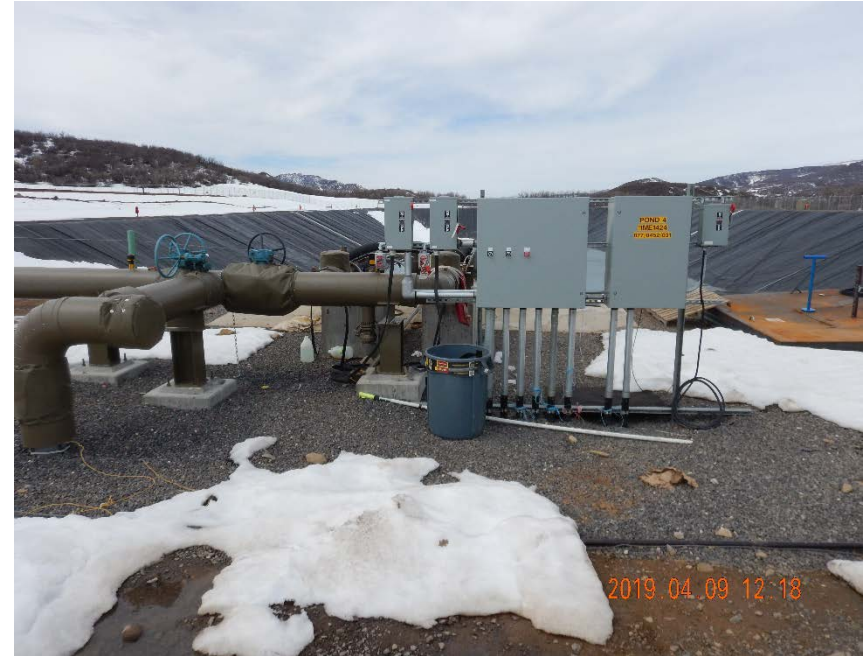
**Photo #36 – Pipeline manifold, valve can, and electrical infrastructure located on east side of 'Pond 4.' Note trash can in foreground was unsecured on inspection date.**

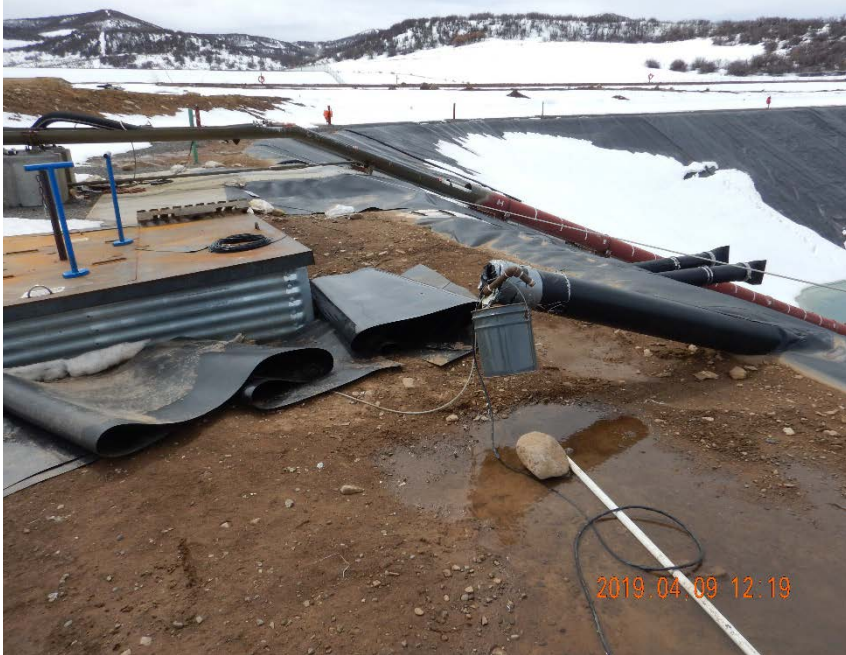
**Photo #37 – View of additional unused equipment and debris (liner material, pvc pipe, wooden pallet, damaged sandbags) located east of 'Pond 4.'**

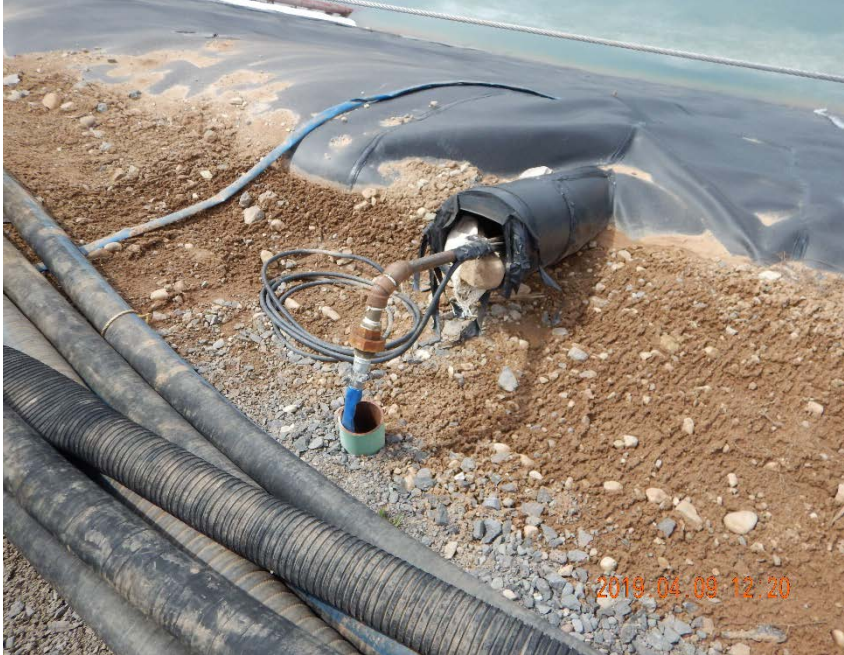
**Photo #39 – Dewatering system outlet on east side of 'Pond 4.'** Note that 2" pipe and hose are supported by damaged sandbag and rock.

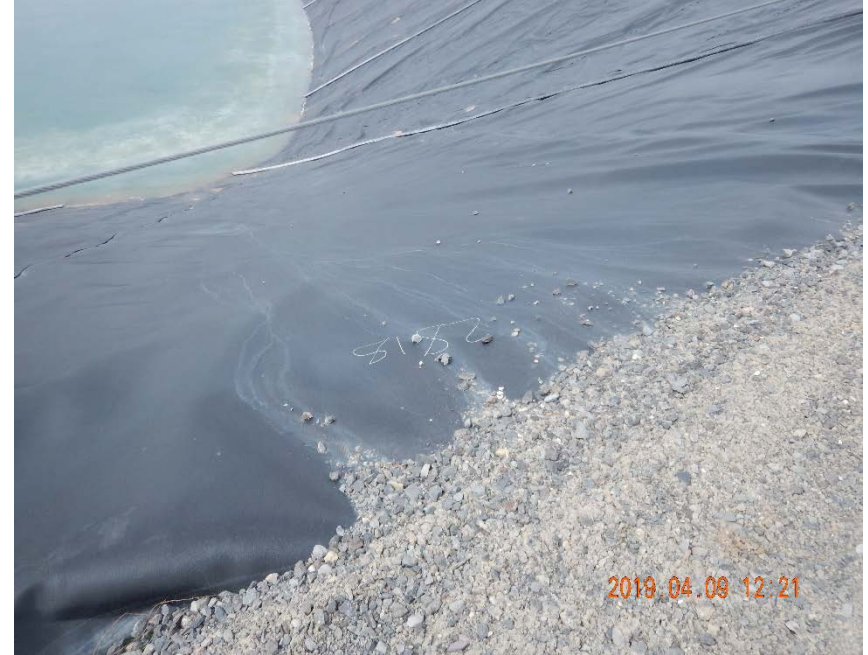
**Photo #40 – Foreign debris (rocks/road base) encroaching into pit from NE corner.**
