## Inspection Photos

Location Name: Harrison Cr Wtr Trtment Fac Impound

Location ID: 425510 & Facility ID: #441238

Inspection Date: April 09, 2019

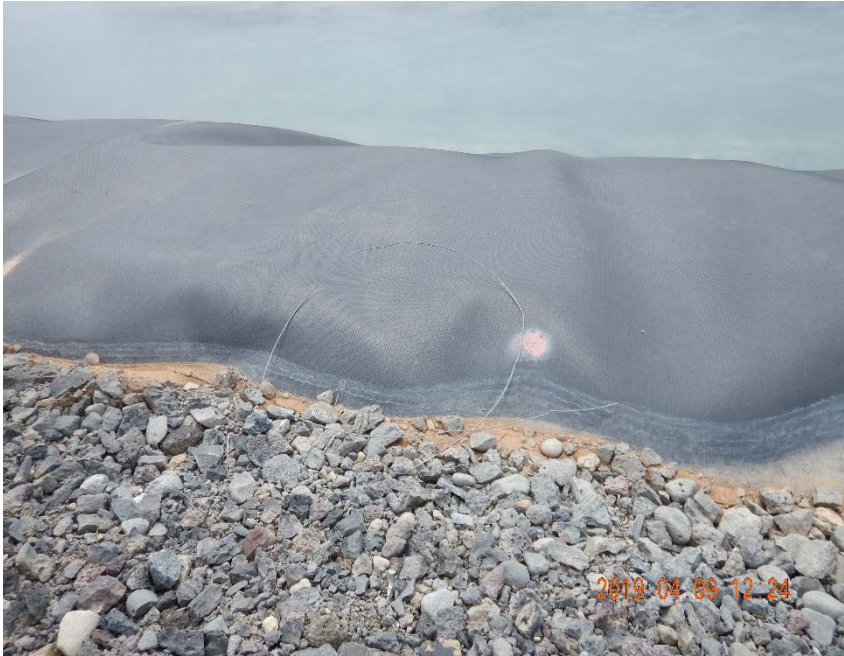
**Photo #41 – Junk and debris (metal wire) resting on top of pit liner at north side of pit.**

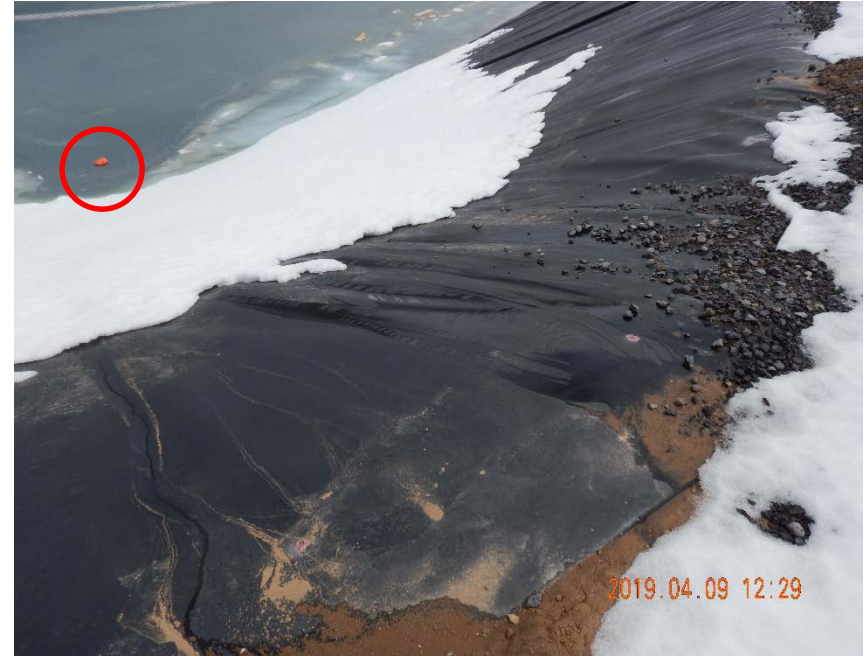
**Photo #42 – Foreign debris (rocks/road base) and stormwater entering pit from SW corner. Note trash on top of pit fluids (red circle).**

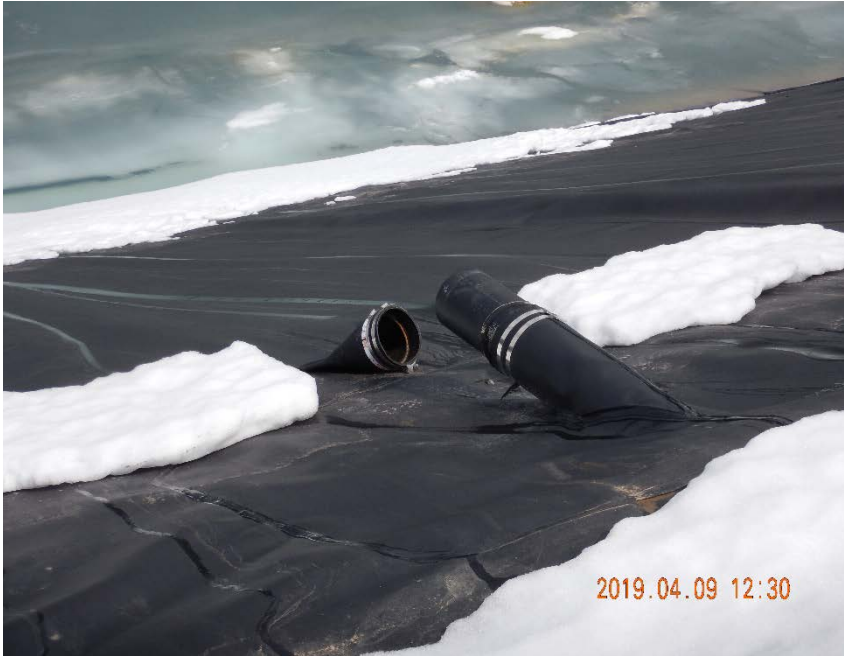
**Photo #43 – Inlet pipe at SW side of pit has come apart, resulting in foreign object and metal hardware in direct contact with pit liner.**

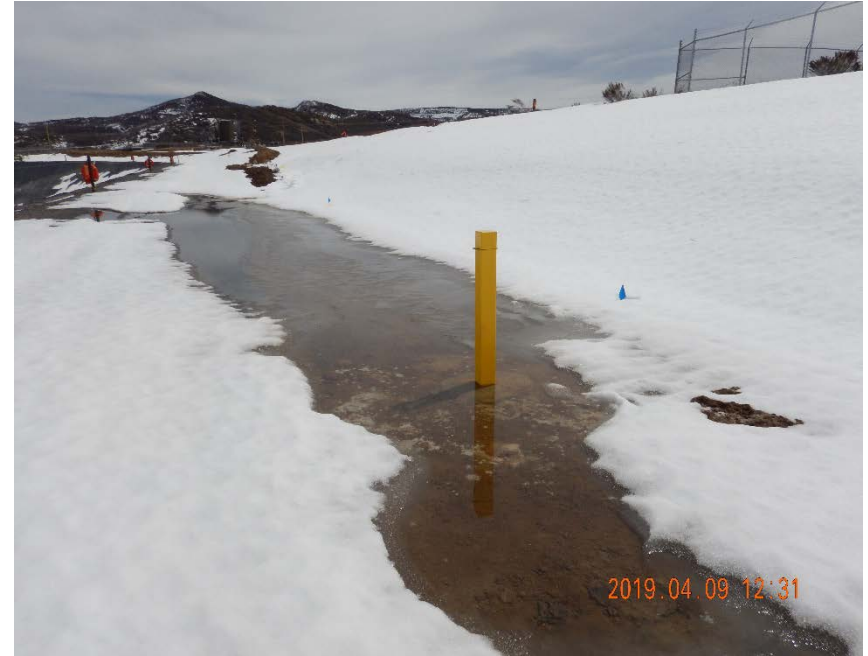
**Photo #44 – Stormwater accumulation in depression on south side of 'Pond 4,' near monitoring well.**

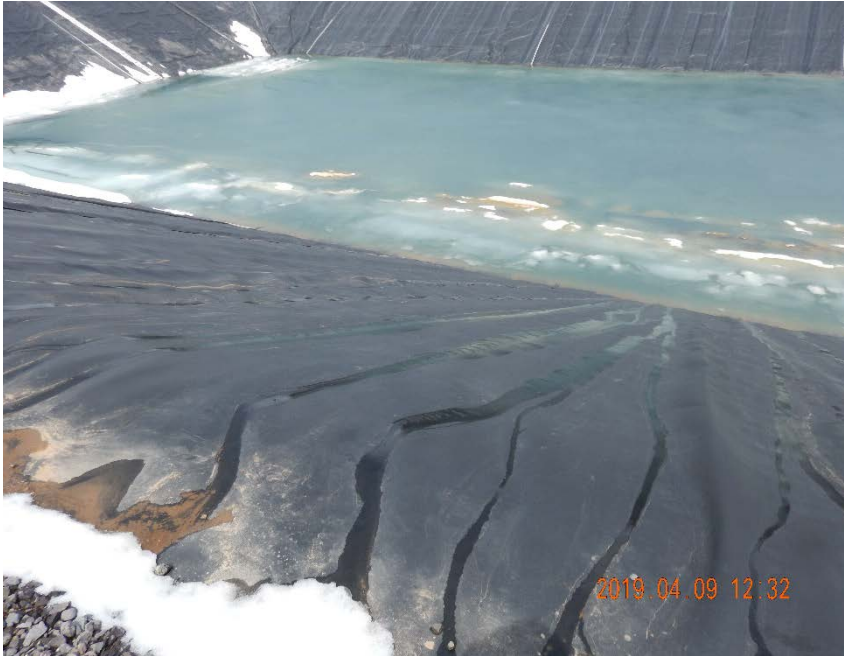
**Photo #45 - Stormwater entering pit from south side.**

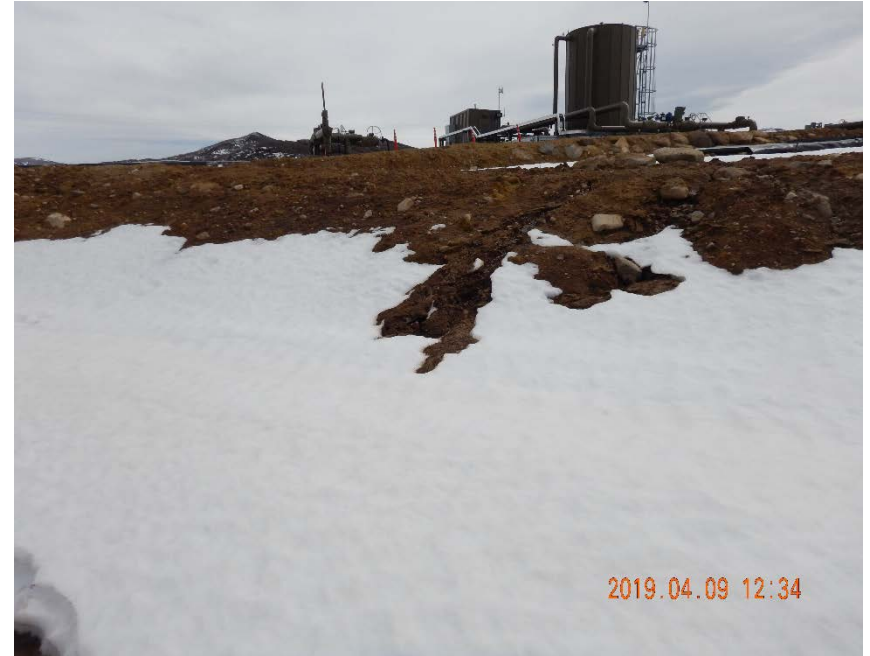
**Photo #46 – Erosion and stormwater run-on toward 'Pond 4' leading from tank battery area SE of pit.**
