Inspection Photos

API: 05-071-06145

Operator: MERIDIAN OIL INC

Inspection Date: 4/2/2019

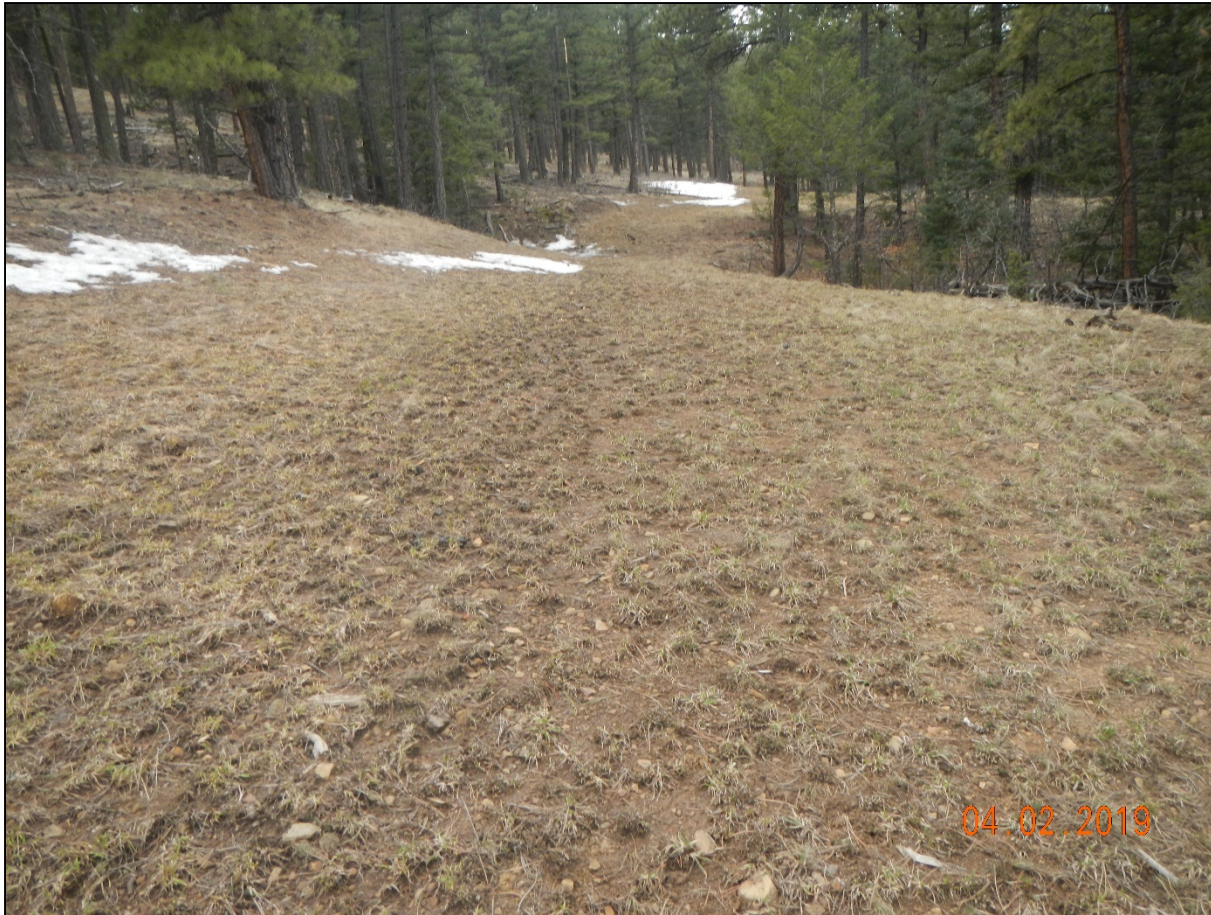
Photo 1. Facing west along the reclaimed access road.

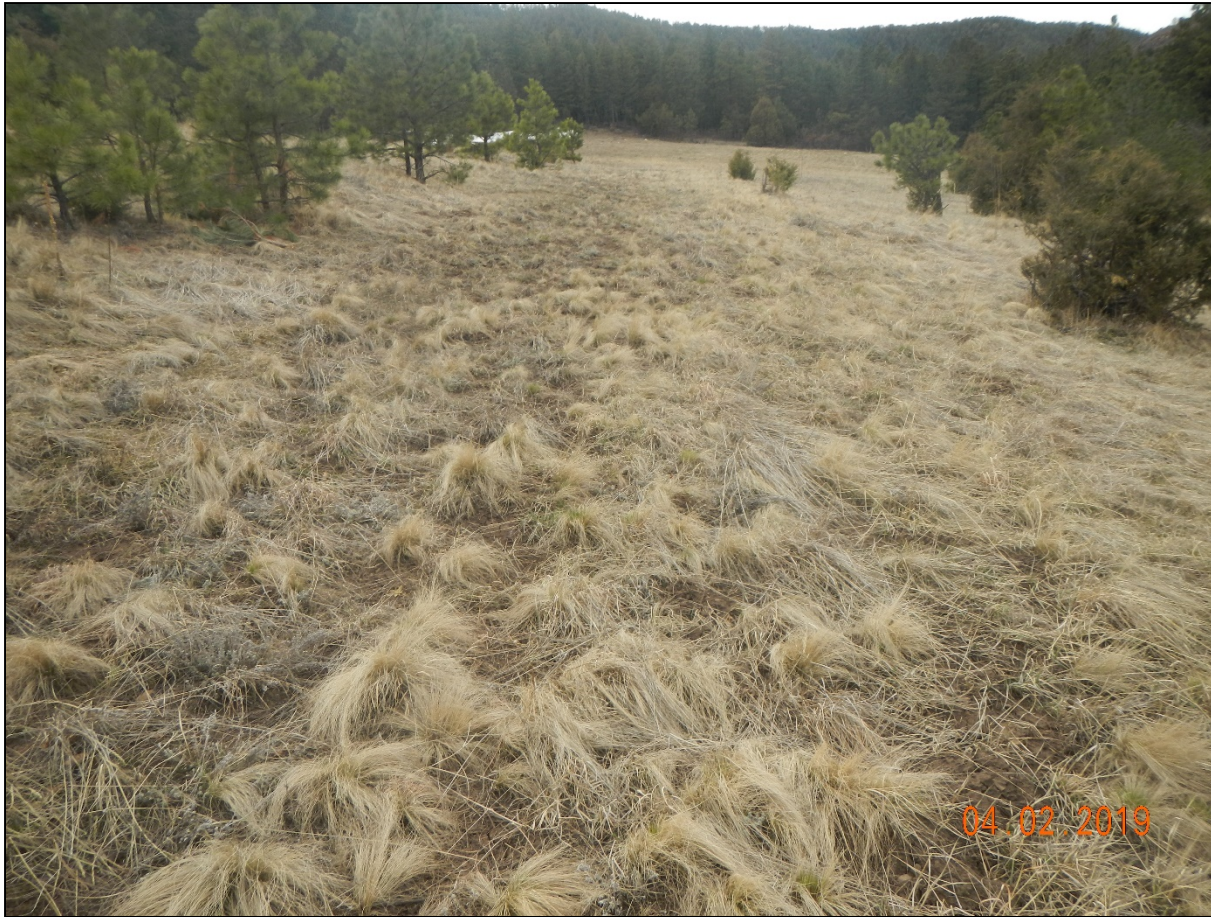
Photo 2. Facing west along the reclaimed access road. Vegetation appears to be fully established.

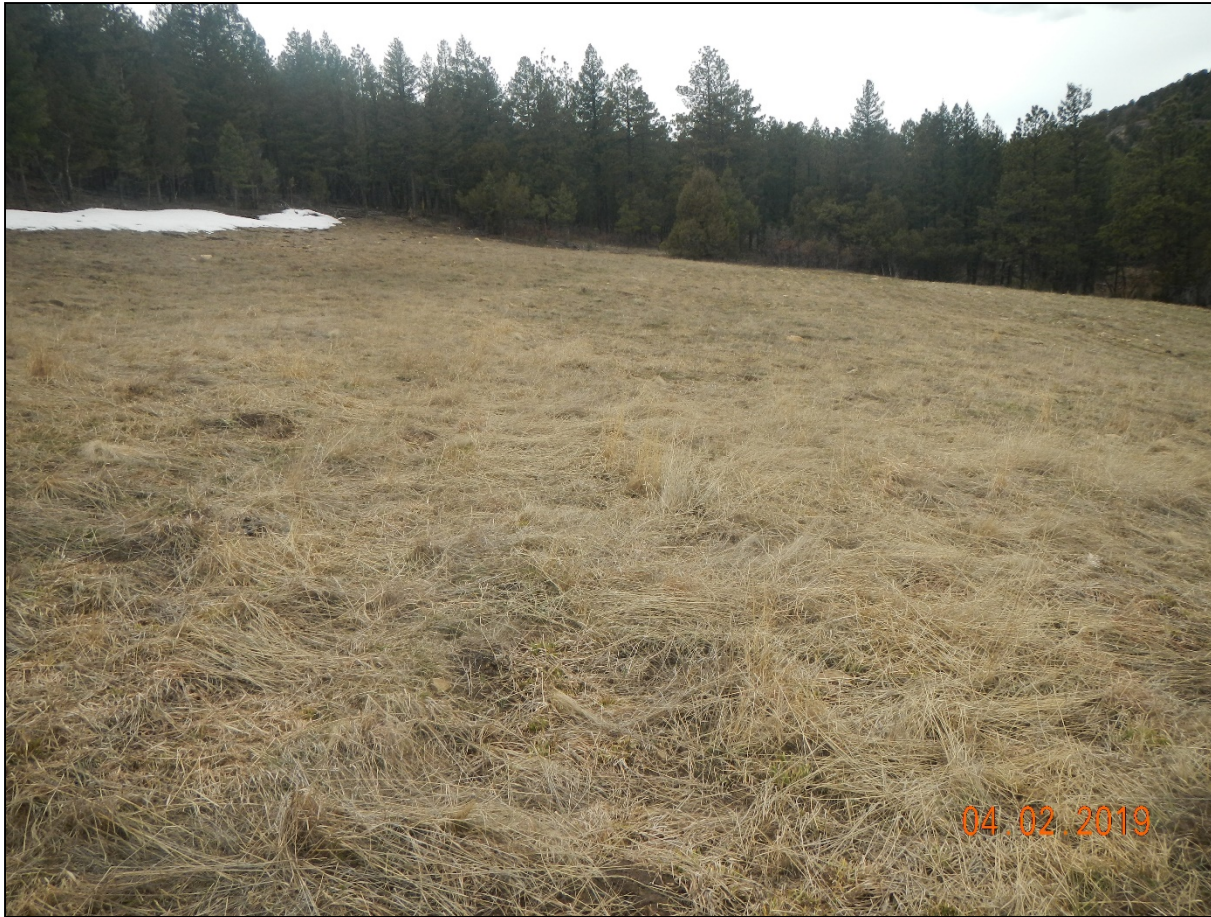
Photo 3. Facing west toward the location.. Vegetation appears to be fully established.
